Slope stabilization efforts along Highway 744:04, Judah Hill Road, Peace River, Alberta

Neil H. Kjelland, Roger K. Skirrow
Alberta Transportation, Edmonton, AB, Canada
 A. James Morgan
Alberta Geological Survey, Edmonton, AB, Canada
 Edward J. Szmata
Alberta Transportation, Peace River, AB, Canada

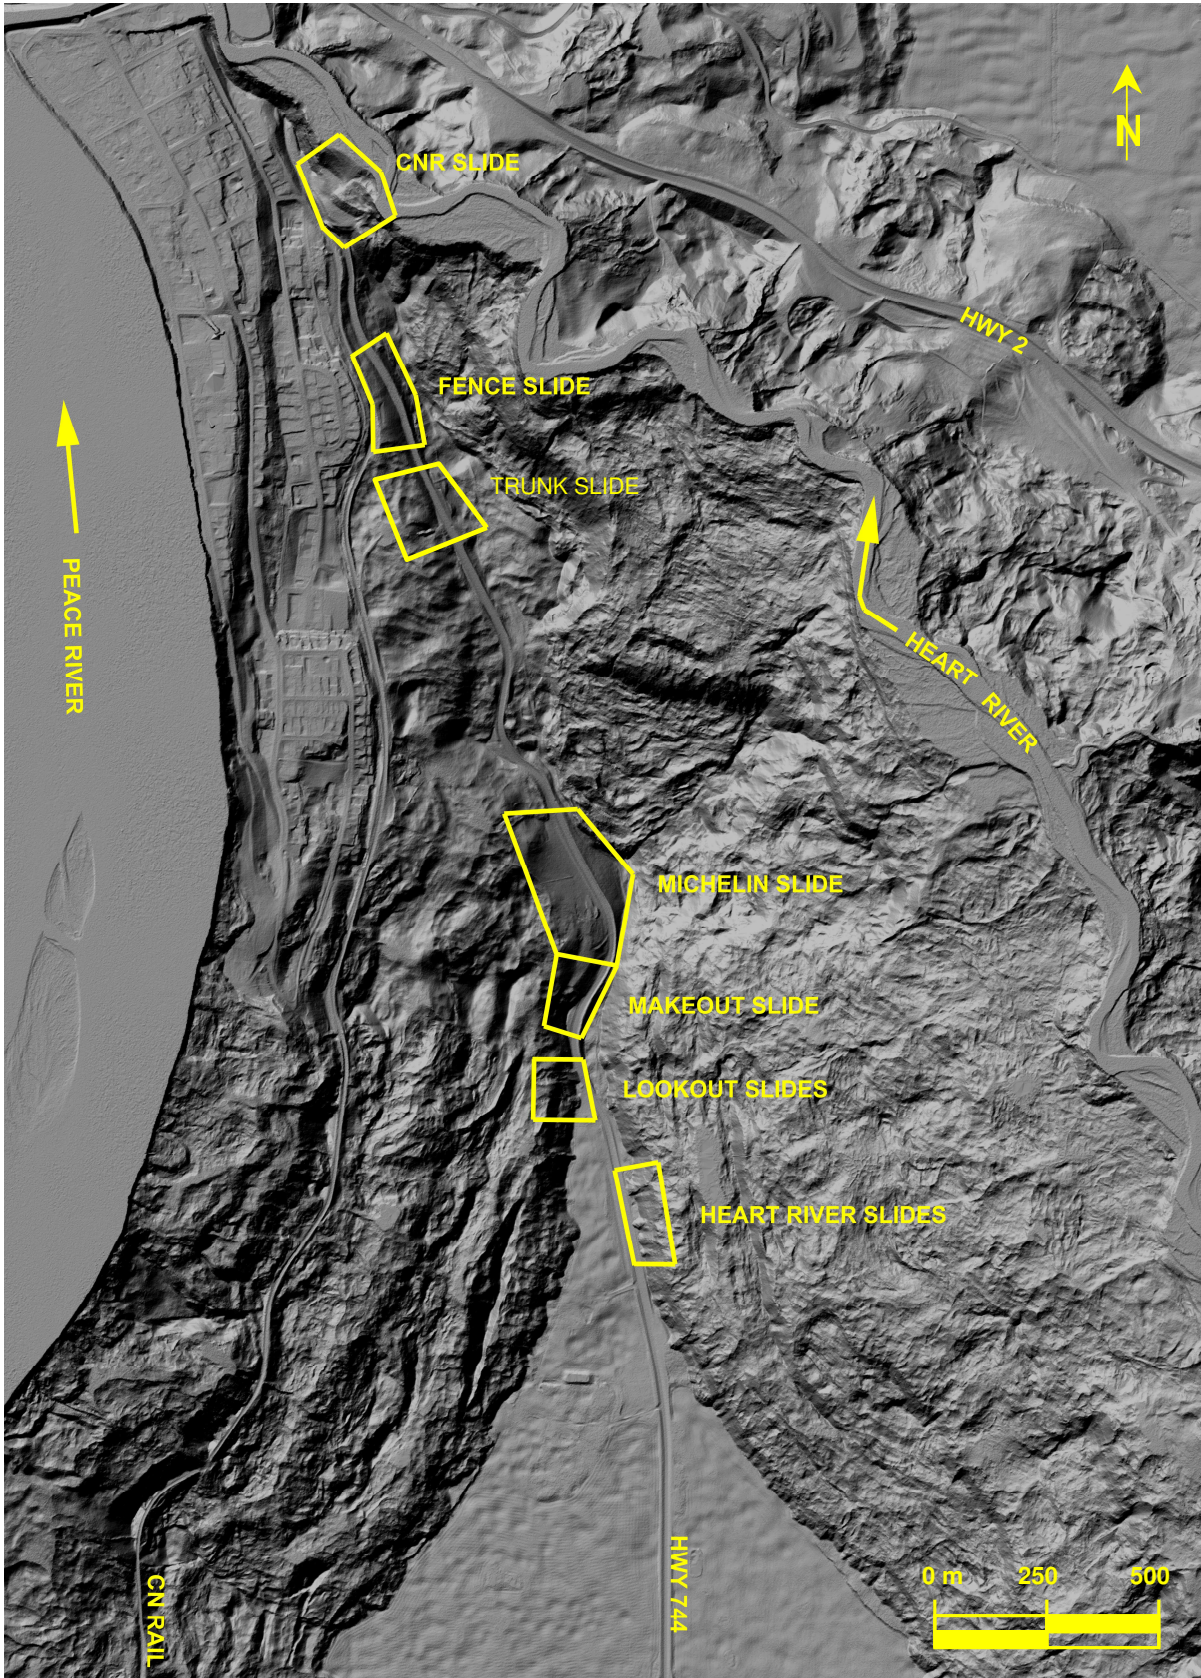
Figure 2. LiDAR image of Hwy 744:04 showing locations of slide areas (courtesy of the Alberta Geological Survey).

Figure 2 shows LiDAR imaging of Highway 744:04 with the 7 slide group locations superimposed over top, and Figure 3 shows an oblique photograph of the road. The LiDAR image clearly indicates that the topography along the east valley wall of the Peace River valley is a remnant of landslide activity, as are all Heart River valley slopes. Judah Hill Road can be seen to intersect many old slide features along its descent into the town of Peace River. Table 1 outlines the geotechnical history of each slide area over the life of the roadway.
