STABILIZATION OF A HIGHWAY EMBANKMENT LANDSLIDE GEOHAZARD

Vishnu A. Diyaljee, Ph.D., P.Eng., GAEA Engineering Ltd, Edmonton, Alberta, Canada
Murthy Pariti, Ph.D., P.Eng., Stewart Weir Ltd, Edmonton, Alberta, Canada

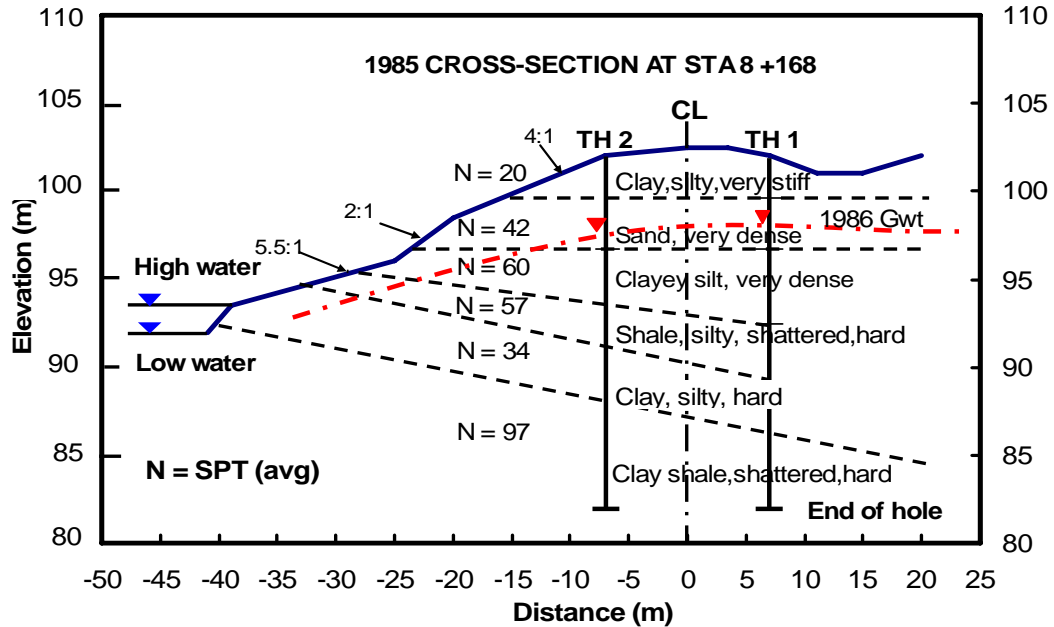
In May 1985, the GSS conducted a detailed geotechnical investigation of the slide area. Six (6) testholes were drilled during this investigation. These consisted of holes for two (2) slope indicators (SI #1 and SI #2), two (2) standpipes and two (2) pneumatic piezometers. The standpipes and pneumatic piezometers were located within 6 m to the north of SI #1 and SI #2, respectively. The SI testhole locations are shown in Figure 3 and identified as ATU. A cross-section within the slide area is shown in Figure 4.

Figure 4: Cross-section Showing Stratigraphy and Testholes (ATU) within Slide Area

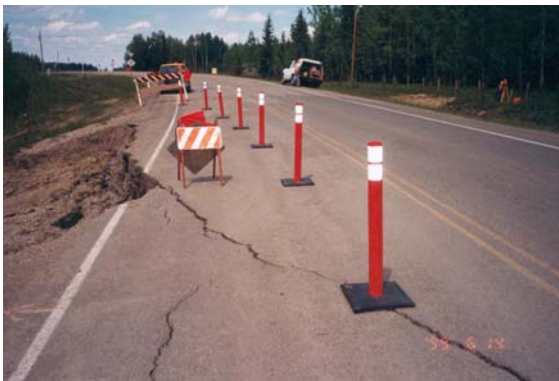
The recommended Option 3 by OMCL was not undertaken by the MD of Yellowhead, presumably as a result of the high cost, and the uncertainty of funding. In the meantime, the slide area became progressively worse by May 1999 resulted in the closure of the southbound lane of the highway. Photographs of the slide area at the time of inspection and prior to construction are shown in Figures 5 and 6.

Figure 5: Southbound lane Closure

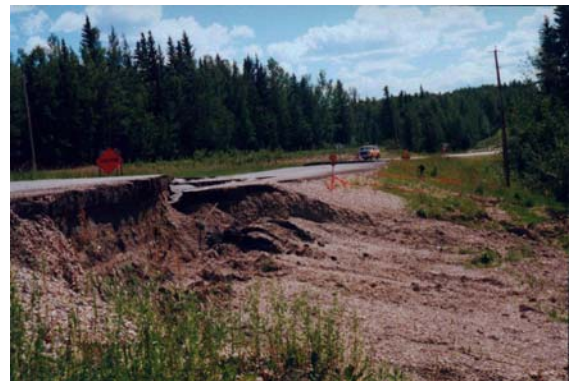
Figure 6: Closure of both lanes

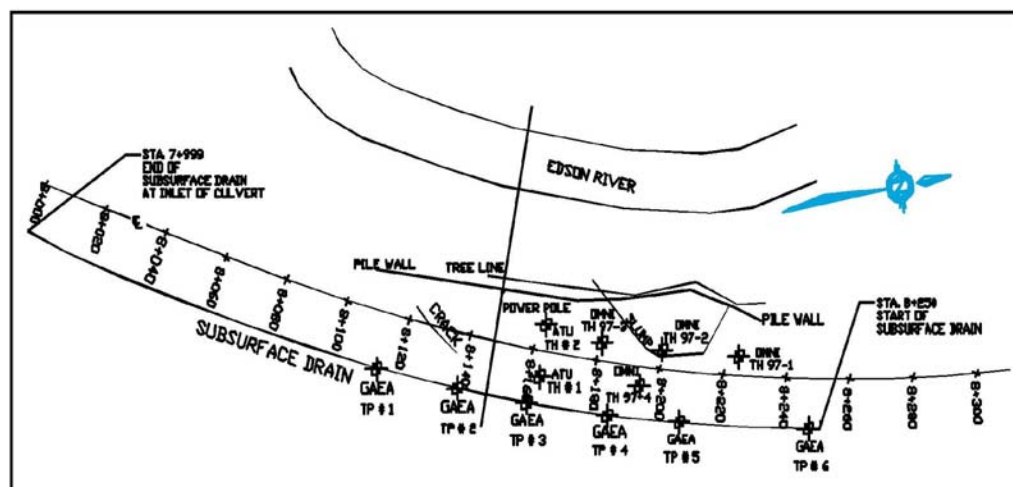
Figure 7: Plan Showing Location of Subsurface Drain

From the observations of seepage locations from the testpits dug in the backslope ditch and on the side slope, it was quite evident that drainage measures would be needed to assist in stabilizing the slide area by installing a subsurface drain in the backslope ditch. This drain would intercept seepage traveling in an east to west direction and discharge it in the Edson River near the north end of the bridge where the highway ditch discharges its surface runoff. Another important measure also recommended was to retain the side slope fill material and arrest river erosion at the toe of the side slope by installing a pile wall close to the tree line. The length of this pile wall would be about 120 metres with offset from the highway centreline varying 12 m at the south end to 27 m at the north end to avoid clearing trees along the riverbank.

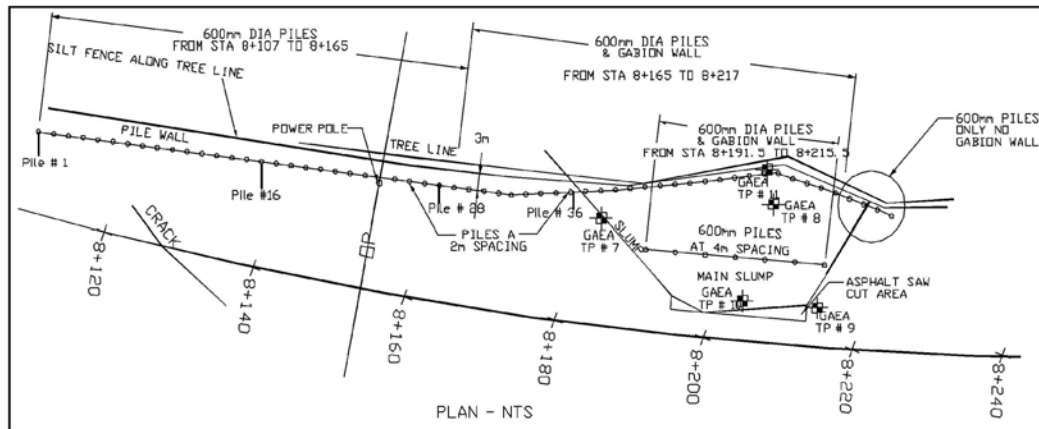
Test pits TP # 7 and TP # 8 were dug in the middle of the slide area while test pit TP # 11 was dug close to the tree line. The material observed in these pits was generally silty clay but with more clay content. Seepage was visible within this material. Test pits # 9 and # 10 were dug closer to the centreline of the road. These two test-pits revealed the existence of very wet pitrun gravel and coldmix which were used to maintain the roadway during the past years. Heavy and fairly consistent seepage was also noticed in the pitrun. Generally, the direction of the seepage appeared to be from the higher ground that exists on the east side of the highway. Based on the cleanliness of the water, flow rate and depth of movement, it was felt that the source of the water would be the subsurface flow from the east (backslope area). Testpits (TP #7-TP #11) are shown in Figure 10 and identified as GAEA.

Figure 10: Plan Showing Layout of Pile Walls and Testpits in Slumped Section

3. Installation of gabion basket walls at two levels on the side slope in the main slump area. The objective of these gabion baskets was to assist in retaining the constructed side slope fill and accommodate any fill settlement. The upper level gabion wall was designed to retain the pitrun gravel fill which was to be used in the main slump area to bring back the highway and side slope to its original grade. The gabions would be constructed to bear against the inside face of the upper piles. The projected length of the upper gabion basket wall was about 50 metres. A similar gabion wall approximately 62 m long would bear against the lower level piles to assist in retaining the fill between the upper and lower level piles. Details of the gabion walls and their location are shown in Figures 10 and 11.

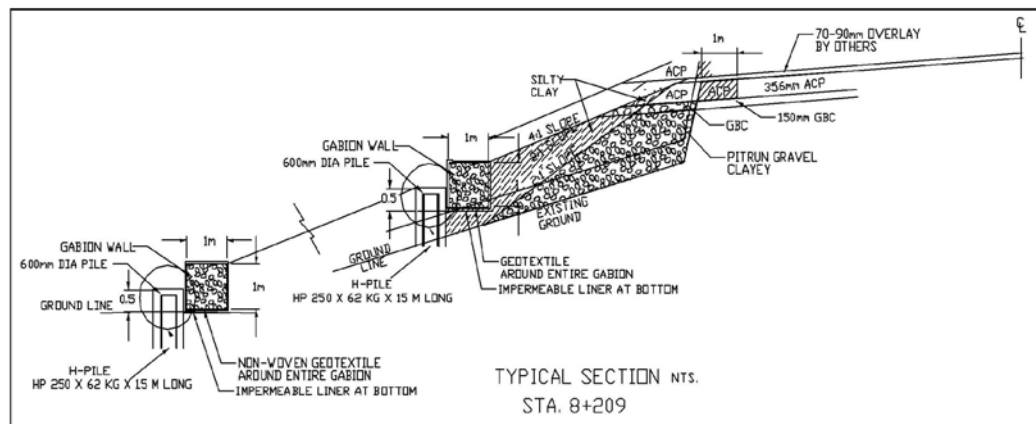
Figure 11: Cross-Section Showing Pile Walls and Slope Rehabilitation

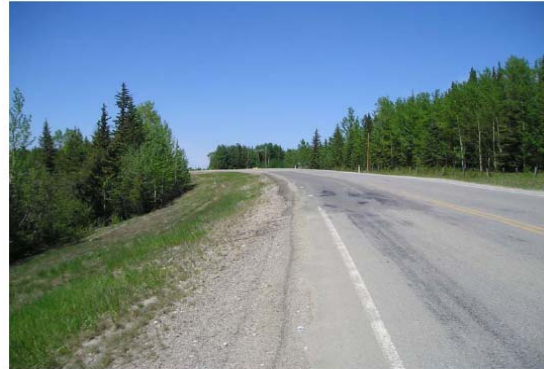
As mentioned in the “Introduction” section of this paper, the site was inspected in December 2005 and conditions found to be satisfactory in the area that was subject to the remedial measures. However, a short crack was observed at the roadway shoulder edge in 2002. There is uncertainty of the cause of the crack and recommendations have been made by others responsible for monitoring this site to undertake installation of slope indicators for determining the nature of the problem. The crack occurring some 40 m to the south of pile #1 places the distressed area within the influence of the bend of the river. There is, therefore, a possibility that some erosion activity may be causing this problem.

Figure 17: Highway Section - May 2005
