EMBANKMENT SLOPE STABILIZATION USING SUBHORIZONTAL DRAINS AT HIGHWAY 39 NEAR DRAYTON VALLEY, ALBERTA

Renato V. Clementino

Thurber Engineering Ltd, Edmonton, Alberta, Canada, rclementino@thurber.ca

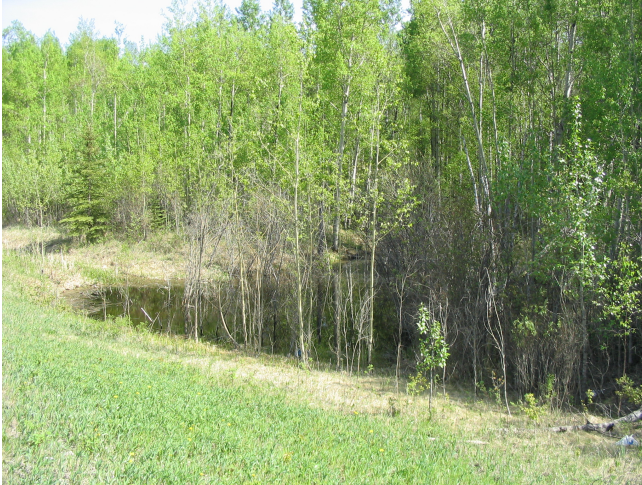
An 800 mm diameter centreline culvert was blocked, probably because of the slide, which caused water to pond in a low area adjacent to the uphill ditch. The pooled water was a continuous source of local groundwater recharge. Figures 1 and 2 show the site conditions.

Figure 1. Pooled water in south ditch at blocked culvert location.

The upslope pond formed by the centreline culvert blockage was a source of groundwater recharge. A new centreline culvert was considered most suitable for maintaining the upslope area dry. In addition to the pond dewatering, the following remediation options were considered to increase the factor of safety against slope failure:

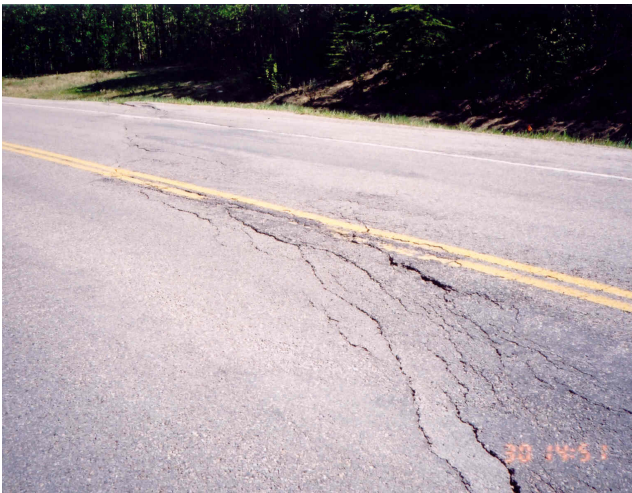
According to Swan (2002), the first distress on the roadway surface was noted around 1978-79. The distressed area was patched twice yearly until the early 1980's. In 1982-84 a trench drain about 100 m long and 2 m deep was installed within the uphill ditch adjacent to the distressed area, and a trench drain was also installed crossing the highway. These efforts reduced the patching rate to about once every other year. With time, the patching rate increased to yearly.

Figure 2. Pavement distress, west flank of the slide, looking southeast.

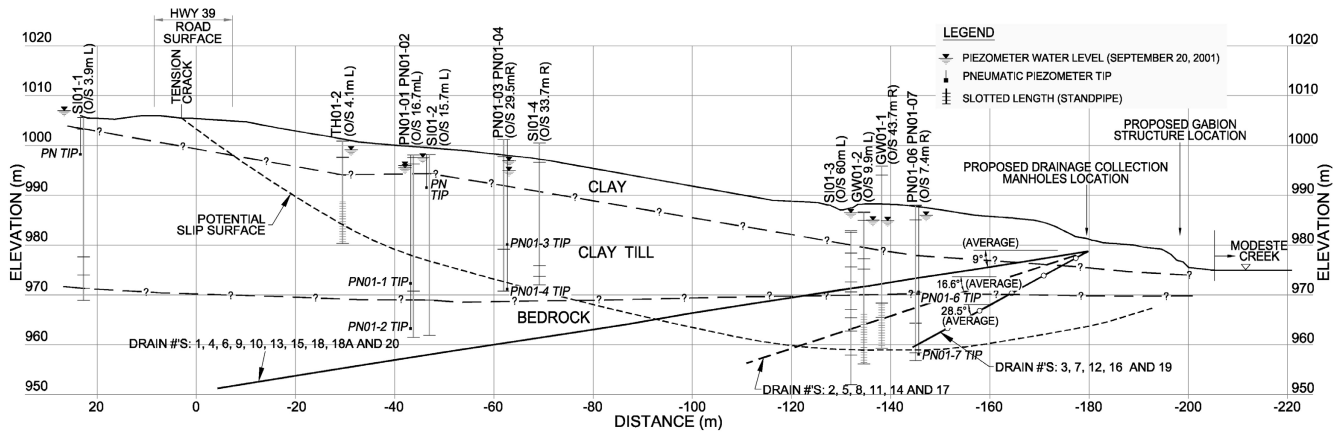
Figure 3 shows a cross section through the centre of the slide with the soil stratigraphy and inferred shear plane based on the depth of movement recorded in the SIs.

Stability analyses were carried out using the limit equilibrium software GSlope. A back analysis indicated that the instability is primarily driven by high pore pressures, with artesian or near-artesian conditions occurring over the lower third of the slope. The back analysis also indicated that the bedrock was likely pre-sheared; and the shear strength of this material was likely near or at residual strength. Toe erosion at creek level was not found to be a significant factor in the slope stability. Additional stability analyses were performed to assess suitable remediation options to improve the slope factor of safety to a target of approximately 1.3.

Figure 3. Cross section showing subsurface conditions, inferred shear plane, and subhorizontal drains.

Reducing the pore pressure by installing subhorizontal drains was considered to be the most cost effective remediation measure. The stability analyses showed that by lowering the groundwater level by about 5 m the slope FS would increase by approximately 30 %.

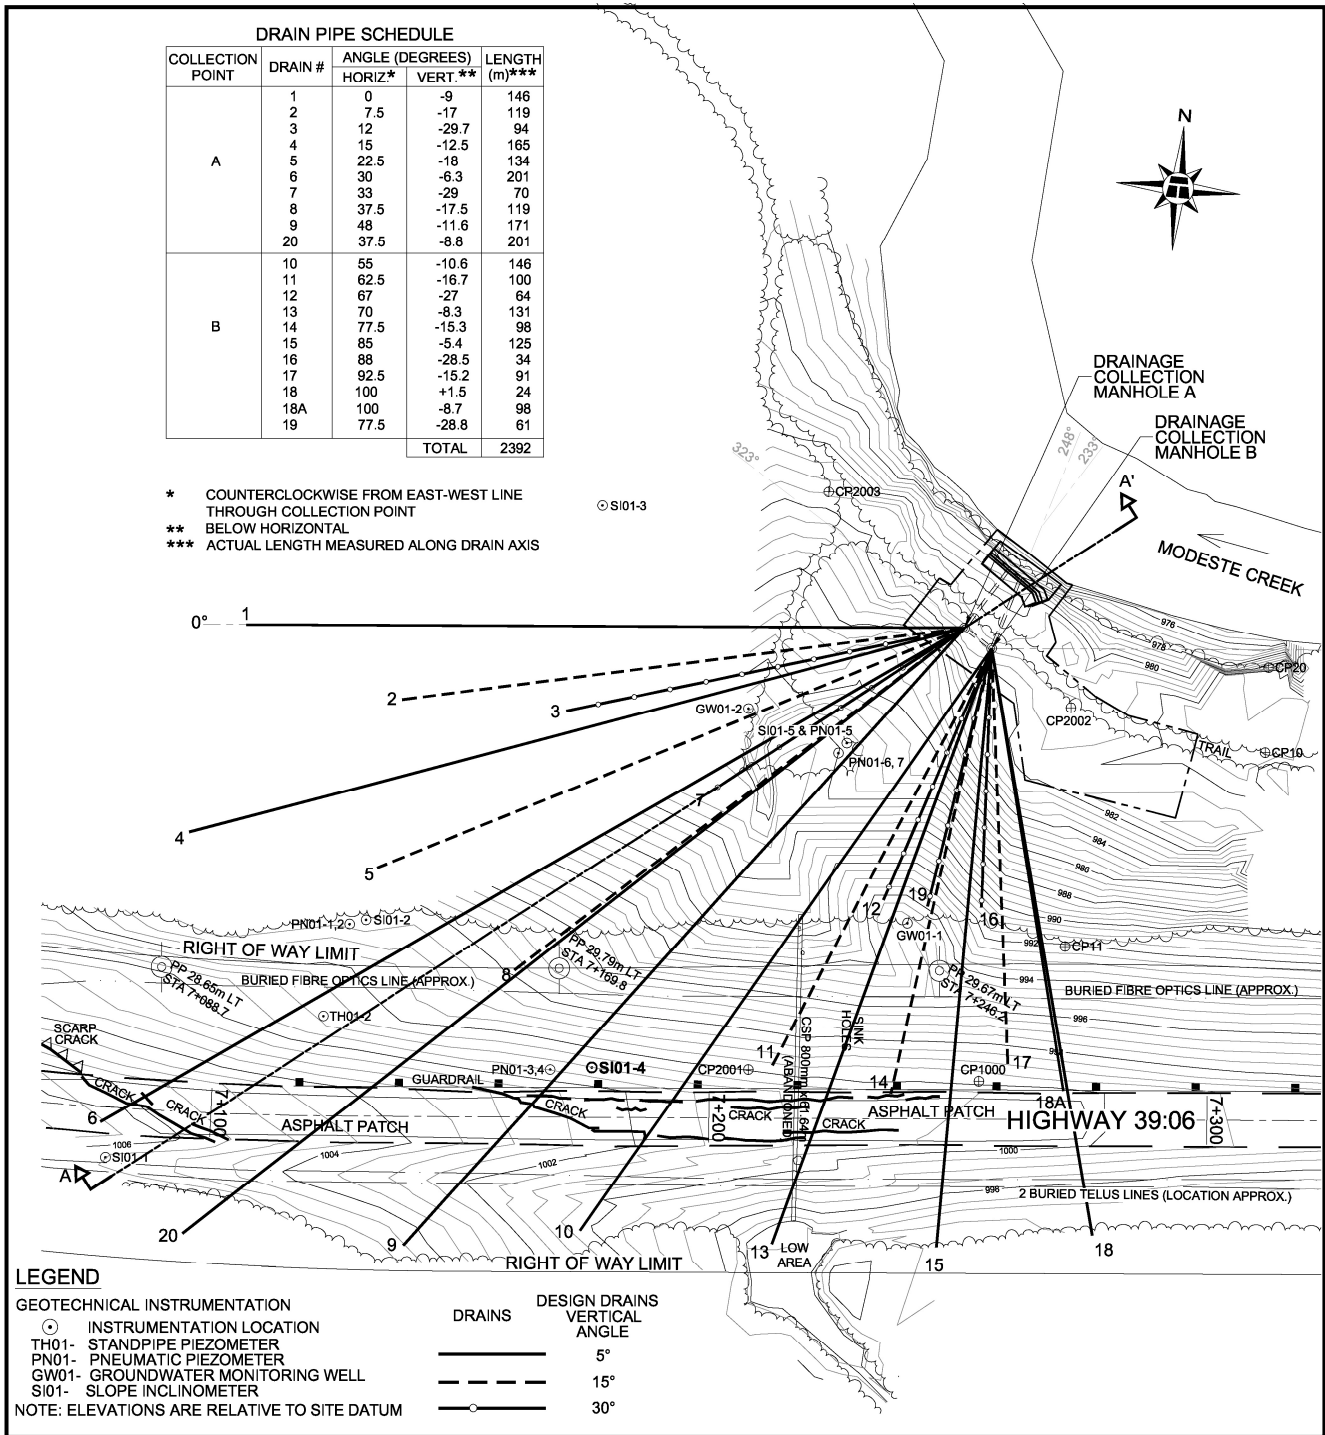
Figure 4. Site Plan showing subhorizontal drains layout.

The subhorizontal drain system consisted of two clusters of drains fanning vertically and horizontally as shown in Figures 3 and 4, respectively. Each drain cluster terminated in a drainage collection manhole consisting of a vertical corrugated steel pipe (CSP) culvert, 1.2 m in diameter, installed near the toe of the slope. Each manhole was

A total length of 2392 m of subhorizontal drains were installed, consisting of 21 drains with lengths varying from 24 m to 201 m. The drains consisted of 38 mm diameter schedule 80 PVC pipes, with 3 rows of 0.25 mm wide slots and 6.4 mm clear spacing between the slots within the rows. Each row of slots was centered at 120° intervals around the pipe circumference.

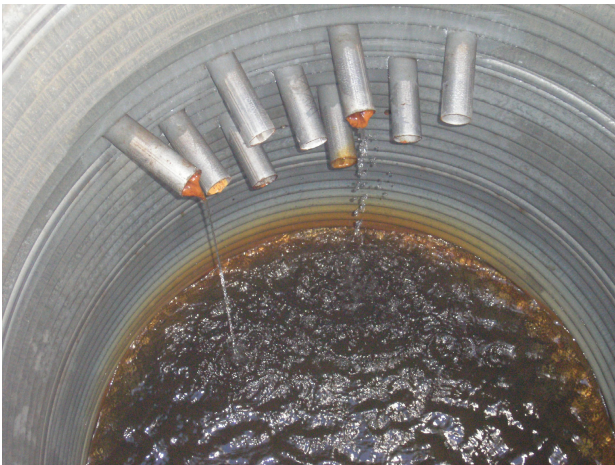
Figure 5. Subhorizontal drain outlets.

Since installation these two drains have continuously yielded water with a few others seasonally producing water. Figures 5 and 6 show a general view of the inside of the manhole and the gabion outfall, respectively.

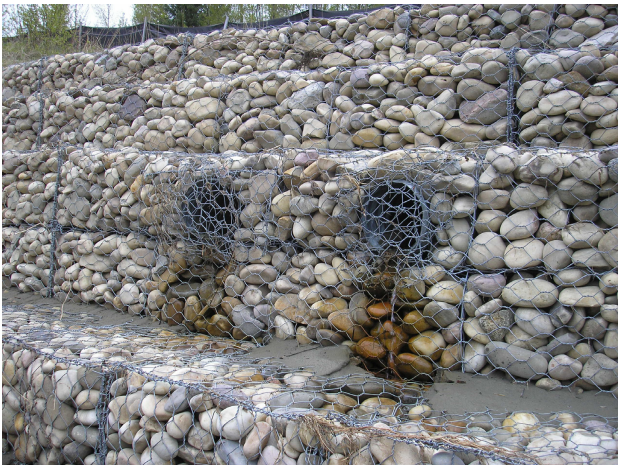
Figure 6. Manhole outlets in gabion outfall structure.

constructed with a 300 mm diameter CSP outlet pipe that drained the groundwater through a gabion outfall structure installed along the river bank. A cross-connection between the two manholes was built to allow for continued drainage in the case that one of the manhole outlets became clogged.

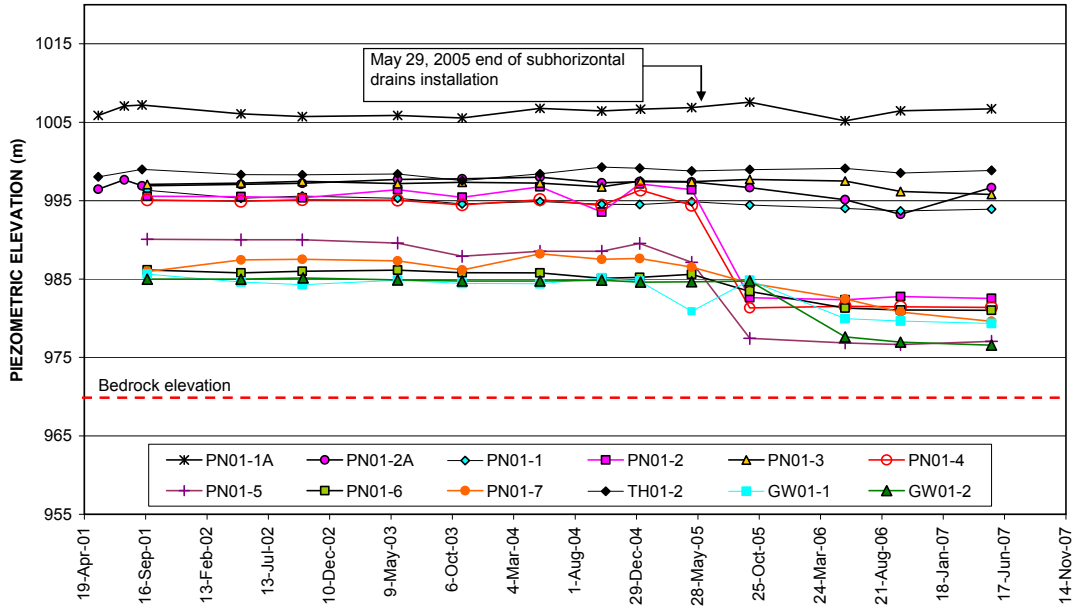
Figure 7 shows the results of the piezometer readings before and after the remediation work. Of the twelve piezometers installed, seven measured a significant drop in groundwater levels. Three piezometers (PN01-2, PN01-4 and PN01-5) showed a relatively fast (5 month) response in lowering the groundwater elevation, and the others show a more gradual response with time. Since the end of the subhorizontal drain installation (May 29, 2005) the recorded drop in groundwater elevation varied from 4.6 m to 13.8 m. No significant rebound in groundwater elevation has been noted in the last 2 years of monitoring. In fact, piezometers PN01-7 and GW01-2 continue to show a slow but continuous drop in groundwater elevation.

Figure 7. Piezometer readings before and after subhorizontal drains installation.

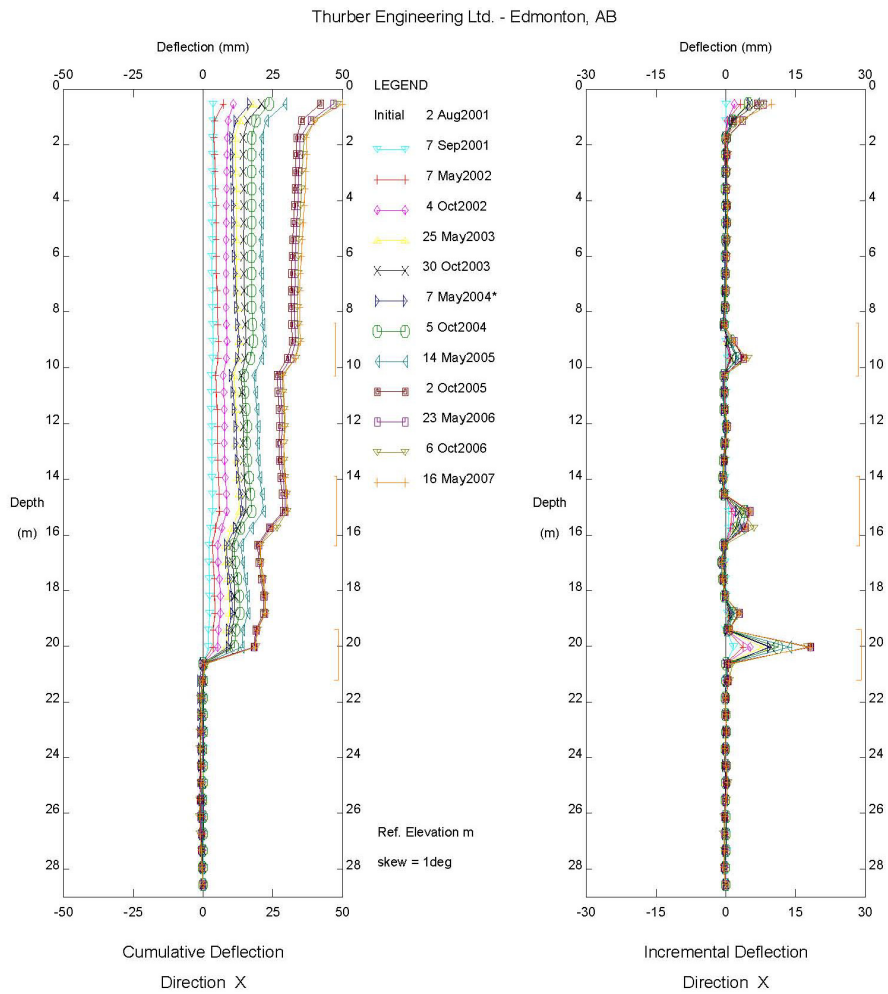
Figure 8 shows cumulative and incremental movement readings from one of the site slope inclinometers (SI01-4) and Figure 9 shows the rate of movement plot from the

Figure 8. Typical slope inclinometer (SI01-4) cumulative and incremental deflection.

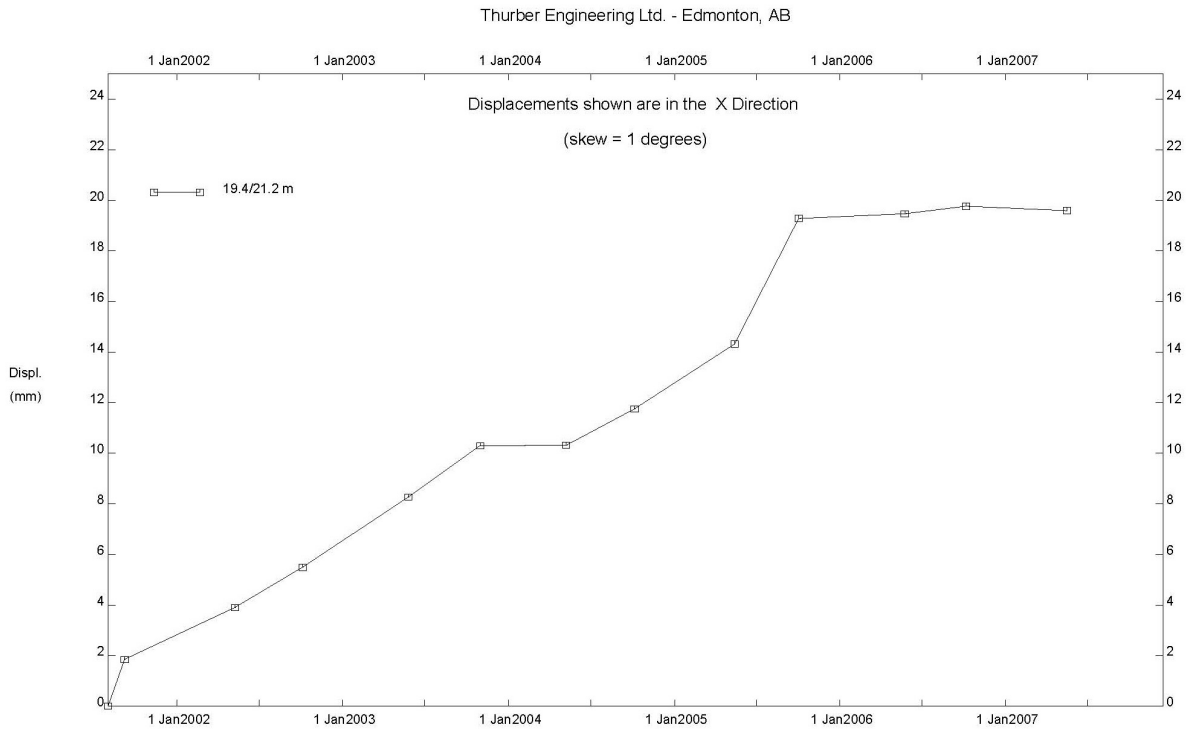
same slope inclinometer. The rate plot shows that the slope movement measured in this SI prior to construction of the subhorizontal drains was approximately 13 mm/year, and dropped to near zero over the next three sets of SI readings following the implementation of the remediation measures. This result is typical of the slope inclinometer results obtained.

Figure 9. Typical slope inclinometer (SI01-4) rate of movement plot
