FOAM COLUMN INJECTION TO A HIGHWAY EMBANKMENT FOUNDATION - RESULTS OF A FULL SCALE PILOT STUDY

Jermaine Smith, P.Eng. (*Presenter)
Project Engineer
EBA, A Tetra Tech Company

At the 2011 Annual Conference of the
Transportation Association of Canada
Edmonton, Alberta

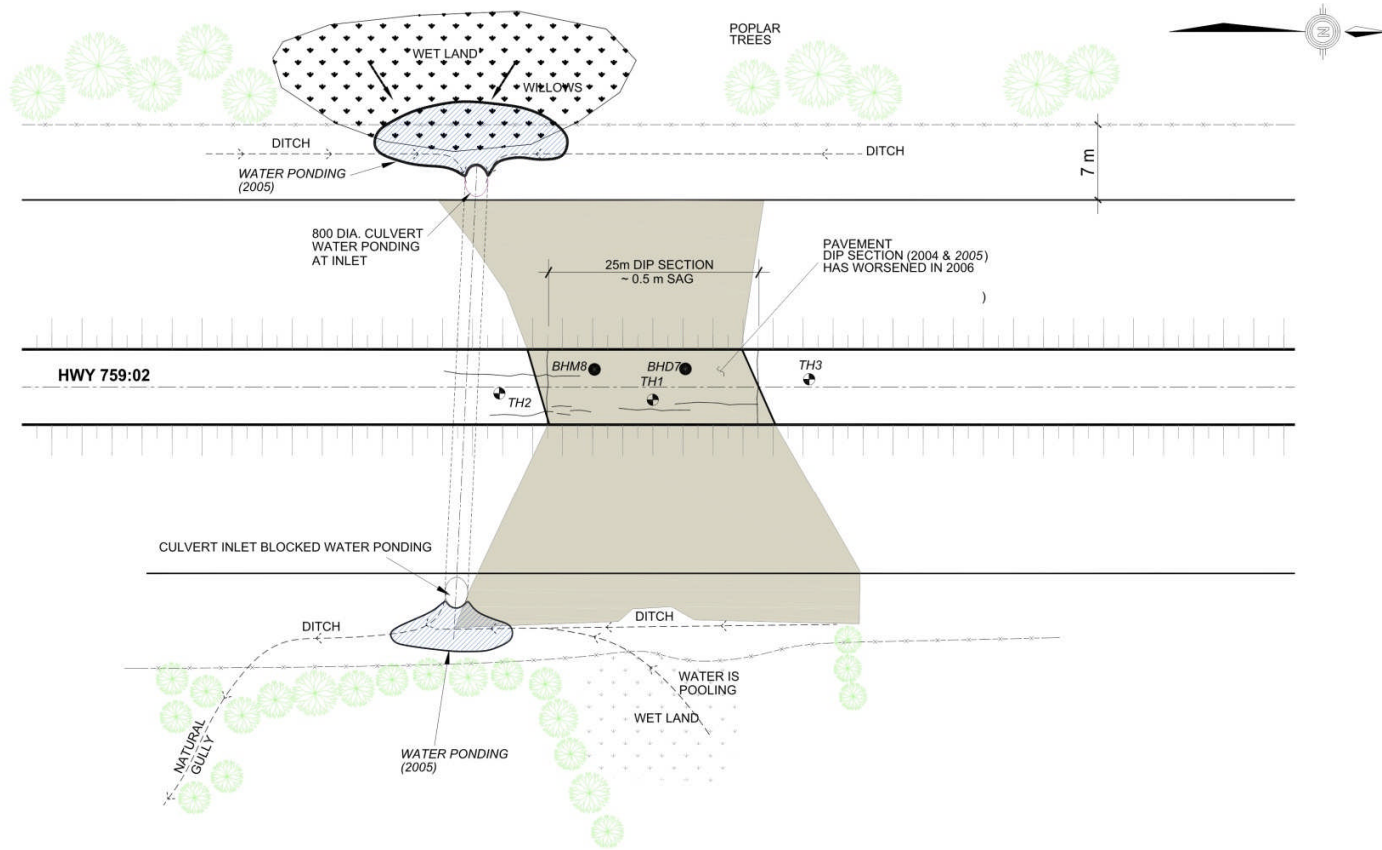
The site could be generally described as a poorly draining and swampy. Evidence of this is seen from the wetlands on either side of the roadway and by the water that pooled on both sides of the highway at the invert and outlet of a culvert located just south by about 20 m from the centre of the dip, as identified in Figure 2.

Figure 2. Site Layout Plan

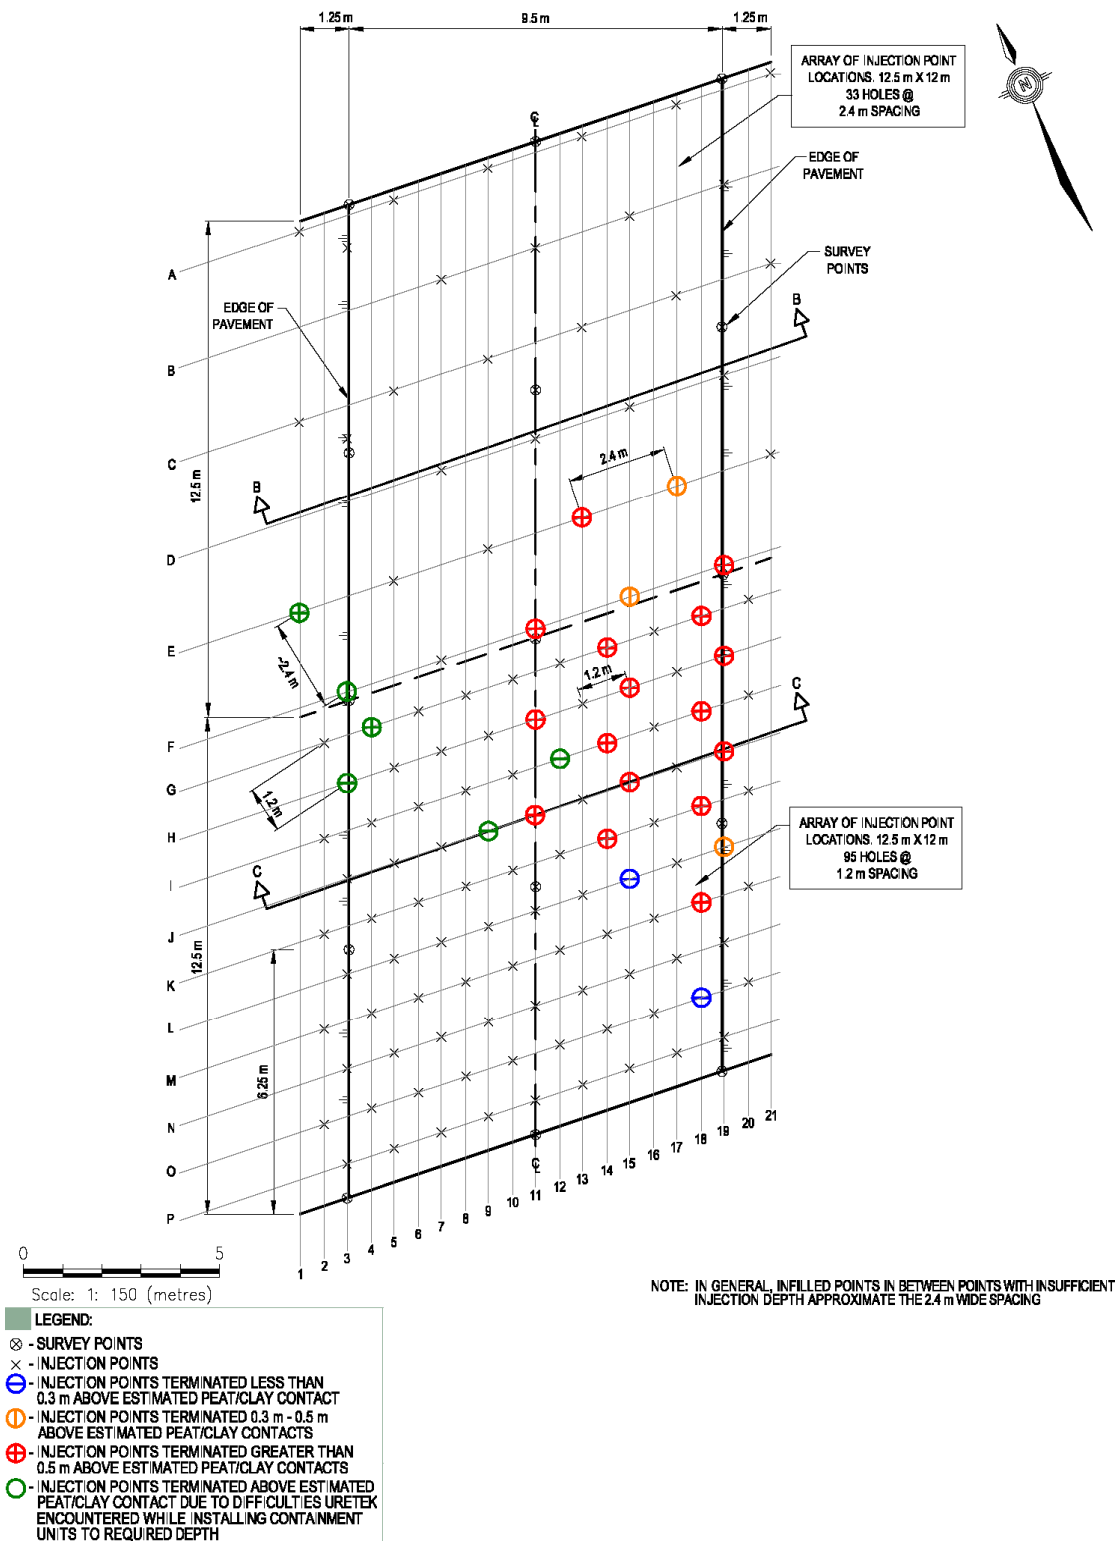
Early in the program a group of 21 containment units placed in the northbound lane were installed to a depth around 6.7 m, but were not embedded in the clay below the peat as prescribed by EBA during start-up, as can be seen in Figure 6. This was evident when comparing the depths at which the containment units were installed with the stratigraphy interpreted from the boreholes conducted by EBA and JWAL.

Six other units were terminated short of the peat/clay boundary as a result of difficulties Poly Mor had while installing the containment units, in holes where slough-in or the cuttings were not cleared from the hole while drilling. This resulted in Poly Mor requiring 2 to 3 workers to try and push the unit deep enough into the ground, and often resulted in the unit not being placed at the required depth. Locations of these injection points can be seen in Figure 6.

Figure 6. As-built layout. Highlighted injection points had special circumstances of note.

The pattern selected to install the containment units entailed completing every other foam injection borehole in a row before moving onto the next row and then once all rows were complete, the remaining foam injection boreholes were infilled. The remaining infill boreholes in this area were installed to the required depth. Settlement data collected to-date indicates early detection of this permitted adequate mitigation.

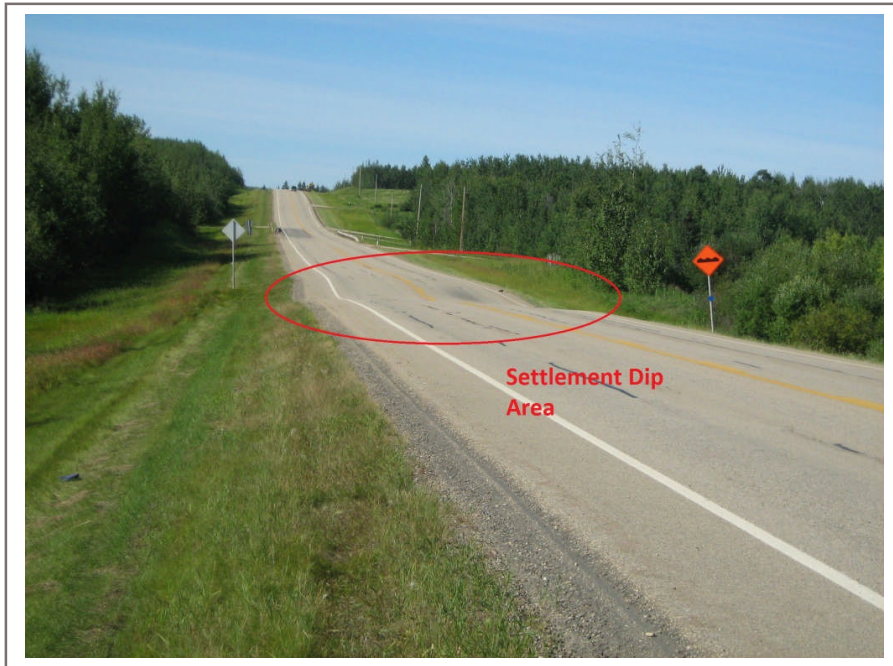
Four metres of embankment fill and asphalt pavement was placed over 4 m of peat, overlying soft organic clay. The compression of the peat resulted in the dip of the pavement which has been historically repaired with asphalt patch overlays. However, the additional weight of the asphalt would cause additional peat compression. This cycle of repeated overlays to repair a perennial dip has continued for many years. In the spring of 2008, when EBA first inspected this site, there was a dip in the pavement surface of approximately 0.5 m as seen in Photo 1 and identified in Figure 2.

Photo 1. Site prior to construction identifying the dip, looking south

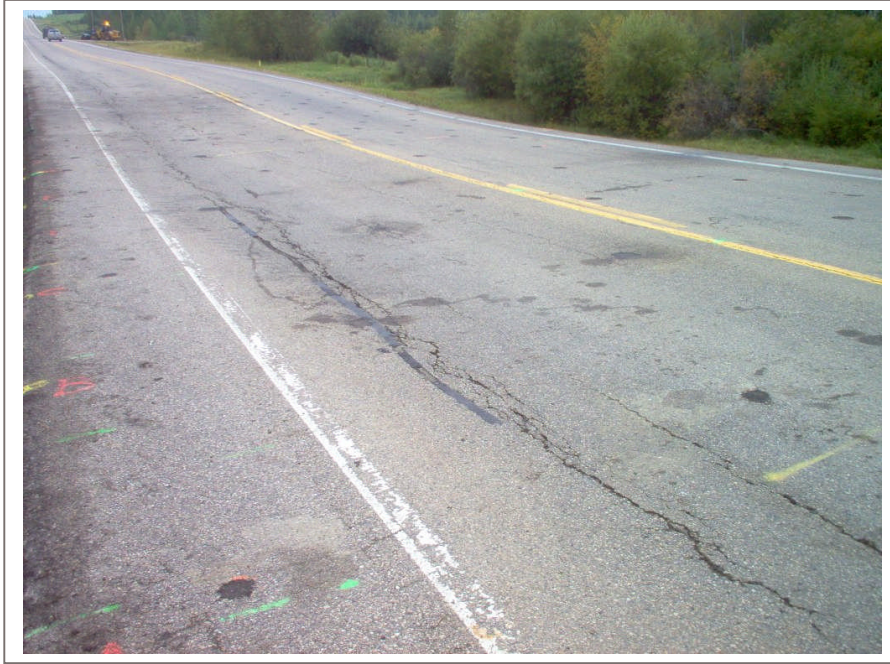
Photo 6. Site after foam injection, looking south. Notice asphalt patched injection points

A total of 60 lbs. of polyurethane foam was injected into each hole. Following foam injection, the conduit and tubing remaining above ground was cut a couple inches below the road surface. If any foam spilled onto the road it was also removed to a couple inches below road surface. A ready-mix asphalt cold-mix was used to patch the hole and bring it to grade as seen in Photo 6. The site after paving can be seen in Photo 7.

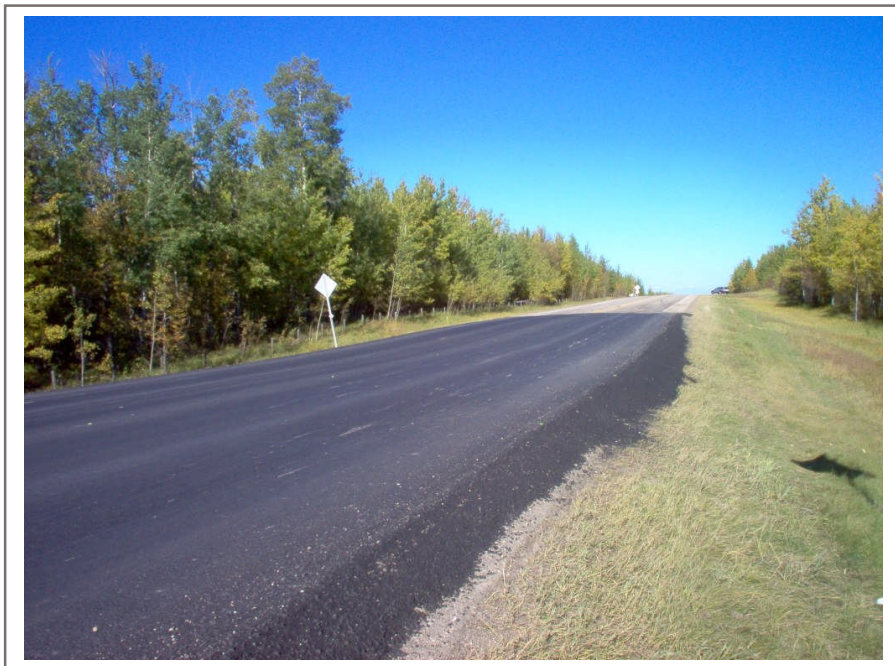
Photo 7. Site after asphalt paving to reprofile dip in the roadway, looking north
