STONE COLUMN USE IN HIGHWAY CONSTRUCTION

V. A. DIYALJEE
M. PARITI

Geotechnical Section, Alberta Transportation & Utilities, Edmonton, Alberta

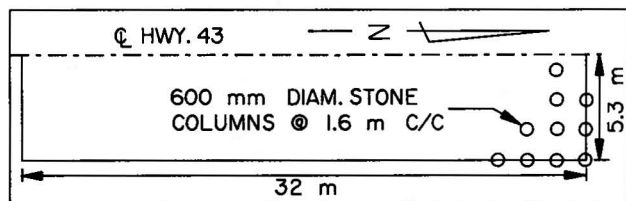
Figure 2: Location of Stone Columns

The distress of a 100 m section of this roadway was diagnosed to be caused by settlement and has been categorized as a bearing capacity related problem. This roadway was constructed in 1959 as a one lane road to the east of the present roadway centreline. In 1979, the roadway was widened to accommodate two lane traffic. This widening was done to the west of centreline and construction consisted of excavating about 4 m of existing ground and backfilling with clay borrow over which the pavement structure was constructed. Performance records indicated that the one lane road had a history of settlements.

An inspection of the 2 lane roadway in 1980 resulted in the drilling of four testholes to determine the nature of the underlying soil. Testholes done to a depth of about 8 m revealed soft clay and muskeg. Muskeg probes and insitu shear tests revealed the depth of firm or hard ground to be about 6 m. Remediation to alleviate the settlement problem consisted of installation of a total of 90 columns as shown in Figure 2. These columns were placed to a depth of 8 m and constructed to a diameter of 0.6 m. The material used to fill the holes was well graded pitrun gravel. Compaction was undertaken by a plate tamper at depth and by a hand tamper near the ground surface (Photos 1 and 2). However, despite this treatment, settlement continued warranting the use of lime flyash injection.

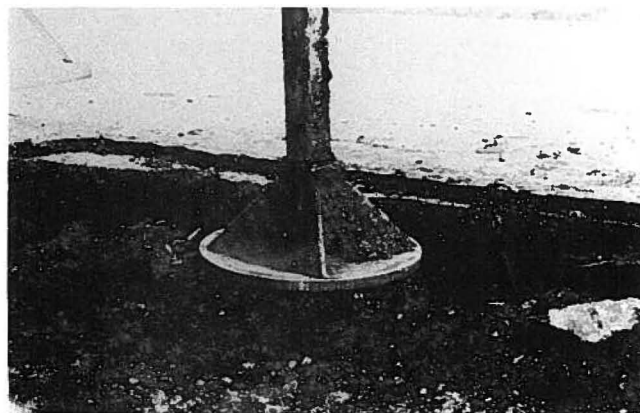
Photo 1: Plate Tamper For At Depth Compaction

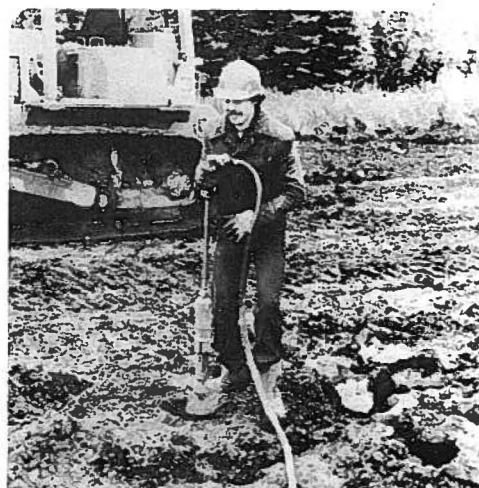
Photo 2: Hand Tamper For Surface Compaction

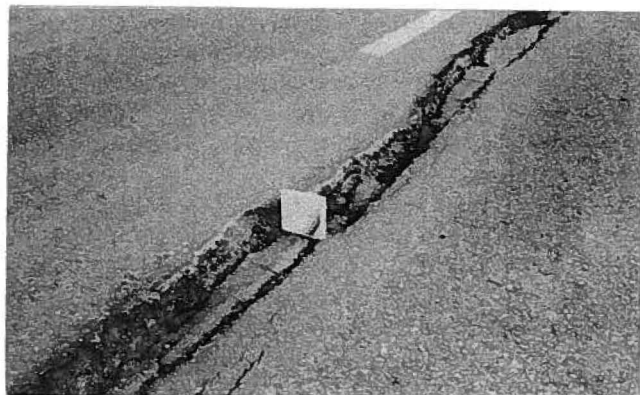
A section of this roadway, Photo 3, had been undergoing distress since its construction in 1960. Treatment up to 1980 consisted of overlaying the cracked pavement with hot asphaltic concrete. In 1980, a lime flyash treatment was undertaken to alleviate the problems at this site. Following this treatment, the roadway was reported to be stable until 1985 when cracking and lateral displacement were reported by district maintenance staff.

An investigation of ground conditions showed similar subsoil conditions prior to lime flyash injection except that the 12 m of soft clay was very waterlogged and possessed a moisture content of 104% compared with about 40% prior to lime injection. Underlying this soft clay was dense sand that was under artesian conditions. The previous investigation had punctured this artesian layer but this was reportedly plugged.

Photo 3: Cracking and Displacement of Roadway

Several approaches were considered to solve this problem. Finally, it was decided that in-place treatment using stone-lime columns would be utilized. The idea of using lime was to reduce the moisture content of the soft clay and improve the strength characteristics of the subsoils.

Two hundred and thirty three stone-lime columns were constructed using a Texoma 600 drill rig. About one half of these columns were constructed to a diameter of 750 mm outside of the shoulder while the remainder were constructed within the roadway to a diameter of 300 mm. The average depth of the columns was 6 m and spacing approximately 1 m on a staggered grid as shown on Figure 3.

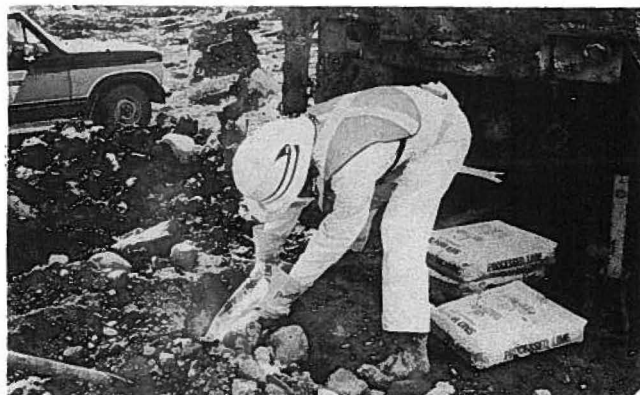
Photo 4: Addition Of Lime To Form Base Plug

The shoulder columns were constructed first. During this construction, trials were incorporated to assess the most effective method for construction of these columns. The approach used was to add about 4 bags of hydrated lime (Photo 4) at the 6 m depth followed by addition of gravel to a height of about 1 m above the excavated depth. The auger was then used to mix the gravel and lime (Photo 5) after which the auger was replaced with a tamping plate as shown in Photo 1 which was used to compact the stone-lime mixture by a pressing and torquing action to form a base plug.

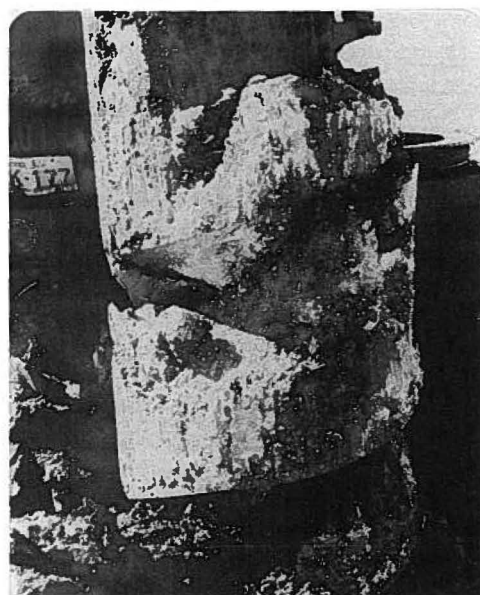
Photo 5: Stone-lime Mixture Using Auger

Following the base plug construction gravel and lime were added to a further 1 to 1.5 m thickness. Mixing of the aggregate and lime was then undertaken by the auger following which compaction of the mix was done using the tamper. This sequence of operation was followed until the columns reached about 300 mm below ground surface. The remainder of the column was then constructed with compacted clay to prevent surface run off infiltration.

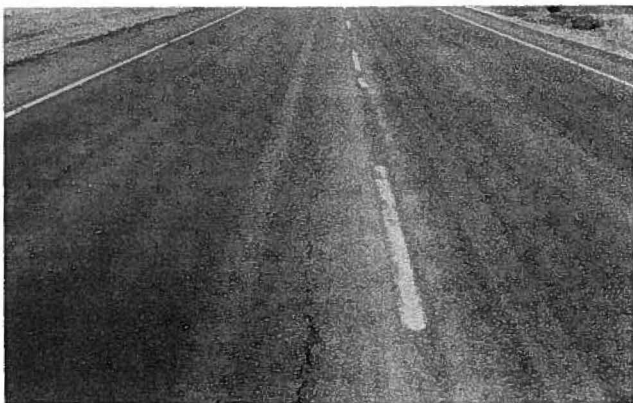
Since completion of the overlay the site has been monitored on a frequent basis. To date, we have observed that the cracks prior to remediation have reflected through the overlay but that the roadway is intact without any signs of displacement as observed previously. Spikes have been set in the roadway to monitor lateral movement of the cracks. These were installed in October 1989. Based on our visual observation, this roadway is performing quite well so far. Photograph 6 shows the roadway condition approximately 2 years following remediation.

Photo 6: Post Construction Roadway Condition

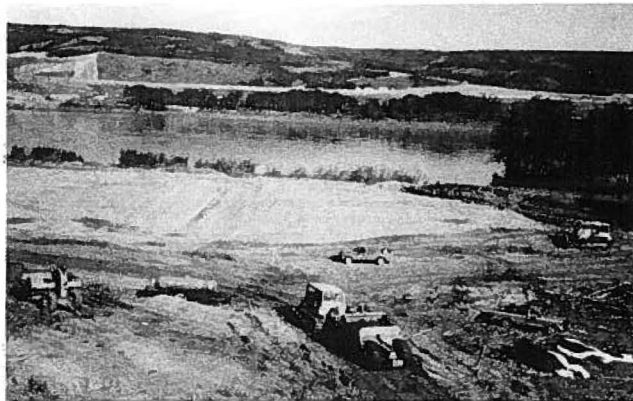
Testhole drilling at the headslope locations showed the ground on the east side to be composed of predominantly a low plasticity silt in a moist to dry condition with standard penetration resistance averaging 10 to 12 throughout its thickness. Underlying this silt is dense gravel followed by hard shale and sandstone. On the west side, similar conditions existed except that a 2 m thick layer of soft silt was found just above the gravel layer. This silt was wet and weak and was considered a poor layer that could result in foundation instability.

Slope stability analyses were conducted using both long term and short term strength parameters. These analyses provided factors of safety ranging from about 1.2 to 1.5. Along with judgement, these factors of safety were considered acceptable. However, it was considered that any improvement to the silt characteristics would be beneficial. Stone columns were considered to provide this increased improvement since they could be constructed to bear onto the gravel layer and hence penetrate the weak layer on the east side. For the west side, the effect would be also an improvement of shearing resistance to the potential slide plane as well as to transfer the embankment load directly to firmer ground below the silt.

Photo 7: Overview Of Headslopes

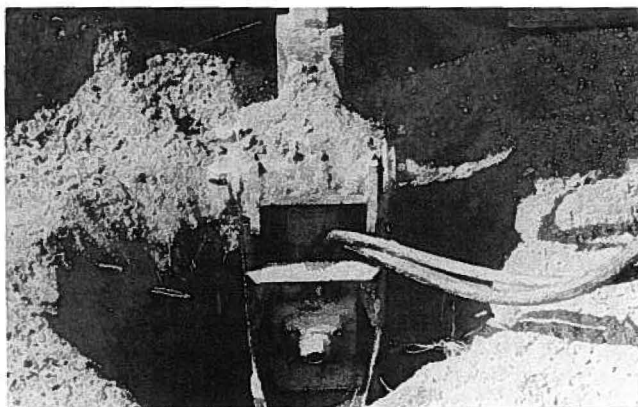
Photo 8: Tamper Attached to Texoma 300 Used To Compact Stone-Columns

A total of 110 stone columns, 750 mm in diameter were constructed on the west approach and 130 of similar diameter on the east approach, Figures 4 and 5. The columns on the west side were constructed with a Texoma 700 drill rig and a Texoma 330 rig. The Texoma 330 rig was used to provide compaction to the stone columns using a pneumatic tamper as shown on Photo 8. For the east approach, the Texoma 700 rig was used to construct the columns with compaction being afforded by a tamper plate attached to the kelly bar. Compaction was applied at 0.6 m intervals as the columns were constructed to grade.

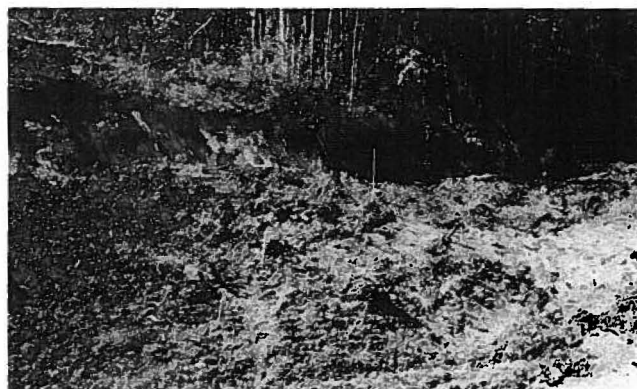
Photo 9: Headscarp of Slide In Main Slide Area

The use of the stone column technique at this site resulted from a slope stability problem that occurred following completion of the roadway grade construction. The instability extended over a length of 300 m and a width of 100 m in a section of roadway that was in a moderate sidehill fill situation (Photo 9).

Following an evaluation of this slide remediation using french drains perpendicular to the roadway and a toe berm over a gravel key at the toe of the fill slope was recommended and implemented. However, further sliding occurred beyond the key trench and extended to the creek banks following completion of the toe berm and roadway grade. An in depth investigation was undertaken and it was determined that weaker layers extended below the level of the constructed gravel key. From this investigation it was determined that the site had undergone previous deep seated movements. This observation was also borne out through discussions with local residents.

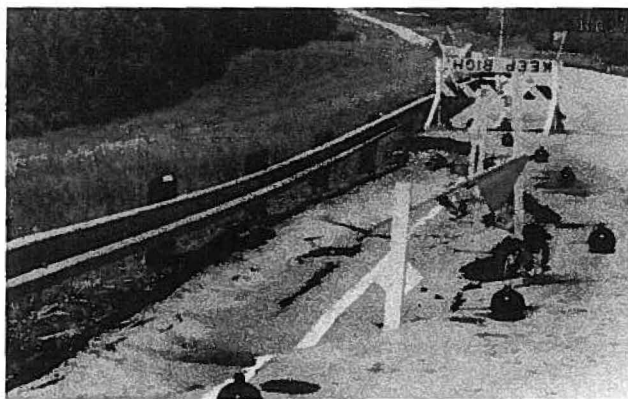
The problem associated with this site can be categorized as a slope stability/bearing capacity problem. This problem dates back to 1976 as shown in Photo 10. At that time the observation was that the fill, which was about 10 m in sidehill construction, was being eroded by the wave action of the lake. Remediation consisted of placement of riprap at lake shore and filling the cracks of slope. In 1980, this problem resurfaced and instrumentation monitoring was implemented.

Photo 10: Roadway Failure

Roadway depression again became a problem in 1988. Following this a subsurface investigation was undertaken from which it was determined that the fill, which averaged about 6 m within the failed roadway was wetter than optimum. Below this fill fractured shale was encountered. Water was also observed to be seeping at the interface of fill and shale. One of the considerations was excavation of the cracked pavement and replacement with granular material along with french drains to bleed any moisture that may be travelling across the roadway. However, since the road was highly trafficked the technique of stone-lime columns was adopted

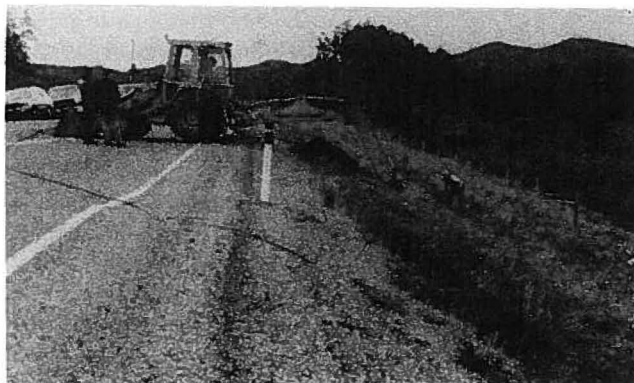
In 1987, a 10 mm wide crack running diagonally through a 50 m long section of roadway on sidehill construction was observed by the local road authority. This crack was associated with minor settlements. In 1988, the distress progressed to a width of 50 mm with roadway settlement of 100 mm and noticeable displacement of the sideslope and fence (Photo 11).

Photo 11: Roadway Prior To Treatment

Investigation of the area revealed that a slide was occurring at contact of the original ground and superimposed fill. One of the options of remediation was a complete replacement of failed material to a depth of 3 m with free draining pitrun gravel. The other option was the utilization of stone-lime columns. This option was finally chosen since it would allow minimal disruption to traffic. The scheme used is shown on Figure 8. These columns were constructed using a Texoma 700 rig.

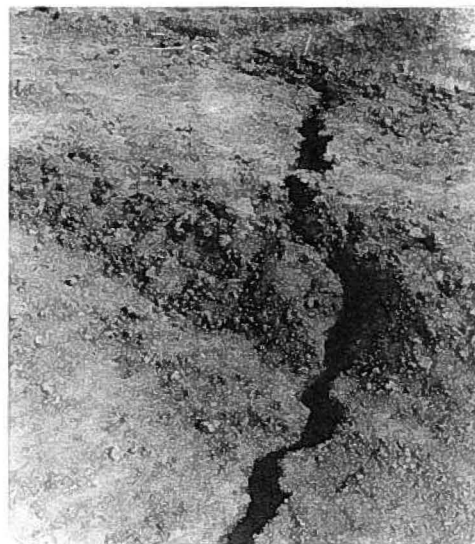
At this site, a single span bridge structure was to be constructed across the Three Hills Creek. This site was one that had a history of problems associated with soft ground conditions and underground springs. A 6 m high approach fill was to be constructed before bridge construction. Shortly after fill construction, cracks were reported in the embankment fill. These cracks were observed to progress diagonally through the approach fill on the side and towards the creek, Photo 12.

Photo 12: Cracks In Headslope

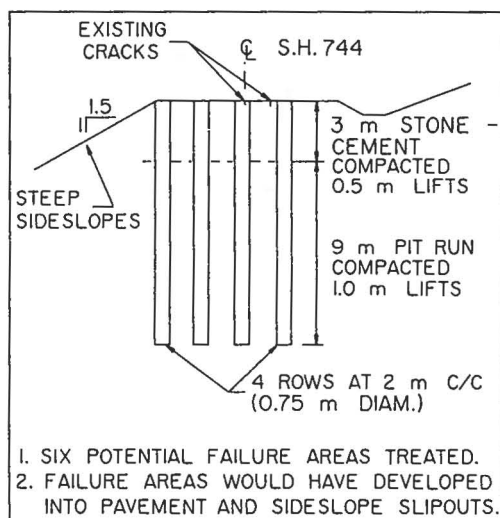
Figure 10: Layout of Stone Cement Columns

An investigation of the roadway through drilling showed the soils to be fairly dry though wetter than optimum at some locations. At first it was felt that there was seepage from the uphill ground but this was ruled out from a study of the topography. The problem was diagnosed to be a loss of bearing capacity through degradation of the sideslope due to runoff from the pavement structure. Some areas where this problem did not occur were associated with areas where pavement runoff was towards the backslope ditch.

The scheme used is shown in Figure 10. As shown, the columns were cemented only in the top 3 m following which plain stone columns were used below to the depth of treatment. The idea was to improve the overall resistance of the subsoils in the top 3 m where the traffic stresses were greatest. In addition, a series of curbs and catchbasins were designed to prevent the water running off the pavement onto the shoulder, weakening same thereby leading to overall pavement deterioration.
