STABILIZATION OF A HIGHWAY EMBANKMENT FILL OVER AN ARCH CULVERT USING STONE COLUMNS

Robin Tweedie, Thurber Engineering Ltd., Edmonton, Alberta, Canada
Renato Clementino, Thurber Engineering Ltd., Edmonton, Alberta, Canada
Dimitri Papanicolas, Thurber Engineering Ltd., Edmonton, Alberta, Canada
Roger Skirrow, Alberta Transportation, Edmonton, Alberta, Canada
Gabrielle Moser, Alberta Transportation, Edmonton, Alberta, Canada

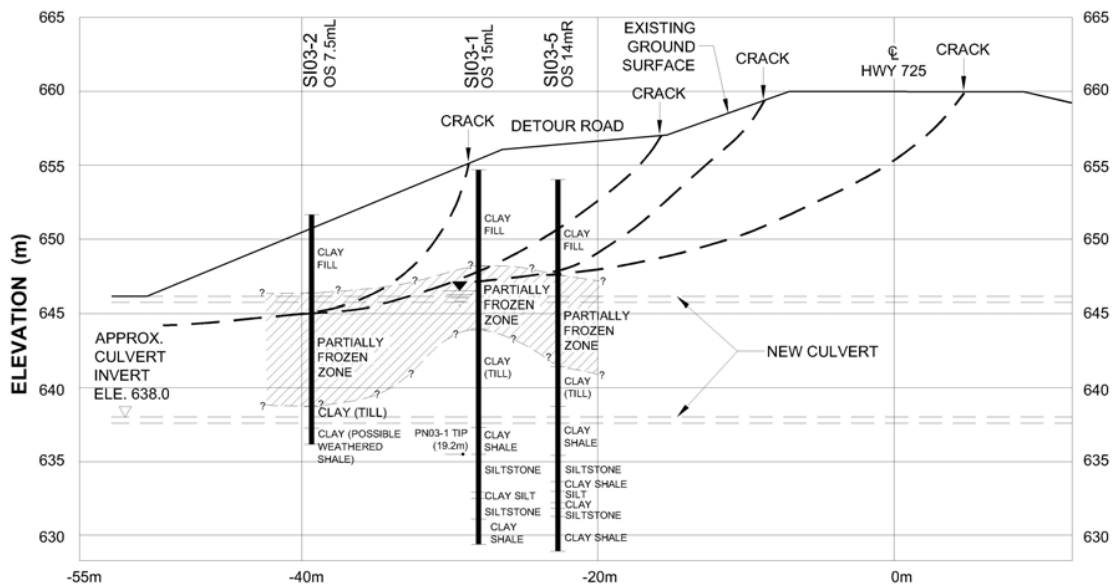
Figure 2. Soil profile of the west slide failure.

The results of geotechnical instrumentation monitoring indicated that the slide was seated in the recently placed embankment backfill material above the crown of the culvert and was still moving at a relatively fast rate.

It was also noted that the backfill around the culvert was well above Optimum Moisture Content and partially frozen (zone of scattered presence of ice and snow in the fill). The failure appeared to be at the interface between the unfrozen and partially frozen fill as shown by the soil profile in Figure 2. There was concern that failure could progress lower into the partially frozen fill during subsequent thawing.

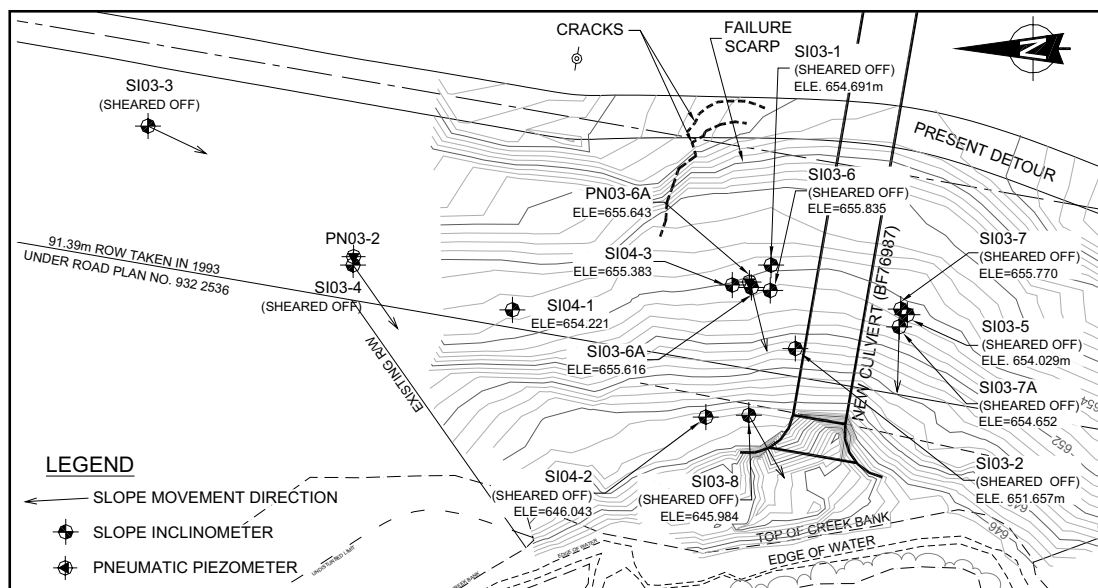
Figure 4. Site plan showing the location of the instrumentation (contour lines represent ground condition after west slide failure)

The locations are shown in Figure 4. The initial inclinometers 03-1 and 03-2 had sheared off at depths of 8.5 m and 6 m, respectively, before they could be initialized one day after installation, indicating the fast rate of slope movements. SI 03-3 and 03-4 installed in the northwest slope did not show any discernible movement over the initial several days.

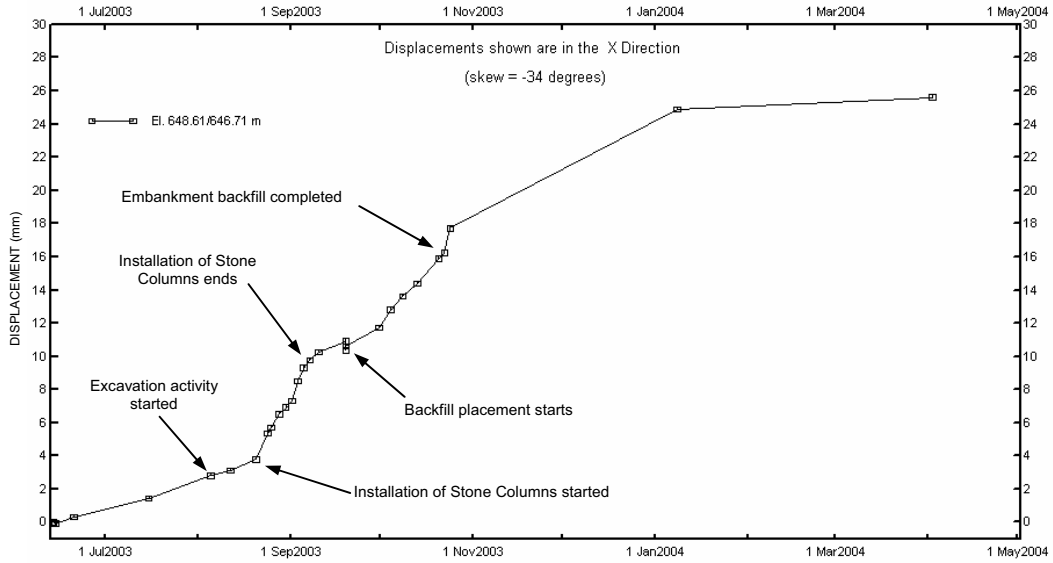
Figure 5. Northwest slope rate of movement with time (SI03-3).

Slope movements in the northwest valley slope were detected at depths of 17.3 and 17.5 m (approx elevation 638.7 and 647 m). These movements increased during the embankment excavation in August 2003, and decreased once backfilling of the embankment was underway. A history of the northwest slope rate movements is shown in Figure 5.

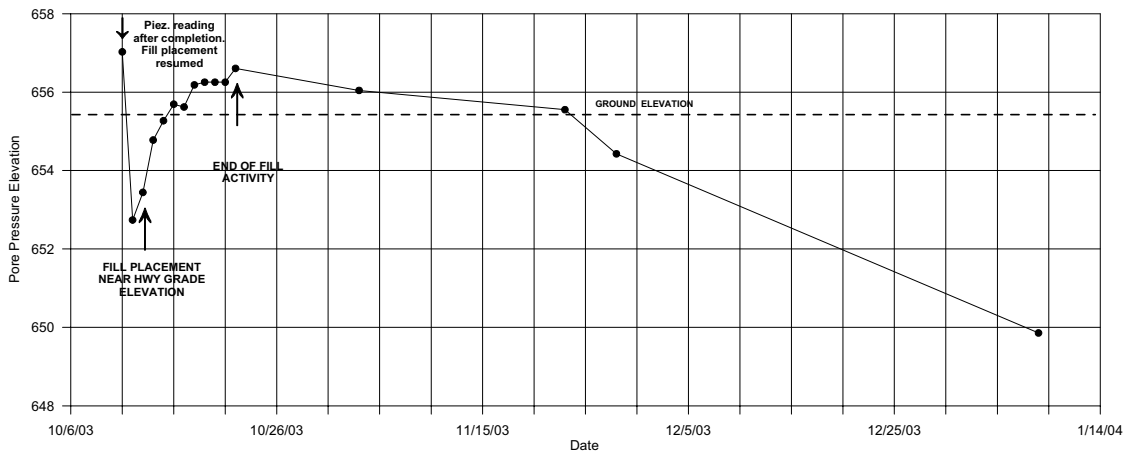
Figure 6. Pore pressure measurement during and after construction.

A pneumatic piezometer was installed in between the stone columns to monitor construction pore pressures during embankment reconstruction. High pore pressures developed in the clay fill during backfilling and significant

lateral spreading occurred within the stone column reinforced zone. The pore pressures have dissipated since construction as shown on Figure 6.

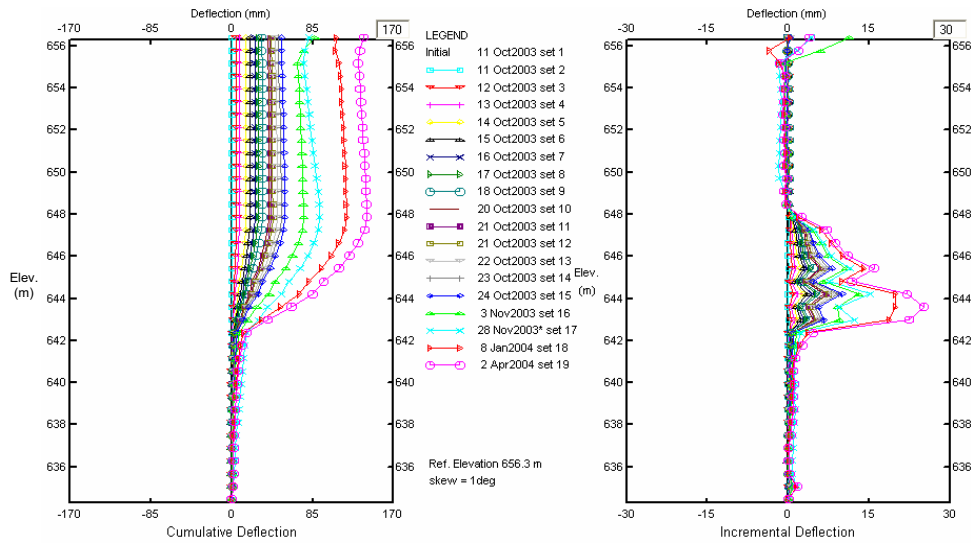
Figure 7 – Slope indicator (SI03-6A) readings at resultant direction.

The west embankment fill initially underwent significant deformation during and following fill construction (Figure7). The movements have slowed down as shown on the rate of movement plot in Figure 8 and the current rate of movement is 82 mm/year.
