Lessons Learned From Failure of High Embankment Excavation Slopes at Culvert Replacement Sites in Alberta

Roger Skirrow, Technical Standards Branch, Alberta Transportation Edmonton, Alberta
Gabrielle Moser, Technical Standards Branch, Alberta Transportation Edmonton, Alberta
Robin Tweedie, Thurber Engineering Ltd., Edmonton, Alberta
Dimitri Papanicolas, Thurber Engineering Ltd., Edmonton, Alberta

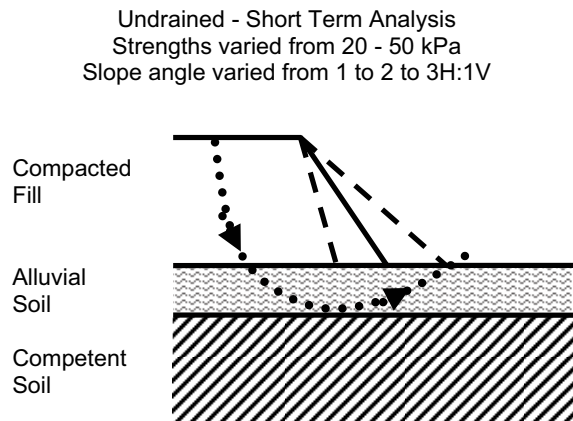
Figure 1: Parametric Slope Stability Analysis

as an aid to gauging the severity of the problem. As shown in Figure 1, the parametric analyses used: excavation depths of 2, 5, 10 and 20 m; cut slopes angles of 1H:1V, 2H:1V and 3H:1V; embankment and foundation undrained strengths of 20 to 50 kPa.

The analysis showed that satisfactory stability conditions were present for the condition of a weak embankment overlying a weak foundation soil for burial depths less than about 6 m. A factor of safety of 1.1, based on an undrained analysis, was used as the acceptance criterion for the stability assessment. The parametric analysis was then related to the risk framework with the results shown on Chart 2.

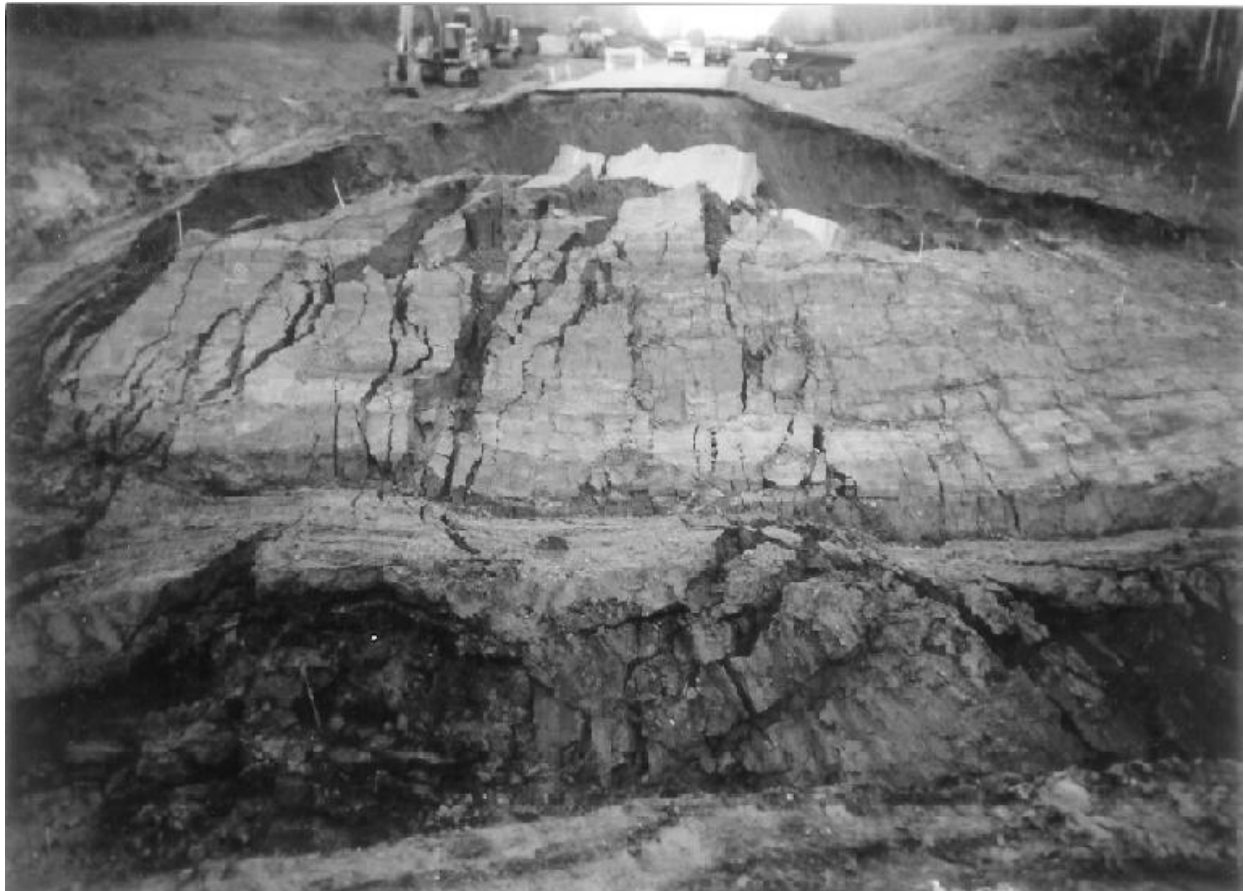
The excavation done for the culvert replacement followed the excavation profile shown on the Department standard drawing S-1418-93 "Installation of Large Steel Pipes". This drawing shows an excavation using 1H:1V sideslopes and a minimum undercut below the culvert base of 0.6 m. One small-scale failure occurred on the east cut slope during excavation. This slide was followed by a large-scale failure that involved the entire west excavation slope, as shown on Figure 2. The exposed cut slopes were further flattened to stable slopes. An additional slide occurred during fill placement that damaged the new culvert.

Work was shut down for several weeks while the situation was evaluated, geotechnical investigations were completed, and obligations and contractual issues were resolved. The slide was attributed to a artesian

groundwater conditions that saturated the lower portion of the embankment fill, and the presence of weak foundation soils; conditions which would have been identified during a geotechnical investigation during the culvert design process.

Figure 2: Excavation Slope Failure, Hwy 88 Culvert Replacement Project
