Shallow slump stabilization using percussion soil nails at Hamelin creek site on Highway 725:02, Peace Region, AB

Renato Clementino, Robin Tweedie, & Harjeet Panesar
Thurber Engineering Ltd., Edmonton, Alberta, Canada
Roger Skirrow
Alberta Transportation, Edmonton, Alberta, Canada

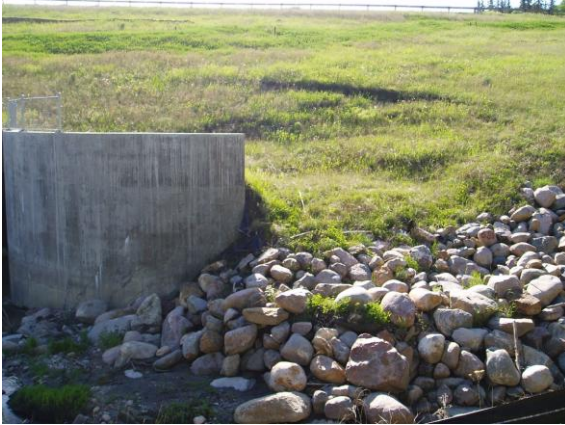
Since the culvert completion, the streambed has degraded 3 m upstream of the culvert inlet as far as 250 m upstream from the culvert inlet. The previous culverts acted as an artificial geomorphological control feature and the culvert invert was lowered intentionally to permit the natural creek bed degradation to continue upstream. However, as an unintentional outcome of this rapid down cutting, two shallow slumps have occurred at the toe of the embankment adjacent to the culvert. These slumps have retrogressed and have raised concerns that they could further destabilize the larger northwest deep seated slide, and thereby increase the rate of deep seated movement and cause more structural distress to the culvert. In addition, the slumped mass had encroached into the creek and was partially blocking the creek flow as shown in Figure 1.

Figure 1. General view of the south slump.

there was concern that excavating at the toe could further destabilize the deep seated landslide. As a result, the approach adopted to remediate these shallow slumps was to use 6 m long by 38 mm diameter steel rods, or 'soil nails' to reinforce the slump mass and improve the local stability. This would also enable removing the slump debris that was partially blocking the creek.

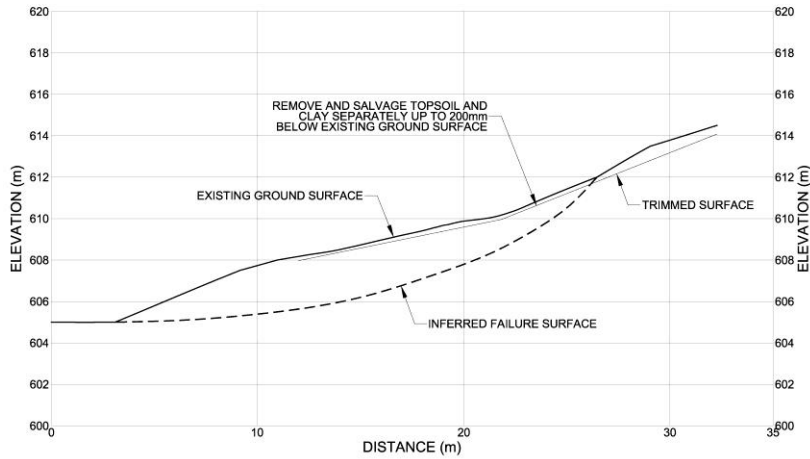
Figure 2 shows the original ground condition after the slump as well as the interpreted slide plane. Based on the slump topography, the depth of slumping was estimated to range from about 2.5 m to 4 m deep. Therefore a 6 m long soil nail was considered long enough to penetrate beyond the failure surface and provide some improvement to the shear strength.

Figure 2. Original ground surface after slump.

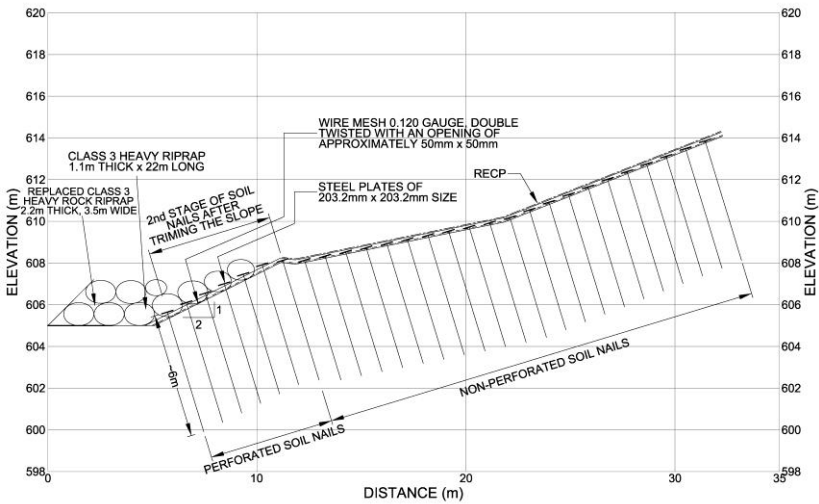
Figure 4. Phase two of percussion soil nails installation.

Figures 3 and 4 provide an overview of the design cross-sections for the Phase 1 and 2 soil nails installation.

To improve groundwater drainage, the nails installed during the second phase at the toe of the slump were supplied perforated to aid in the dissipation of excess pore water pressure from the slope.
