# UPDATE ON THE LITTLE SMOKY LANDSLIDE

Roger Skirrow, Alberta Infrastructure and Transportation, Edmonton, Alberta, Canada

Don Proudfoot, Thurber Engineering Ltd, Edmonton, Alberta, Canada

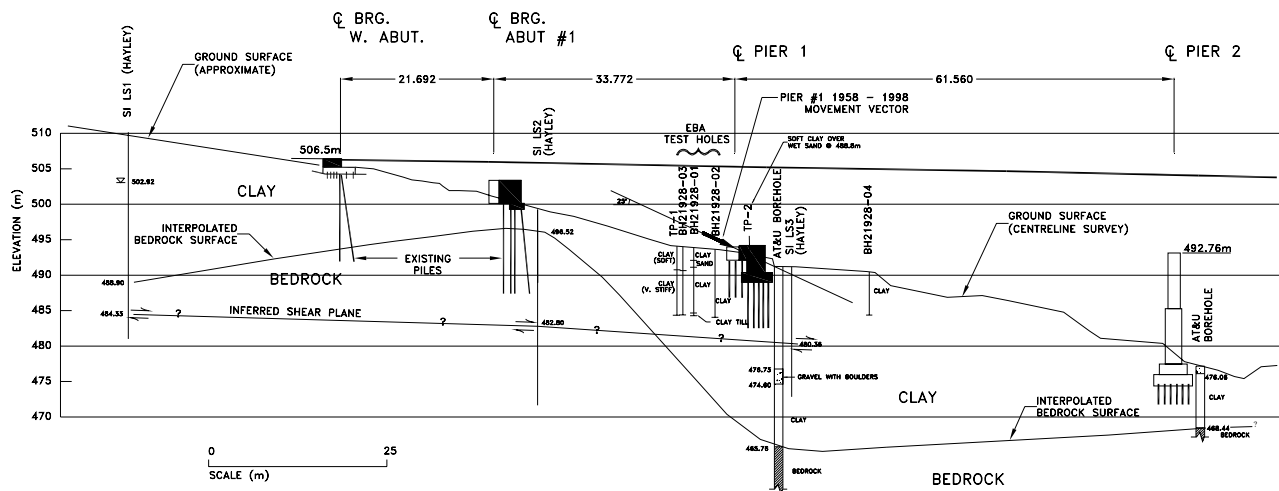
Fig.5. Stratigraphic Cross-section C-C' through south bridge abutment

The south abutment of the bridge appears to be located along the flanks of the two adjoining slide zones. At this location the subsurface soil conditions consist of clay overlying clay shale bedrock. A deeper, narrow infilled channel appears to be present along the river channel, where bedrock is encountered at about 470 m in the south half of the channel and at about 460 m in the north half. The inferred slip surface of the slide is partially located in the top of the shale and the overlying clay as shown in Figure 5. Slide movements are in a direction that is slightly skewed in an upstream direction to the centreline of the bridge with an average rate of about 125 mm/yr.

Asphalt patches and milling are typically carried out twice a year at the north slide and once a year at the south slide to maintain the highway surface in a sufficiently smooth condition. The concrete cap of the south abutments and pier of the bridge were widened in 1998, aligned in the direction of the slide movement and provided with adjustable bearing seats and pins to allow the slope to move under the bridge without causing distress to the bridge. Mitigation options such as armouring of the river bank, dewatering the slope, pile walls, and even a tunnelling option have been discussed. The only alternative mitigation option that is economically feasible is to realign the highway to take a more direct approach in and out of the valley. This would reduce the length of highway exposed to movements, and

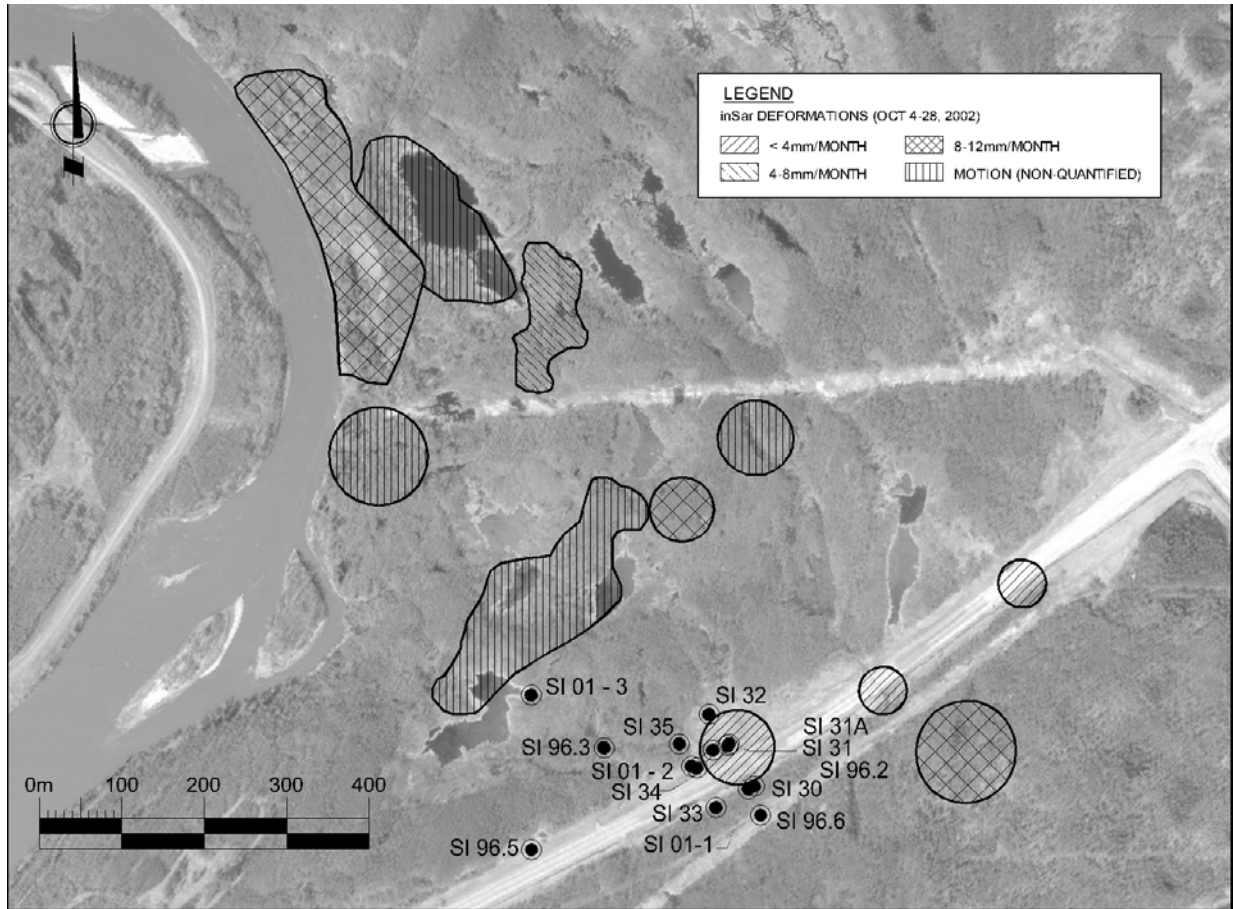
Fig. 6. Zones and rates of movement from InSAR

A zone of movement detected by the InSAR assessment was found to be centered over the embankment where the majority of the SI's are located. The range of motion detected by the InSAR was between 3.2 to 4.4 mm/month. This is comparable to average rates of movement (up to October 2001) in the SI's in this area of between 2.3 and 5.2 mm/month. The movement rates on the slope inclinometers are reasonably close to those observed in the InSAR analysis, providing further indication that the movements mapped by InSAR are realistic.

Although we were able to detect the ground movement over the 24 day time period, it is not considered that the use of spatial InSAR is likely the most effective method for monitoring of slopes at the Little Smoky Crossing because the vegetation cover on site leads to decorrelation between SAR images. Froese et al, 2001 provide a more detailed discussion of the InSAR technique for detection of slope movement along with specific discussion of the Little Smoky site.
