# Reconstruction of a roadway over an active landslide using lightweight cellular concrete

Allen Veenland & Shane Duval  
*Tetra Tech Canada Inc., Calgary, Alberta, Canada*  
Brad Dolton  
*CEMATRIX, Calgary, Alberta, Canada*  
Roger Skirrow  
*Alberta Transportation, Edmonton, Alberta, Canada*

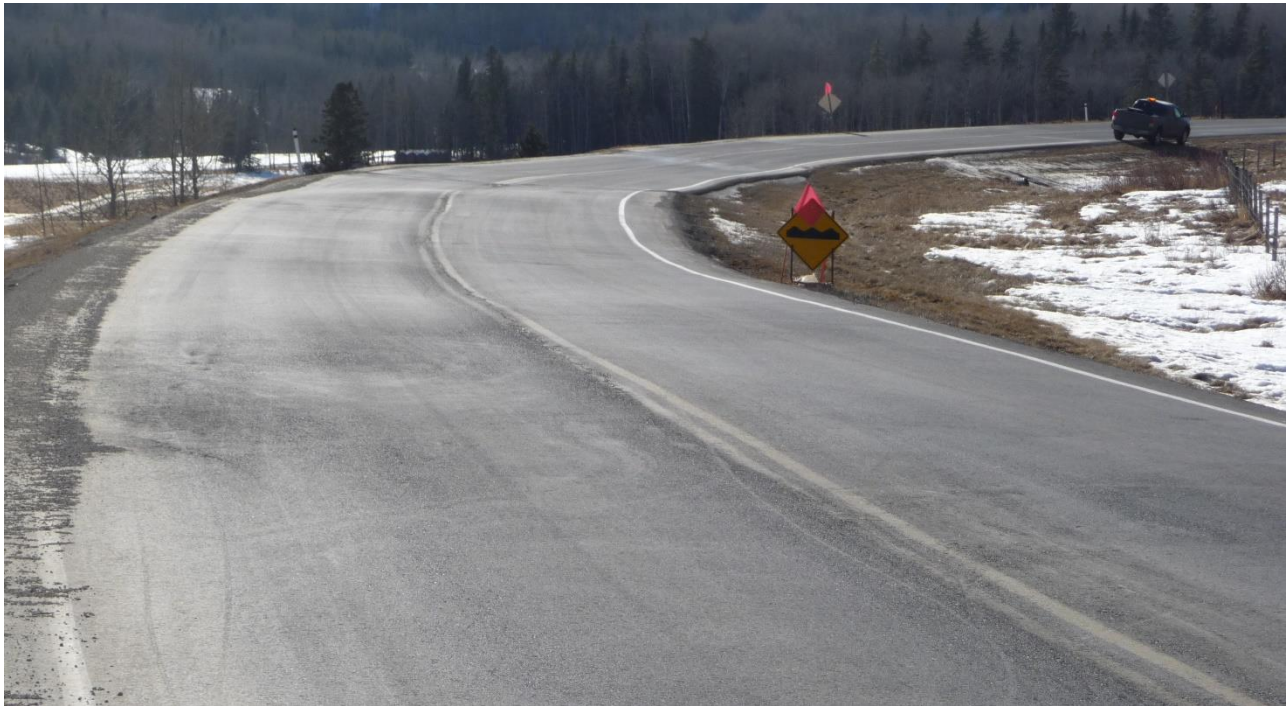
Instability at S022 has been evident since early in the 2000s. The resulting distress to the pavement was evident in the form of significant cracking and surface undulation along a roadway length of approximately 200 m. In order to maintain a reasonable driving surface, repairs consisting of milling, pavement overlays, or both were performed on approximately an annual basis. The relatively gentle slope below the road embankment and the presence of wet, areas upslope of the road segment exhibiting distress

suggested the possibility that the pavement distress was related to a wet, unstable subgrade; however, the monitoring of slope inclinometers installed in 2007 confirmed landslide movement. The large-scale cracking pattern in the road surface followed a discernable arcuate pattern that extended across both traffic lanes. The presence of bedrock exposures to the north of the distressed area suggested the landslide was bounded to the north by the bedrock ridge. Construction of the road embankment appeared to have created a poorly drained area on the north side of the road, which likely produced an elevated groundwater condition in the slide mass.

A pavement overlay was placed in 2015. The condition of the roadway in 2016 is shown on Figure 3. Significant cracking and surface undulation was evident at this time. Figure 4 shows the poorly drained condition on the northwest side of the road in August 2016.

Figure 3. Photo of roadway looking SW, 2016

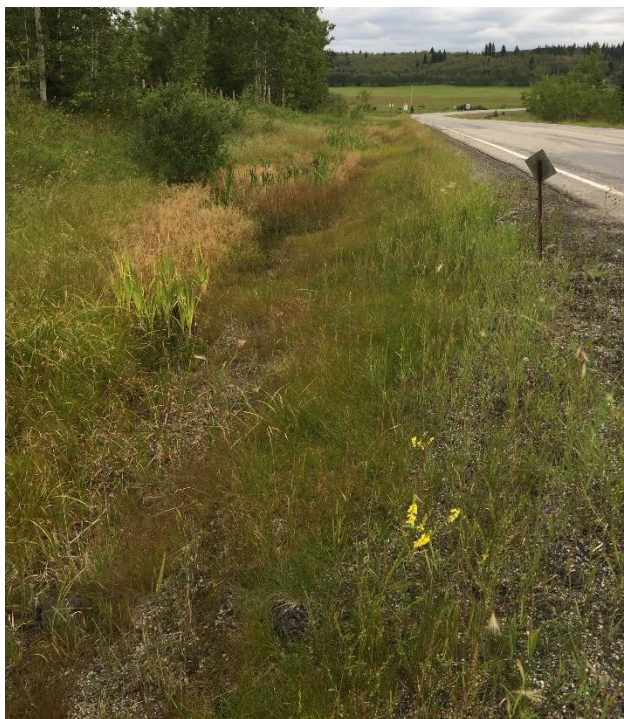
Figure 4. Photo of poorly drained area on NW side of roadway looking NE, August 2016

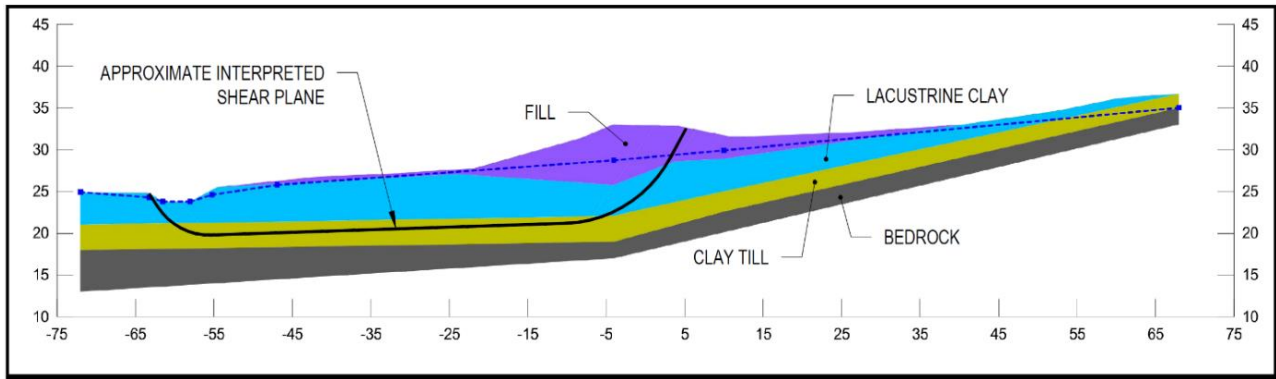
Two slope inclinometers, which subsequently confirmed landslide movement, were installed during the investigation in 2007. The slope inclinometers were approximately 60 m apart. The depth of movement in the two locations was estimated at approximately 7.5 to 8.5 m and 10.5 to 11.5 m below grade. The movement depths indicated that the landslide was based near the transition between the lacustrine and clay till layers.

A typical interpreted stratigraphy section is shown on Figure 5.

Figure 5. Typical Interpreted Stratigraphy Section

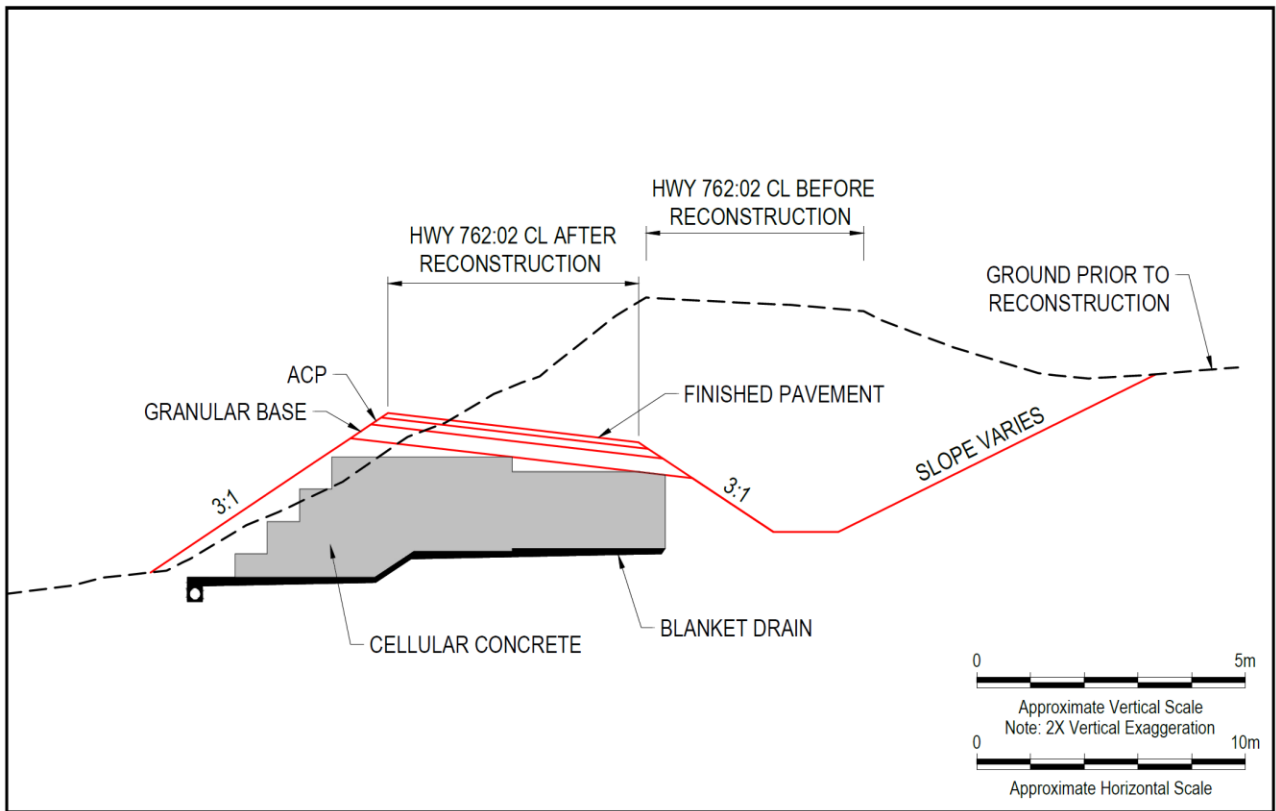
Figure 6. Typical section for reconstructed roadway embankment

- Lowering of the roadway grade by 0.6 to 2.2 m. This required a shift of the alignment away from the bedrock ridge backslope. This slight realignment had the advantage of maintaining traffic on the existing roadway through the construction period.
- Replacement of some of the existing embankment fills and underlying native soils with lightweight cellular concrete (LCC). Design thicknesses of LCC ranged from 1.0 to 3.6 m.
- Deepening of the backslope ditch and installation of an additional culvert to enhance surface drainage.
- Placement of a gravel blanket drain beneath the LCC to lower the local groundwater level and prevent floating of, or accumulation of groundwater in, the LCC. Non-woven geotextile fabric was placed on top of the gravel blanket drain to prevent infiltration of LCC during placement. A specialized woven geotextile filter fabric was placed beneath the blanket drain.

A typical section for the reconstructed roadway embankment is shown on Figure 6.

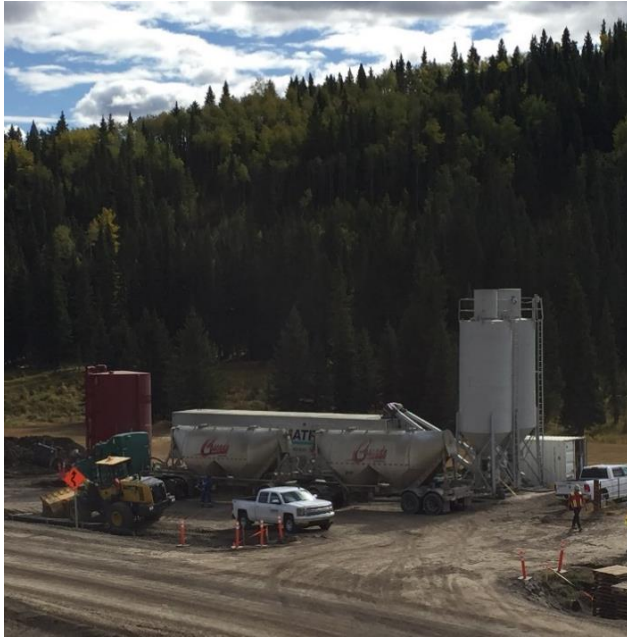
Figure 7. Photo of Dry mix unit with cement bulker onsite

In light of the relatively large volumes, a “Dry” mix unit was mobilized to the site. These units are capable of pumping a distance of up to 1 km; therefore, the cellular concrete was produced from one location only. The “Dry” mix setup on the site is shown in Figure 7. In the photo, a bulker is evident delivering cement into the silos located at the rear of the cellular concrete pump unit. Water was delivered to site and stored in the tank shown at the left side of the photo.

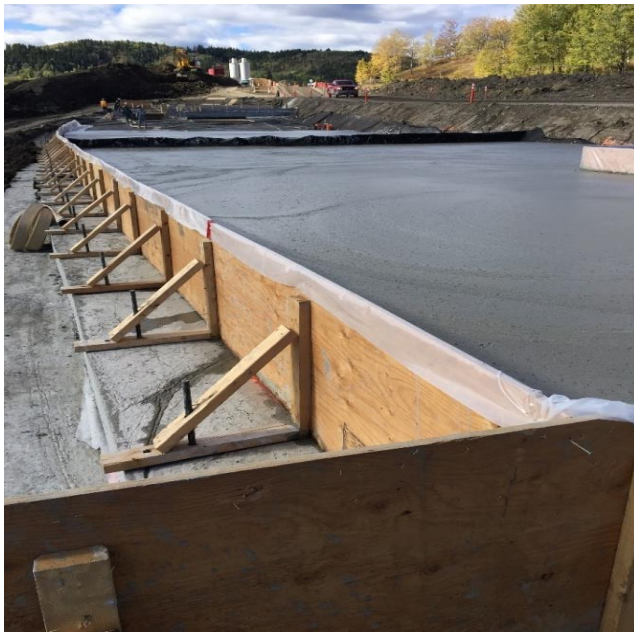
Figure 8. Photo of wood formwork on sides of cellular concrete, and transverse nonwoven geotextile partitions

slope, nonwoven geotextile partitions were used to stabilize the fresh material. Wooden formwork lined with polyethylene sheets was also provided to contain the LCC during placement. The wooden forms were held in place using steel rods hammered into the underlying soil or cured cellular concrete. After the placement of each layer, the LCC was allowed to cure overnight. Formwork was removed the following morning, and reused to contain the next layer of LCC. A photograph of the formwork and geotextile partitions is shown in Figure 8.

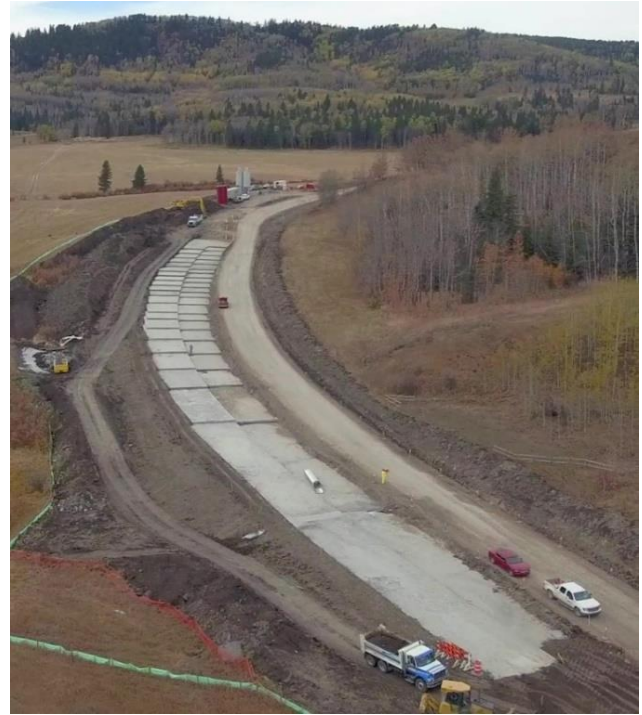
Figure 9. Photo showing completed placement of cellular concrete prior to backfill with granular

A total of 5,600 m<sup>3</sup> of cellular concrete were placed over twenty three pour days between September 8 and October 8, 2017, inclusive. Although the dry mix unit can produce up to 100 m<sup>3</sup>/hour, daily pour volumes were limited due to the LCC geometry. Daily production ranged from 129 to 582 m<sup>3</sup>/day, with an average of 246 m<sup>3</sup>/day. Figure 9 below shows an aerial view after LCC was in place.

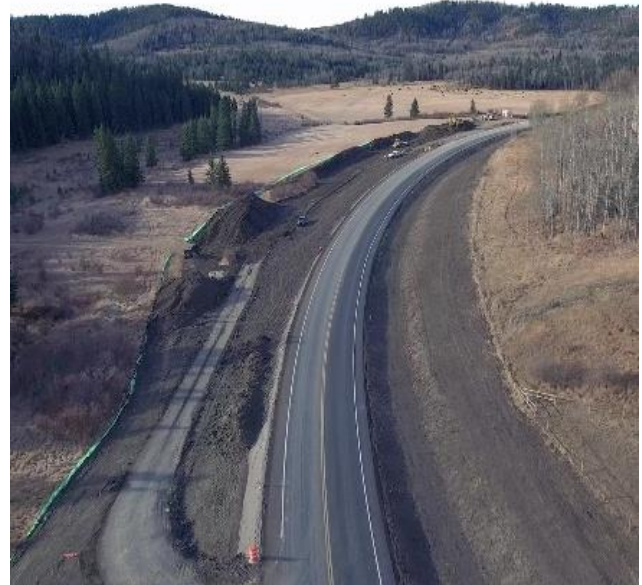
Figure 10. Photo after placement of asphalt

Typically, granular base material may be placed and compacted the day after LCC placement. For this project, the majority of the base gravel was placed and compacted approximately one week after all the LCC was in place. Construction traffic was not allowed to drive directly on the LCC without the gravel in place. A dozer and skid steer were used to spread out the gravel once it was delivered to site. Static (no vibration) compaction was used to compact the gravel. Vibratory compaction was permitted during placement of the asphalt. Figure 10 shows an aerial view of the site after asphalt was placed.

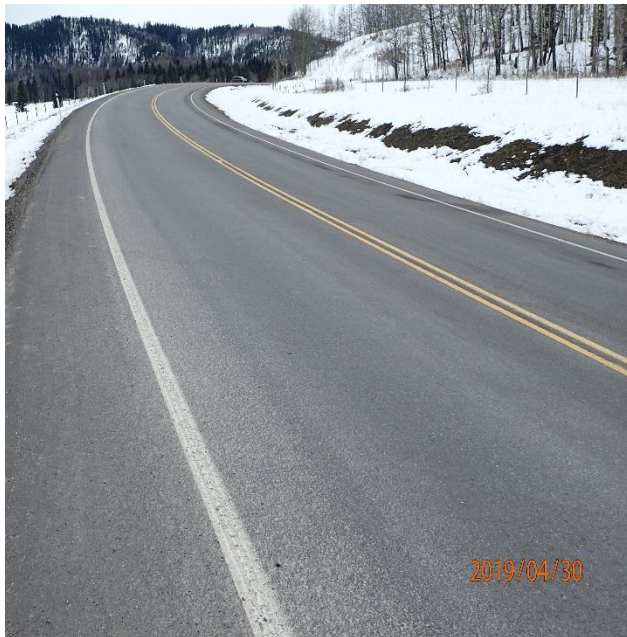
Since completion of 2017 construction, no significant movement of the roadway has been noted by visual monitoring, and no repairs of the roadway have been performed.

A photograph of the current roadway condition is shown on Figure 11.

Figure 11. Photo looking SW, April 2019
