# Landslide Stabilization Using Wick Drain Dewatering of Artesian Groundwater Pressures - Highway 40:30 North of Hinton, Alberta

Ken Froese & Don Proudfoot  
*Thurber Engineering Ltd., Edmonton, Alberta, Canada*  
Roger Skirrow  
*Alberta Transportation, Edmonton, Alberta, Canada*

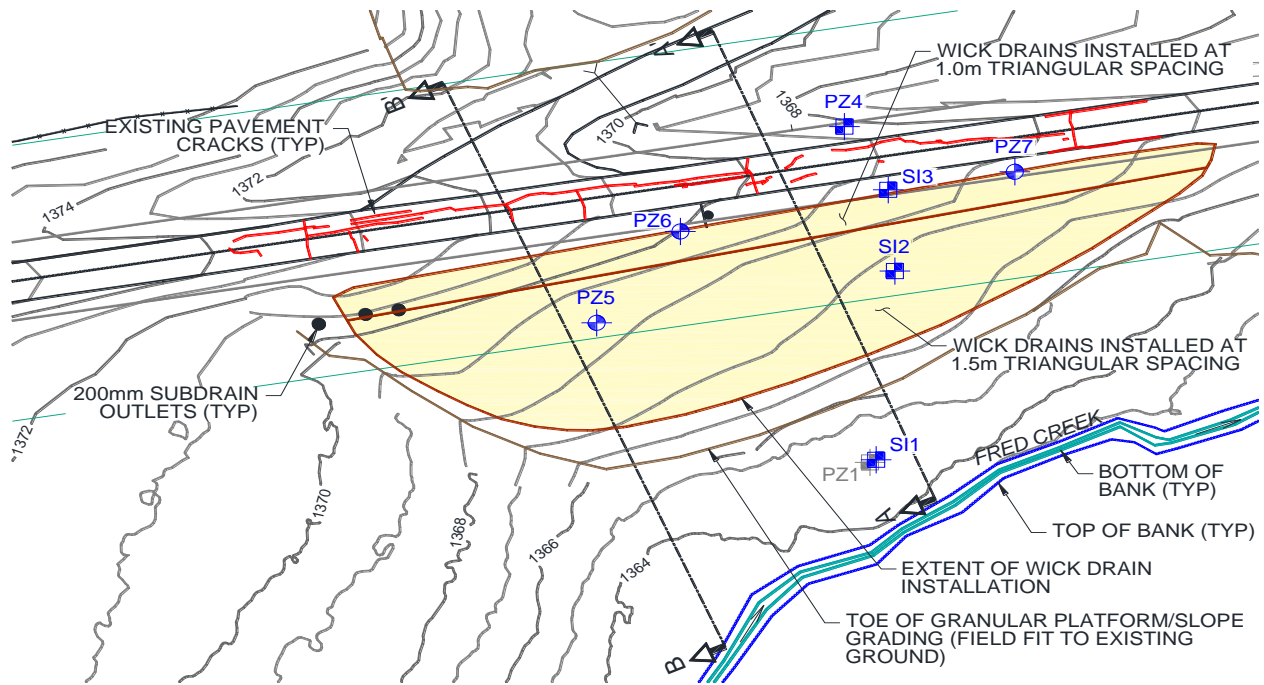
Figure 2. Site plan showing crack pattern prior to construction, cross-section location, and wick drain footprint.

In 2005, the distress was documented as a 60 m long arc-shaped crack through the paved highway with crack widths up to 40 mm. No vertical differential across the crack was observed at that time; however, the highway had recently been patched. The crack pattern appeared to be the backscarp of the re-activated 1979/1980 landslide, possibly triggered by toe erosion from the Fred Creek and/or a high water table. Although toe erosion was not mentioned in the historical documentation as a factor, it may have been in the re-activation of movement. The terrain downslope of the highway was uneven, and a toe bulge could not be identified. By the time of the 2008 annual routine inspection, the crack length had extended to about 130 m. During the 2014 inspection for the HWMP, the crack had extended to 150 m in length.

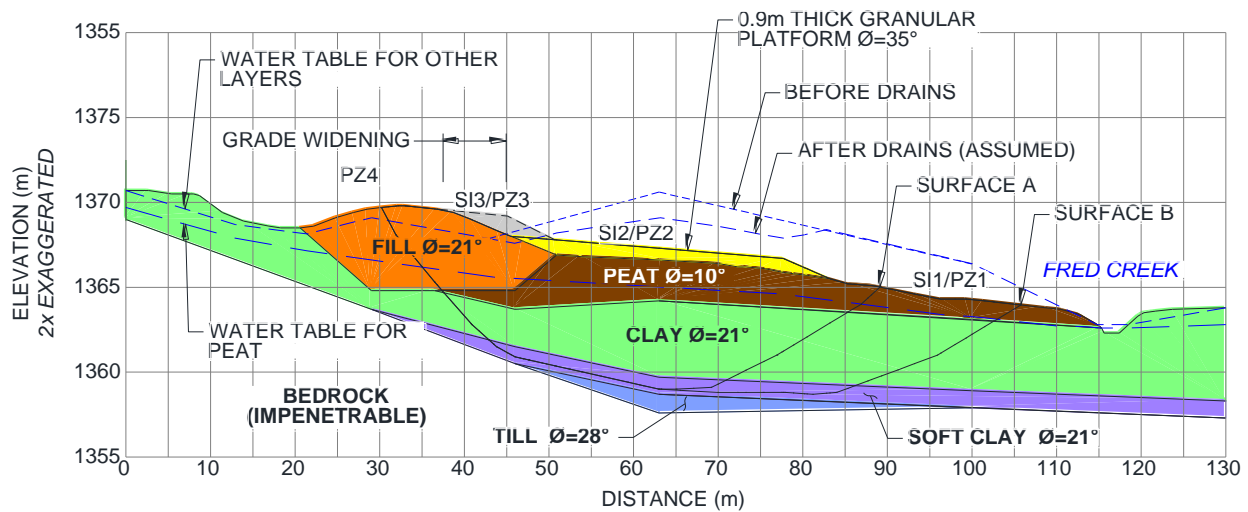
Figure 3. Generalized slope stability scenario

In order to determine soil properties, a back-analysis of the existing conditions was undertaken. Section A-A' was used for this analysis and was aligned such that it was oriented in the resolved direction of the slide movement and in the vicinity of the 2007 test holes. Initial soil and groundwater parameters were selected based on the available subsurface information and groundwater readings and previous experience on similar sites and the back-analyses used to refine the parameters to obtain a factor of safety near unity. The cracks on the highway and likely toe bulge above the creek were used to control the slip surface location. The soil parameters determined by the back-analysis are shown on Figure 3.

Two potential slip surfaces were identified as representative and used as the basis for evaluating the remedial option. The first surface (A in Figure 3) had a shorter overall failure plane which resulted in a back-calculated factor of safety (FS) of 0.97. The second surface (B in Figure 3) assumed a longer failure plane (toe closer to the creek) which encompassed the shallow movement observed at the southernmost inclinometer (SI1). The resulting FS under the same presumptive soil strengths and measured groundwater conditions was 1.03. These analyses were expected to represent the range of likely failure surfaces operative at this location.

The remedial option evaluated was a 25 m extent of wick drains (measured perpendicular away from the highway) installed over the zone immediately downslope from the existing roadway embankment to reduce the artesian pore pressures in the clay layer where the failure surface is presumed. In addition, a 0.9 m thick working platform (required for wick installation, protection, and long term drainage) was also included in the model. The effect of the remedial measure was assessed on both of the failure surfaces identified in the back-analysis. The FS on the slip surfaces increased from 0.97 to 1.77 (82 percent) and from 1.03 to 1.51 (47 percent), respectively, for surfaces A and B. For these analyses, it was assumed that the wick drains would lower the artesian groundwater level to at least halfway between the original condition and the top of the sand blanket platform (lower water table shown in Figure 3).

The fill for future grade widening was anticipated to add approximately 3.3 m of road top width measured from the edge of the existing embankment over the slide area. The side slope was to be 4H:1V. The short-term effect of the grade widening fill was modeled using presumptive B-bar parameters of 0.6 for the existing clay fill of the embankment and 0.7 for the native clay to account for the initial increase in pore water pressures that could result with placement of the fill. The analysis assumed that the wick drains were installed far enough in advance of the detour construction to allow for dissipation of the existing artesian pressures (that is, the B-bar increase applied to the lowered water table rather than existing conditions). The resulting short-term FS were 1.39 and 1.25, respectively for A and B, which is still an improvement of 43 percent and 21 percent as compared to original conditions. After construction and the reduction of excess pore water pressures, the long-term stability was estimated to improve to FS of 1.73 and 1.50, respectively, for the two surfaces A and B considered.
