Stabilization of Roadway Landslide Using Anchored Drilled Shaft Piles Performance Evaluation over the Last 15 years

Vishnu A. Diyaljee, F.ASCE, P.Eng

Managing Director, GAEA Engineering Ltd, 33 Ashby Field Road, Brampton,
Ontario, Canada; diy001@gaeaeng.com

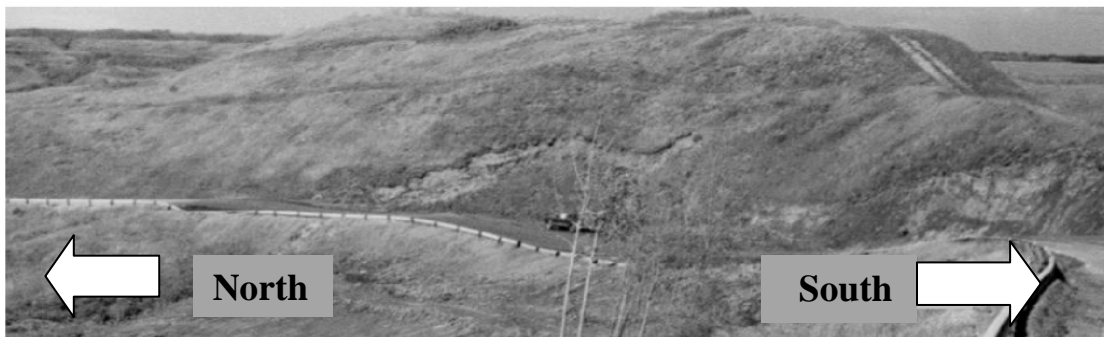
Observations along the roadway section of the slide area showed that the head of the slide had dropped a further 0.5 m to 1 m during the rainy period and that the headscarp cracks which are visible along the uphill ridge (hogsback) had opened up significantly, Fig.4. There was, therefore, a general concern by the MD that these cracks, if not sealed, would allow rainfall runoff to infiltrate the ground and cause further movement of the slide area.

FIG.4. Vertical Drop in Roadway and Backslope Michelin Slide - North

1. Displacement of the sliding mass by the addition of fill overtop of the roadway.
2. Sealing of cracks uphill and downhill of the roadway section.
3. Re-routing of ditch drainage away from the headscarp and downhill of the slide. A centreline pipe uphill of the slide area was observed to be discharging into the slide area which was badly cracked
4. The use of lightweight fill material within the roadway to bring the sunken portion of the road to grade through excavation of about 2 m within existing road and replacement with hog fuel or sawdust.

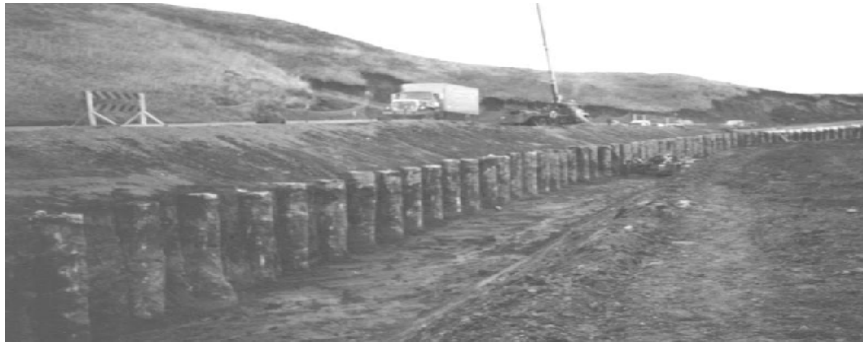
FIG.7. Installed Vertical Piles

Ninety one (91) piles were designed to cover a distance of 180 m. Based on the S.I movements sixty (60) of these piles (Nos 1 to 60) were installed from Sta 57+870 to Sta 57+990 each to a depth of 20 m while the remaining thirty one (31) piles were each installed to a depth of 24 m. Pile concrete was designed using Type 10 cement for a 28-day compressive strength of 30 MPa, slump of 120-150 mm and air content of 5.5 % and piles installed during March and April of 1997 as the first stage of the remediation design. Compressive strength cylinders tests were taken during each pile installation and tested after 7 and 28 days. All 7 day results averaged round 25 MPa while the 28-day strength averaged around 32 MPa. Fig.7. shows the completed piles. Twenty (20) selected spliced H-Pile steel reinforcement were subject to Magnetic Particle Testing of the welds to acceptance standard of CSA W59 Clause 11. In general the steel piles subjected to visual inspection and wet colour contrast showed no defects. In summary all piles were constructed to meet the design requirements. The pile holes were generally dry requiring no temporary casing to be used except for holes 5 through 19 where some wet areas were encountered between 4 and 14 m requiring the use of casing to prevent sloughing. The casing was removed after concreting.

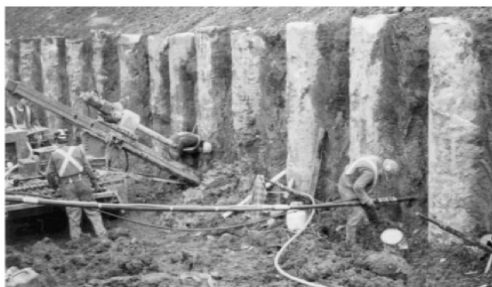
FIG.8. Installation of Tie-Backs

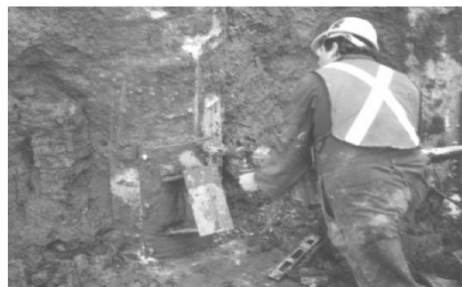
FIG.9. Installation of Waler Seat

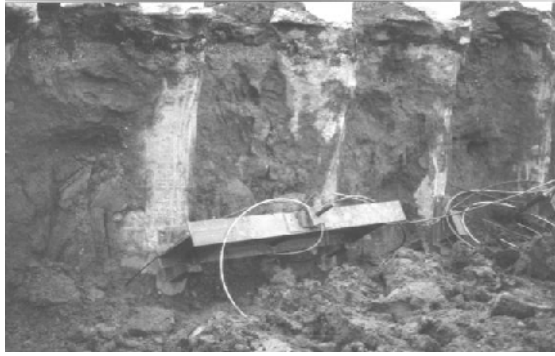
FIG.10 . Installation of Waler

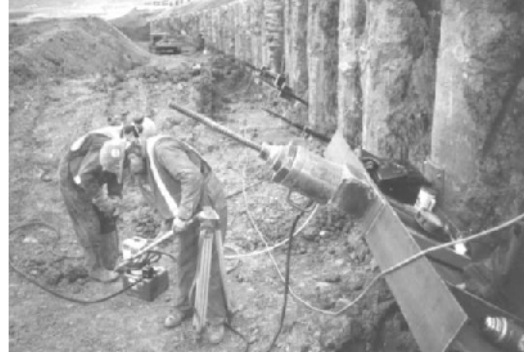
FIG.11. Tie-back test Set-up

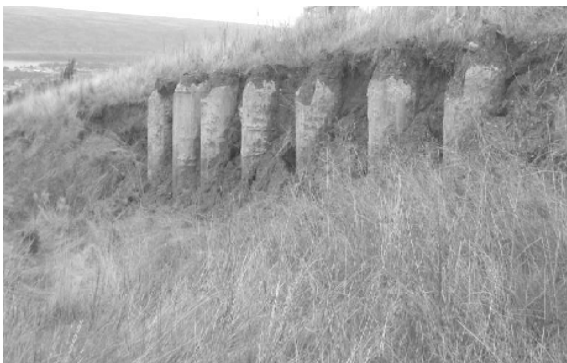
Over the years up to the last site review in 2012, some 16 years since stabilization, and a further review by Roy Callioux, P.Eng (Private Communication) on May 13,2013 a noticeable drop of the sideslope downhill of the pile retaining wall has been observed. Approximately 3-4 m of the wall is now exposed on the downhill side, Fig. 12. As well, there is the development of a slide (known as the Michelin Slide–South) which was stabilized by others in 1999 that is to the south of the Michelin Slide–North and the Makeout Slide, Fig.2. The Makeout Slide occurred in 2005 and was stabilized the same year using an earthworks solution consisting of a toe berm with geogrid reinforcement. This slide is also showing some distress as noted in Fig.14.

FIG.12. Michelin Slide - 2012

In terms of the Michelin-North slide the loss of support downhill of the piles as shown in Fig. 12 is not considered critical as this loss was taken into consideration during the design of the pile wall. Nature has now provided the development to allow additional tiebacks to be installed at higher and lower levels of the piles. This same situation occurred at the CNR slide which after the loss of the passive support allowed tiebacks to be installed, Fig 13. However, the timing of this additional remedial work is critical and needs to be done before the soil completely moves off and downward to fully expose the toes of the piles. The time span to implement this additional work can be judged from the slope indicator monitoring. So far, slope indicator SI 43 is still intact and has shown 15 mm of cumulative movement in the A direction and 30 mm in the B direction since 2008.

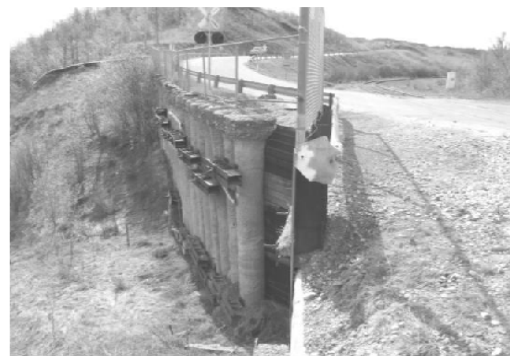
**FIG. 13. CNR Slide, May 13, 2013
25 years after Stabilization**

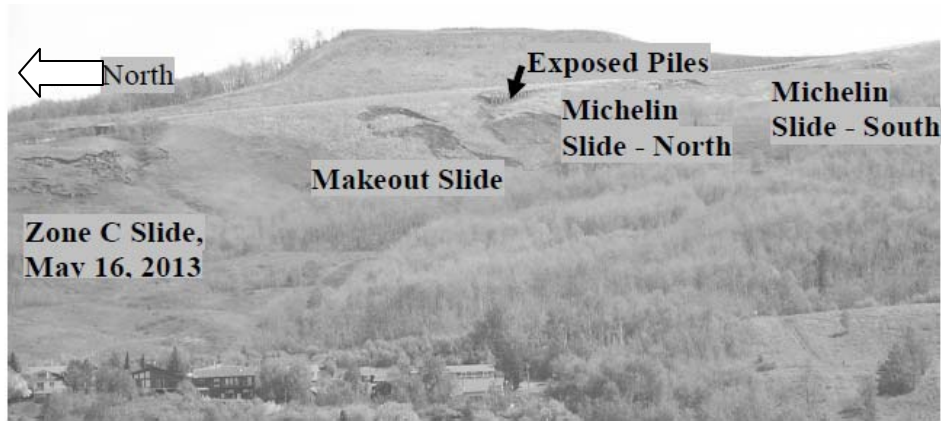
FIG.14. Looking Uphill at Slides on Judah Hill Road, May 22, 2013

It is the prevailing opinion that the recent development of the Michelin-South slide is part of a larger slide area encompassing the Michelin-South slides and Makeout slides. It has been noted that at the Michelin South slide location the slide movement has now encompassed the Heart River slope and the tentative recommendation by others is the construction of a double retaining wall with an estimated projected expenditure of C\$2.5 to C\$5 million dollars.

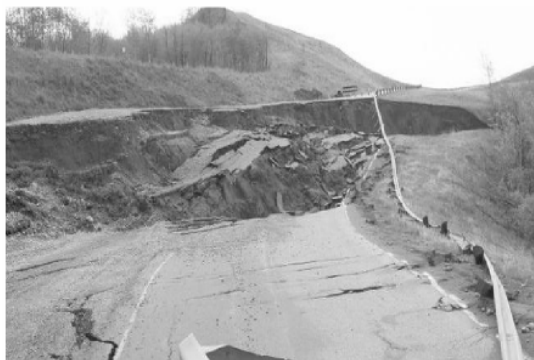
FIG.15. Slide at Zone C May 16, 2013

Recently on May 16, 2013 a major landslide occurred just north of the Makeout slide (Fig.15) resulting in the closure of the entire Judah Hill Road. The approximate location of this slide is shown in Figs.2 and 14. This section of

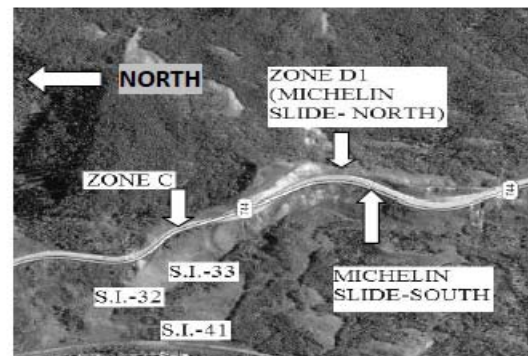
FIG.16. Location of SI 32, 33 and 41

roadway had been identified in 1994 as a potential slide area and slope indicators SI 32, 33 and 41 were installed in September 1994. These were read by the GSS six (6) times from October 1994 up to and including May 1996 and showed subtle movement zones at 12, 16 and 18 m (SI 32), 20, 25 and 36 m (SI 33), and 20, 30 and 34 m (SI 41). It is not known whether the SIs were read in subsequent years.
