Kehiwin Lake Landslides, Hwy 41:23 Near Elk Point, Alberta: Historical Development and Remedial Measures

Tarek Abdelaziz, Donald Proudfoot
Thurber Engineering Ltd., Edmonton, Alberta, Canada
Roger Skirrow
Alberta Transportation– Geotechnical and Materials Section, Edmonton, Alberta, Canada

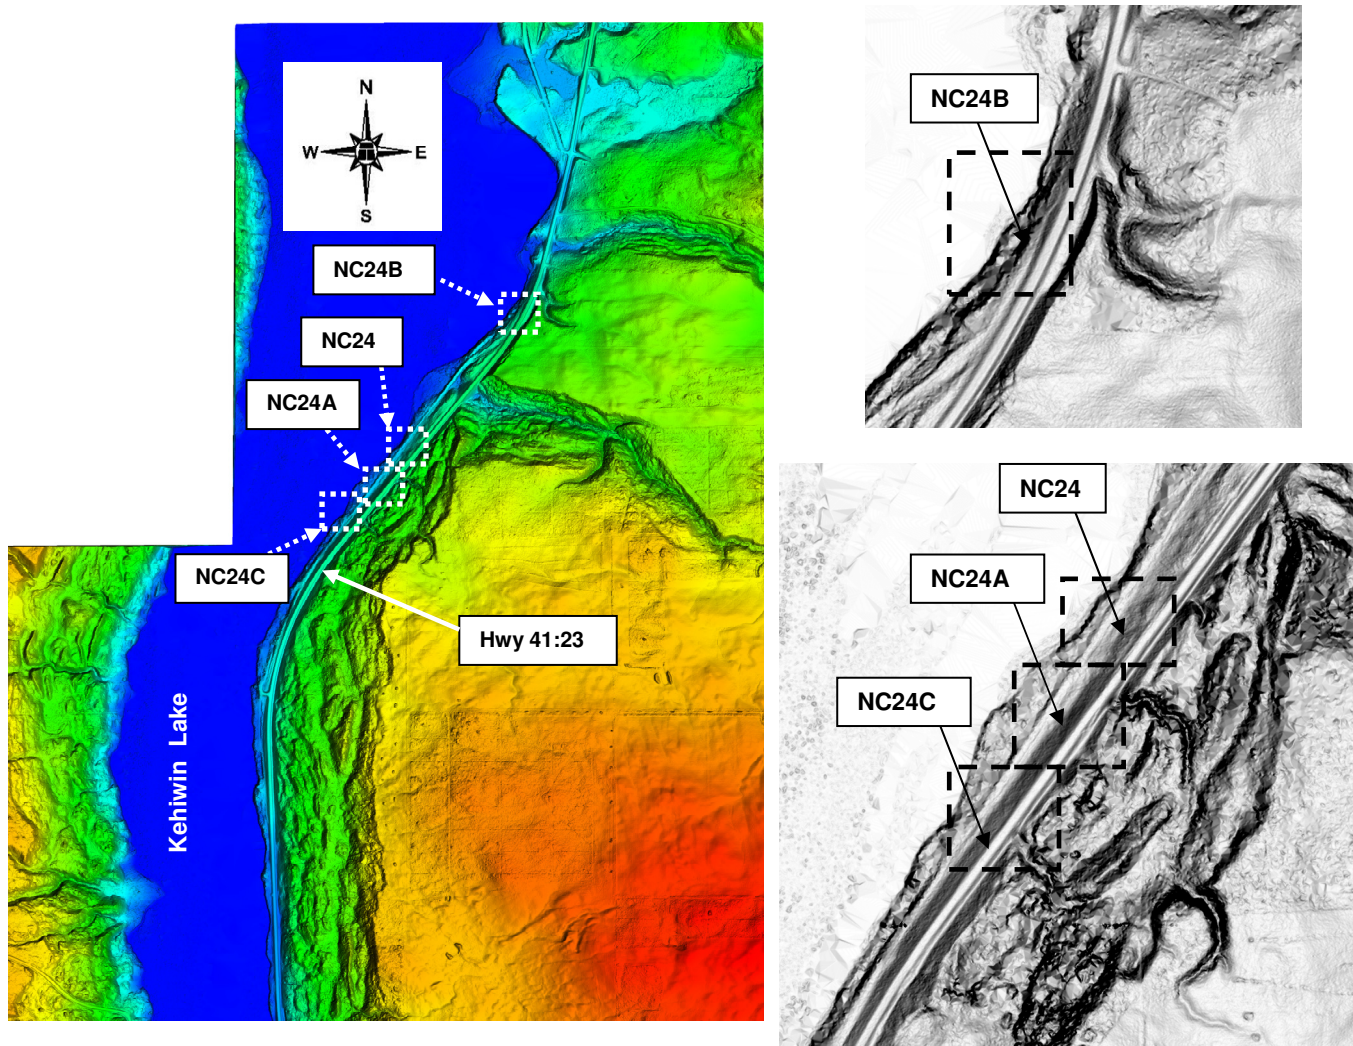
Figure 2. Shaded relief plans showing landslide locations

A shaded relief plan showing approximate locations of the landslide sites is presented in Figure 2.

As shown on Figure 2, the highway alignment is generally bounded on the east by a meta-stable hill slope and on the west by the Kehiwin Lake. The highway alignment is located approximately 80 to 100 m to the east of the lake shoreline. The top of hill is about 20 m above the lake shoreline at the NC24B site, and 45 m at the NC24, NC24A, and NC24C site locations.

The surface expressions of the hillside upslope of highway at the landslide sites are hummocky, suggestive of extensive historic landslide activity. Additional evidence of past landslide activity includes the presence of multiple steep scarps, extensive gullies within the slope, irregularity in the shape and texture of the slope surface, tilting trees, buried trees within the hill and along the lake shore slopes, and significant toe bulging and presence of scarps near the lake shoreline. Erosion and depositional features near the lake shoreline were also visible from the LiDAR image.

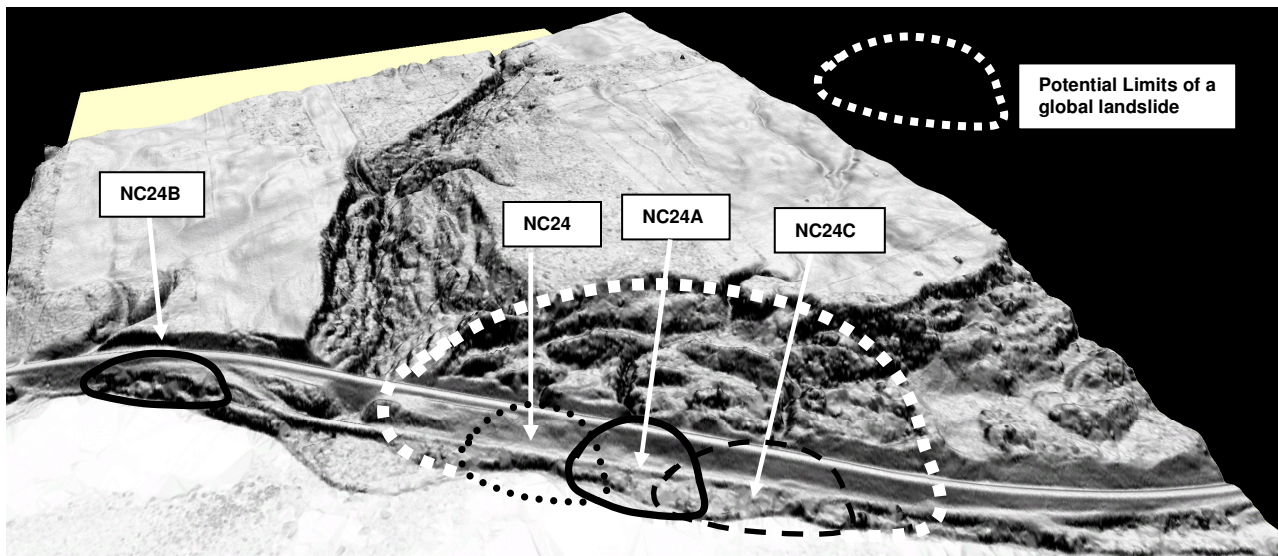
Figure 3. A 3D rendering image along the highway alignment at the landslide sites (Vertical Exaggeration is 3:1; N.T.S.)

Figure 3 provides a 3D rendering image at the three adjacent landslide sites. It can be seen from the figure that three landslides developed between km 7.7 and 7.9 (NC24, NC24A, and NC 24C) are local active landslides that lie within a much larger dormant global ancient landslide that extends much further upslope of the highway and along the highway. Sites NC24 and NC24C sites are located approximately 200 m from the left and right flanks of the global landslide, which presents the possibility that additional landslides might occur outside the limits of the active landslides but within the limits of the global landslide.

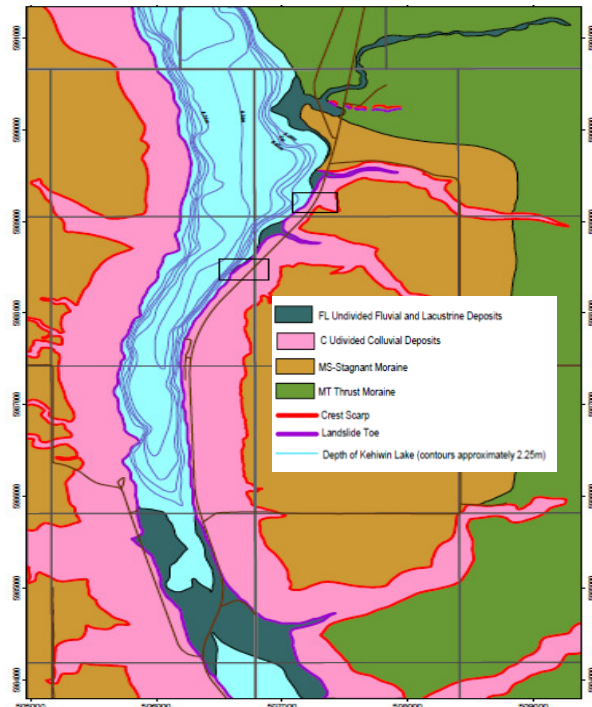
Figure 4. Surficial geology map of study area (N.T.S.)

The surficial geology map, published by Fenton and Andriashek (1983) and presented in Figure 4, reveals three major surficial deposits in this area: moraine, colluvium, alluvium and lacustrine deposits. The uplands are mainly covered by glacial deposits (Stagnant and Thrust Moraine). In general, the moraine mainly consisted of clayey-sand till inter-bedded with either stratified sediment or glacially incorporated beds of older till and inter-bedded lenses of sand and silt. The Stagnant Moraine unit to the east of the Kehiwin Lake is underlain by the Thrust Moraine. The Stagnant Moraine had formed after the ice advance ceased and typically has a chaotic structure, whereas the Thrust Moraine had formed as a result of the ice thrust processes, and typically contains blocks of weathered and re-worked bedrock.

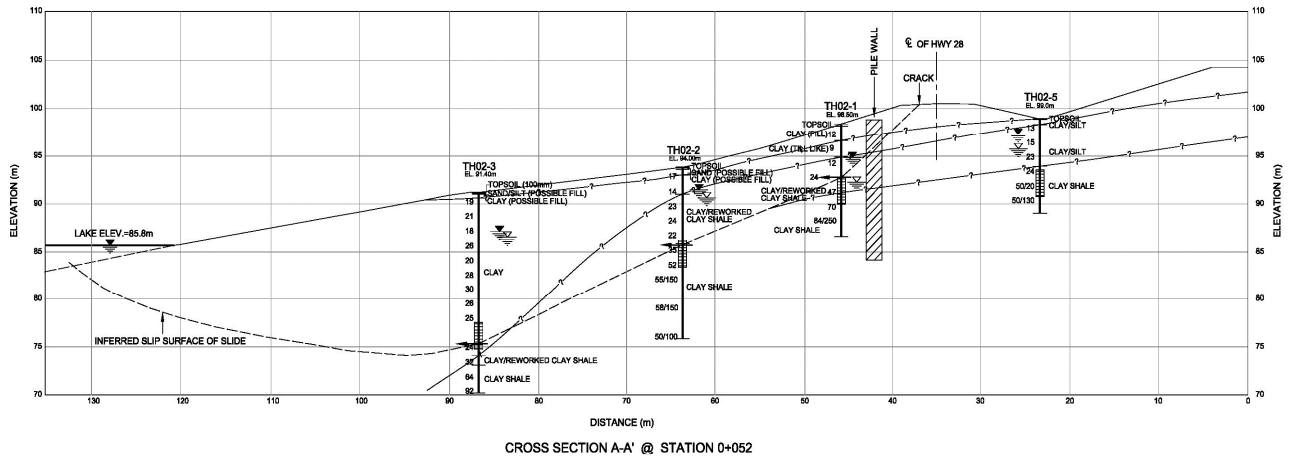
Figure 5. Stratigraphic cross section along the NC24 site

The landslide features included observations of pavement distress on both lanes, the presence of 10 to 20 mm wide longitudinal and diagonal cracks, and 10 to 20 mm local depressions along the highway surface. A total of 13 test holes, complete with slope inclinometers and standpipe piezometers, were drilled at this site in 2002. A stratigraphic cross section at the site is presented in Figure 5. The geotechnical investigation indicated that the sub-surface conditions consisted of 2 to 3 m of clay fill overlying colluvium soils. The colluvium soils consisted of a mixture of clay, clay till, re-worked clay shale, and was underlain by clay shale bedrock. The thickness of the colluvium increased from 5 m near the highway to about 17 m near the lake shoreline. The slope inclinometers showed that the slip surface was located within the high plastic re-worked clay shale formation near the top of the bedrock. The slip surface was located between 5 to 6 m depth below the top of the highway. The ground water levels within the landslide area were 1.5 to 4 m below ground surface.

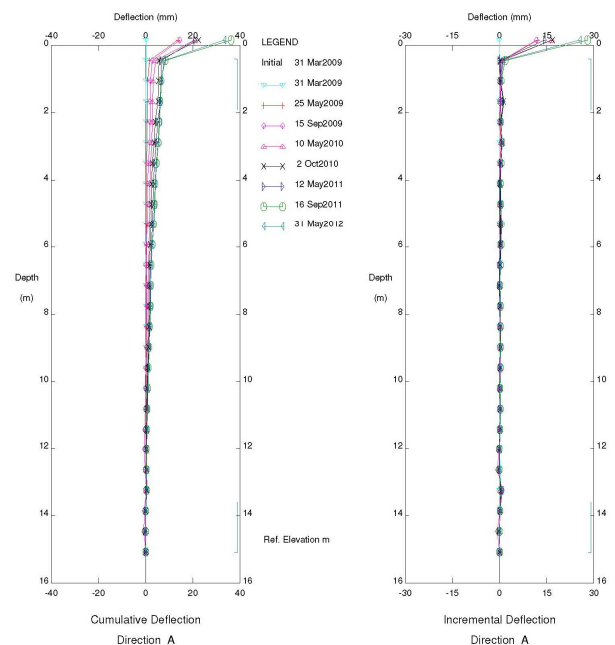
Figure 7. SI09-1: Incremental and cumulative deflections versus depth plots for NC24 pile wall

Three slope inclinometers (SI09-1 to -3) were installed in piles #7, 18, and 29 to assess the effectiveness of the remedial measure and confirm design assumptions. Between 2009 and the 2013, the slope inclinometers indicated that the pile wall was effective in stabilizing the landslide. The pile head deflections ranged from 2 to 9 mm. For illustration purpose, the incremental and cumulative deflections versus depth plots in SI09-1 are presented in Figure 7.

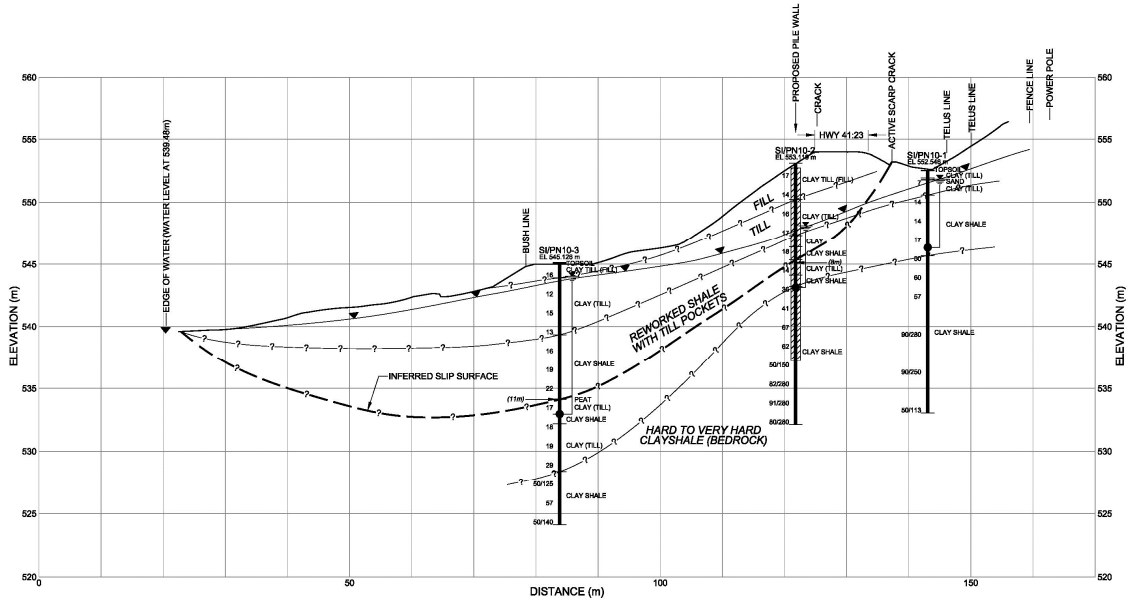
Figure 8. Stratigraphic cross section along the NC24A site

A total of 9 test holes, complete with slope inclinometers, pneumatic and standpipe piezometers, were drilled at this site in 2010. The geotechnical investigation indicated that the sub-surface conditions at this site were very similar to the NC24 site. However, it appeared that additional fill was placed to raise the highway vertical profile at this location. The depth of movement in the slope inclinometers was within the high plastic re-worked clay shale formation near the top of the bedrock. However, the slip surface was deeper than the NC24 site and was located between 9 to 10 m depth below the top of the highway. A stratigraphic cross section at the site is provided in Figure 8.

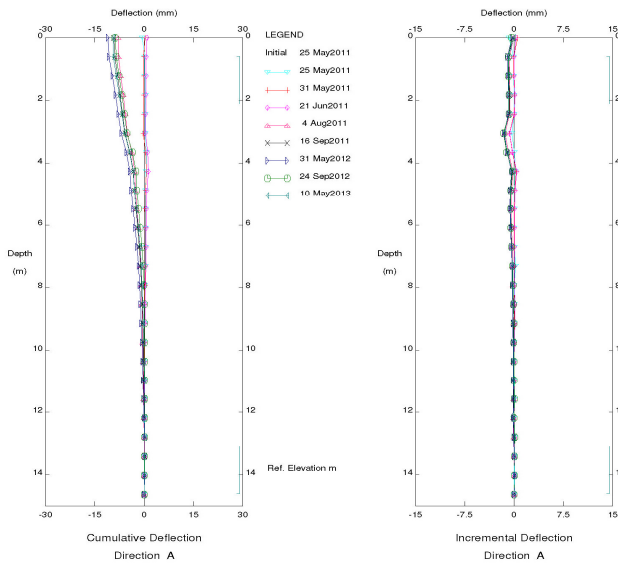
Figure 12. SI11-3: Incremental and cumulative deflections versus depth plots for NC24A pile wall.

Four slope inclinometers (SI11-1 to SI11-4) were installed in piles P9, P27, P45, and P60 to measure the pile wall deflection. Vibrating wire load cells were also installed in ten of the anchors for long term monitoring of the anchor loads. Between 2011 and the 2013, SI011-1 to SI011-3 have shown that the pile wall deflected laterally by -1.5 to -10 mm (i.e. pile wall deflected towards the highway, in response to locking off the anchors). For illustration purpose, the incremental and cumulative deflections versus depth plots in SI11-3 are presented in Figure 12. Figure 13 shows the variation of anchor loads with time for the NC24A pile wall. It should be noted that VC1708 and VC1710 anchors were locked off at 240 kN, whereas the remaining anchors were locked off at 290 kN. The anchor lock-off loads dropped by 13 to 28 % and it should be noted that the majority of the load losses occurred during construction. The reduction in the anchor loads can be attributed to the non-simultaneous locking of anchors and re-distribution of loads along the wall. It is of interest to note that the decline in anchor loads was not accompanied by any ground movements and therefore the performance was considered acceptable as long as the current and future load losses did not reduce the anchor loads below that required for maintaining the stability of the retaining structure.
