# Soil-Structure Interaction Response of a Tangent Cast-in-Place Pile Wall in Peace River, Alberta

Luis A. Martinez, Lilianne Landry-Paré & Donald Proudfoot  
*Thurber Engineering Ltd., Calgary, AB, Canada*

## ABSTRACT

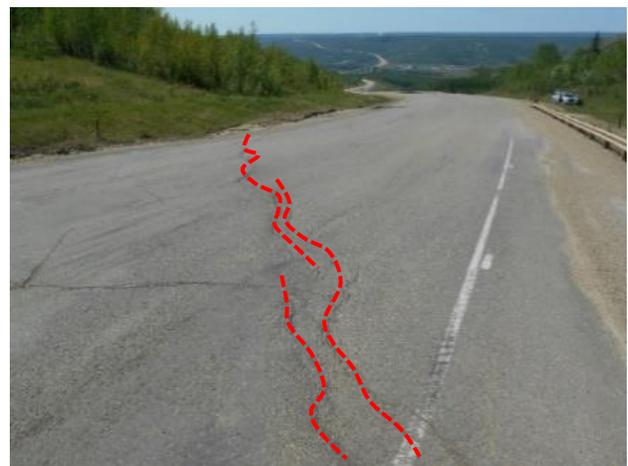
Since its construction in the 1980s, Highway 986:01, in the Peace River region of northern Alberta, has been an important transportation corridor for the resource industry, with an average daily traffic count of 840 vpd. The road is affected by erosion and slope stability problems. These problems are notorious since the highway was built on active landslide areas. Alberta Transportation (AT) initiated a geotechnical instrumentation monitoring program in 2000 to assess the movement progression of various at-risk geohazard sites. One site, located on Highway 986:01 about 20 km northeast of the Town of Peace River, was selected in 2014 to undergo extensive landslide mitigation work. At this location, tension cracks opened on the embankment slope and extended diagonally across the roadway, and the pavement abruptly dropped up to 300 mm (Figure 1).

Figure 1. Looking southwest at cracking and scarp across roadway in 2015.

The landslide mitigation work was designed and administered by Thurber Engineering Ltd. (Thurber) on behalf of AT and consisted of stabilizing the road embankment using a cast-in-place concrete tangent pile wall supported by ground anchors.

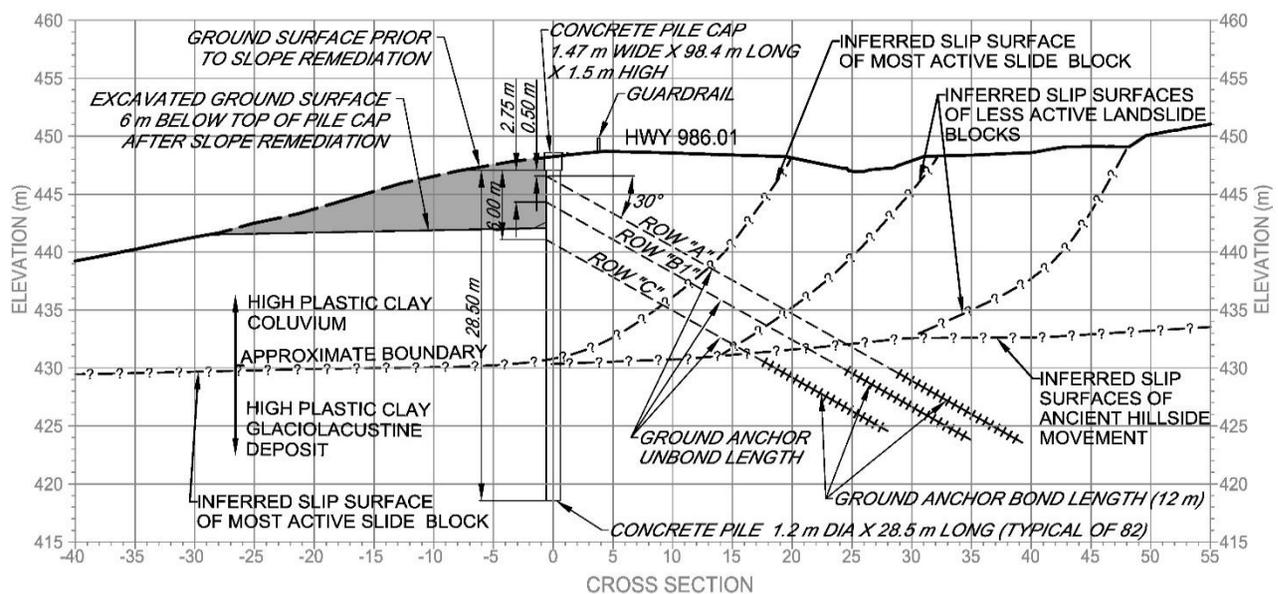
Figure 2. Typical cross section of the tied-back pile wall

To estimate the maximum total combined anchor load, a slope stability analysis was conducted assuming that the high plastic clay colluvium was sliding over stable glaciolacustrine clay and had a residual friction angle of 14.5 degrees. Figure 2 shows the inferred slip surface based on the slide backscarp visible in the highway pavement and the upslope highway ditch further south, as well as the previously installed slope inclinometers. The slide geometry was further confirmed by the soil logging during piling activities and an additional geotechnical drilling investigation conducted during construction.

After the installation of the anchors, the third anchor row was buried to about 1.5 m below the finished ground surface downslope of the pile wall (or about 6 m below the top of the pile cap) as shown in Figure 2. Since the wall was designed assuming a total exposed wall of up to 10 m, this implies that the finished ground surface downslope the pile wall may drop down an additional 4 m without jeopardizing the geotechnical and structural stability of the wall. This drop in grade was accounted for in the design as mainly caused by long term creek created erosion at the toe of the slope. It was also assumed that by offloading the

The selected road embankment stabilization consisted of building a tied-back cast-in-place concrete tangent pile wall as shown in the typical cross section in Figure 2.

The pile wall was 98 m long and included 82 piles of 1.2 m in diameter and 30 m in vertical length connected by a continuous concrete pile cap. Three rows of ground anchors (230 anchors in total) were used to support the wall. The combined bond and free length of the anchors varied from 29 m to 46 m.

The anchors were installed through the piles at 2 m, 4 m and 7.5 m below the top of the pile cap. The anchors used were 32 mm diameter double corrosion protected DYWIDAG anchors. The bond length was 12 m and was installed within the stable glaciolacustrine clay (Figure 2).

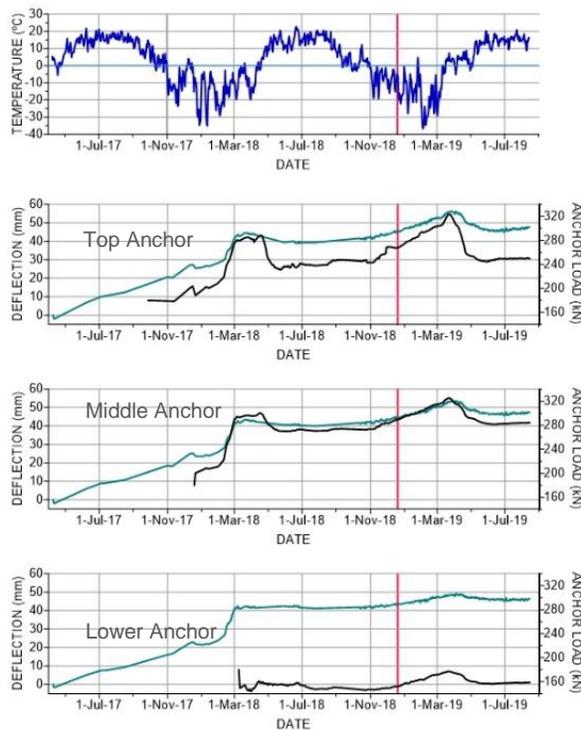
This figure reveals that deflections mainly occurred during construction and that the maximum pile deflection to June 2019 was about 50 mm. The maximum deflection is regarded as small considering the size of the piles (30 m pile length).

The responses of the upper two anchor load cells suggest a gradual load increase during the winter of 2019 followed by a rapid load decrease as the air temperature rises above zero degree Celsius in early spring. The response of the lowest load cell suggests that the anchor load at this elevation is less sensitive to winter. It is our opinion that the load increase in the upper two anchors during winter is due to some combination of anchor head contraction imposed by the freezing temperatures and expansion of freezing soil and ice exerting pressure on the wall. The lowest row of anchors is covered by 1.5 m of fill, and some amount of snow in the winter; and thus, it is mostly protected from temperature changes.

The maximum anchor load recorded was about 330 kN which is well below proof test results (532 kN).

Figure 5. Temperature (in blue), cumulative anchor loads (in black) and cumulative pile deflections (in green) at each anchor location.

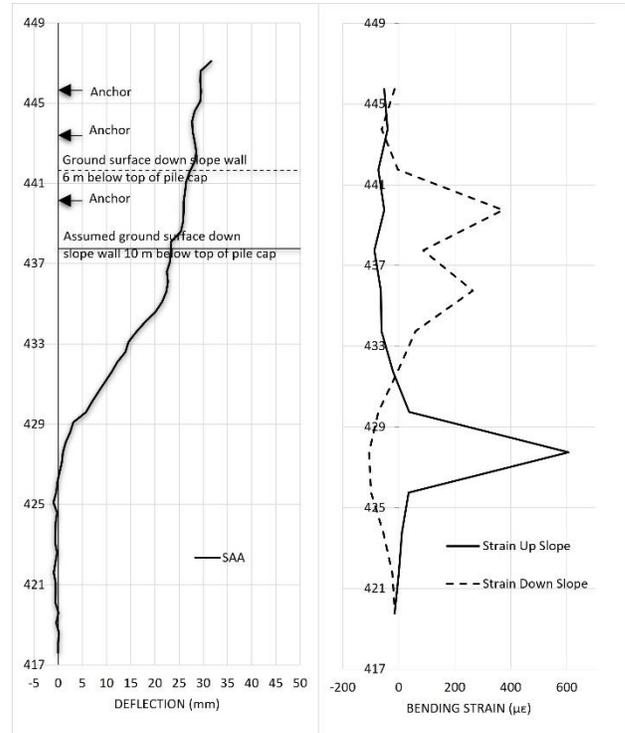
Figure 6. Pile deflections and pile strains at 2 m vertical intervals for December 20, 2018

The strain gauge data suggest that possible partial hinges in the pile may have developed at three locations as indicated by the two strain spikes in the gauges facing down slope near the lower anchor at about elevation 438 m, and one strain spike in the gauges facing upslope near elevation 428 m. These partial hinges are likely the result of internal stresses being transferred from the concrete to the reinforcing steel as the pile cracked in response to deflections.

The bending moment calculated from the strain gauge data on December 20, 2018, corresponding to the lower strain spike of 354 kN.m plotted in Figure 6, shows an excellent agreement with the back calculated bending moment curves using hinges from Mathcad and S- FRAME. The bending moment of 354 kN.m is substantially lower than the 2094 kN.m bending capacity of the pile. It should also be noted that the value of the lower strain spike (tension) was about 600 micro strains which is well below the yielding strain of the steel which is 2000 micro strains. This suggests that this hinge is an elastic and not a plastic hinge.

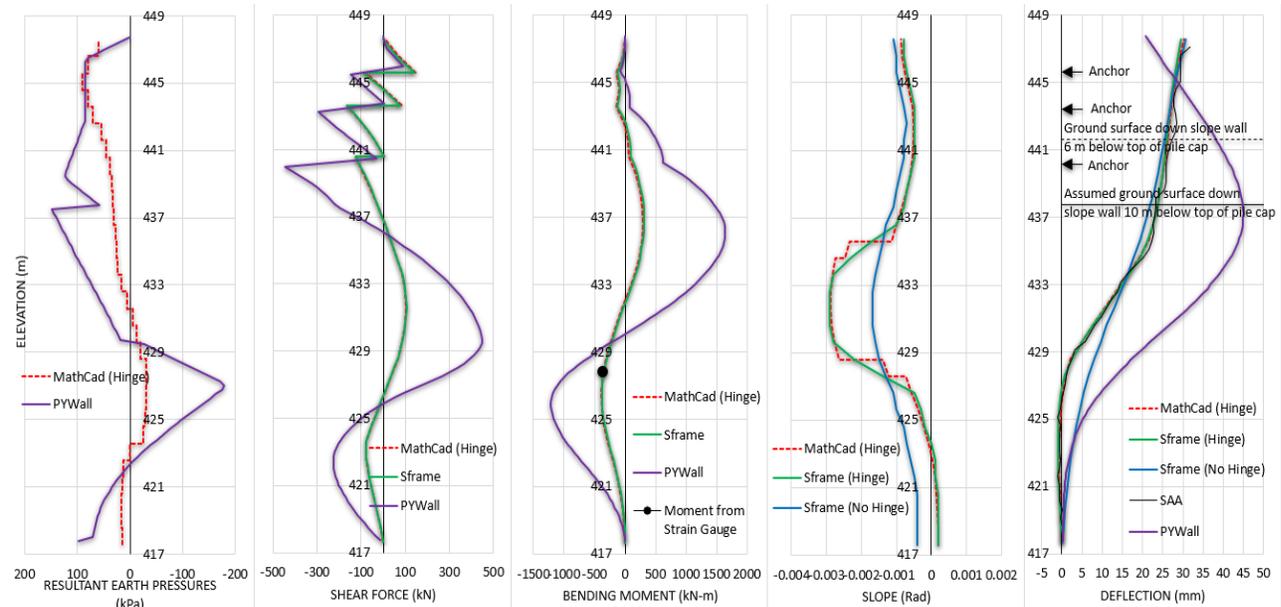
Since deflection convergence was not achieved after several trials, the two lower pile partial hinges suggested by the strain gauge data in Figure 6 were included in the Mathcad subroutine as additional boundary conditions to achieve convergence. This addition was the key to match the calculated deflections with the measured deflections as shown by the Mathcad and S- FRAME results in the plot of deflections in Figure 7. If hinges are not included, the calculated deflections (and thus, the associated bending moments and shear forces) could be quite different as shown by the S- FRAME results in the plot of deflections in Figure 7.

The hinges used in the analysis can be seen in the plot of slopes in Figure 7. The partial hinge in the vicinity of the lower anchor was not included in the analysis as its contribution did not substantially impact the results.

The maximum measured deflection for the pile at the middle of the wall was about 30 mm. This value appears to

be high when compared to a typical maximum wall deflection of 25 mm. However, when comparing the measured anchors loads and the back calculated internal loads in the piles (bending moments and shear forces) with the actual anchor/pile capacity, it appears that the pile structural future performance is guaranteed.

PYWall software was used to estimate the design pile shear forces, bending moments and deflections for a total exposed wall of 10 m. The analysis was conducted for a trapezoidal earth pressure distribution calculated using a load 1.3 times the active load. The design curves are shown in Figure 7 and are greater than the curves for December 20, 2018, since at this date the ground surface in front of the wall was only 6 m below the top of the wall. It should be noted that at the time this paper was submitted, the ground surface in front of the wall is unchanged.

Figure 7. Results of the soil-structure interaction analysis using various methods of analyses for pile at the middle of the wall on December 20, 2018: from left to right, resultant earth pressures, shear forces, bending moments, slopes and deflections.
