# Baptiste Creek Bridge Landslide, HWY 2:42 Near Athabasca, Alberta: Design and Construction of Remedial Measures

José Pineda, Tarek Abdelaziz

Thurber Engineering Ltd., Edmonton, Alberta, Canada

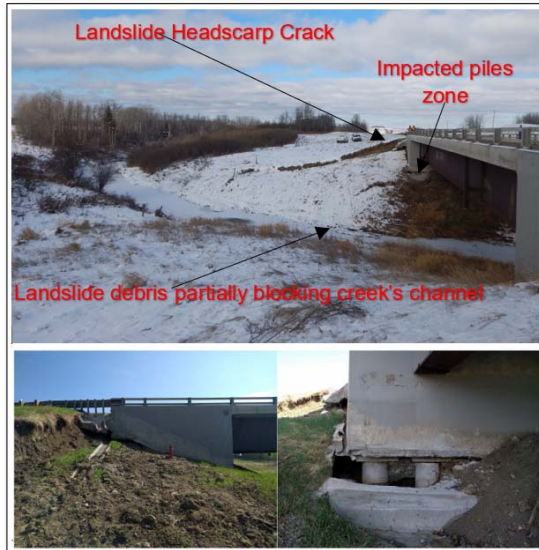
**Figure 2. Landslide Features (2017 and 2018)**

According to Thurber Engineering Ltd. (2018), a landslide occurred in 2017 within the northwest approach fill of Alberta Transportation's Bridge File BF7055 located on Highway 2 at the Baptiste Creek crossing, in North-Central Alberta. The site location is presented in Figure 1. The movement resulted in a void below the southbound highway shoulder, loss of soil from behind and below the northwest abutment wingwall, exposure and rotation of two exterior integral-abutment pile casings, and landslide debris constricting the creek channel. The main features of the landslide are presented in Figure 2.

In September 2017, Alberta Transportation personnel noticed a lateral movement of the northwest side slopes of the bridge approach embankment, and the formation of voids adjacent to the taper of the existing drain trough and below the northwest corner of the abutment seat. The highway maintenance team poured a Class C concrete into the voids in an attempt to enhance the situation. However, a major slope movement occurred abruptly within the northwest approach embankment in October 2017. The sudden movement resulted in the formation of a gap below the wing wall and the abutment seat, and a complete failure of the drain trough.

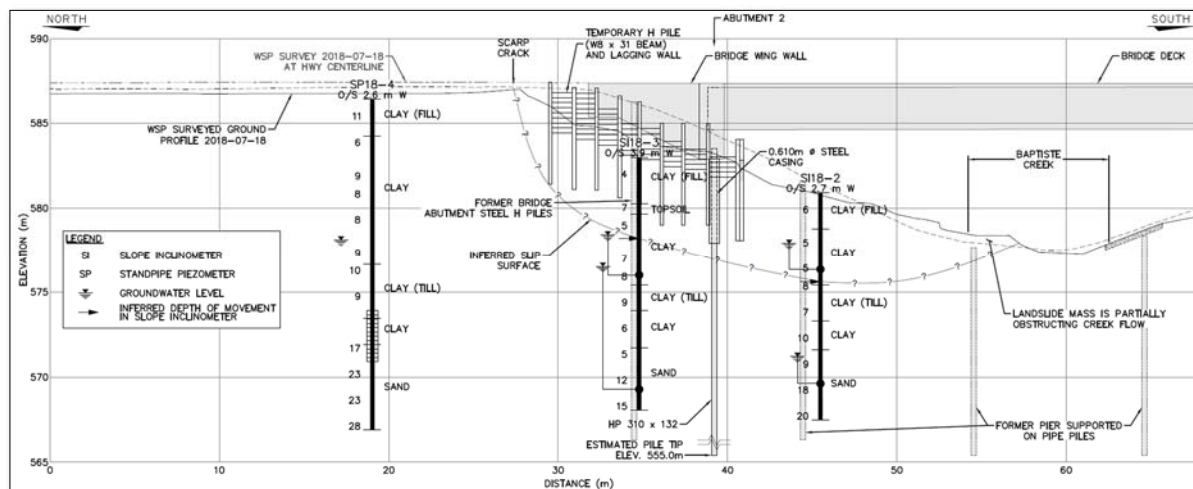
**Figure 3. Stratigraphic Cross-section of the Northwest Approach Embankment, with Inferred Failure Surface and Temporary Stabilization Measures.**

Figure 3 shows a stratigraphic cross-section of the northwest approach embankment and the temporary soldier pile retaining wall. Geotechnical investigation results, and design and construction of the permanent landslide repair are discussed in the following sections.

The soil conditions encountered in the test hole locations consisted in descending order of clay fill, clay, clay till, and sand, as shown on Figure 3. The clay fill was typically grey to brown, with occasional sand and silt lenses and trace gravel and oxides. SPT 'N' values in the clay fill typically ranged from 4 to 11 blows per 300 mm penetration, indicating a firm to stiff consistency. The natural moisture content of the clay fill typically varied from about 17 to 31 percent. One Atterberg Limits test conducted in the clay fill indicated high plasticity.

The inferred slip surface is presented on Figure 3, and the planar extent of the landslide is shown on Figure 4. The results of the geotechnical investigation indicate that a deep-seated failure occurred at this site. The placement of steeply inclined fill (transitioning from 2H:1V at the head slope to 3H:1V at the side slopes), and the presence of weak high plastic clay are likely the main causes for the slope movement. Lack of proper

bank erosion protection at the toe of the slope may have also contributed to the instability at this site.

A temporary stabilization measure was implemented by the highway maintenance crew in July 2018, and included installation of a soldier pile retaining wall with timber lagging parallel to the southbound shoulder and below the north abutment seat; placing granular fill to backfill the gap between the wing wall, abutment seat and the temporary retaining wall; filling the voids below the roadway and behind the wingwall with expanded foam, constructing a concrete curb along the edge of the highway southbound lane to divert runoff away from the landslide area, and placing a half corrugated steel pile (CSP) down-drain at the end of the curb to convey the runoff to the bottom of the highway side slope.

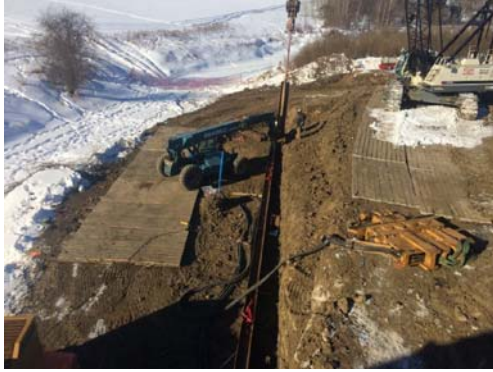
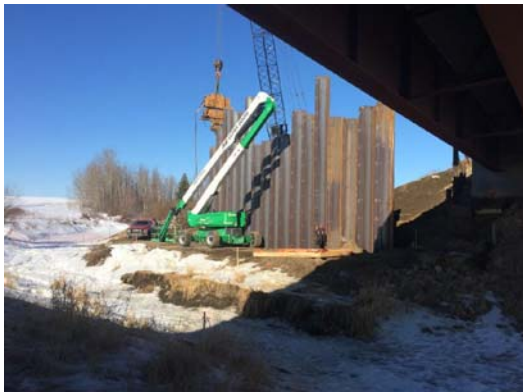
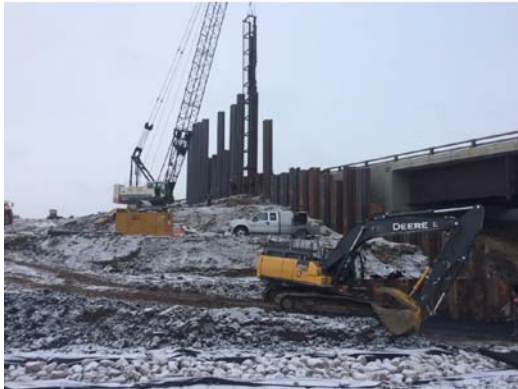
While driving Sheet Pile Wall 'B' with a vibro-hammer, it was noticed that sheet pile section B15 was tilting out of alignment (Figure 5b). As piling continued, it was observed that sheet piles B14 and B16 were also starting to drift out of plumb. The contractor chose to drill a 200 mm diameter test hole around the sheet pile wall to determine if there was an obstruction that was causing the sheet pile to deflect during driving; however, the test hole did not reveal any obstruction. After a joint survey and discussion about the misaligned piles between the consultant and the contractor, it was agreed to continue driving the piles and monitor them to see if the misalignment would become worse.

**Figure 6a. Guide Beam Installation**

**Figure 6b. Installation of Sheet Pile Wall 'A'**

**Figure 6c. Installation of Sheet Pile Wall 'B'**

Prior to driving the sheet piles, a guide frame was set on the ground to help maintain the alignment of the sheet piles. The guide frame consisted of a welded H-beam running along the pile wall alignment and stakes to maintain the frame's position. The sheet piles were installed using a J&M Model 44-50 hydraulic vibro-hammer for the initial drive. Sheet piles were checked for plumbness and alignment during driving to ensure the sheet piles remained within the specified tolerance. After the initial drive with the vibro-hammer, a Pileco D25-32 diesel hammer was used to drive the sheet piles to their required depths. (See Figures 6a, 6b, and 6c).

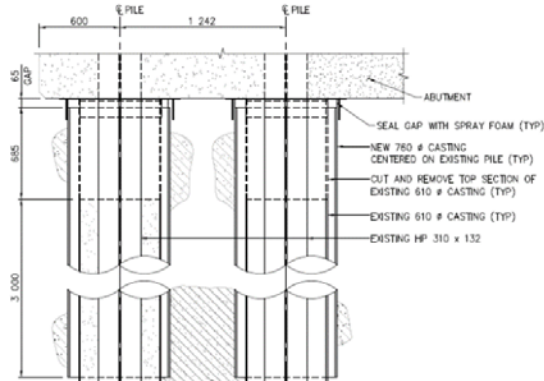
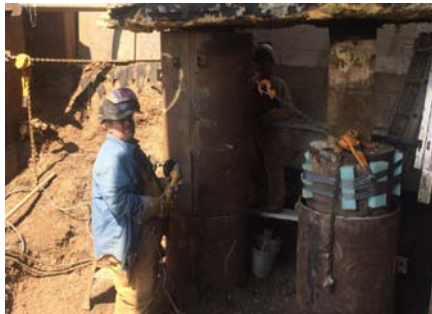
The upper portions of the two-northwest integral-abutment piles impacted by the landslide were exposed to facilitate their repair. Upon exposing the impacted piles, it was evident that Class C concrete (previously placed to temporarily backfill the voids below the highway and abutment seat) had inadvertently flowed into the casing of the first exterior integral-abutment pile. Therefore, the originally proposed scheme to use a jacking system to re-center the existing casings, had to be adjusted as follows: 1) Cutting the upper 750 mm of the two exterior pile casings; 2) Hand chipping the exposed concrete around the exterior abutment H-piles 3) Hydrovacating a larger excavation around the remaining casings; 4) Installing (and subsequently removing) a temporary shoring system below the bridge; 5) Installing a new 760 mm diameter casing around the existing pile casings in the upper 3 m below

**Figure 8. Cross Section of Impacted Piles Retrofit**

**Figure 9. Installing Casings Around Impacted Piles**

the abutment seat (See Figures 8 and 9); 6) Sealing the gap between the underside of the abutment seat and the top of the casings with spray foam; 7) Backfilling the excavation around the new casings with 3 MPa fillcrete.

At the first exterior abutment pile, the bottom 3 m of the original 610 mm diameter pile casing remained filled with Class C concrete, which would result in a stiffer response to thermal movements. However, detailed structural analysis by Geometrix indicated the adjusted system would provide sufficient structural capacity and the required flexibility for accommodating future thermal movements of the bridge superstructure.

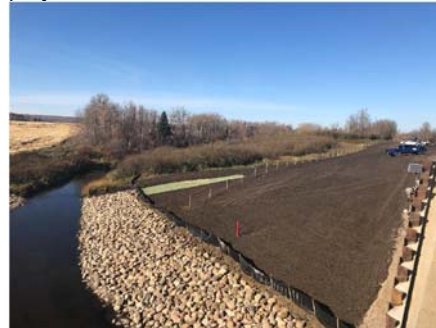
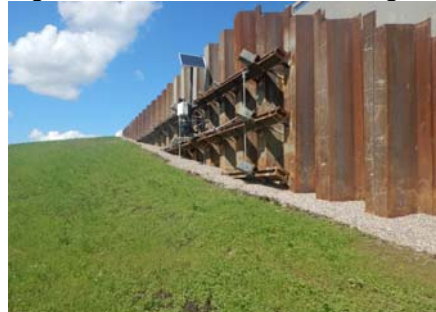
Figures 11a and 11b show the site condition after completing all permanent repairs required on this project.

**Figure 11a. Site Conditions During Final Inspection**

**Figure 11b. Site Conditions One Year After Construction**

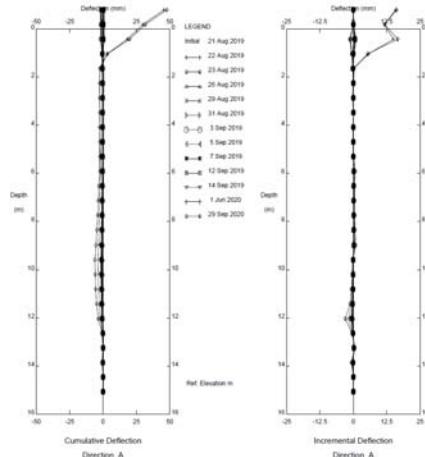
Figure 12. Slope Inclinometer Data, Pile Wall 'A'

Based on monitoring results up to the Fall of 2020, slope inclinometer SI19-1 has shown no discernible movement since initialization (Figure 12). Plots for the SI seem to indicate possible settlement of the casing around 12 m depth, which could correspond to a potential loss of grout at this depth during installation.

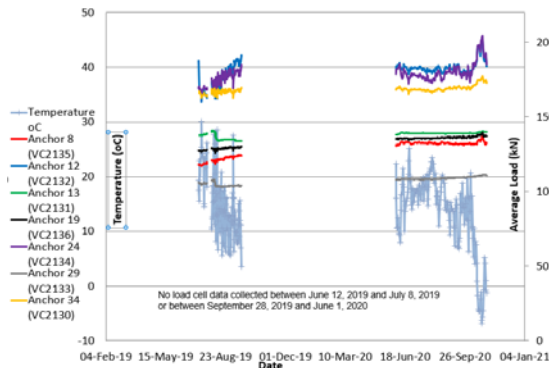
Figure 13. Anchor Load Cell Data, Pile Wall 'B'

The load cells installed in Pile Wall 'B' (Figure 13) all showed reductions in anchor loads after installation ranging between 4 and 20 percent. However, the readings have been relatively stable between 2019 and 2020 and no signs of significant wall movement were noted after construction completion.

similar pile wall projects. Seating and friction losses and load re-distribution between supports are typically the main reasons for load reduction. Anchors 12 and 24, which have the least depth of cover behind the wall, exhibit a well-defined correlation between the anchor load and ambient temperature. A temporary increase of 20 kN in anchor load occurs during the winter season due to frost effect. However, the anchor load during winter season is still below the design load, and hence it is not a concern at present time.

Additional monitoring during the winter months is recommended to confirm the stress and strain trends observed to date.
