Alberta Highway 858:02 embankment stabilization—geotechnical investigation, design, and construction

X. Wang, H. El-Ramly & D. Proudfoot
Thurber Engineering Ltd., Edmonton, Alberta, Canada

ABSTRACT: An embankment failure on Highway 858:02 north of Lac La Biche, Alberta was investigated through field drilling and monitoring programs. The embankment is founded on peat and soft clay deposits. The results of field monitoring indicated that the embankment failure is characterized by translational failure mode. The failure is attributed to high groundwater table in the area and poor foundation soils. Discrete steel piles have been selected to improve the slope stability by providing horizontal restraint to the unstable embankment mass. Slope stability analyses were carried out to determine the additional resisting force required to increase the factor of safety to the desired level. The maximum shear force and bending moment that each pile has to resist were evaluated using lateral pile analyses. The pile type and number of piles were selected based on the results of the lateral pile analyses. During construction, excess pore water pressures generated by pile driving were monitored. Th

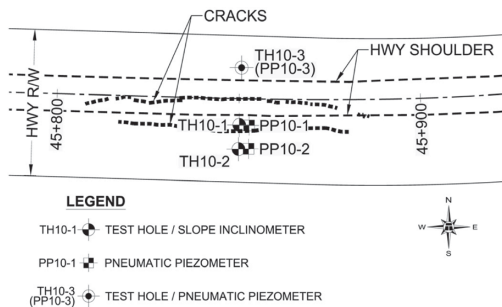
Figure 2. Pavement cracks and test hole locations.

As part of the geotechnical investigation, site reconnaissance and survey of the slide area were carried out in 2010. The results of field observations and survey are presented on Figure 2 and summarized in following paragraphs.

At the slide location, the highway embankment is about 2 m in height and the inclination of the embankment side slope is approximately 11° to the horizontal. The slide area is about 70 m long and 25 m wide in a plan view. The highway east-bound traffic lane experienced extensive cracking and an overall arc shaped pattern of tension cracks was observed in the pavement surface during the site reconnaissance. Relatively continuous cracking was noted along the centerline of the highway and extended for a distance of about 30 m. The crack widths ranged from less than 5 mm on the west limit of the slide to about 50 mm near the centerline of highway and on the east edge of the slide area.

In addition to the cracks on the highway pavement, ground cracks and a shallow graben running parallel to the highway were observed on the south embankment side slope. The cracks on the sideslope were located at a distance of about 3 to 4 m from the edge of the pavement. The crack widths ranged from 5 mm to 75 mm.

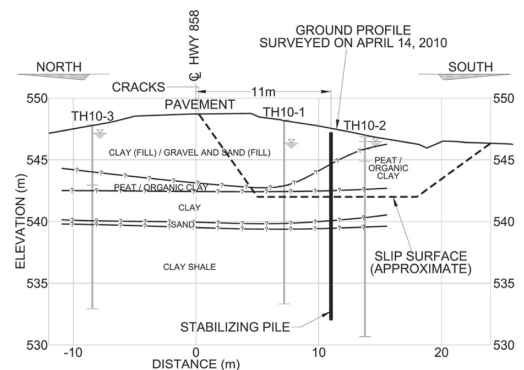
Figure 3. Geotechnical profile of embankment slope and slip surface.

The general subsurface conditions encountered at the test hole locations consisted of clay fill, over peat and organic clay, over clay and sand, overlying clay shale. The general soil conditions are summarized on the stratigraphic cross-section presented on Figure 3. Brief descriptions of the soil units encountered at the site are presented below.

Figure 4 indicates a near horizontal slip surface located at elevations 542 to 542.5 m, suggesting a translational failure mode. Based on the field observations and slope monitoring results, an approximate location of the slip surface is shown on Figure 3.

As noted on the borehole logs, the roadway embankment is founded on buried peat and organic clays, overlying a soft clay deposit. The base of the observed slip surface (approximate elevation of 542 m) coincides with the top of the soft clay layer. The embankment failure was likely triggered by elevated groundwater table combined with poor foundation soils characterized by very low shear strength.

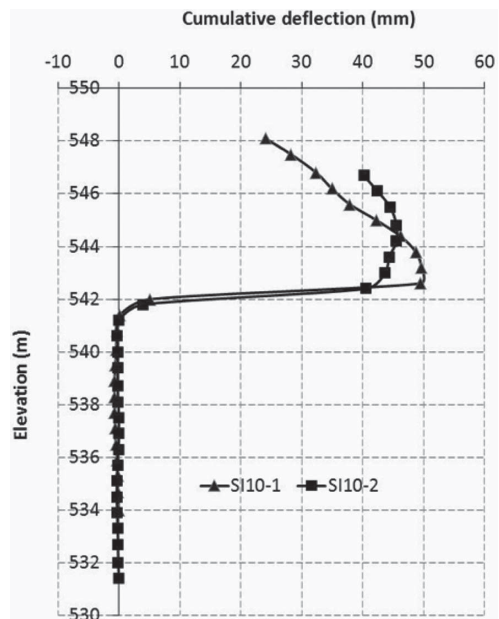
Figure 4. Cumulative deflection measured from slope inclinometers between March 15 and June 16, 2010 (positive values denote downslope movements).

Slope movements were monitored using two slope inclinometers, SI10-1 and SI10-2, installed during the geotechnical investigation. The results of slope monitoring are presented on Figure 4, and show a maximum deflection up to 50 mm along the slip surface over a period of approximately 3 month

(March to June 2010). In August 2010, both slope inclinometers were sheared off.

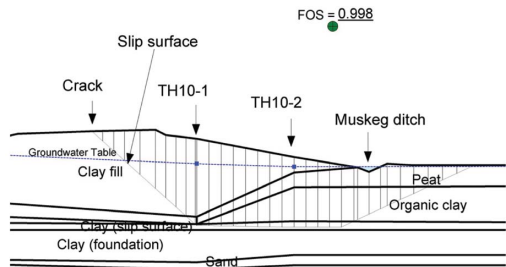
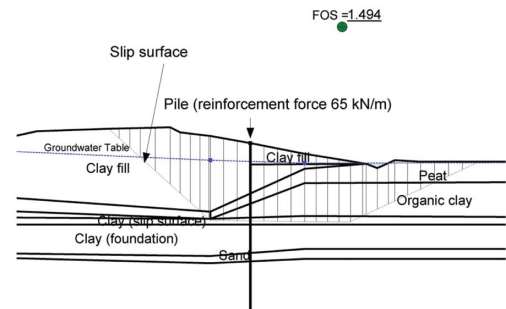
Figure 5. Slope stability analyses for the design of stabilizing pile.

Figure 5 presents the stability analyses of the embankment slope without and with the stabilizing piles. The result of the stability analyses indicate that a resisting force of 65 kN per linear meter along the highway is required to improve the long term factor of safety of the embankment slope from near unity to approximately 1.5. The factor of safety used in the design is greater than 1.3 to take account

of future deterioration of the slope. The actual mobilized resistance required to ensure the stability of the embankment slope is expected to be less than the above value specified. (i.e. 65 kN/m).

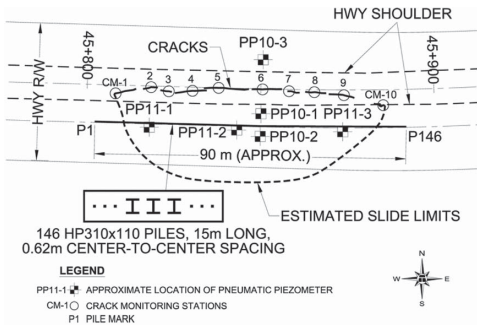
Figure 6. Sketch of the stabilizing pile design.

The slide conditions, including the extent and width of the pavement cracks and settlement of roadway surface, were documented prior to the start of construction. The slide development was continuously monitored during pile installation. The locations where pavement cracks were monitored during construction are shown as CM-1 to CM-10 on Figure 6. The monitoring results were used to assess the construction induced ground movement.

Crack development during the piling operation was estimated by comparing the crack dimensions measured prior to and immediately after the pile installation. The maximum increases in the crack widths and vertical drops of the pavement were approximately 4 mm at CM-8 and 10 mm at CM-6, respectively. The results of crack monitoring indicated that adopted methodology for pile installation minimized the adverse impacts of construction activities on the stability of the marginally stable slope.

The results of the lateral pile analyses indicate that discrete steel piles consisting of HP310 × 110 at a center-to-center spacing of 0.62 m (2 times the pile width) will be adequate to stabilize the sliding mass. The pile tip elevation is 532 m (15 m below the ground surface at the pile location), approximately 8 m below the slip surface.

The calculated pile lateral deflection at the ground surface and maximum bending moment are 75 mm and 160 kN · m, respectively. In order for piles to function effectively, the piles are located approximately 11 m from the centerline of the highway, near the midslope location. A total of 146 piles are required to stabilize the failed slope. An illustration of the layout of the stabilizing piles is shown on Figure 6.

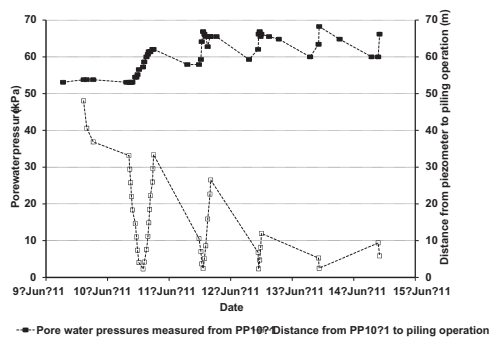
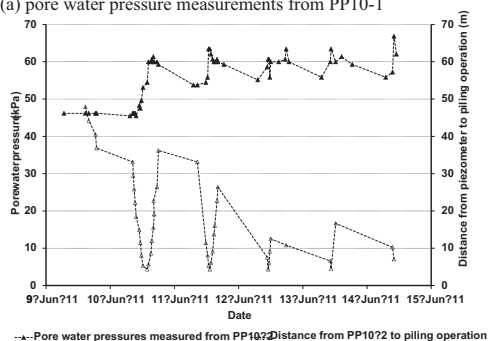
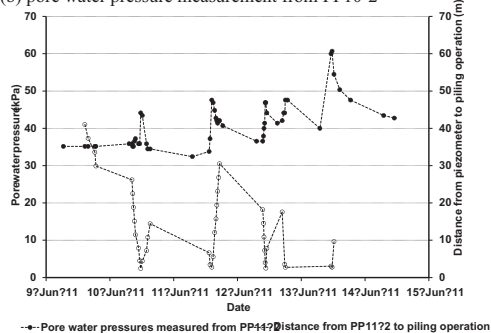
Figure 7. Pore water pressure monitoring during pile installation.

The development of excess pore water pressures at three piezometers located near the center of the pile wall is presented in Figure 7. The plots show the variation of the measured pore water pressures with time and distance to the location of piling operation. Examination of these plots indicates the following observations:

1. Excess pore water pressures typically increased as the distance to the piling operation decreased;
2. A cumulative increase of excess pore water pressure was observed over time as the number of installed piles increased;

3. An increase in pore water pressure was measured as piles were installed within a distance up to 30 m (approximately 100 pile widths) from the piezometer location.
4. The excess pore water pressures generated during the pile installation dissipated relatively rapidly. A significant portion of the construction induced excess pore water pressures dissipated within 24 hours. The presence of the peat layer immediately above the sliding zone was likely responsible for the rapid pore water pressure dissipation.
