fr: ASCE Geotechnical Special Publication #101
- Slope Stability 2000. edited by
D.V. Griffiths, Gordon A. Fenton, and
Timothy R. Martin.

STABILIZATION OF MEIKLE RIVER SLIDE ON HIGHWAY 35

Vishnu Diyaljee¹, Fellow, ASCE, Murthy Pariti² and Roy Callioux³

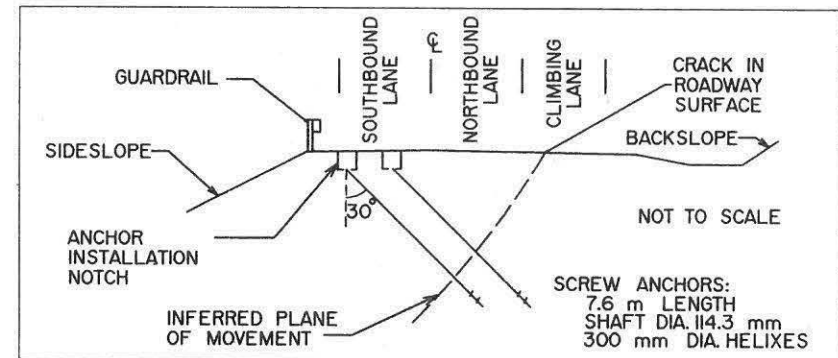
Figure 4. Installation of Screw Anchors

Fifty (50) helical screw anchors each consisting of a 7.6 m long by 114 mm diameter shaft and two 300 mm diameter helixes, were installed in the slide area by Alberta Anchors Inc. of Fort Saskatchewan. For the installation of the anchors, two notches were made in the road by excavating the asphalt and base course to a depth of about

1.5m below ground to facilitate the insertion of the anchors and to ensure that they were buried below ground. The anchors were installed in an inclined direction towards the backslope of the road at an angle of approximately 30° to the vertical (Figure 4). After the installation of the anchors was completed, the notches were backfilled with gravel and the surface was repaved.

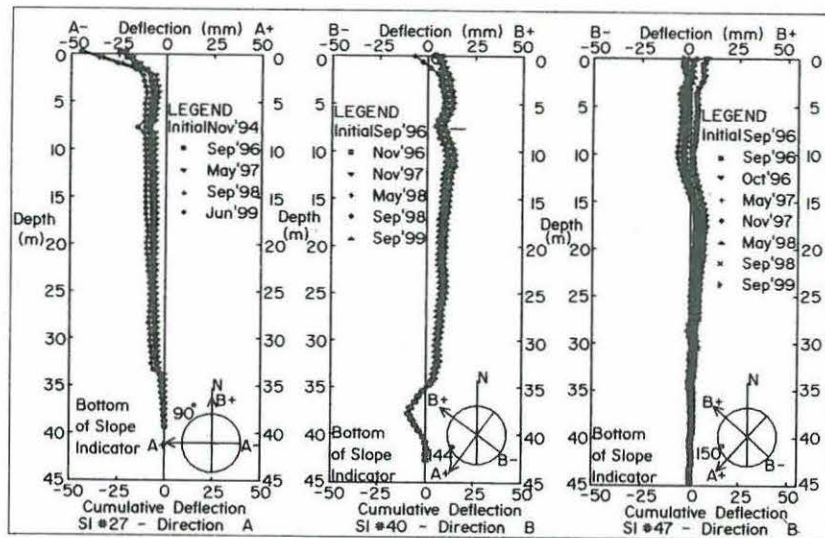
Figure 5. Typical Slope Indicator Plots on Possible Realignment Location

1. A realigned section would still be exposed to slide terrain as may be inferred from the deep seated nature of movements shown by the slope indicators installed in the area considered feasible for realignment (Figure 5).
2. The realignment would have to be done through privately owned land and hence could be subject to long delays due to likelihood of expropriation measures to acquire the necessary right-of-way.
3. Shifting the alignment of the highway would also involve steeper grades, longer

While the installation of drilled straight shaft piles was considered a feasible alternative in principle, it was also recognized that the slide activity along this 1 km stretch of roadway was deep seated, as inferred from Figure 5, wherein existence of multiple slide zones is generally noticeable at depths varying from 5 to 40 m. However, in the immediate vicinity of Site 2, the depth of slide zones vary from 8 to 28 metres. Figure 6 shows typical monitoring data of two slope indicators of Site 2.

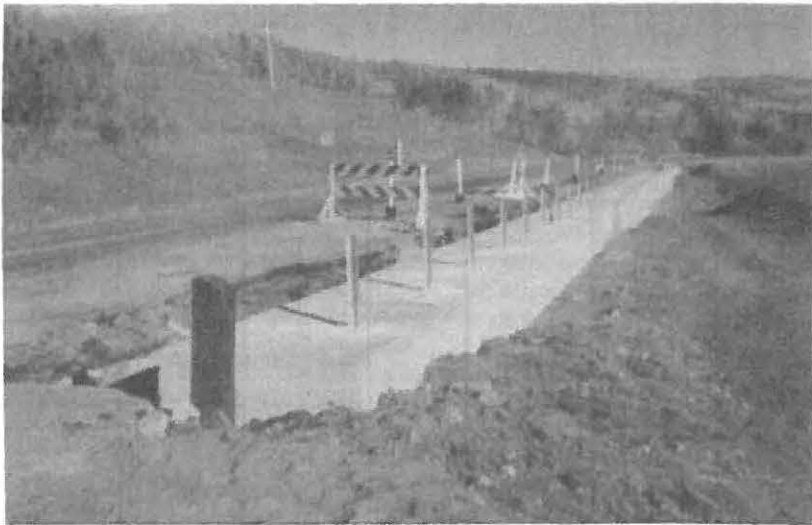
Figure 7. Completed Capping Beam Installation

The capping beam construction contract was undertaken between August 20 and September 5, 1998 by Ruel Concrete Ltd of Peace River, Alberta. Concrete was supplied by Szmata Concrete and Aggregates Ltd, of Grimshaw, Alberta. The guardrail was mounted on top of the capping beam after its completion, Figure 7. The traffic lane adjacent to the pile wall was restored with an additional gravel base course and paved with new asphalt concrete pavement.

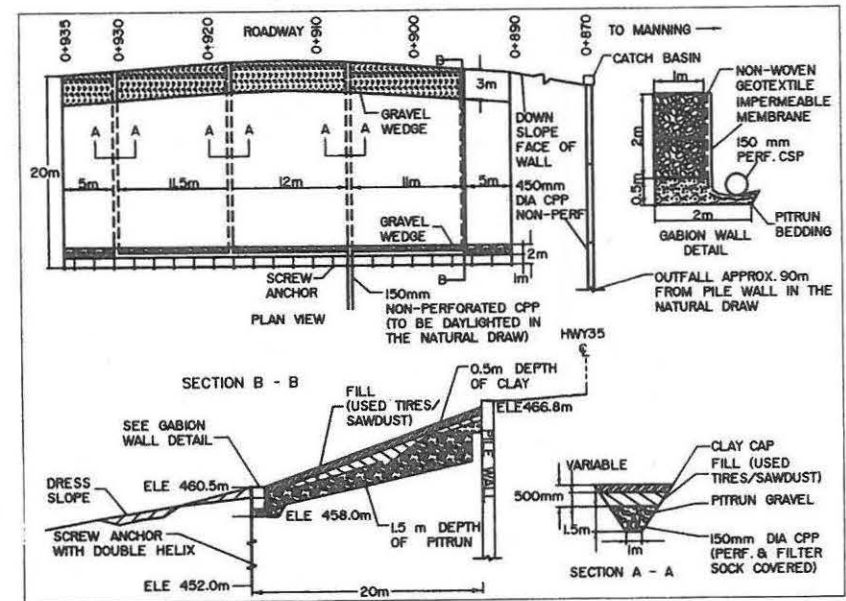
Figure 8. Gabion Wall Installation and Drainage Measures

Four shallow gravel filled finger drains with perforated pipe were installed in the slumped material of the sideslope between the pile wall and the gabion wall. These were installed

perpendicular to the centre line of the roadway to tap into the seepage below the road elevation coming from the uphill terrain. These finger drains were then connected to a longitudinal collector drainage pipe system installed behind the gabion wall. A 150 mm diameter non-perforated corrugated plastic pipe was then connected to the collector pipe and daylighted away from the gabion wall further down the slope.

Following the completion of the gabion wall and the subsurface drainage system, the sideslope between the gabion wall and the pile wall was reshaped to a uniform slope using discarded tires and wood chips as part of the fill material to reduce the lateral pressure on the gabion wall. A non-woven geotextile was then laid on top of the tires/wood chips and then capped with clay material. A typical drawing related to the gabion wall construction and drainage measures is shown in Figure 8.

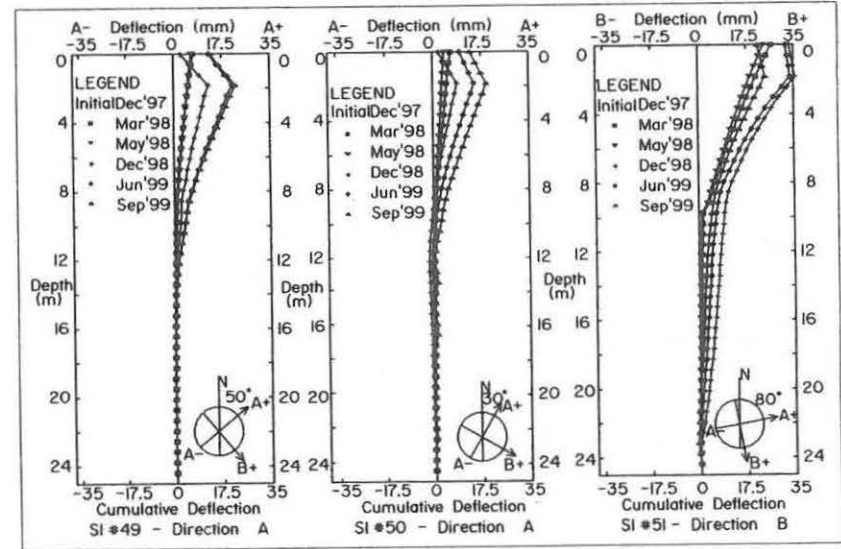
Figure 9. Typical Plots of Slope Indicators in the Pile Wall

The slope monitoring instrumentation is being read on a semi-annual basis. The three slope indicators installed in the pile wall are showing slow creep movements generally within the top 8-12 metre depth range (Figure 9). Below that depth, the movements are practically negligible. It is also interesting to note that there is a kink in the deflection plots at about 2 m depth below the road. This kink generally coincides with the depth of surficial sloughing, noticed prior to the pile wall installation, on the side slope of the highway. Typical time-movement plots corresponding to both A and B grooves of SI #50, which was installed in the middle of the pile wall, are shown in Figure 10. The rate of movement is generally in the order of 0.02 mm/day and there is no indication of drastic changes observed in the displacement plots.
