SH1  
from: ASCE Geotechnical Special Publication #101  
- slope stability 2000. edited by  
D.V. Griffiths, Gordon A. Fenton, and  
Timothy R. Martin.

## STABILIZATION OF A SLIDE USING A TIEBACK PILE WALL

Vishnu Diyaljee<sup>1</sup>, Fellow, ASCE, Murthy Pariti<sup>2</sup> and Roy Callioux<sup>3</sup>

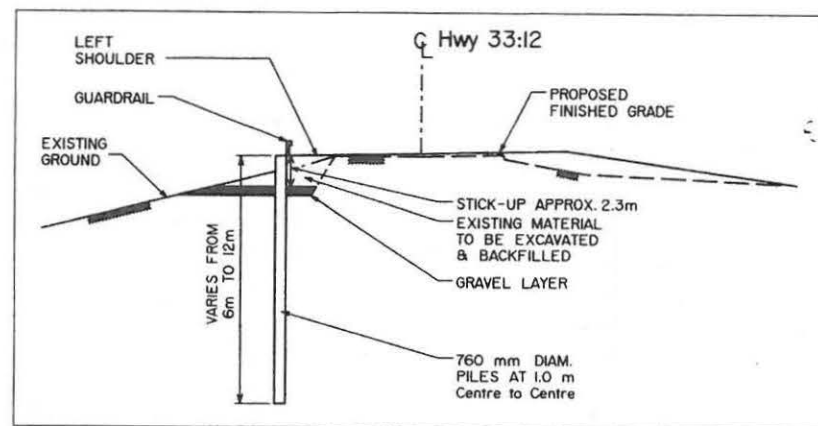
Figure 2. Location of Pile Wall along Roadway

A pad was prepared on the side slope about 2.5 m below the elevation of the road as an access for the drilling equipment. In total, 82 piles, each 760 mm in diameter, were installed from Sta. 9+620 to 9+700 at an average center-to-center spacing of 1 m. Although these piles would be conventionally anchored into bedrock or hard shale in typical piling projects, the depths of piles in this project were constrained by the location of horizontal drains installed within the slide area in the previous years. The location of the pile wall in relation to the roadway embankment is shown in Figure 2.

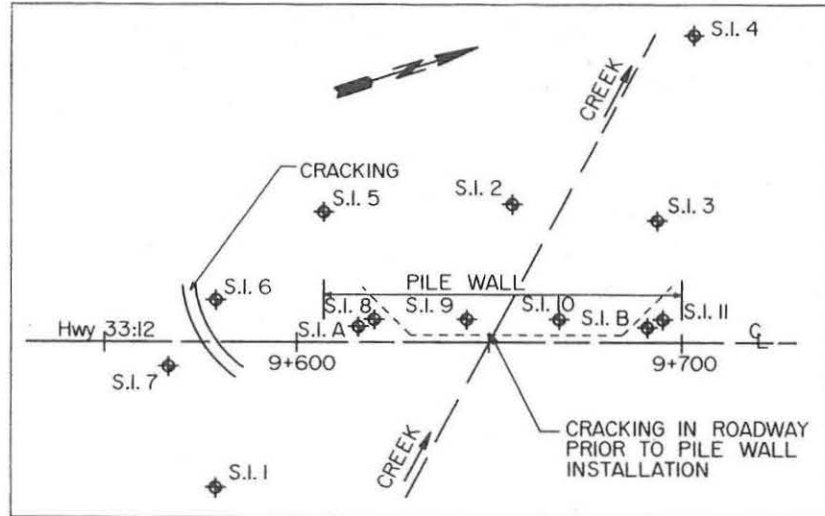
Figure 3. Layout of Slope Indicators and Crack Patterns

The highway grade was raised by about 1.0 m during the summers of 1990 and 1991. Prior to the construction of the grade raise, a site inspection was done in May 1990 to check the performance of the pile wall. This inspection revealed that little or no lateral movement was evident in the roadway embankment fill in the area of the concrete piles, but the road had settled considerably south of the pile wall close to Sta. 9+560.

Cracking of the pavement at about 60 m south of the pile wall location (Sta. 9+560) was observed even before the installation of the wall in 1989 and became more pronounced in the summer of 1990. This cracking was almost diagonal to the centreline of the road and can still be observed today (Figure 3).

The cracking south of the pile wall continues to be a matter of concern. Since the depth of movements are in the order of 12 to 18 m, a recommendation was made to extend the pile wall southward to encompass the pavement cracking location. However, no specific measures have been implemented to date. It is likely that the pile wall system may be extended sometime in future if continued maintenance of the roadway surface by patching is no longer considered to be a cost effective approach in keeping this section of roadway functional.

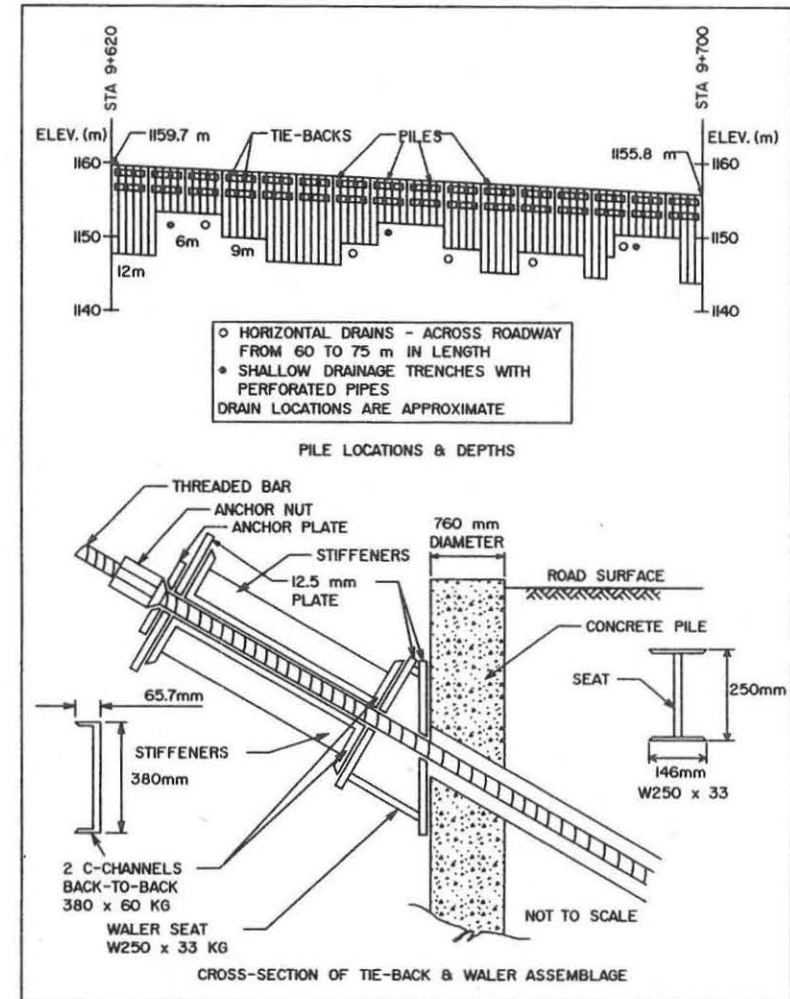
Figure 4. Details of Tieback Installation

The design of the tiebacks was undertaken using laboratory obtained shear strength parameters of  $c'=12$  kPa and  $\phi'=25^\circ$  for the native soil behind the pile wall. The design called for two rows of tiebacks consisting of 28 tiebacks in each row installed at 1 m and 3 m depth, respectively, below the top of the piles. Each waler beam was designed to be a composite section consisting of two of C380 x 60 kg channels laid back to back

and covered both at the top and bottom by steel plates of 12.5 mm nominal thickness. Typical details of the tieback installation are shown in Figure 4.

Two anchors were installed in each beam at an angle of  $30^\circ$  to horizontal. Each anchor consisted of a 36 mm diameter Dywidag Grade 150 steel rod inserted in a 125 mm pre-

drilled hole and grouted for a length of 7.5 m into the intact shale zone. The length of each anchor in the native silty clay zone was about 36 m. Each anchor was designed to resist a tensile force of 600 kN. Fifty (50) MPa strength cement concrete was specified for the grout.

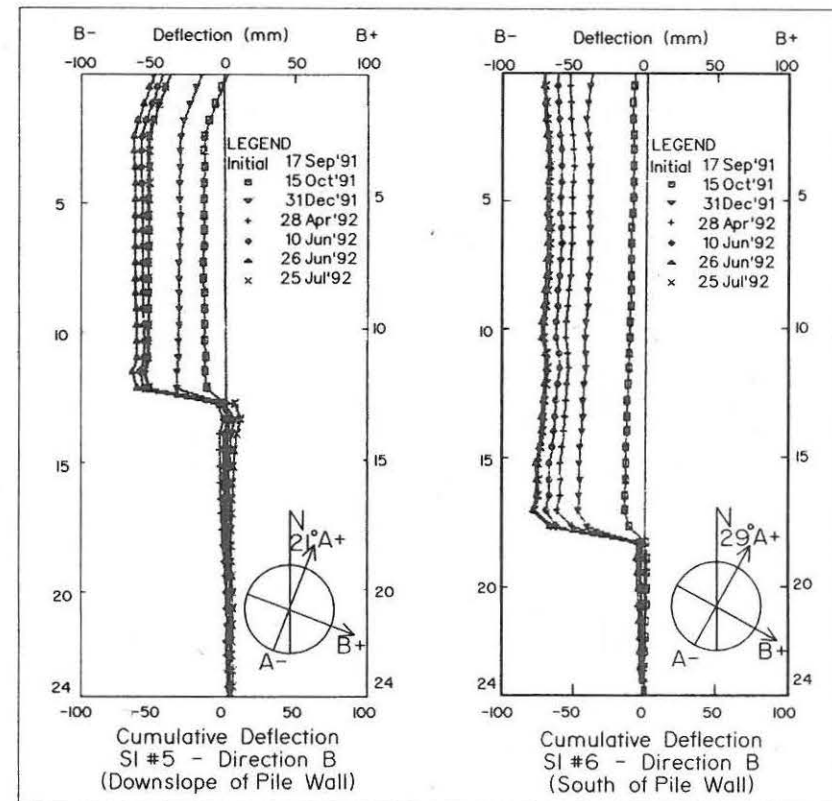
Figure 5. Typical Slope Indicator Plots Outside of Pile Wall

Well-defined failure planes are indicated in the plots of the slope indicators located by the pile wall and south of the pile wall, as shown in the typical plots of Figures 5 and 6.

Slope indicators #5 to 7 installed in the crack area have sheared at different depths varying from 8 m in SI #7 to 18 m in SI #6. Generally, the average depth of movement is about 12 m below the road.

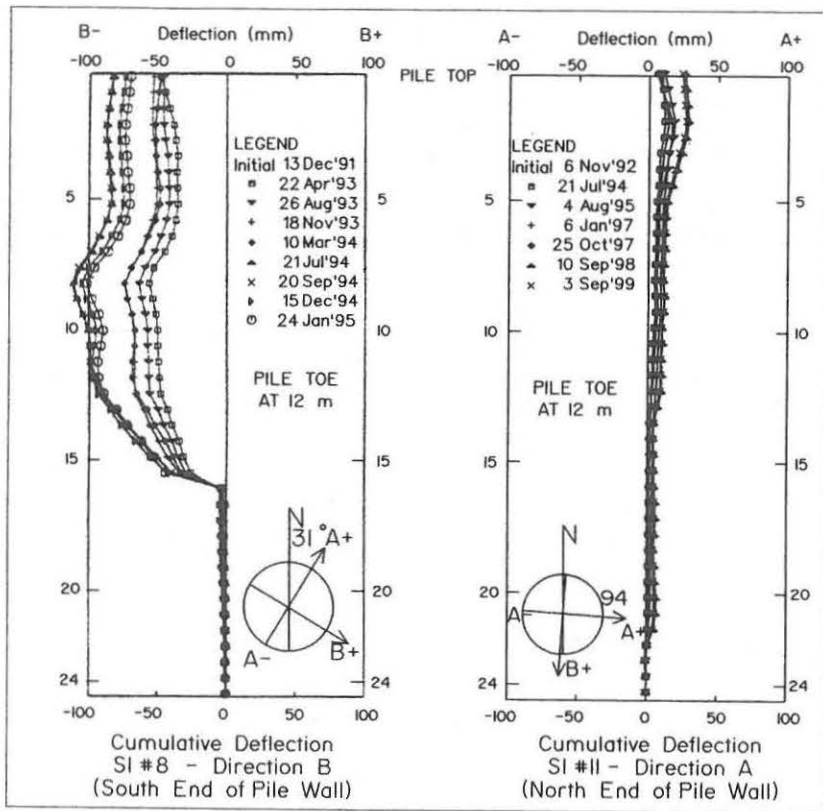
Figure 6. Typical Plots of Slope Indicator Within Pile Wall Location

It is interesting to note from the plots of Slope Indicators (SI #8 and 11) within the pile wall area that slide movements are occurring in the roadway embankment at more than one depth. The depth of deepest failure plane varies from about 16 m at the south end (as shown by SI #8) to about 22 m (as shown by SI #11) at the north end. From this observation, it is clear that slide movements are occurring well below the tips of the deepest piles. A cross section of the roadway embankment showing typical soil stratigraphy and the ground movements is presented in Figure 7. As far as the rate of ground movement is concerned, the time-movement plots typically indicate continuing slow creep movements and no evidence of dramatic changes was noticed either in the plots or visually on the ground to date.

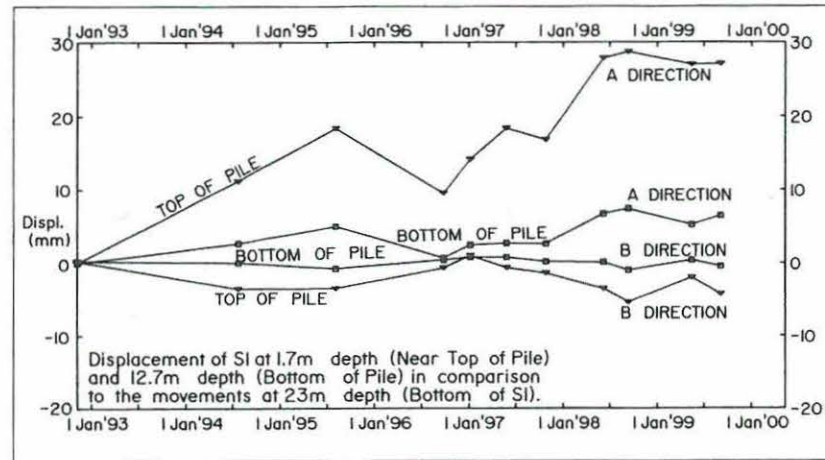
Figure 8. Time-Movement Plots For SI #11

A set of typical time- movement plots of SI #11 is presented in Figure 8. It is further noticed that the sub- surface movements are more restrained below the 12 m depth mark in comparison with the movements between the road elevation and the bottom of the piles.

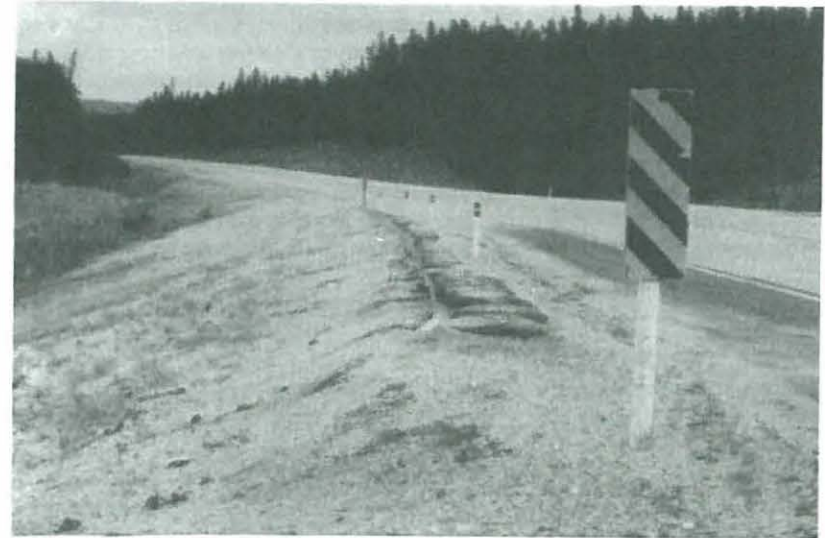
Figure 9. Recent Photograph of Pile Wall and the Highway

It is nearly 10 years since the pile wall was installed. Although the slope indicators show slow creep movements in the order of 30 to 50 mm at the road level over this time, the pile wall seems to be holding well, and there is no distress observed in the two driving lanes. Only a small settlement is visible in the shoulder area adjacent to the piles. A photograph taken recently of the road and the piles is shown in Figure 9.
