Void backfill design for a steeply dipping coal-mine void below a highway in Canmore, Alberta,

Chris Grapel, P.Eng., Courtney Mulhall, EIT, & Hanh Hong, P.Eng.
Klohn Crippen Berger, Edmonton, Alberta, Canada
Brian Rogers, P.Eng.
Klohn Crippen Berger, Calgary, Alberta, Canada
Neil Parry, P.Geoph.
TetraTech Canada Inc., Edmonton, Alberta, Canada
Roger Skirrow, P.Eng.
Alberta Transportation, Edmonton, Alberta, Canada

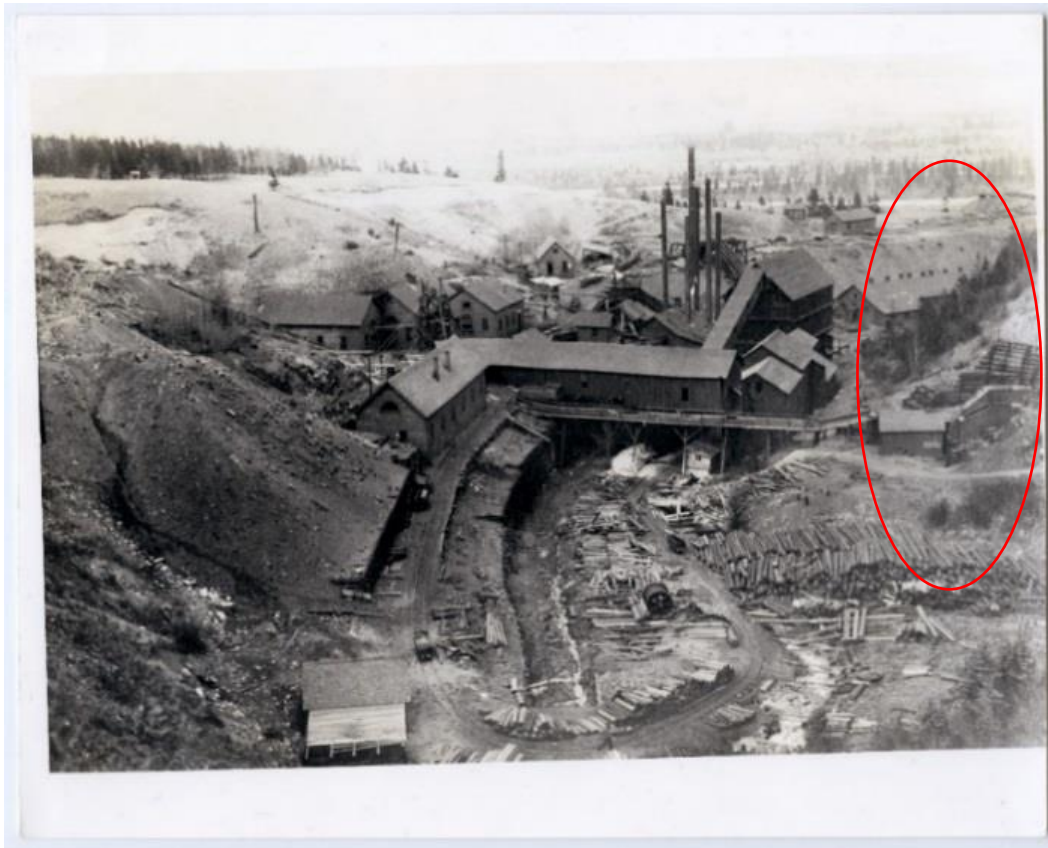
The 2017 work included a site reconnaissance to the base of Canmore Creek near the location of the No. 2 seam portal. The portal is fenced off and could not be accessed or viewed through the dense bushes within the enclosure. A stream of water was observed to be discharging from the toe of the slope and it is believed that the stream is groundwater discharge from the No. 2 seam. A faint pig-manure odour was present at the base of the creek valley near the fencing, indicating that hydrogen sulphide gas may be present in the mine.

Figure 4. Canmore No. 1 mine in Canmore Creek. Photo provided by Canmore Museum and Geoscience Centre. Portal to No. 2 seam circled in red.

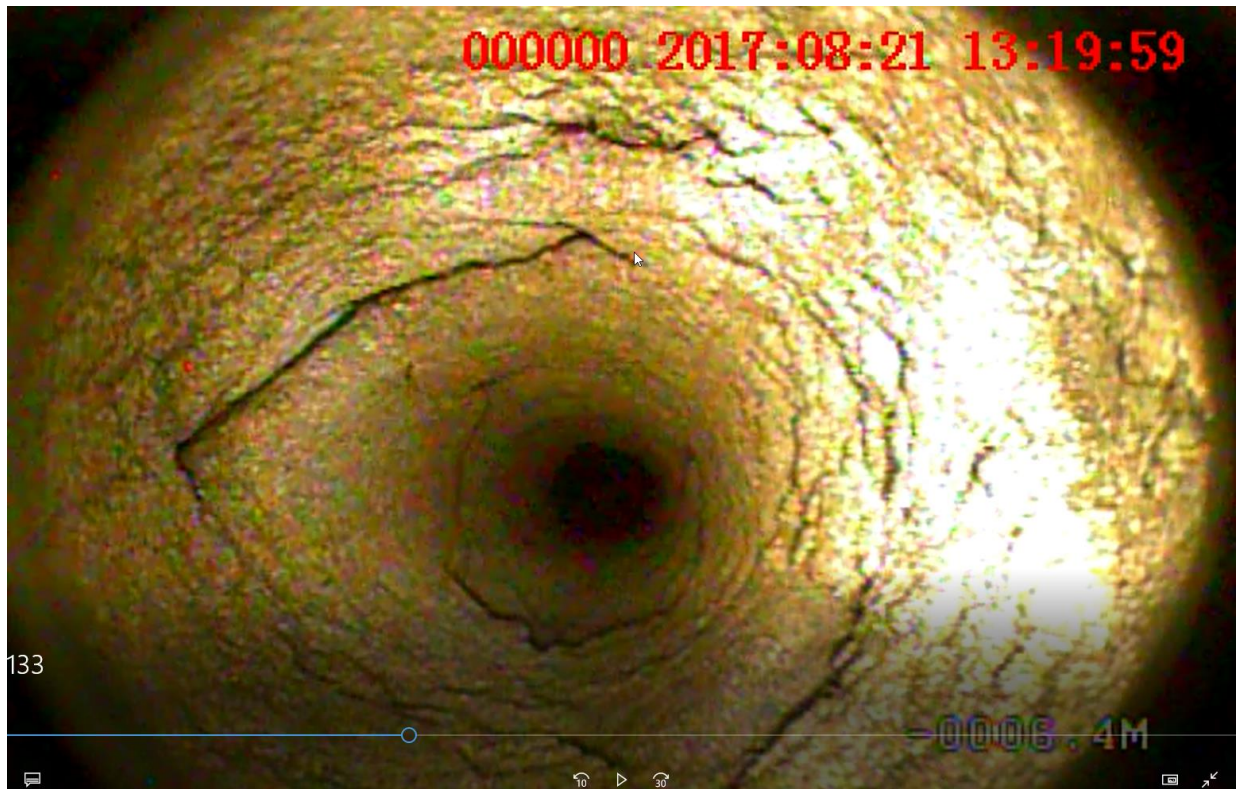
The 2017 video-camera survey detected what appeared to be either deteriorated bedrock joints, or evidence of cracking in the intact bedrock above the roof that could indicate impending roof collapse. An image from the 2017 downhole-video-camera survey showing the condition of the borehole walls is presented in Figure 6. The resolution of the 2003 downhole-video-camera data was not sufficient to permit comparison and detection of change between the 2003 and 2017 video-camera surveys.

The observation of what appear to be dilating joints in the borehole walls during the 2017 downhole-video-camera

survey described in Section 4.3 suggests that the bedrock above the coal-mine void is straining and could indicate that strain associated with ongoing roof collapse could be slowly propagating towards surface. The elevated resistivity below the highway recorded in the ERT survey shown in Figure 10 could also indicate that dilation of bedrock joints associated with strain of the roof over the coal-mine void is occurring.

Figure 6. Image from 2017 downhole-video-camera survey of metal-capped borehole

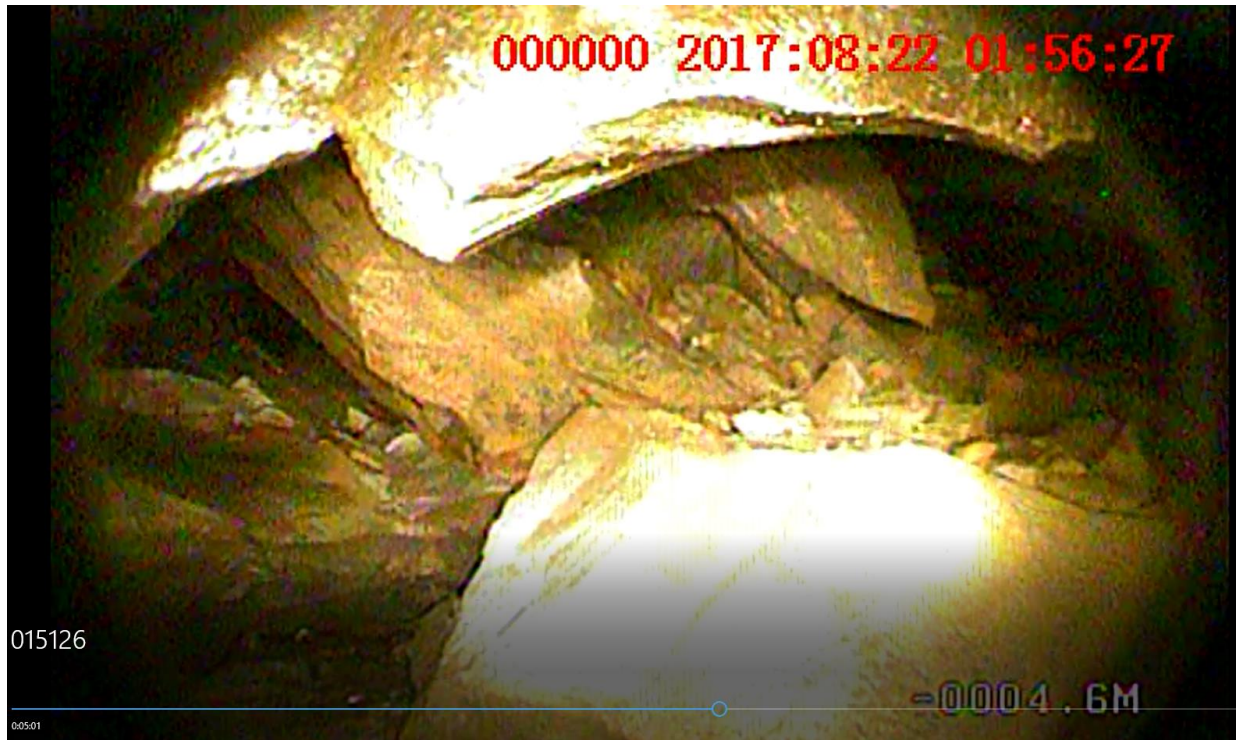
The rockfill below the open void consisted of cobbles and boulders. Figure 7 taken during the 2017 video-camera survey shows the condition of the collapse material.

Figure 7. Image from 2017 downhole-video-camera survey of metal-capped borehole. Note roof collapse material.

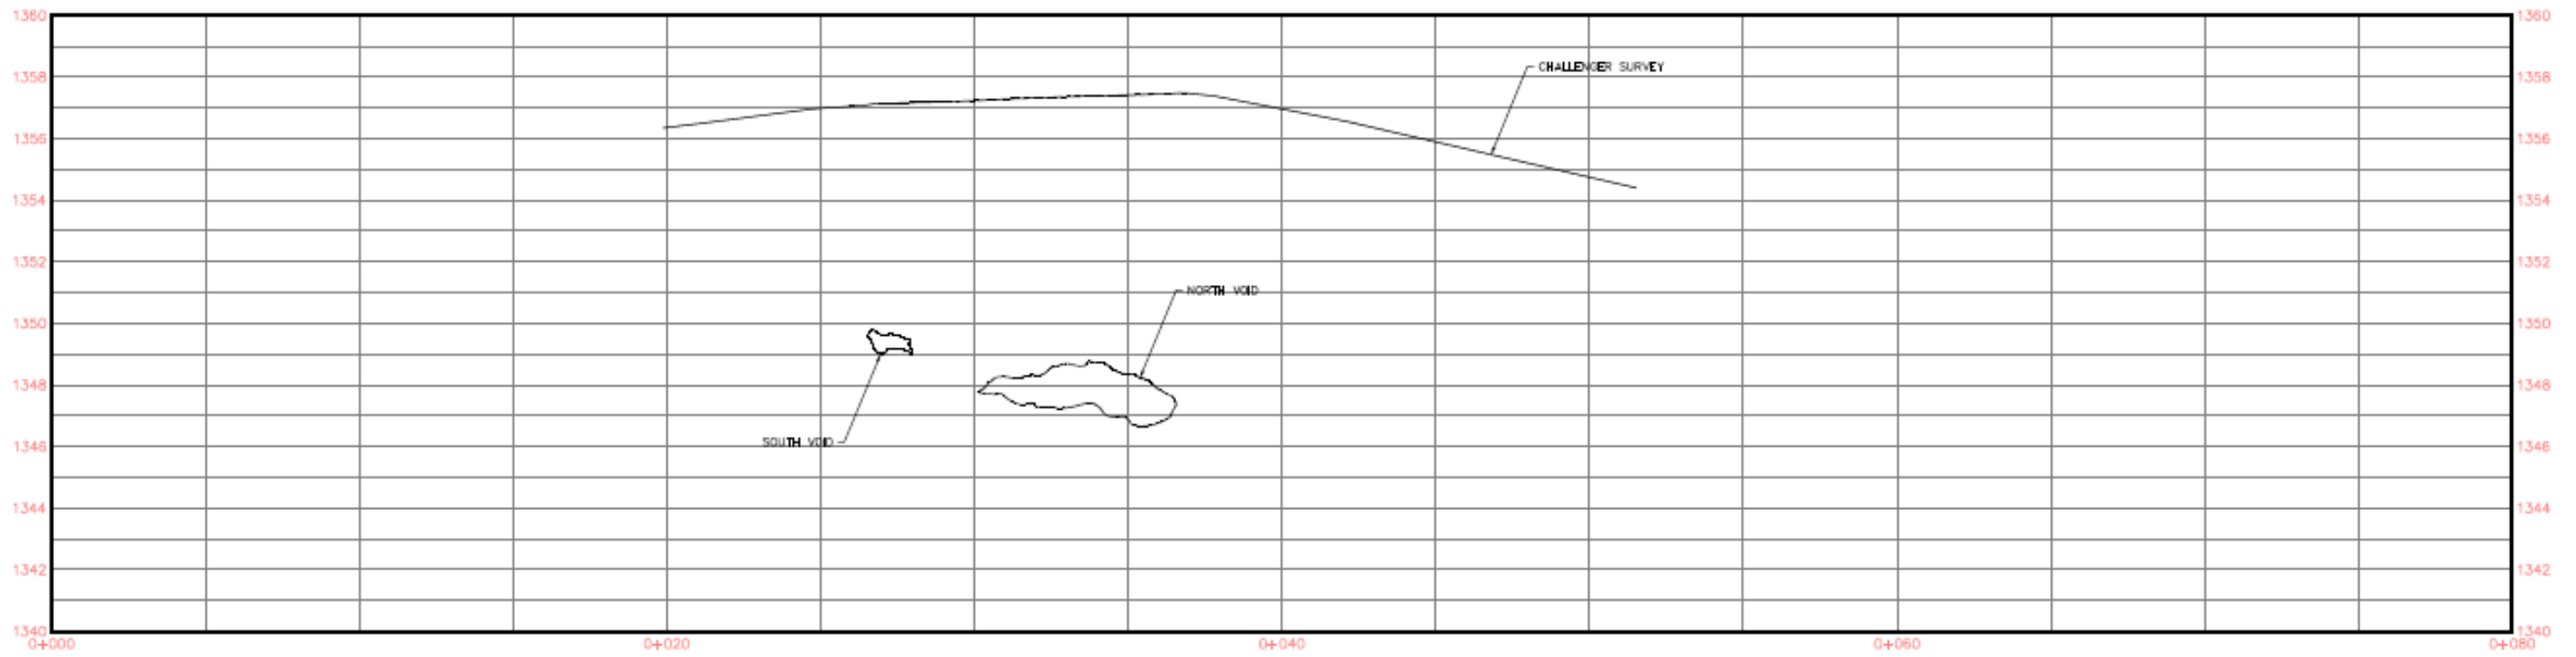
A downhole-LiDAR camera survey was undertaken to assess the extent of the open coal-mine void located beneath the highway. The downhole-LiDAR camera was unable to fully open in one borehole near centerline, limiting the extent of the void surveyed. Although the void is believed to be continuous below the highway, the downhole LiDAR camera data could only confirm the presence of two open voids. The geometry of the surveyed voids is presented in Figure 8.

Figure 8. Geometry of surveyed voids from downhole-LiDAR-camera survey

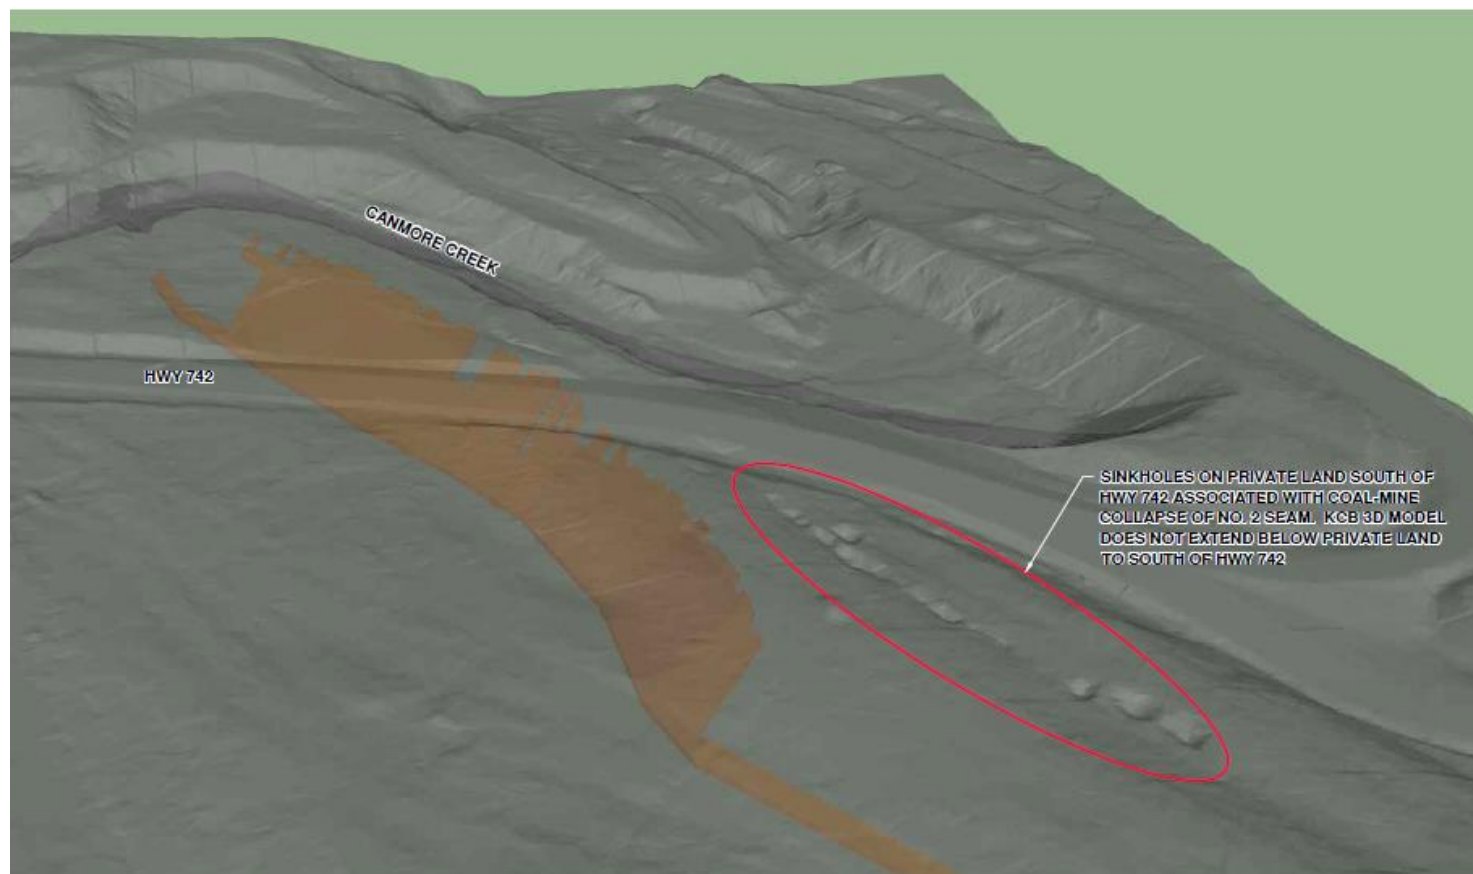
The Town of Canmore gave KCB and AT LiDAR data collected in 2013 for use in this study. Figure 9 shows an oblique north-facing view of the LiDAR data of the site and surrounding areas collected by the Town of Canmore, including the highway surface and coal-mine-collapse features on privately-owned land to the south of the highway.

Figure 9. Oblique north-facing view of the S012 site and surrounding areas using 2013 LiDAR data.

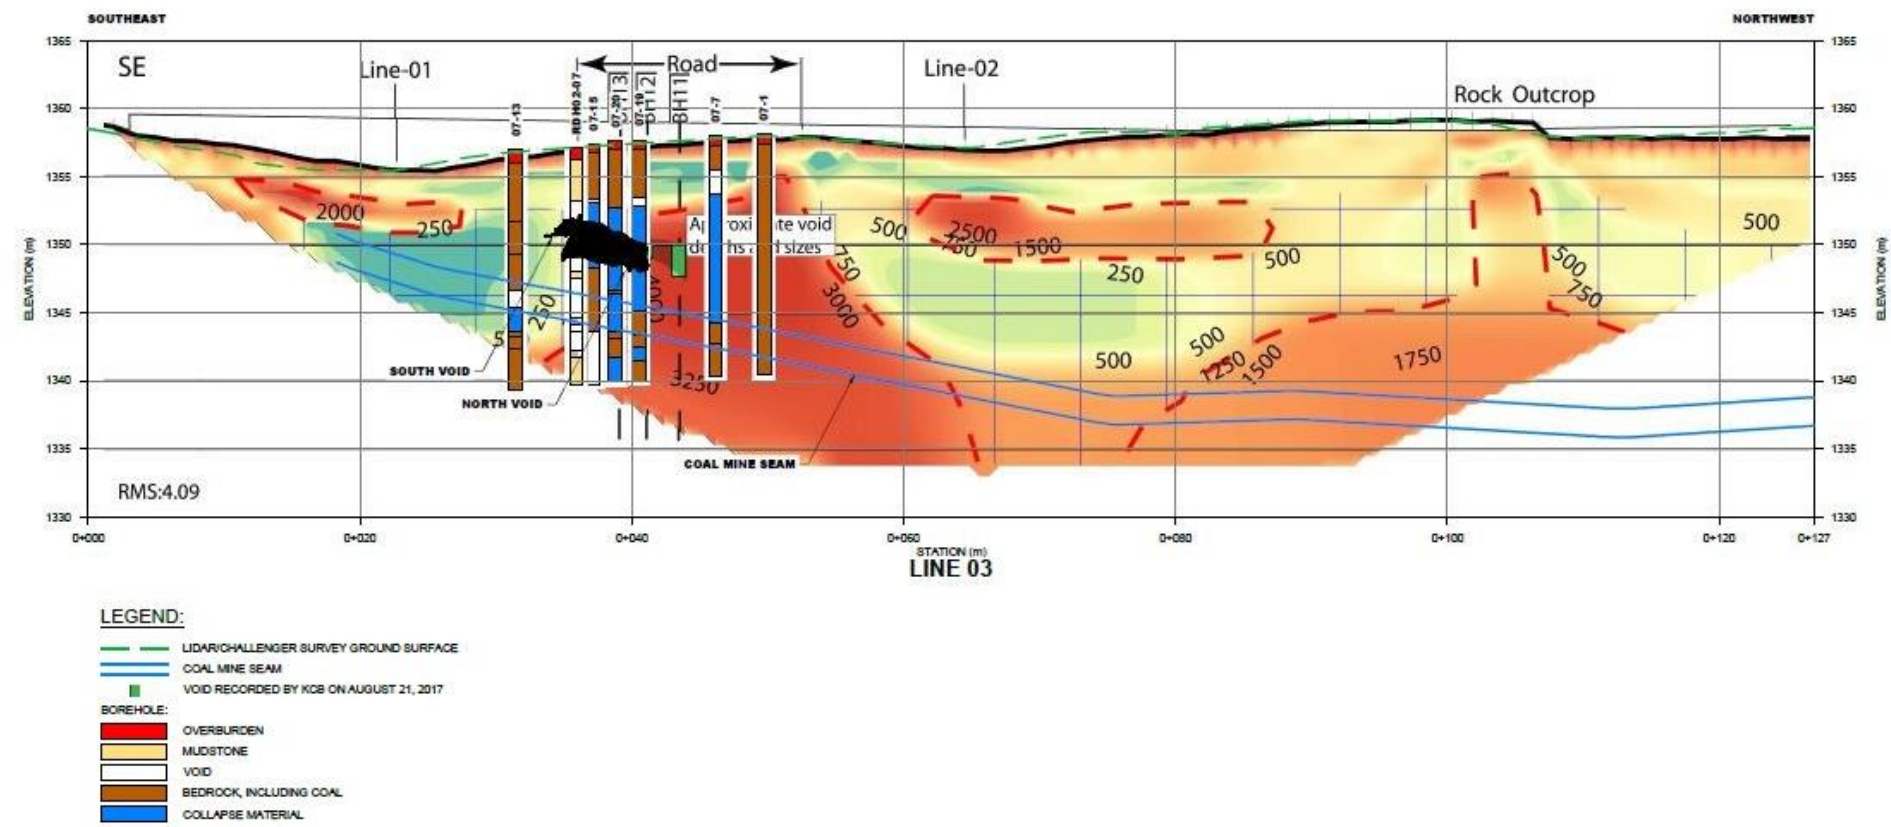
The historic coal-mine record drawings and the data collected from the 2003, 2007 and 2017 investigations were assembled in the Civil 3-D model. Sections through the Civil 3D model are shown in Figures 10 and 11. Figure 10 shows how the floor of the modelled coal-mine and the interpreted open voids and voids backfilled with collapse material generally matches the 2003 and 2007 borehole data. Some variations were noted between the borehole data and the modelled coal-mine void, and drilling is planned to investigate the location of the coal-mine workings at greater depths.

Figure 10. Cross section through Civil 3D model along Line 03
