BF 76474 Hwy 40 Over Smoky River Hydrotechnical Summary

File 76474 - Smoky River near Grande Cache

Hydrotechnical File History

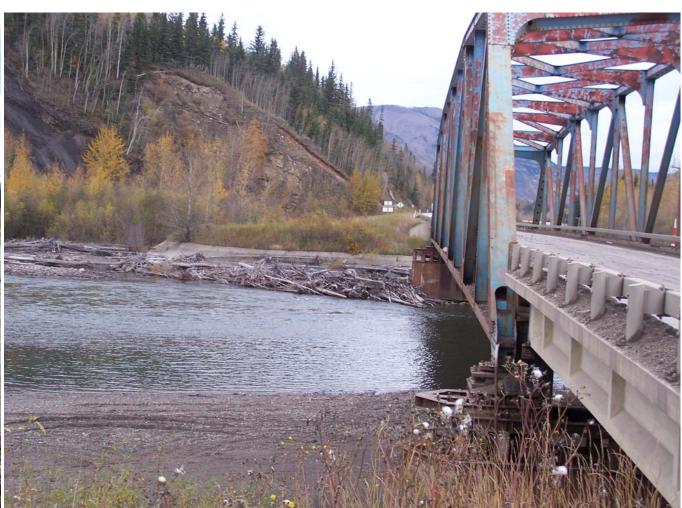
Looking North; flow left to right

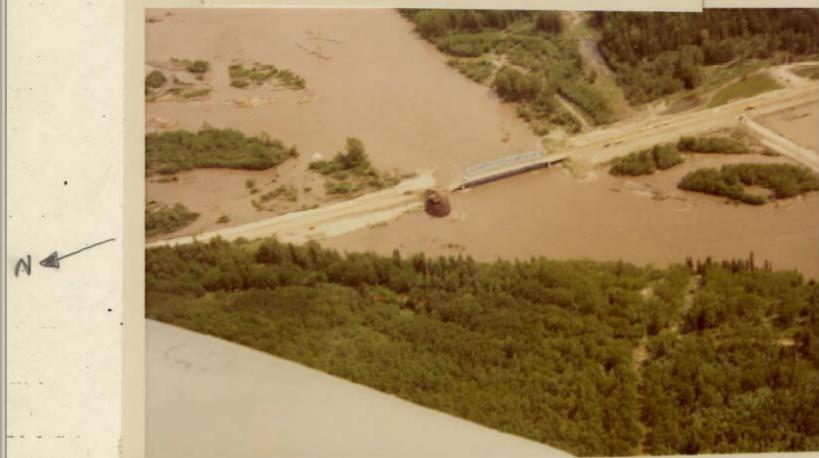
Day After High Water. Level Had Dropped 405 Feet When These Photos Where Taken.
