TESTING **REPORT**

Swan Hills #3
DRS780140
E06-067-09-W5M
W05-067-09-W5M

June 25, 2024

Holsted Aggregates Ltd.

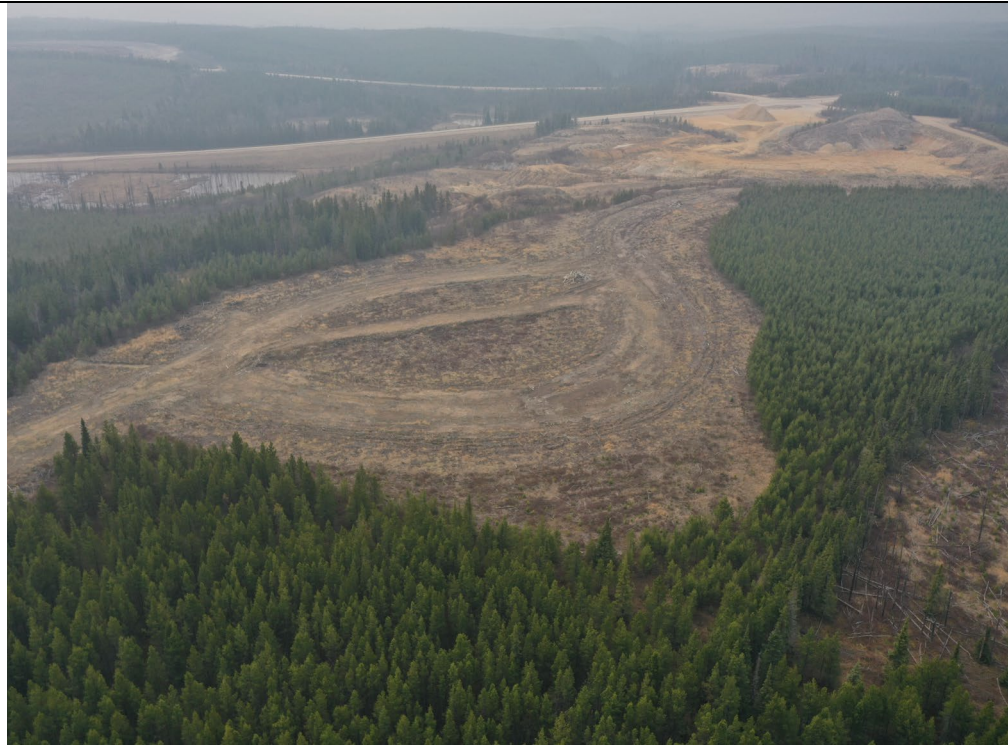
Photo 1

This aerial photo is facing south the southern open meadow recently used as a temporary logging laydown yard.

An adjacent private gravel pit (SML890105 - T&L Aggregates) is located along the photo top. This pit has several gravel faces approximately 10 m in height.

This open meadow has broken rig mats piled in various locations across it.

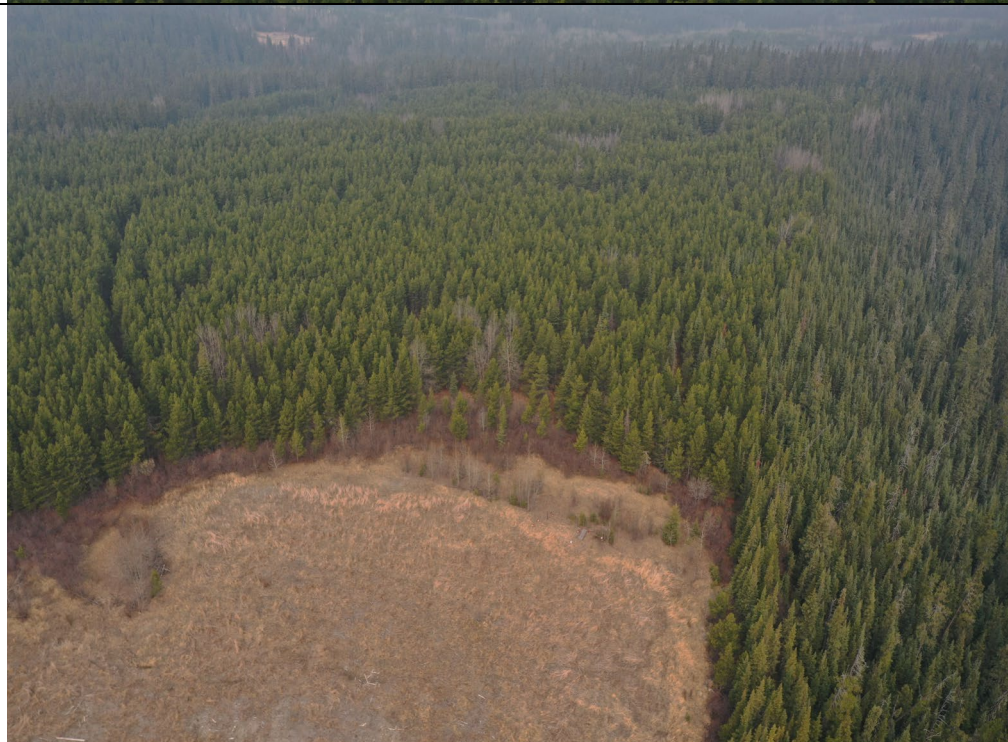
Photo 2

This aerial photo is facing northwest.

The northern open meadow can be viewed along the photo bottom.

Treed aggregate area C (L.S. 9_NE06-067-09-W5M is located across the top half of this photo.

The vegetation has a high density, and old trails are extremely overgrown with willows. Prospecting followed the path of least resistance.

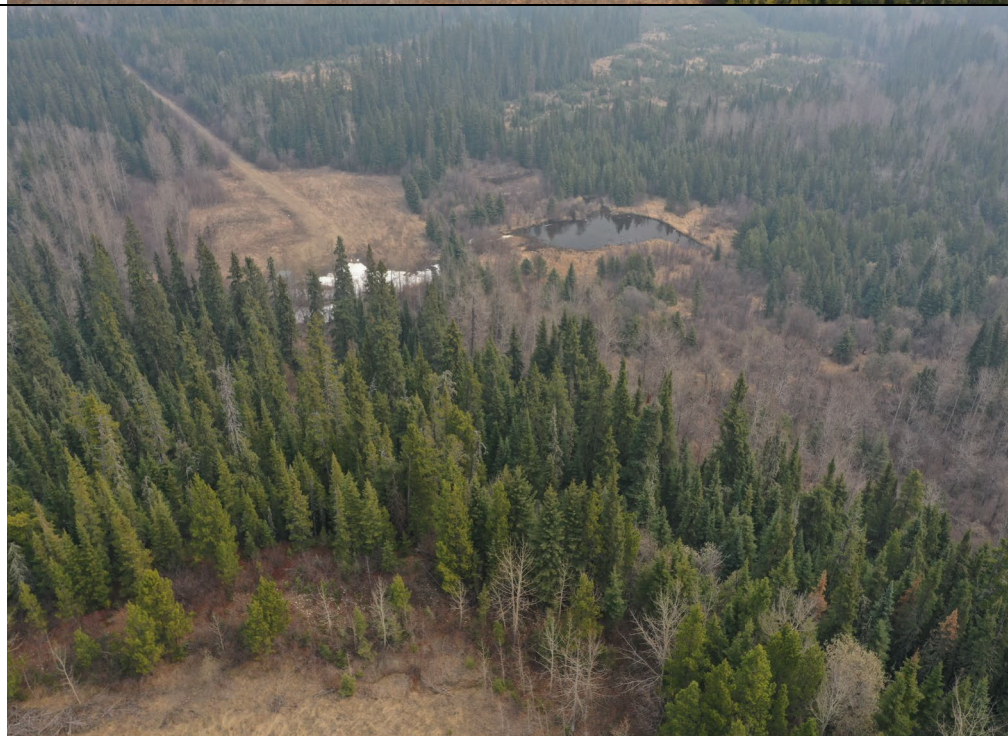
Photo 3

This aerial photo is facing north overlooking an example of the surrounding low-lying areas around this DRS.

The top half of this photo contains MSL1452 and the northeastern most portion of DRS780140.

A 40 m [3:1] natural ridge exists beneath the coniferous vegetation across photo bottom. This drop calculation was estimated through Lidar mapping.

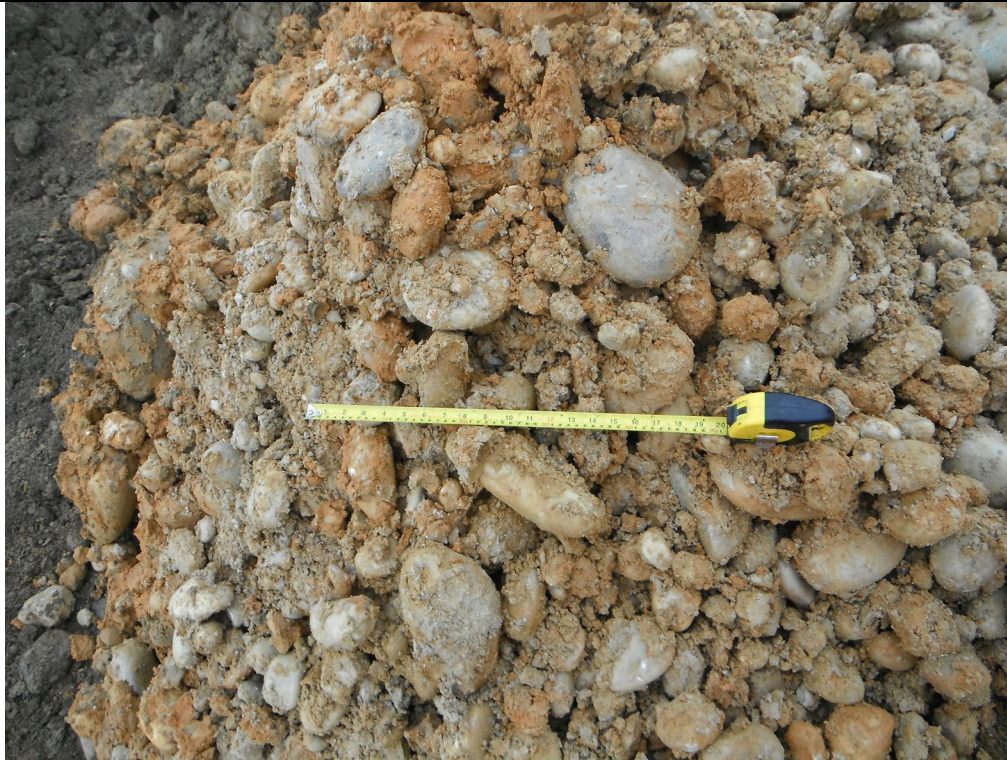
Photo 4

Sample spill pile of TH#110

Aggregate field notes:
23% = 80-100 mm
12% = 15-300 mm
0% = +300 mm
Top size = 270 mm

The aggregate is encased and coated in clay and sandy clay with a high plasticity.

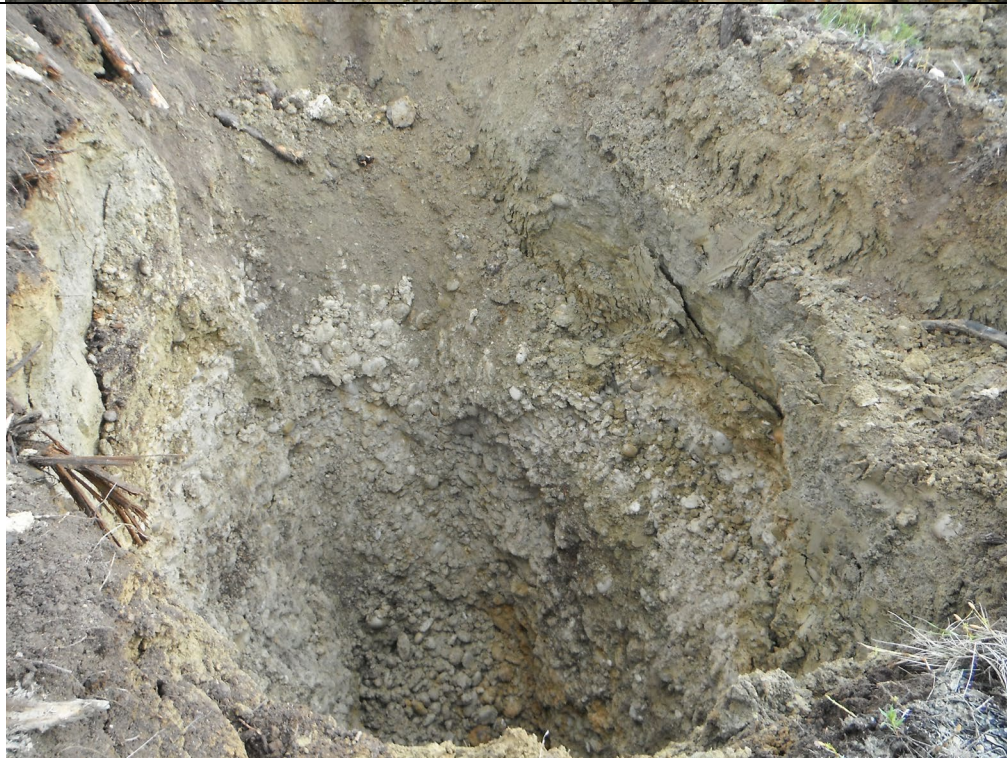
Photo 5

Test hole profile of TH#117

Contents:
0.16 T
0.12 Sb
2.2 SC
3.8 CG

Test hole profiles slumped regularly during excavation.

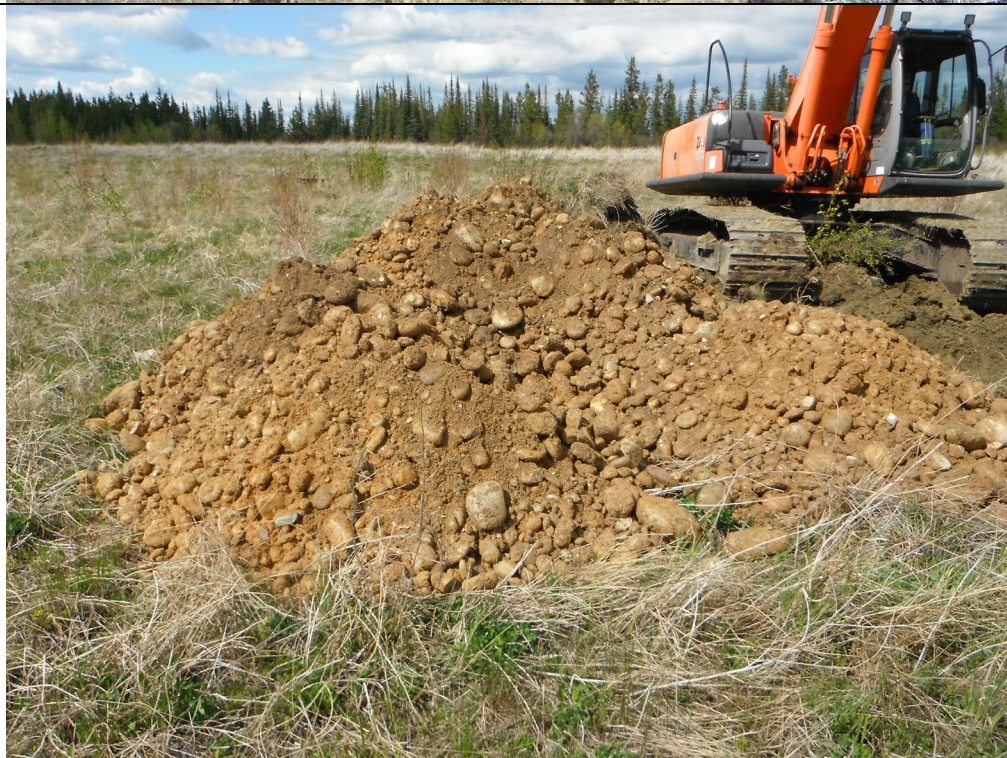
Photo 6

Spill pile of TH#125

Aggregate field notes:
25% = 80-100 mm
15% = 15-300 mm
1% = +300 mm
Top size = 300 mm

The sandy clay aggregate contained ironstone, and broken quartz material.

The sandy clay is highly plastic and sticky.

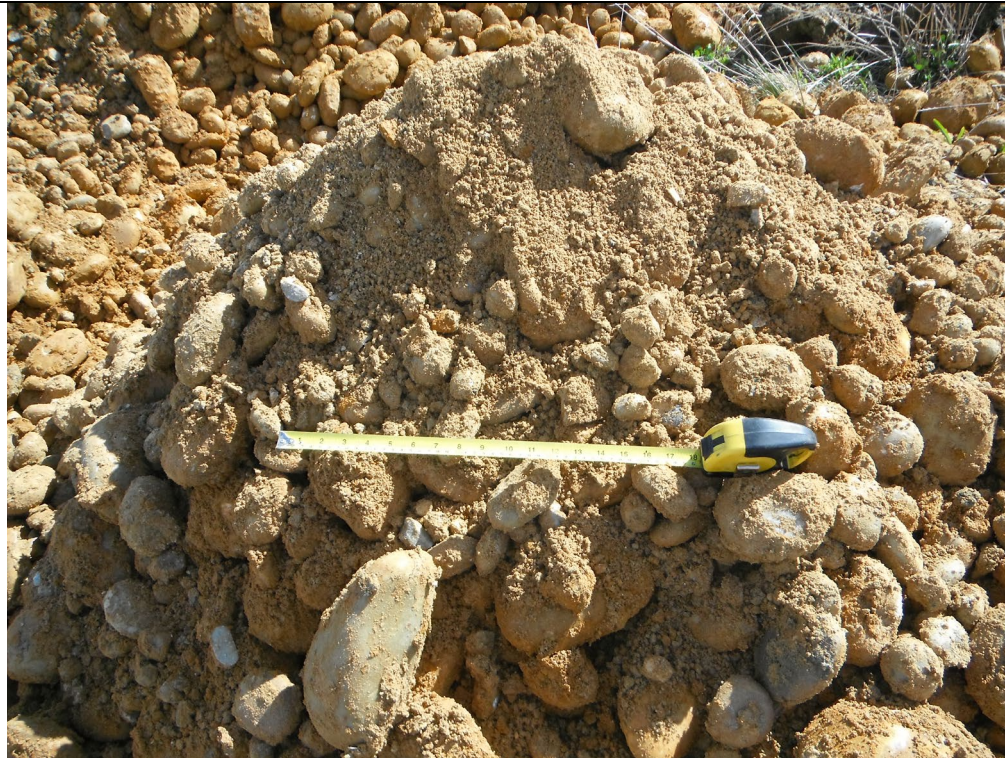
Photo 7

Sample spill pile of TH#131

Aggregate field notes:

25% = 80-100 mm

15% = 15-300 mm

0% = +300 mm

Top size = 280 mm

The aggregate is encased and coated in clay and sandy clay with a high degree of plasticity.

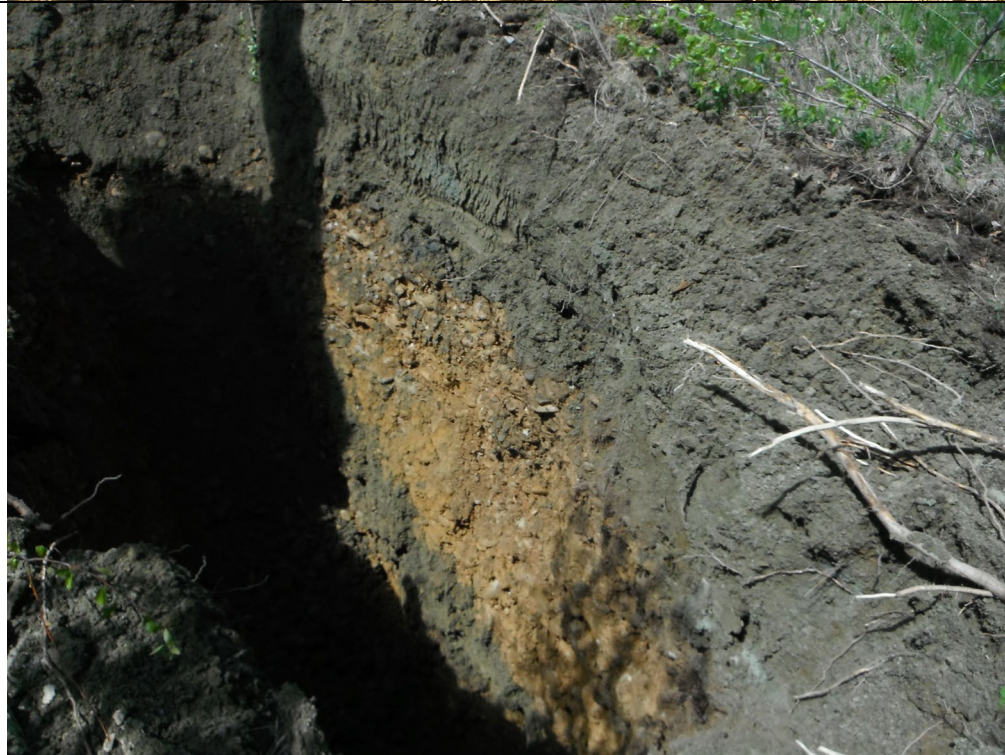
Photo 8

Test hole profile of TH#134

Contents:

0.07 T

0.1 Sb

2.4 STR(C)

3.0 SiCG

Clay material was collected from a hillside slump along HWY 33 and dumped/spread across the open meadows of L.S. 12_NW05-067-09-W5M. Branches and processed wood were identified within this overburden profile.

(STR) OB is as deep as 3.9 m in several areas.

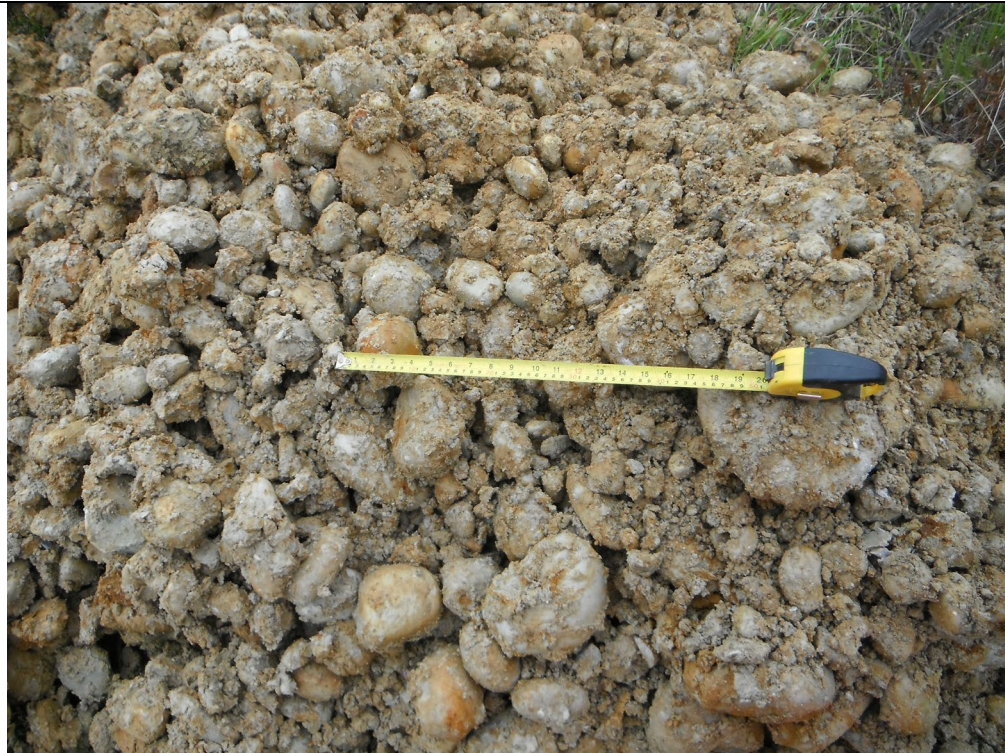
Photo 10

Sample spill pile of TH#100

Aggregate field notes:

23% = 80-100 mm

12% = 15-300 mm

0% = +300 mm

Top size = 250 mm

Aggregate area **B** located along the southern boundary contains the poorest material with the highest ratio of clay-gravel.

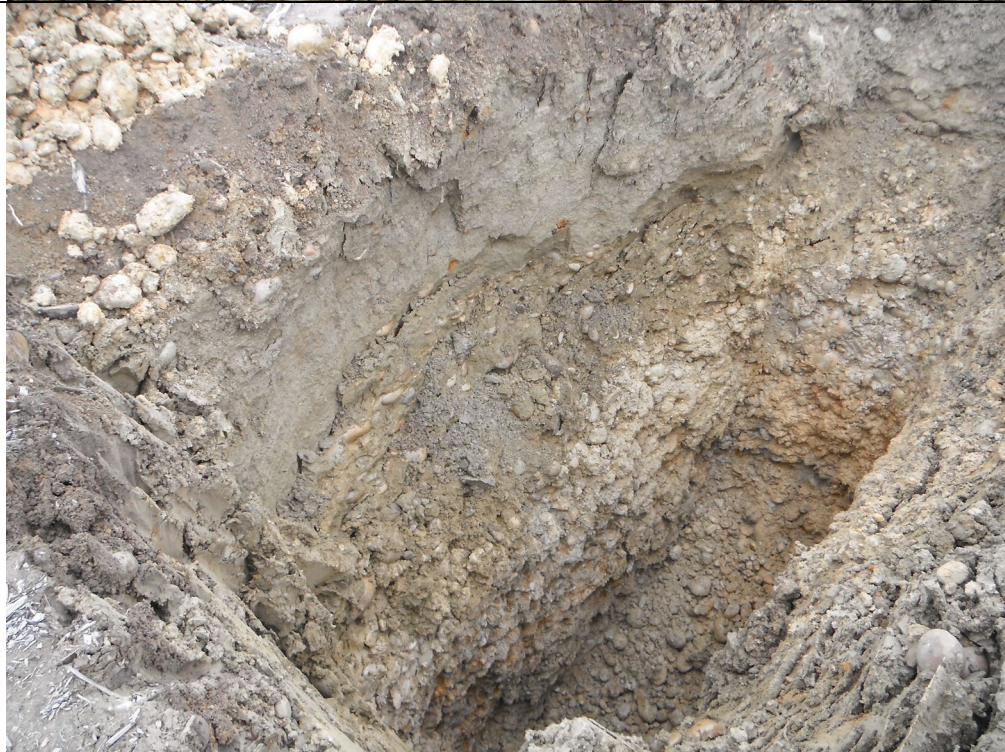
Photo 11

Test hole profile of TH#134

Contents:

3.0 SC

0.7 SCG

0.1 WSCG

2.6 SCG

This test hole was located along a reclaimed logging trail and did not have topsoil or subsoil across its surface.

A trickle of water was identified at mid-depth of this profile.

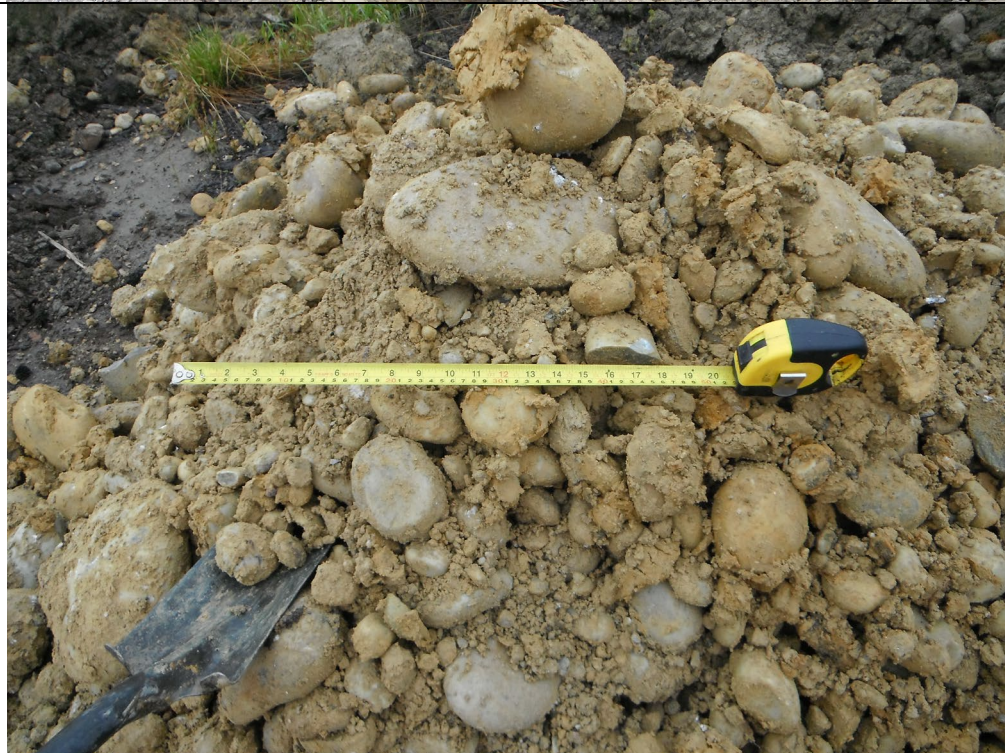
Photo 12

Sample spill pile of TH#108

Aggregate field notes:

20% = 80-100 mm

15% = 15-300 mm

5% = +300 mm

Top size = 300 mm

Shovelling the aggregate material was exceptionally difficult due to the high plasticity of the material.

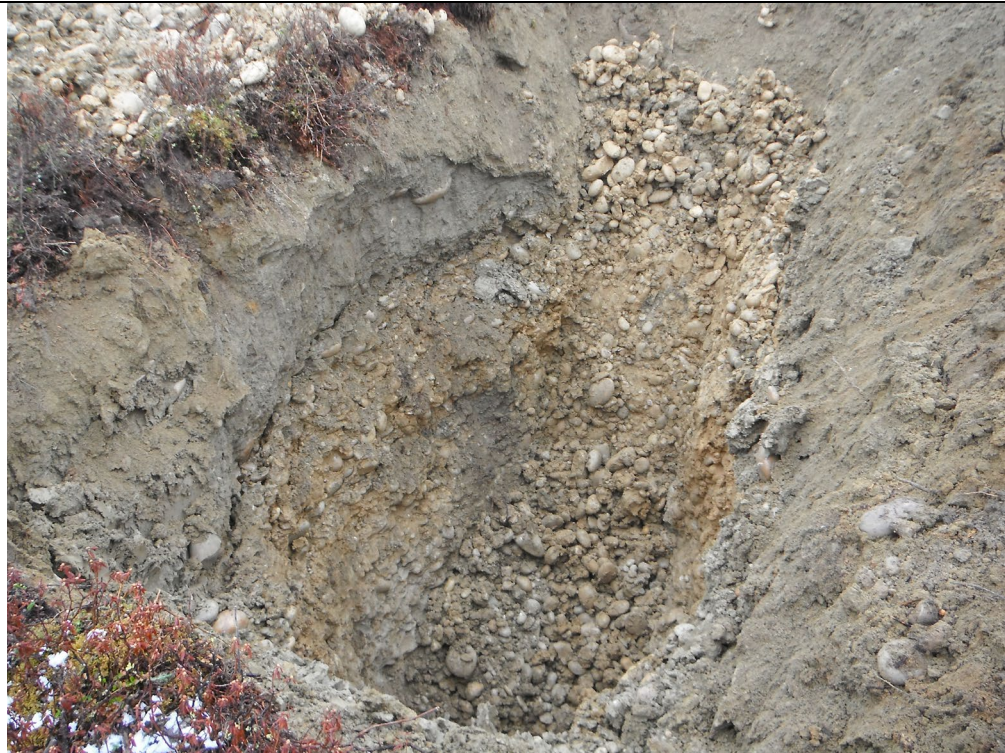
Photo 13

Test hole profile of TH#114

Contents:

- 0.15 T
- 0.07 Sb
- 2.5 C
- 3.8 CG

This test hole is located along the edge of the southern open meadow.

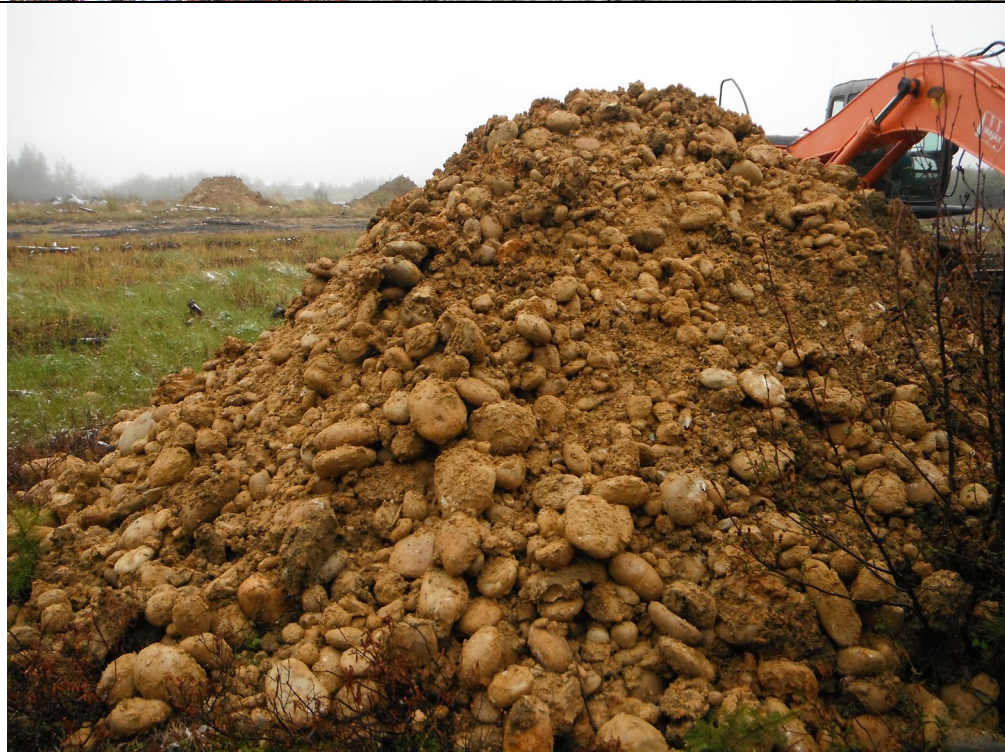
Photo 14

Spill pile of TH#116

The aggregate across aggregate area B remained a consistent clay aggregate with minor colour changes throughout.

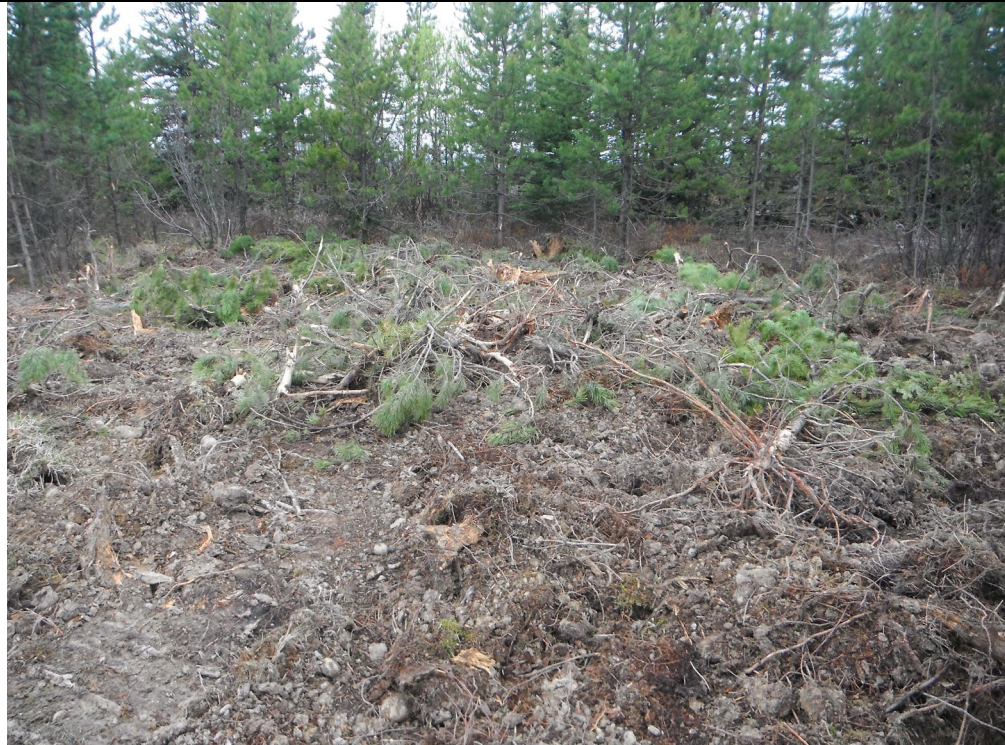
Photo 15

Backfilled and reclaimed TH#113

This photo is overlooking the typical conditions of each backfilled test hole within the open meadow areas.

Care was taken at each test hole to backfill each hole in reverse order, periodically pack down the backfilled material, and spread topsoil/subsoil/vegetation across the disturbed area.

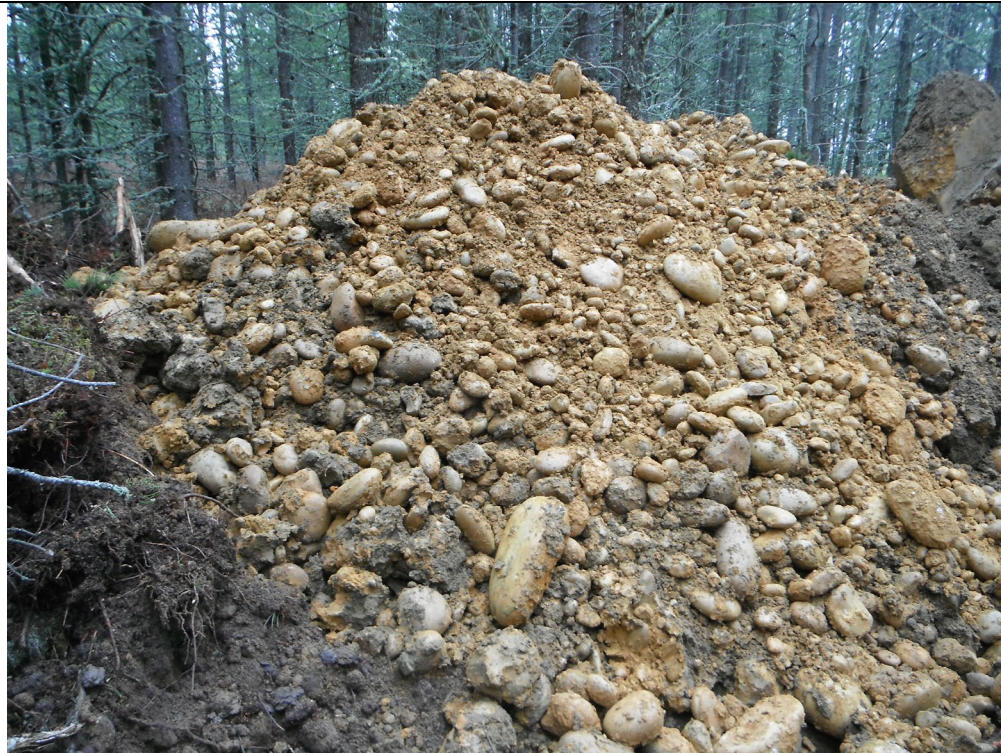
Photo 16

Spill pile of TH#122

Aggregate field notes:

23% = 80-100 mm

15% = 15-300 mm

0% = +300 mm

Top size = 275 mm

Aggregate area C located across L.S. 9_NE06-067-09-W5M. This area is covered in dense pine.

| CATEGORY | RECOMMENDED ACTION |
|--|---|
| BRUSH/TIMBER | Attention required - Two area have been previously logged (Aggregate area A and B). Aggregate area C will require logging or de-brushing prior to further development |

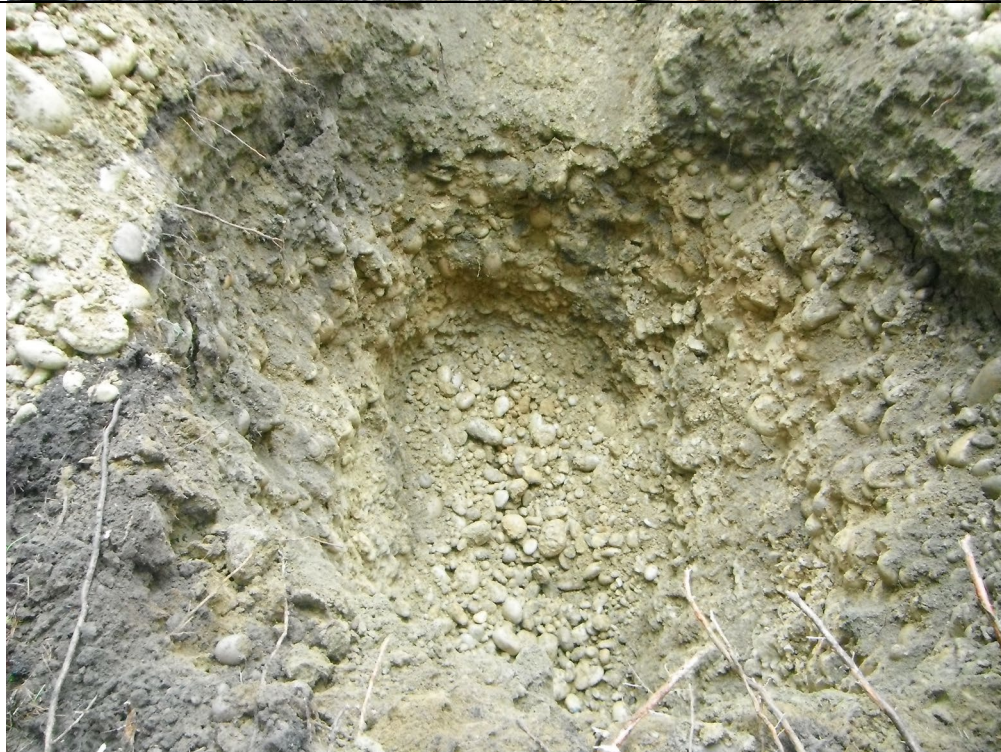
Photo 17

Test hole profile of TH#127

Contents:

0.08 T

0.07 Sb

1.1 SC

4.7 SCG

The aggregate across this deposit transitioned between clay gravel and sandy clay gravel (photo #17).

The presence of sand within the clay gravel was identified visually however handling the agg. confirmed a high degree of plasticity confirming clay.

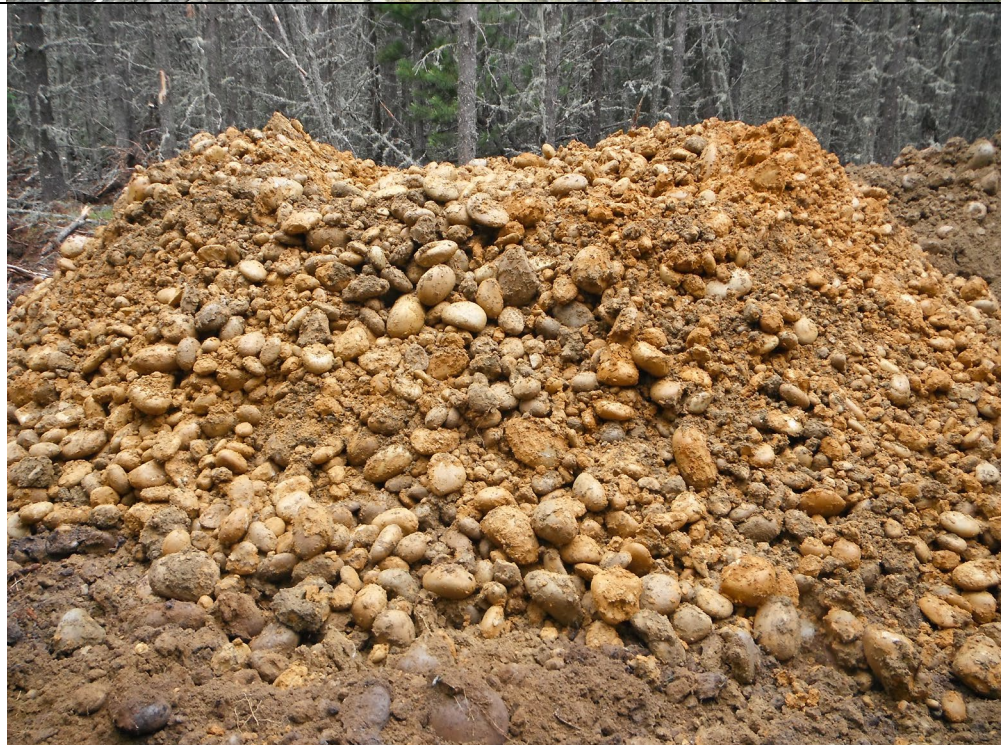
Photo 18

Spill pile of TH#136

Aggregate field notes:

25% = 80-100 mm

12% = 15-300 mm

0% = +300 mm

Top size = 280 mm

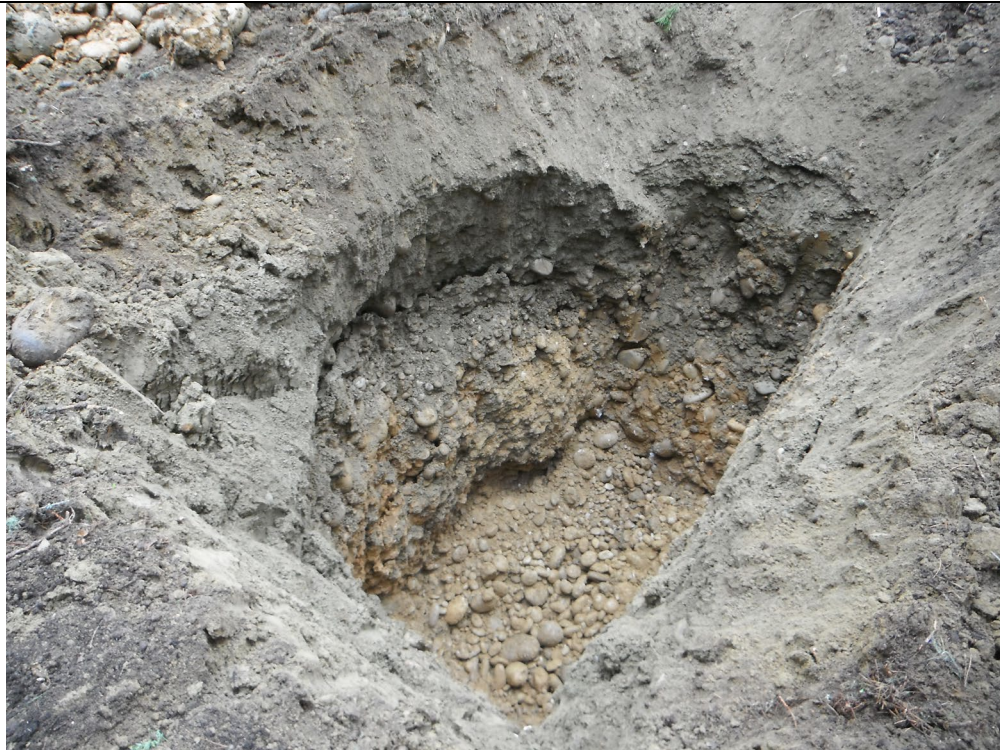
Photo 19

Test hole profile of TH#141

Contents:

- 0.1 T
- 0.07 Sb
- 2.5 SC
- 3.2 CG

This test hole is located approximately 15 m east of the edge of the 30 m [4:1] natural slope ridge from the deposit area.

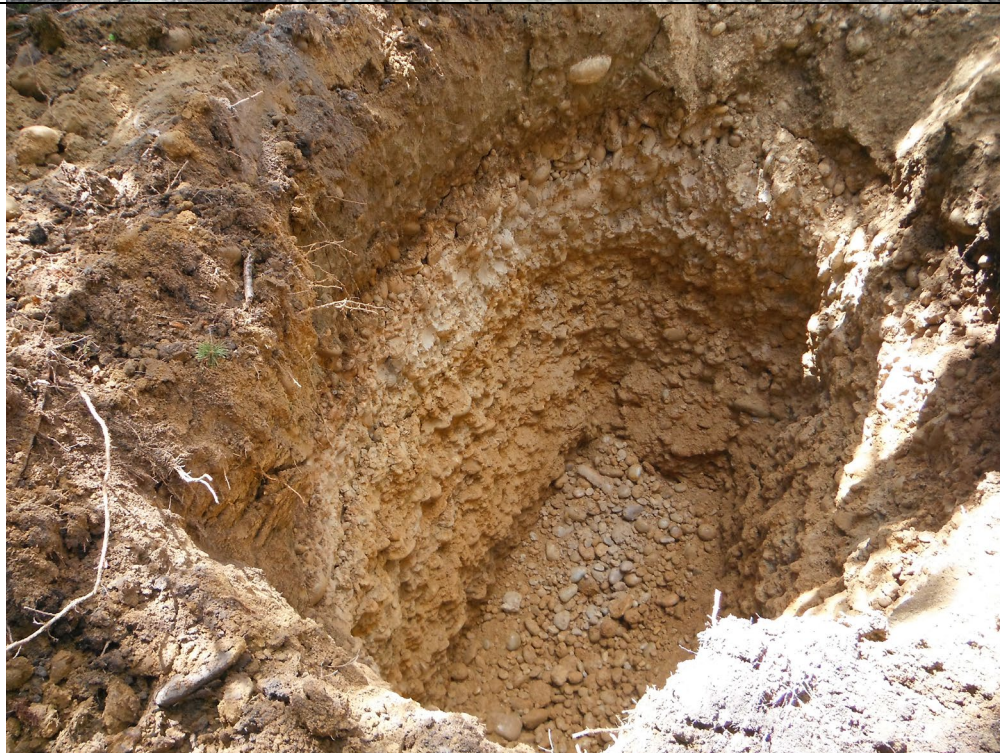
Photo 20

Test hole profile of TH#147

Contents:

- 0.15 T
- 0.1 Sb
- 2.2 SC
- 3.4 SCG

The aggregate across this deposit transitioned between clay gravel and sandy clay gravel (compare photo #19's CG and photo #20's SCG).

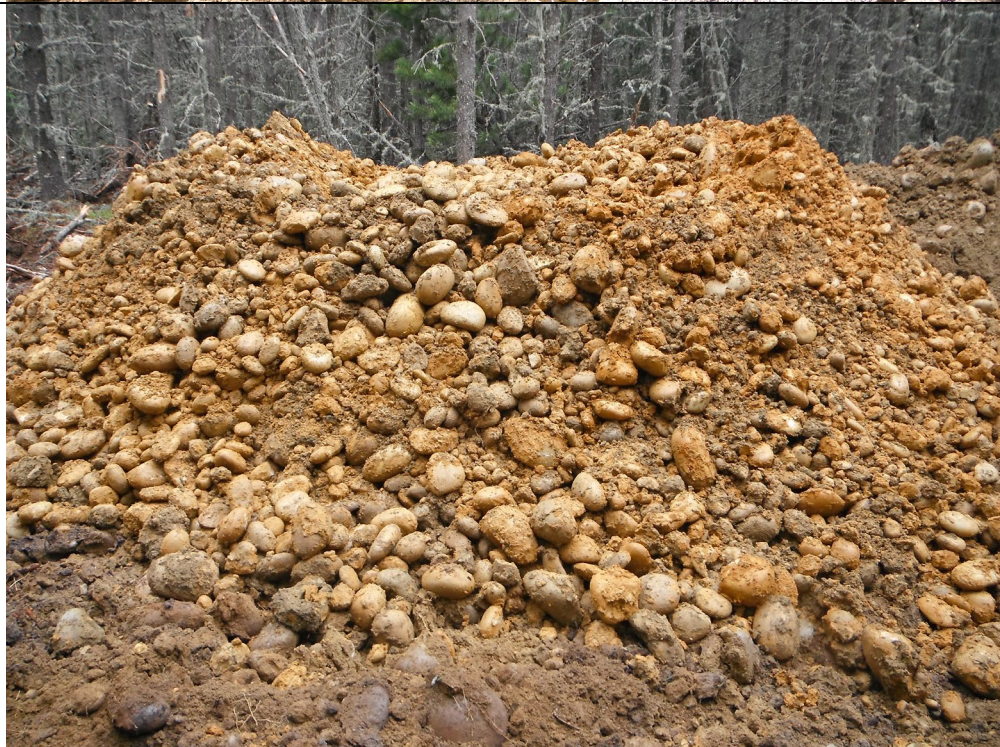
Photo 21

Spill pile of TH#150

Aggregate field notes:

- 25% = 80-100 mm
- 17% = 15-300 mm
- 2% = +300 mm
- Top size = 310 mm

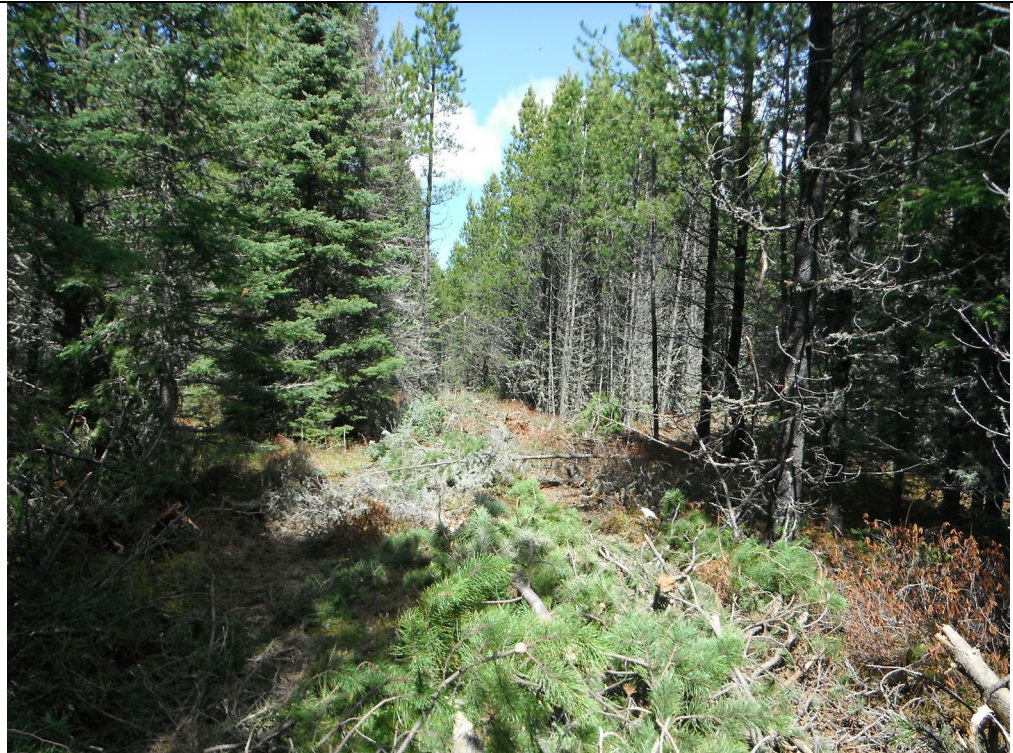
Photo 22

This photo is overlooking an example of a reclaimed avoidance trail created during 2024 testing activities.

The primary tree species onsite is Lodgepole Pine, White Spruce, and Black Spruce.

The tree density across L.S. 9_NE06-067-09-W5M was very dense and historic avoidance lines were no longer useful for equipment travel.

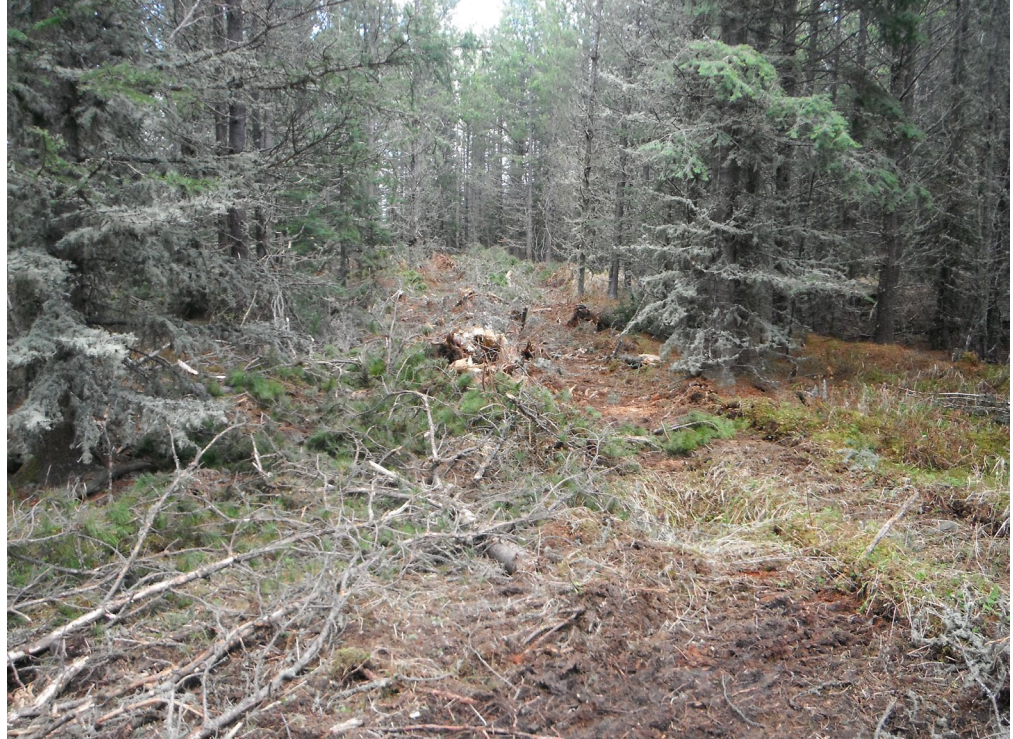
Photo 23

This photo is overlooking an example of a reclaimed avoidance trail created during 2024 testing activities.

Care was taken to break apart vegetation into 1.0 - 1.5 m pieces and pushed flat to the ground.

The path of least resistance was taken by equipment resulting in winding trails with frequent dead ends.

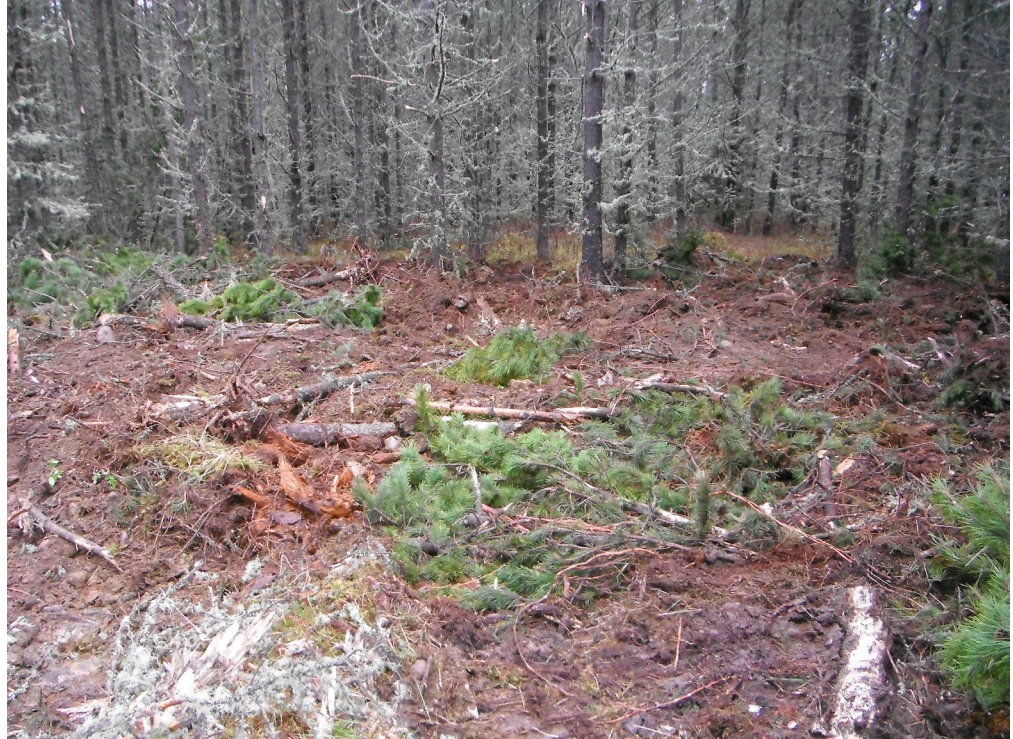
Photo 24

This picture is overlooking an example of a backfilled test hole from within the treed areas of L.S. 9_NE06-067-09-W5M.

Each test hole required special considerations to spill pile location and size to ensure its contents did not spill into the surrounding trees.
