Priddis River Hazard Study

Channel Stability Investigation Report

July 31, 2019

Alberta Environment and Parks

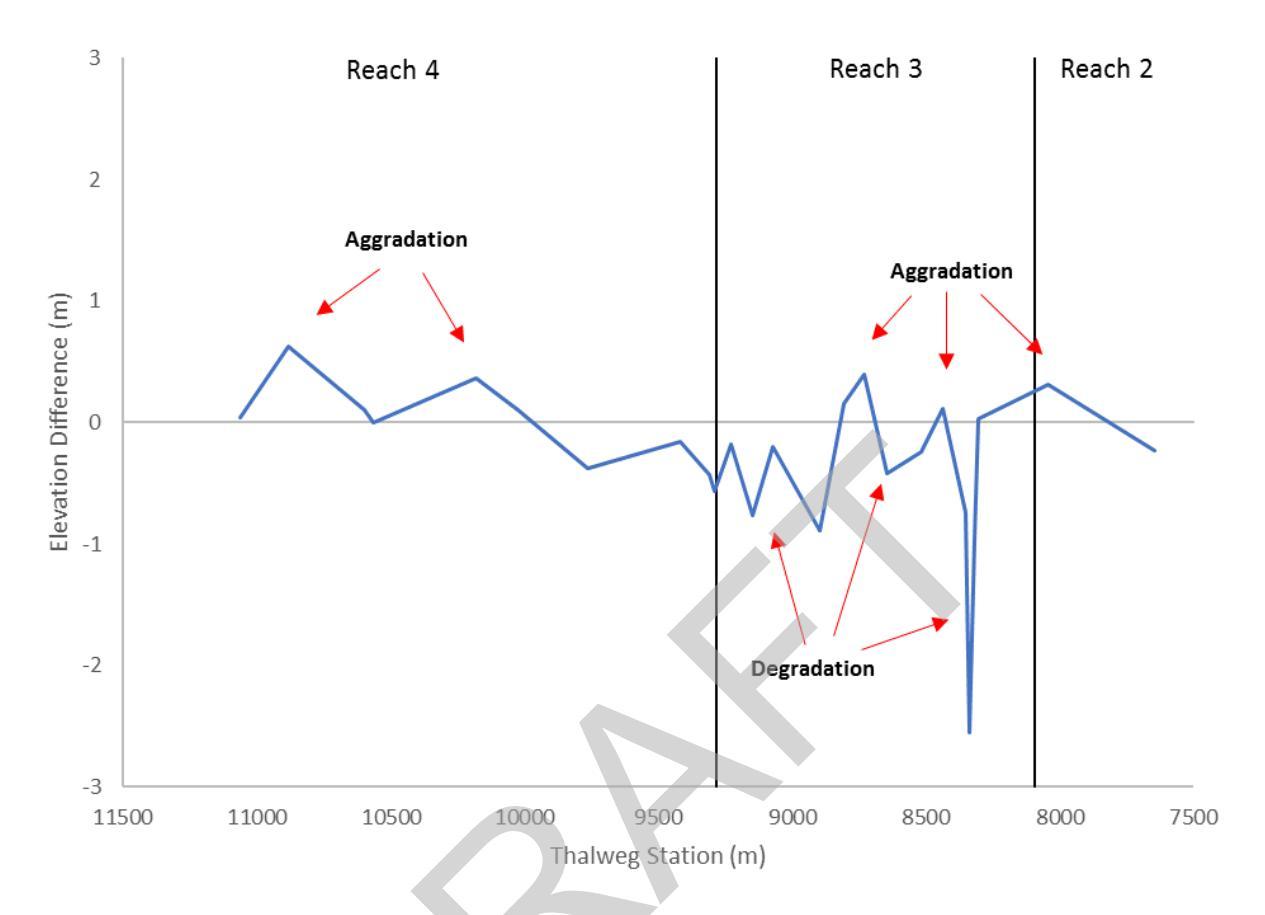
Figure 3. Fish Creek thalweg elevation difference comparing 2004 data to 2018 data.

To consider the differences in the thalweg profiles between 2004 and 2018 in more detail, a graph displaying the elevation differences are presented in Figure 3. The bed experienced aggradation from cross-sections 78 to 65, and degradation between cross-sections 64 to 49. The change in bed elevation fluctuated for the remainder of the channel, including a large scour hole developed at XS 40.

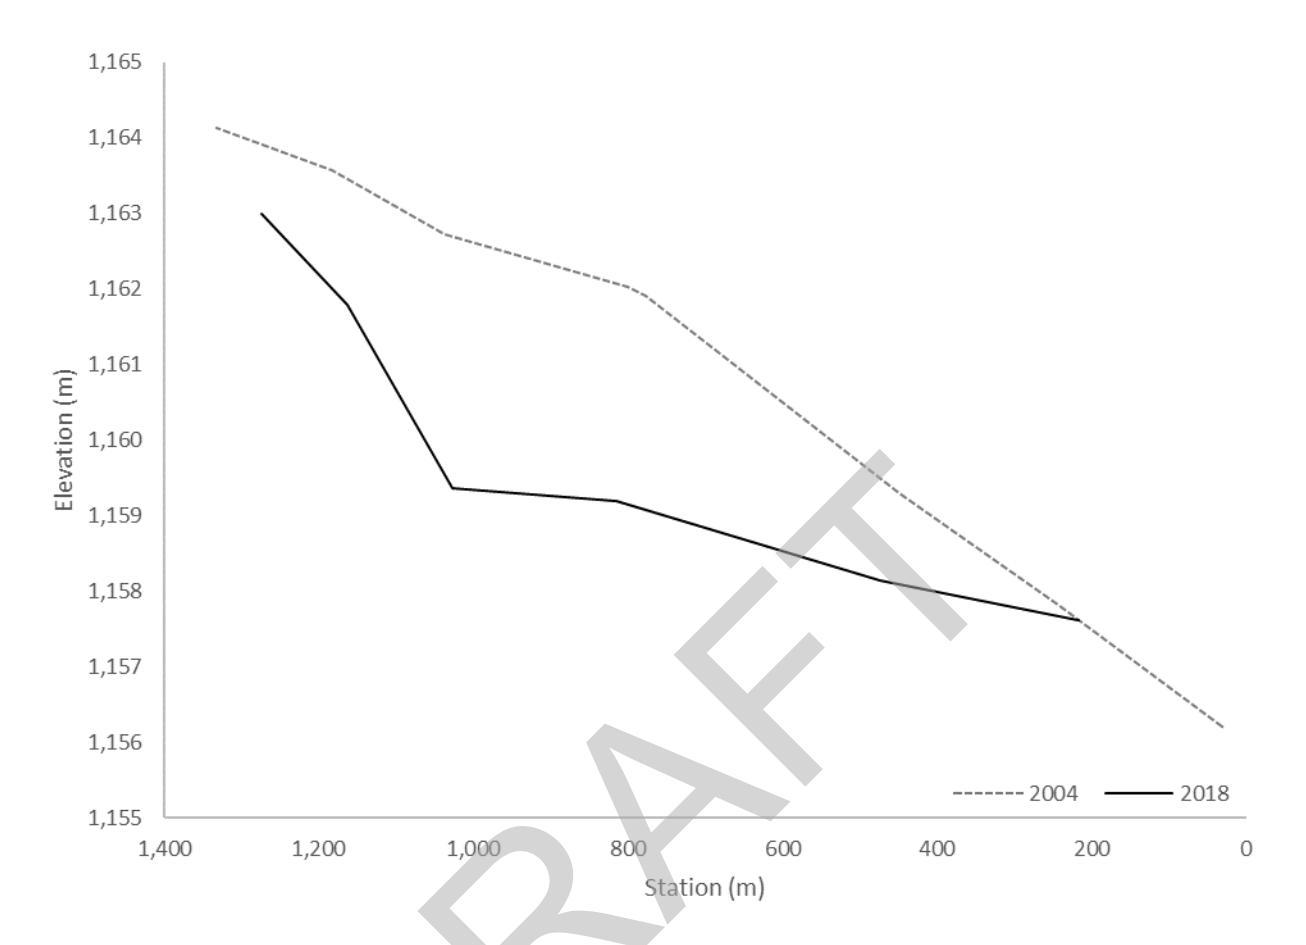
Figure 4: Priddis Creek thalweg profile comparison.

The Priddis Creek thalweg profile from 2018 shows a general concave-up profile in contrast to the concave-down profile developed from the 2004 data (Figure 4). The change in profile concavity can be explained by the results of the elevation difference profile (Figure 5), which shows degradation throughout the assessed section of Priddis Creek.

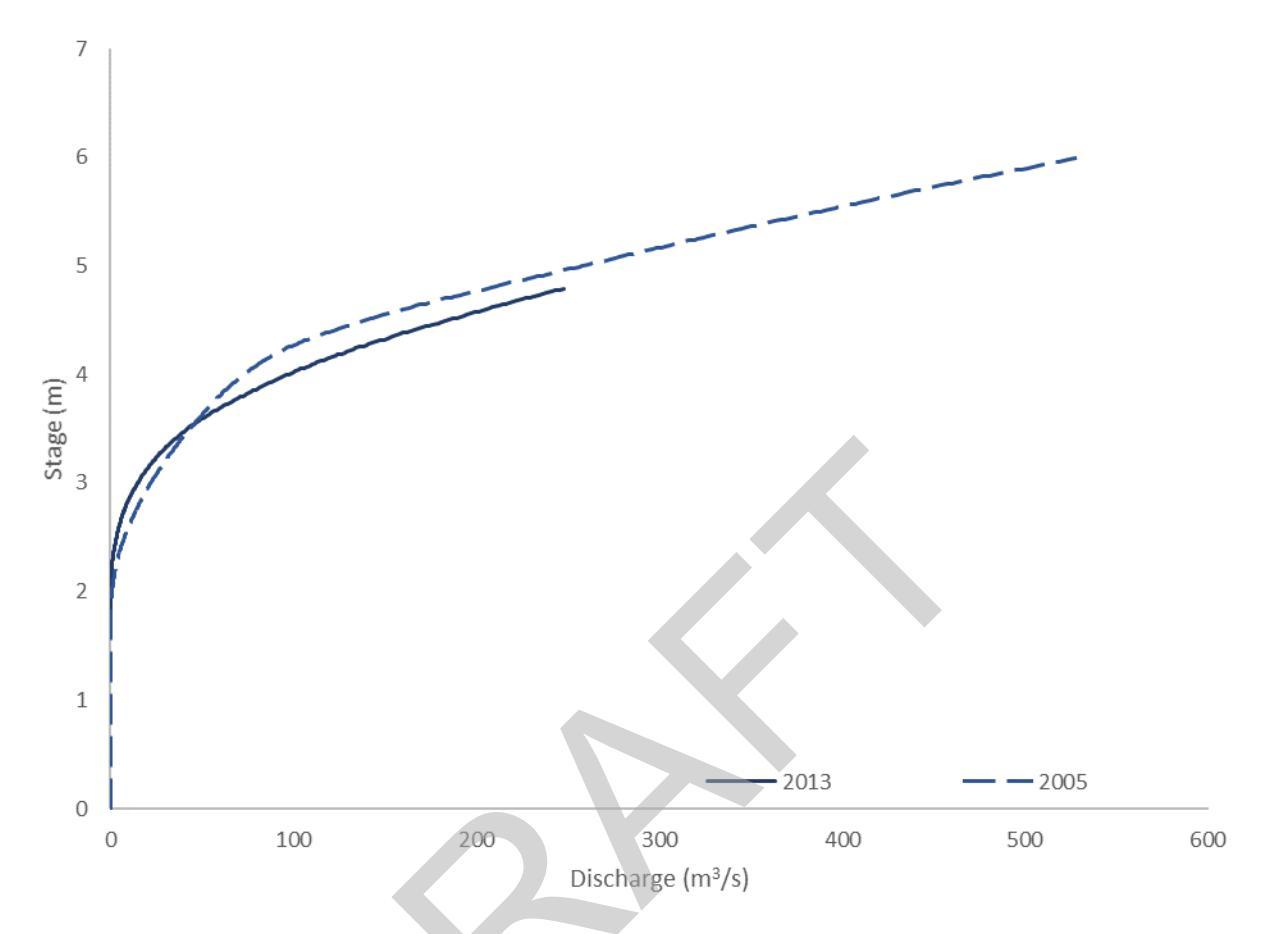
Figure 6. Historical rating curve comparison for WSC 05BK001.

The hydrometric station is located within Geomorphic Reach 3 and is roughly located at the 2018 Stantec cross-section 54.
