Channel Stability Investigation Report

Red Deer River Hazard Study

1783039-070-R-Rev0

July 17, 2019

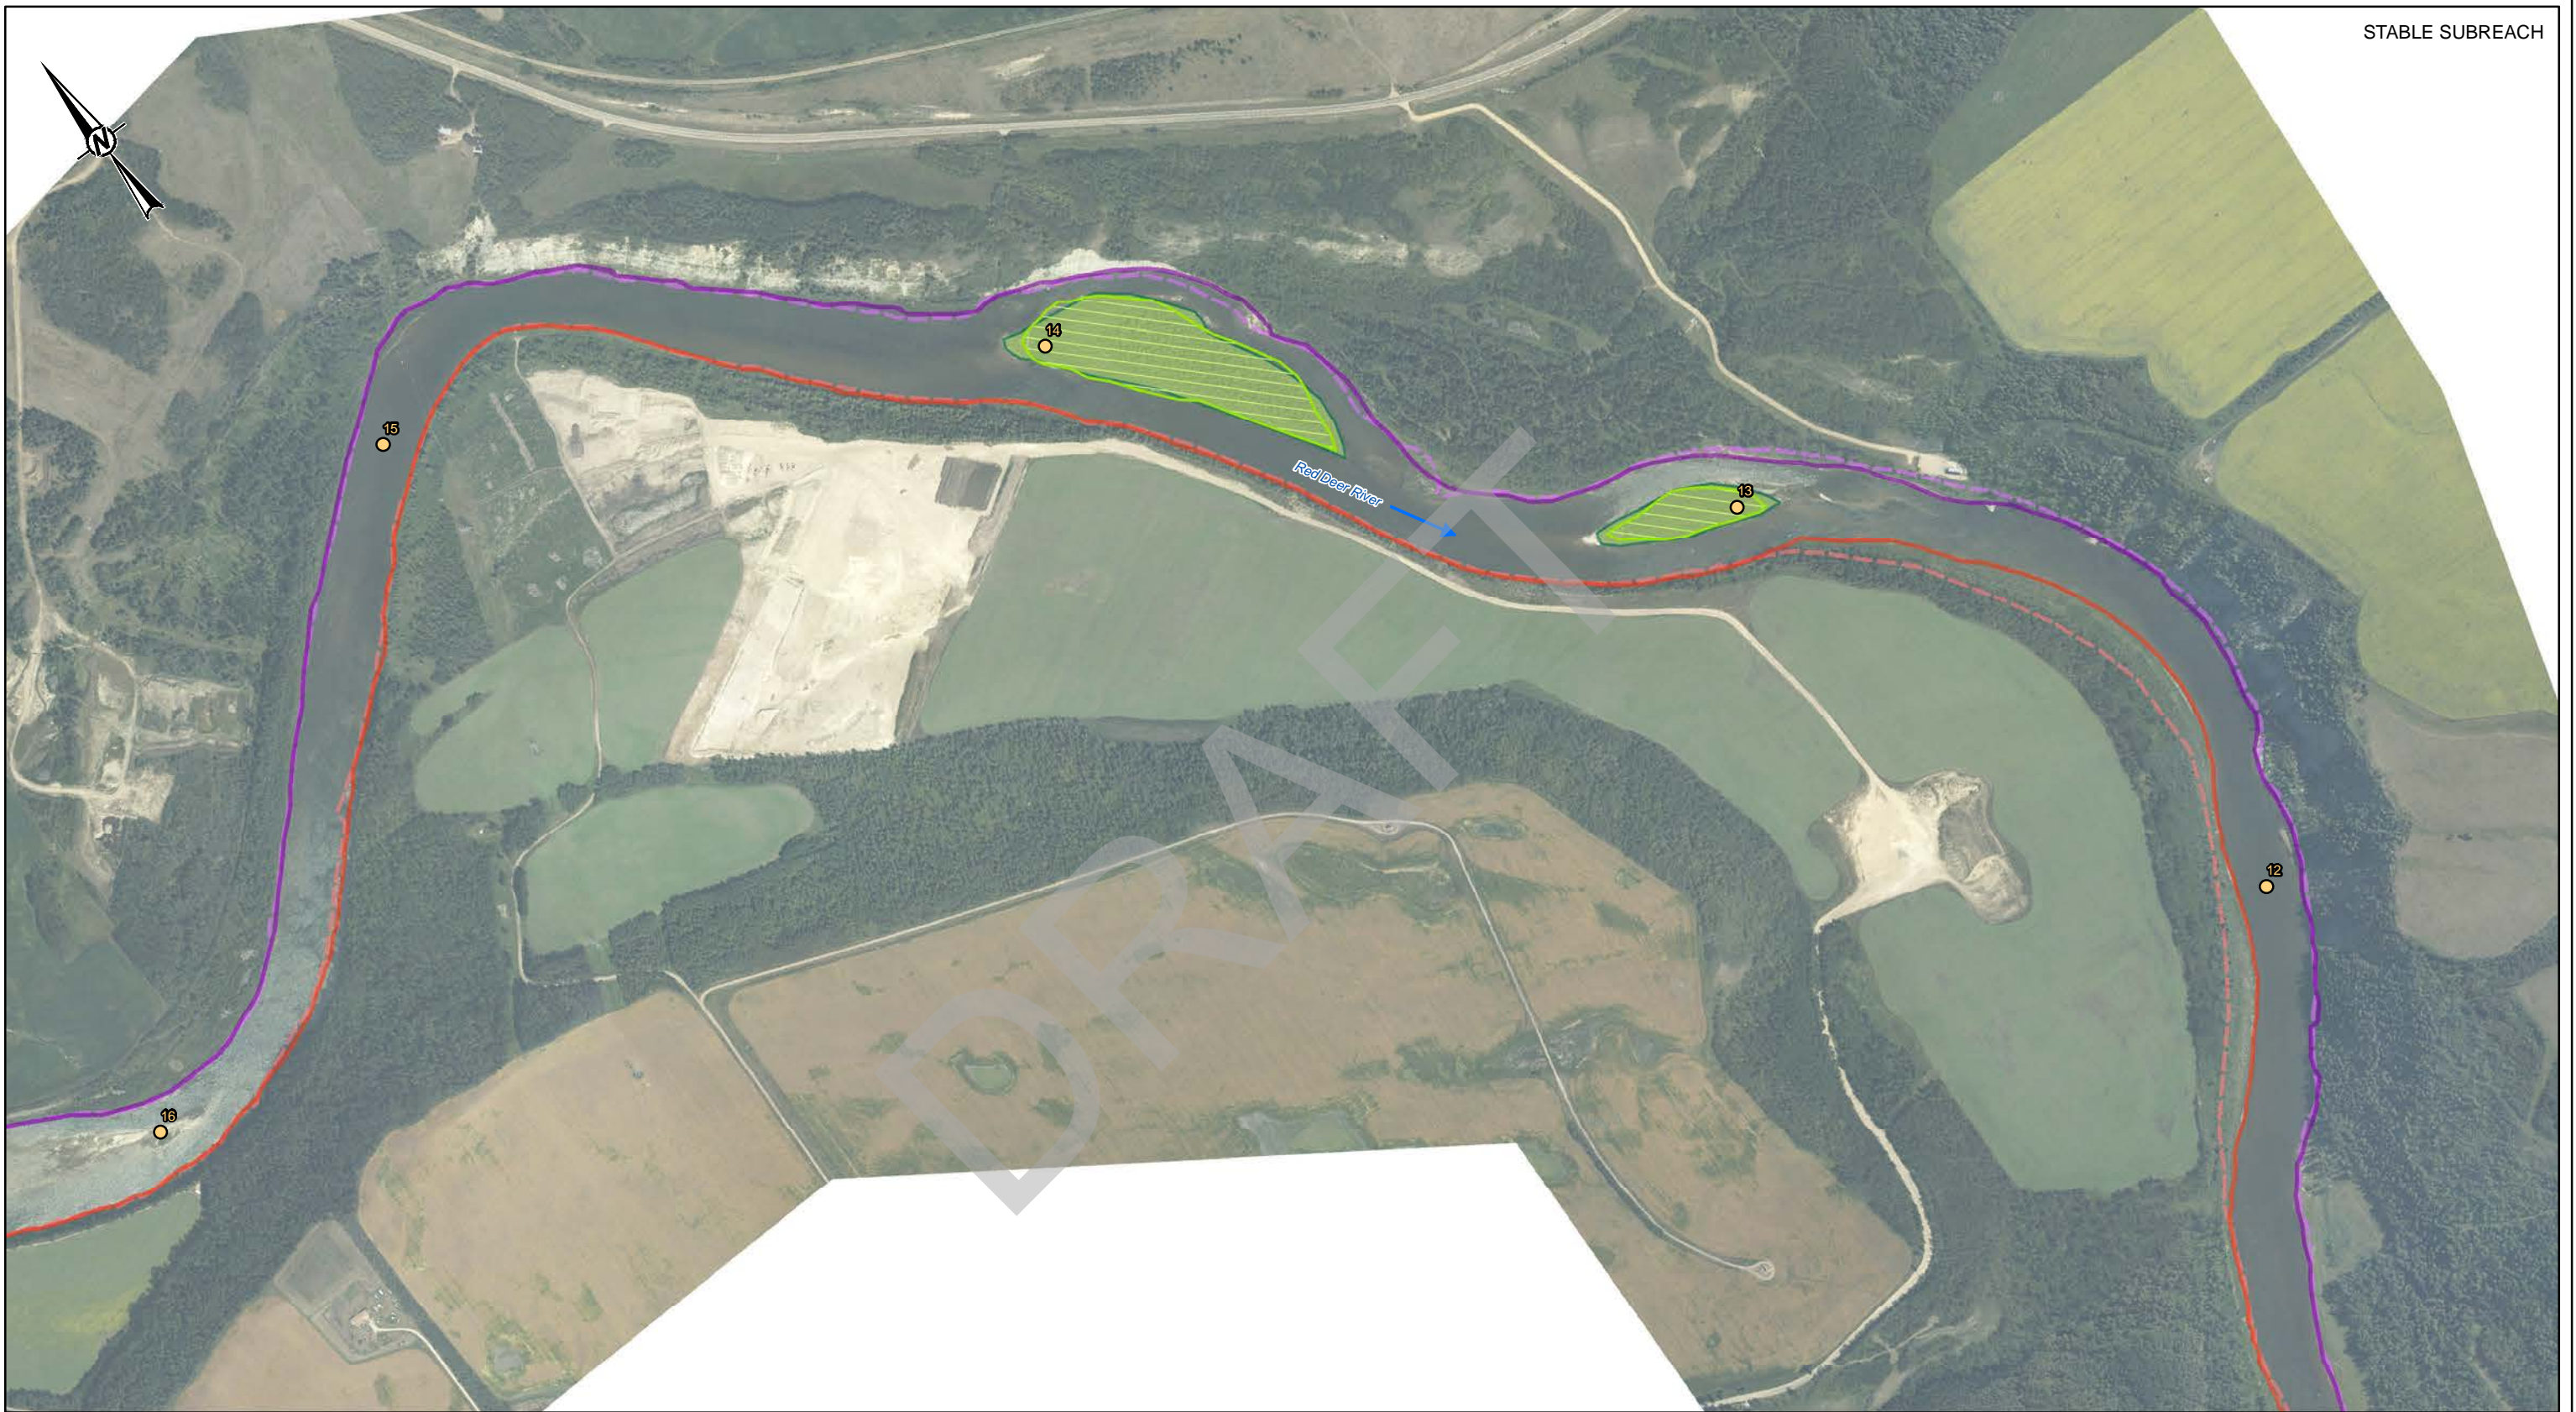
TITLE
 CHANNEL BANK COMPARISON OF REACH 1 - RED DEER RIVER FROM HIGHWAY 11 TO BLINDMAN RIVER - REPRESENTATIVE SUBREACH

Reach 1, which extends from Highway 11 to Blindman River, is typically straight to gently meandering. The valley is narrow due to confining terraces on both sides, and the modern floodplain is sporadic. The channel corridor is primarily single-threaded, with occasional vegetated islands, point bars, and side bars. The channel corridor width typically narrowed over the observed period due to stabilization of side bars. Otherwise, the position of the banks remained approximately stable.

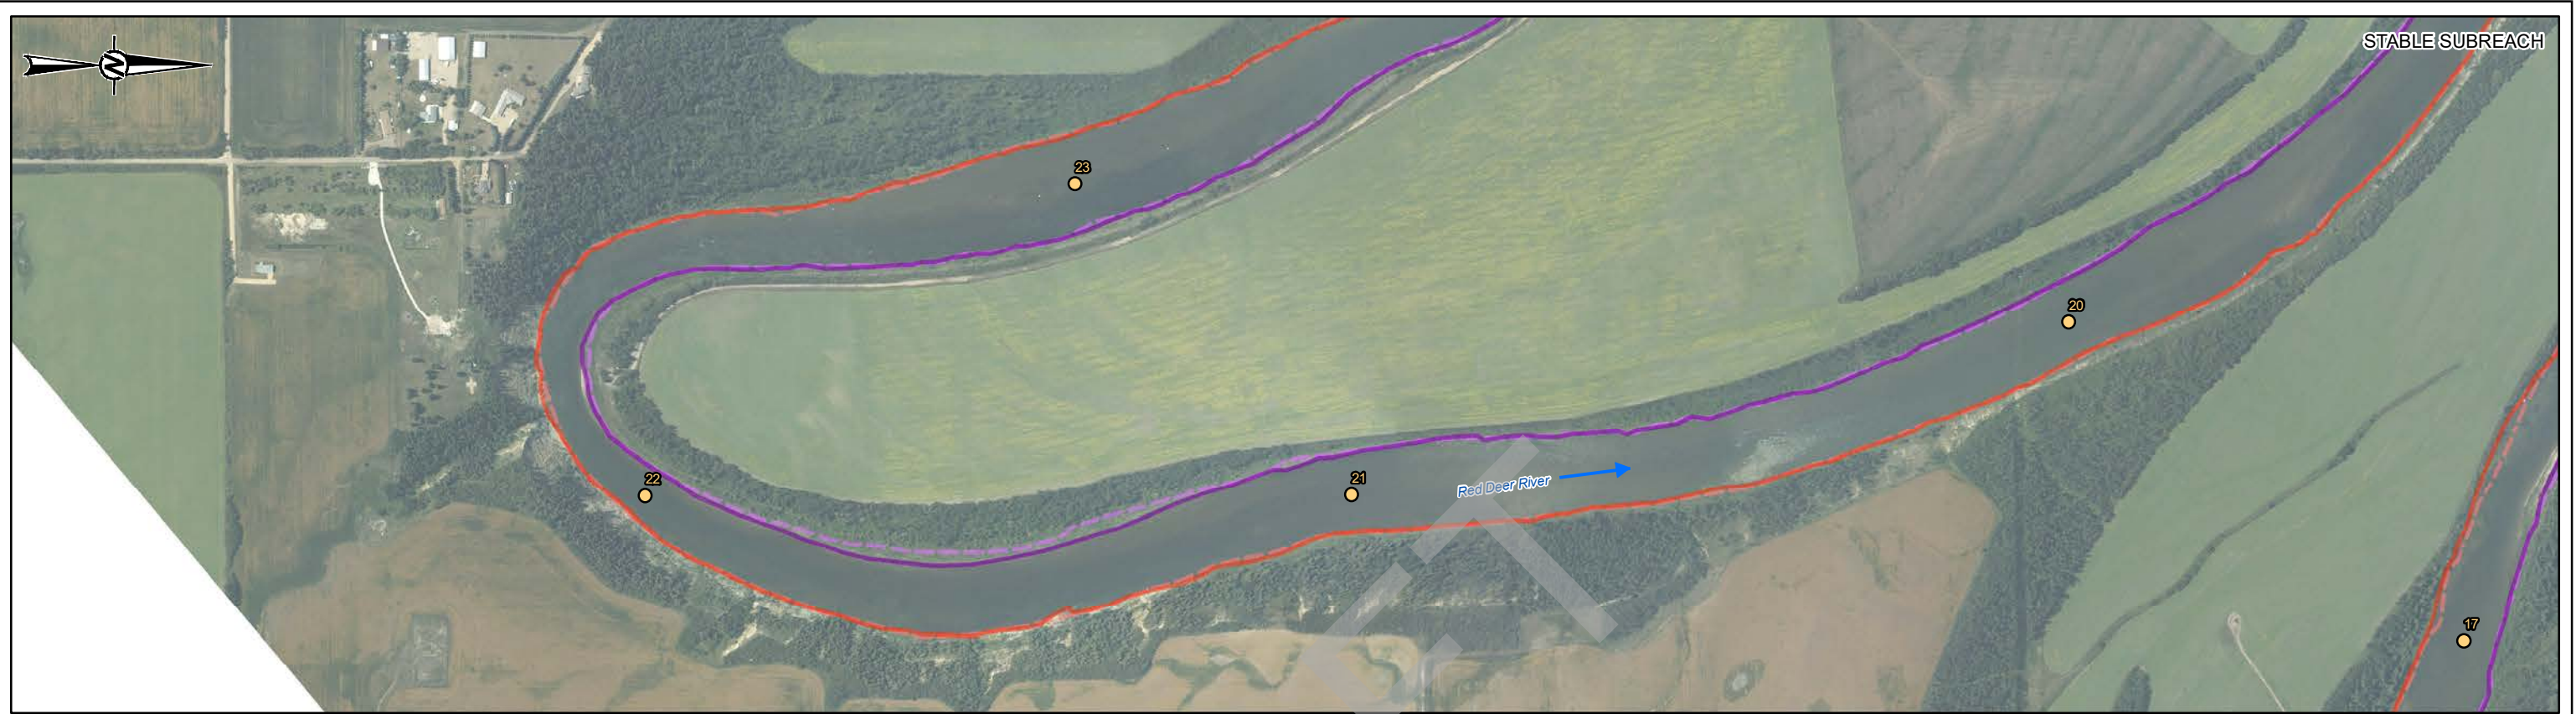
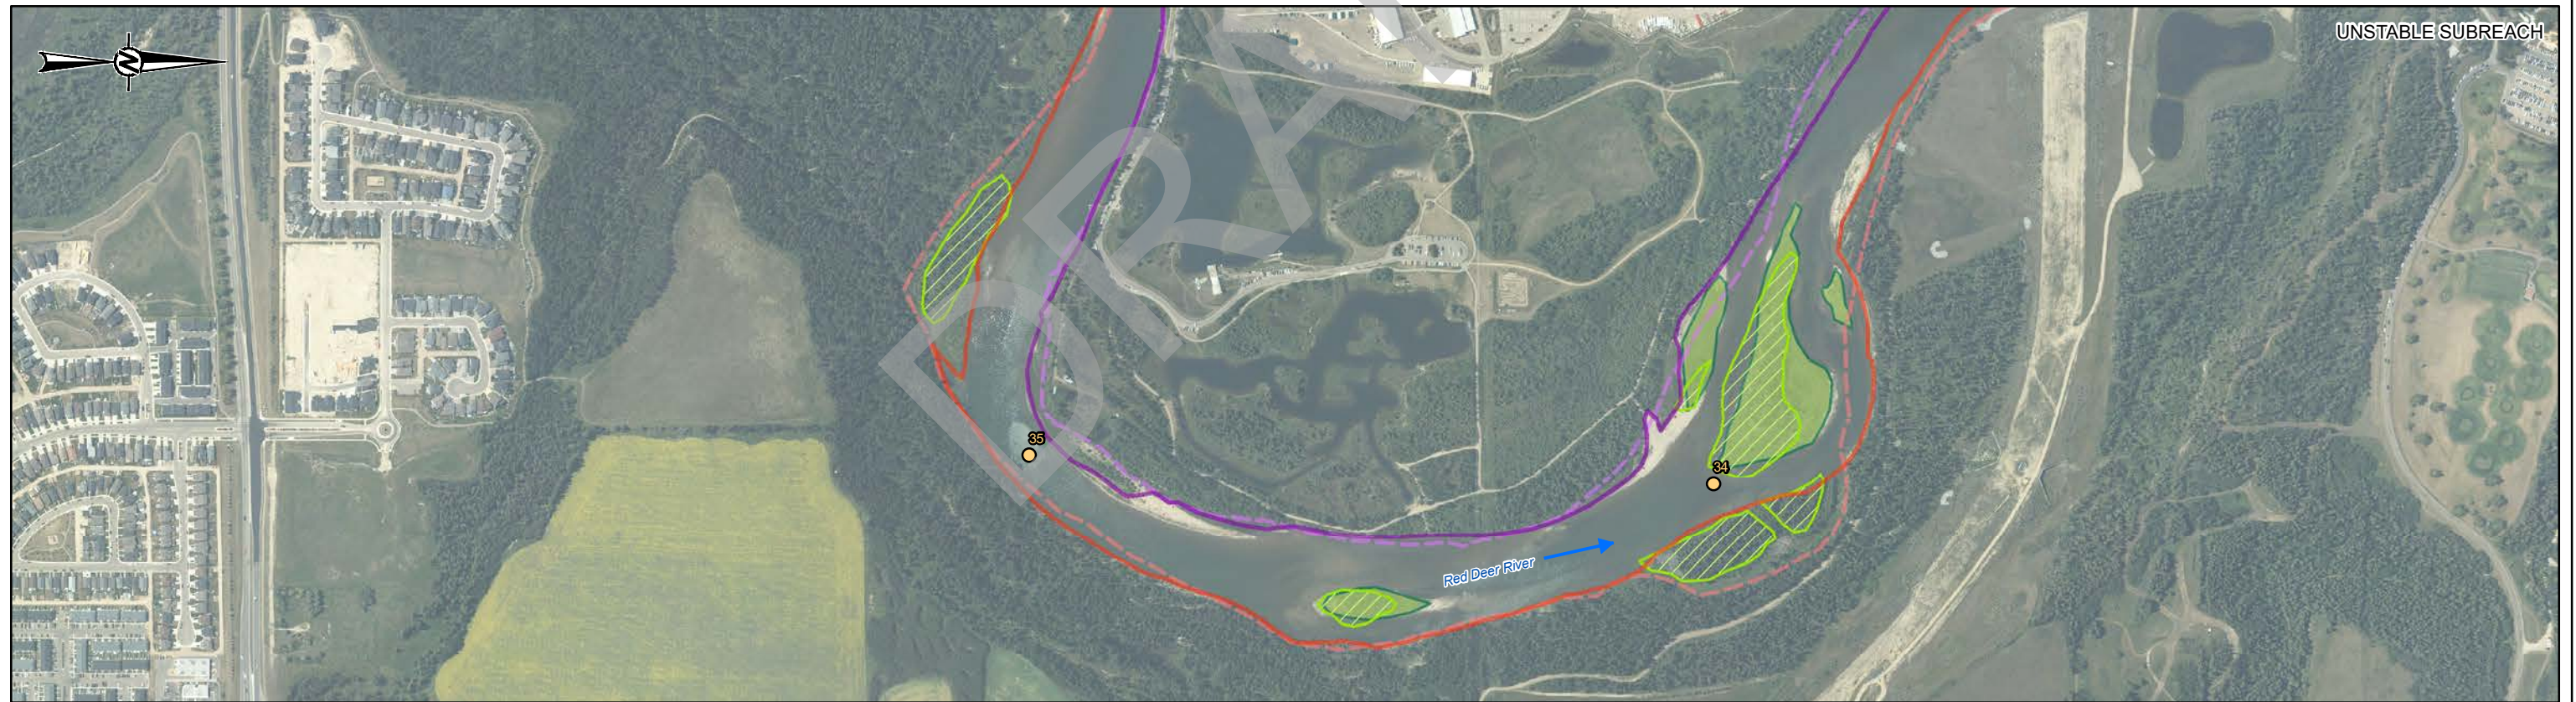
PROJECT NO. 1783039 **CONTROL** 8000 **REV.** 0 **FIGURE** 4

A subset of Reach 2 showing a typically stable meander is presented in Figure 4. The terrace has confined the meander, leading to a highly sinuous planform. No bars or vegetated islands are apparent, and the banks have remained approximately stable over the observed period.

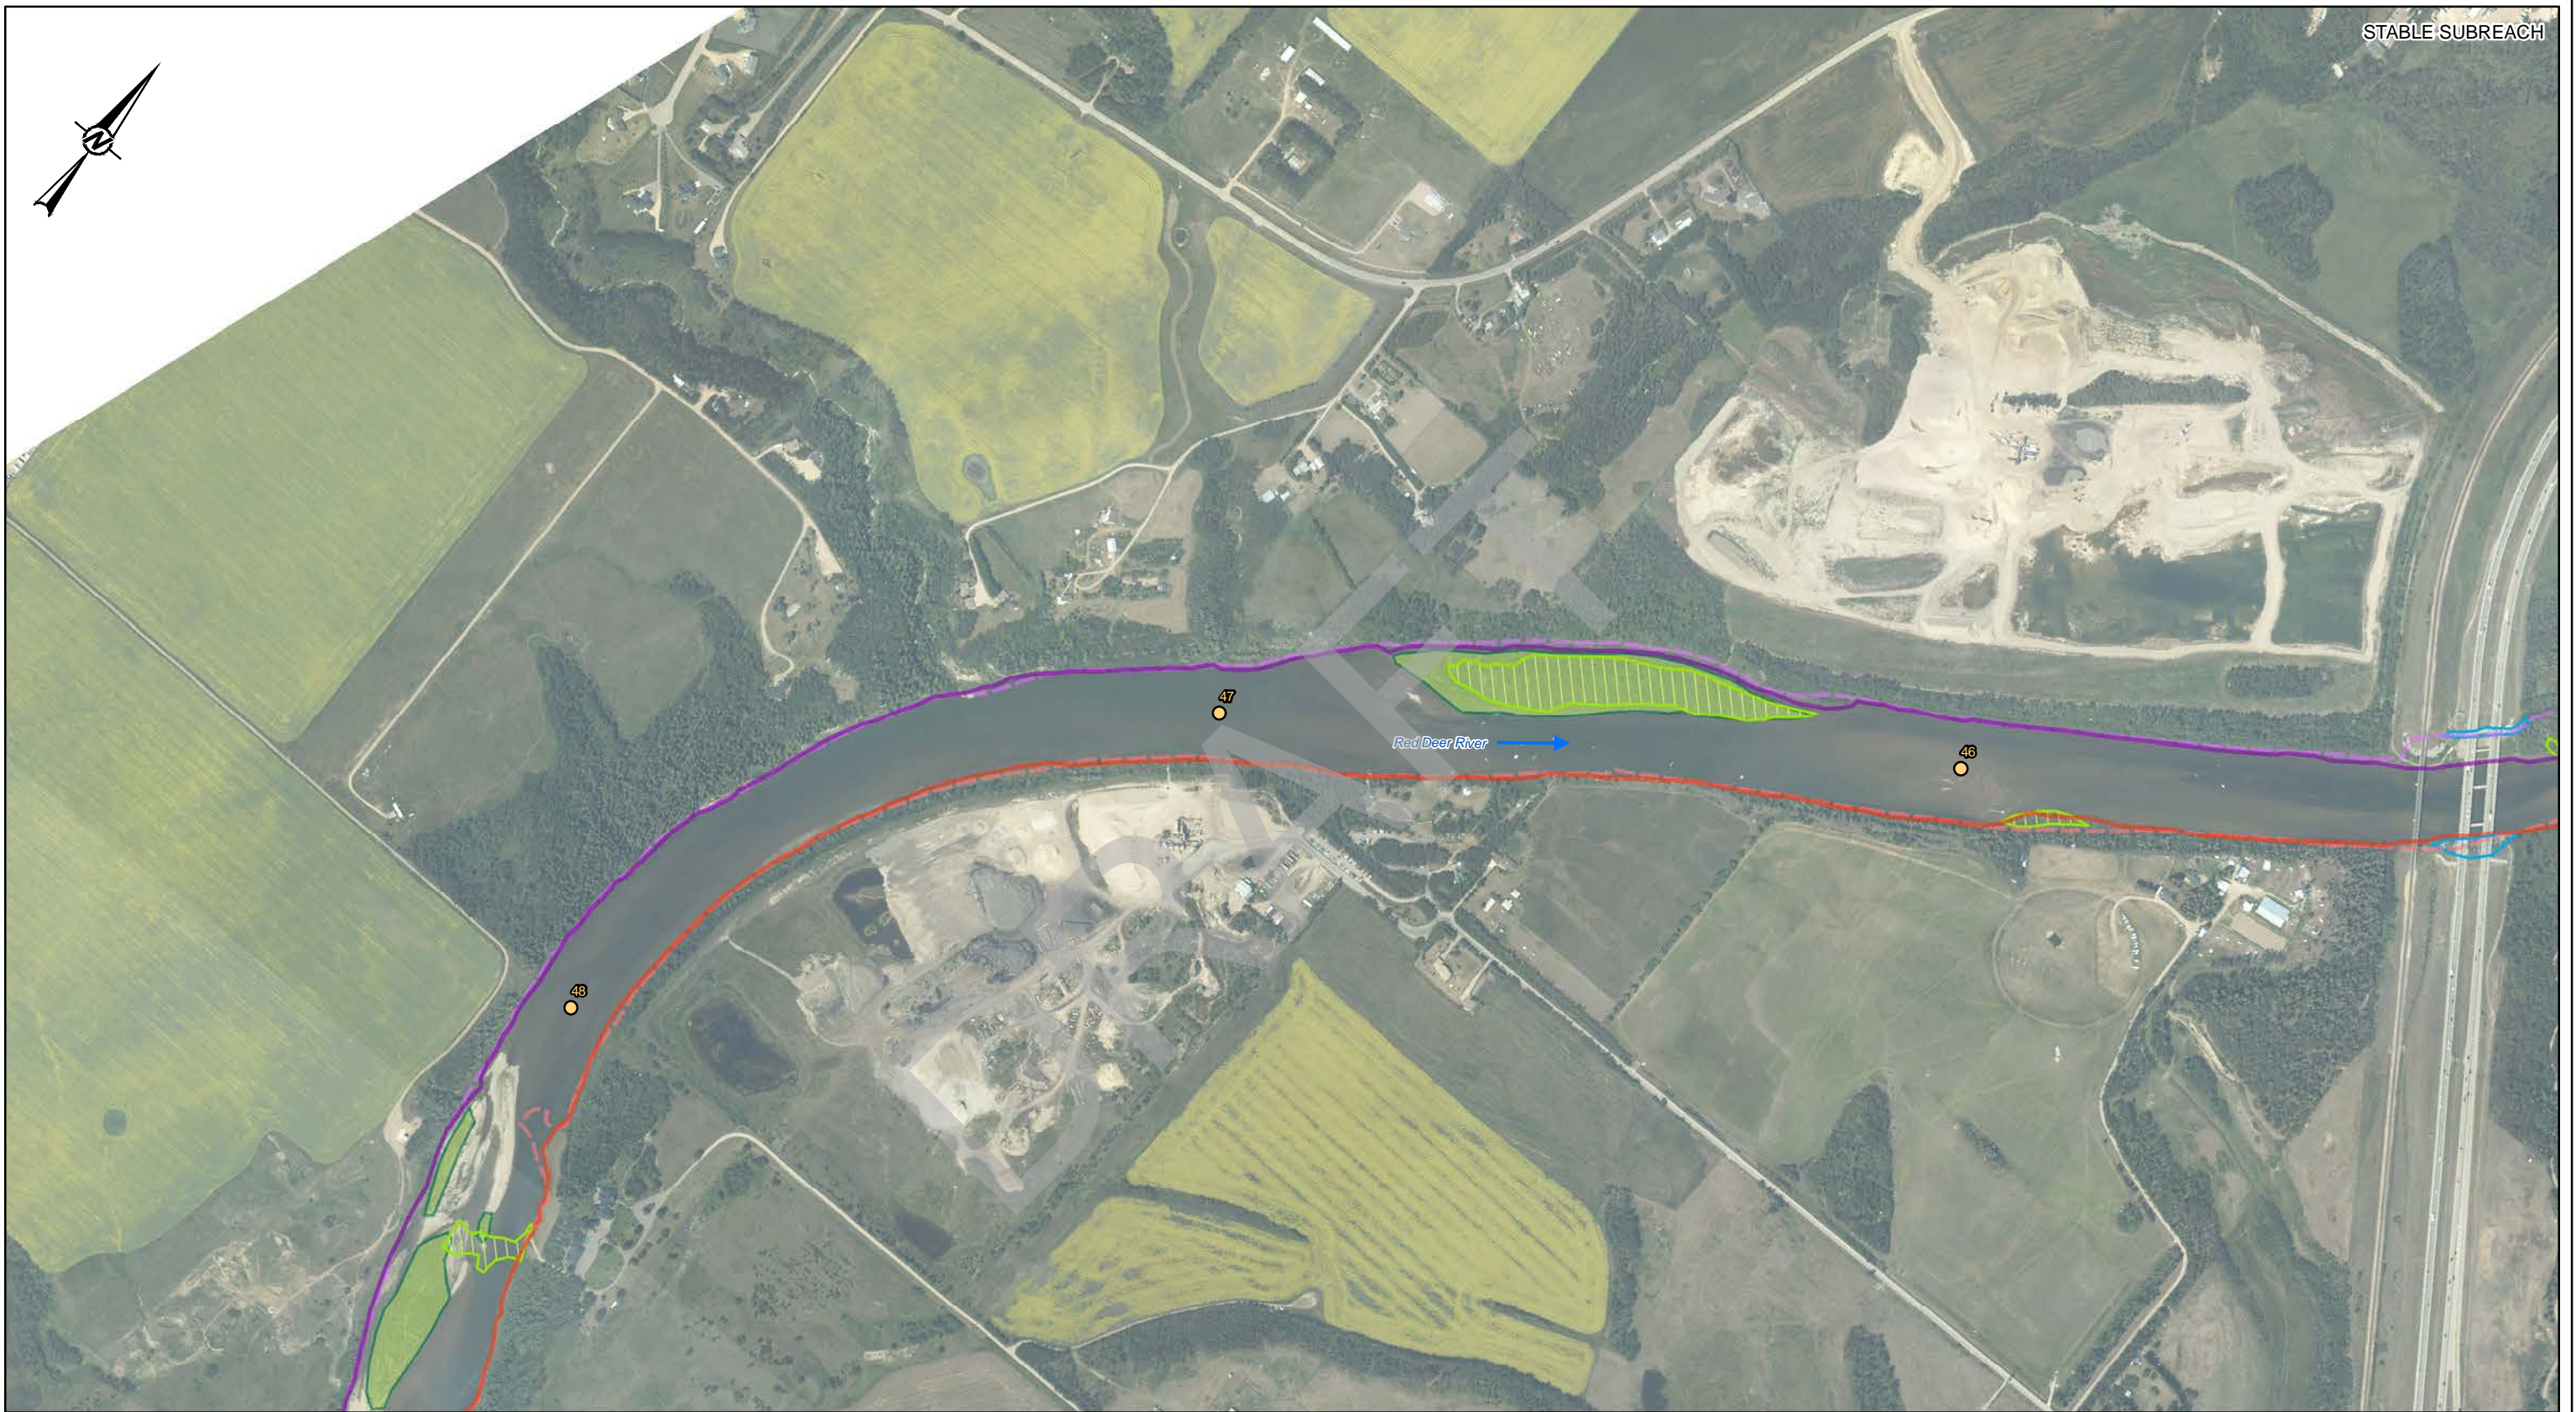
TITLE
 CHANNEL BANK COMPARISON OF REACH 3 - RED DEER RIVER FROM WASKASOO CREEK TO STN 50+200 - REPRESENTATIVE SUBREACH

A subset of this reach is presented in Figure 5. A vegetated island located close to the left bank grew on its upstream end over the observed period. The position of the banks remained approximately stable.

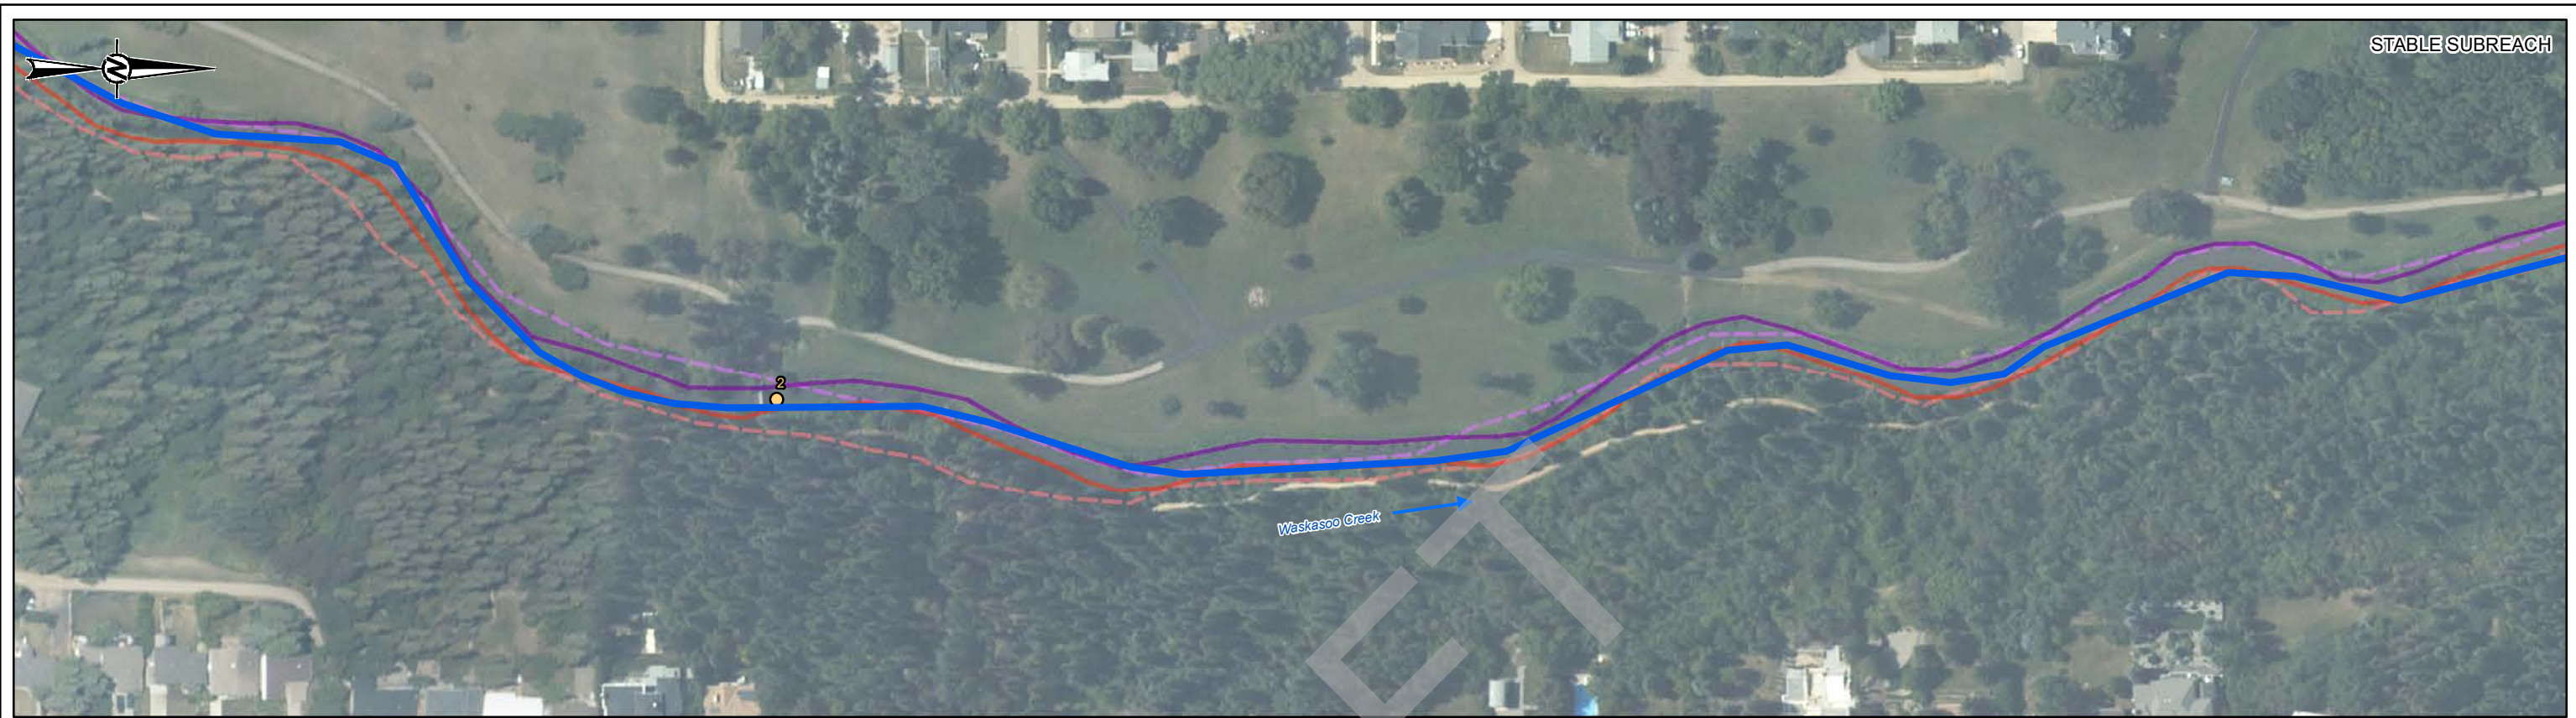
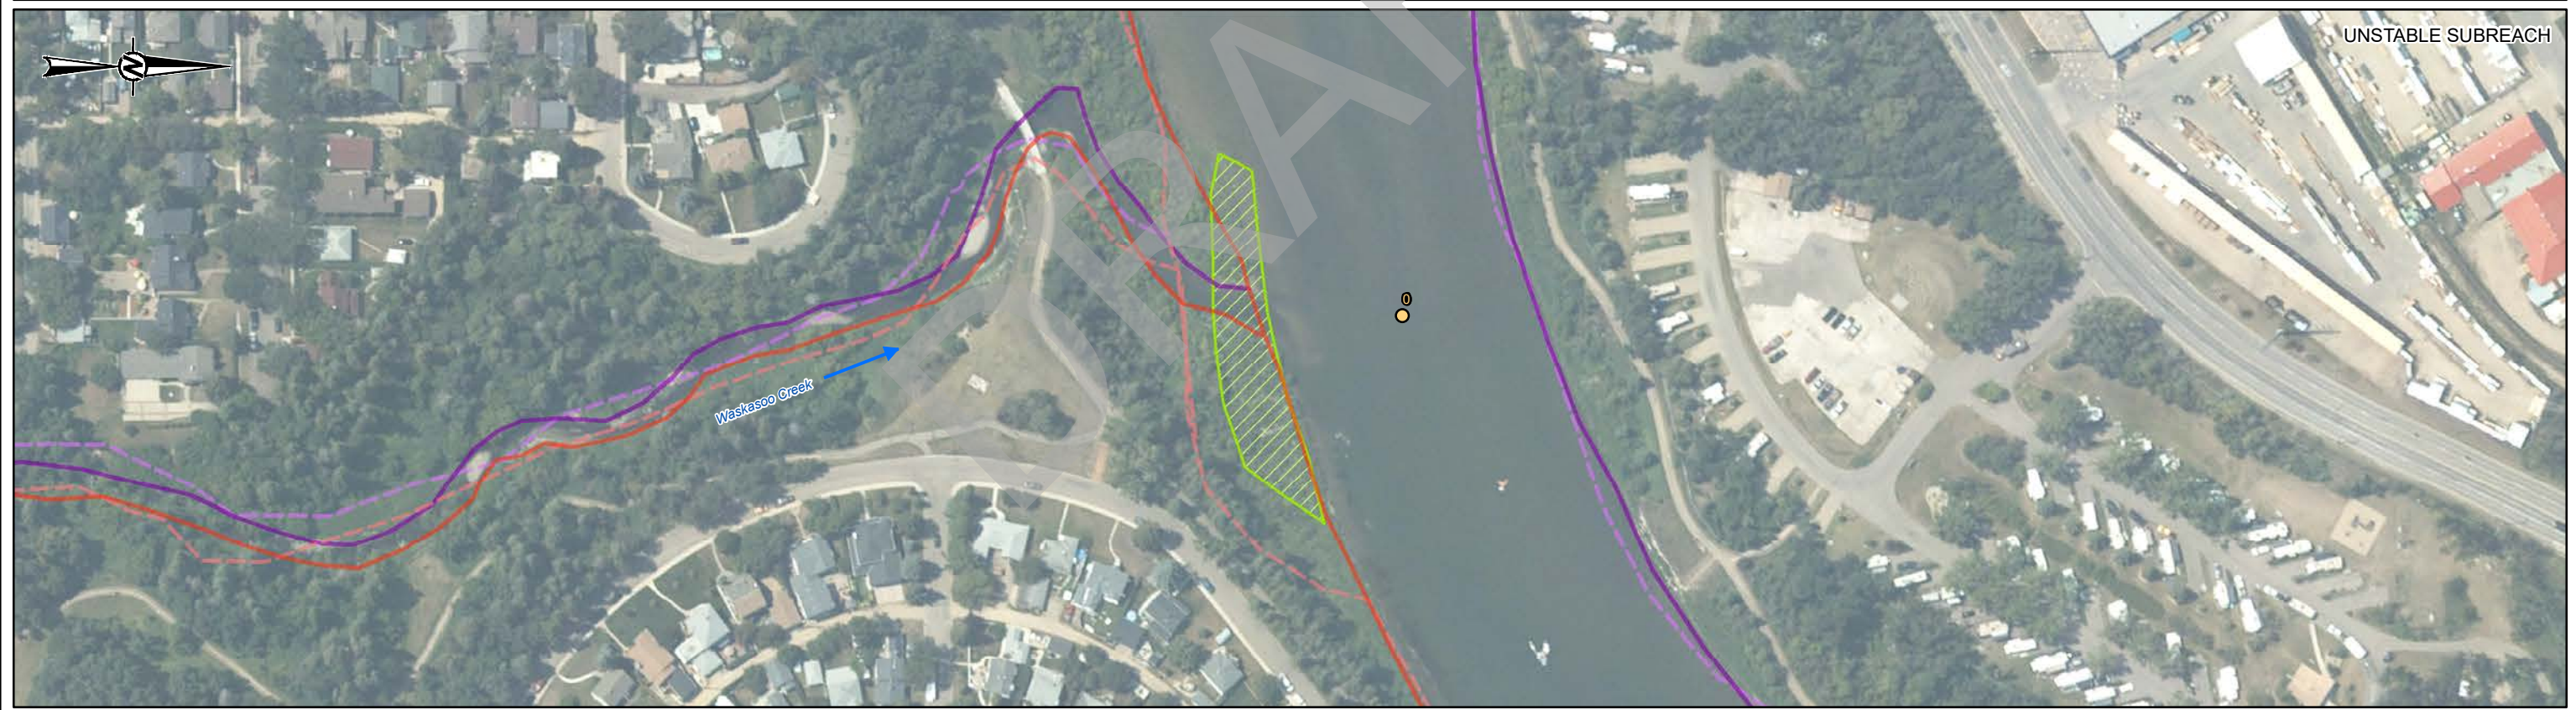
PROJECT NO. 1783039 CONTROL 8000 REV. 0 FIGURE 6

A second subset of Reach 4 showing stable conditions typical over the rest of the reach is presented in Figure 6. The channel corridor appears to have remained in approximately the same position, although visibility of the active channel was low due to tree cover. Limited bank erosion may have occurred at the apexes of the meander bends.

A subset of Reach 4 showing the typically unstable conditions near the stream mouth is also presented in Figure 6. The channel appears to have been artificially straightened prior to 1962. Over the observed period, the channel transitioned to a more meandering planform. Meander bend apexes migrated up to approximately 20 m, and the stream mouth migrated downstream approximately 30 m in response to a leftward shift of the right bank of Red Deer River.

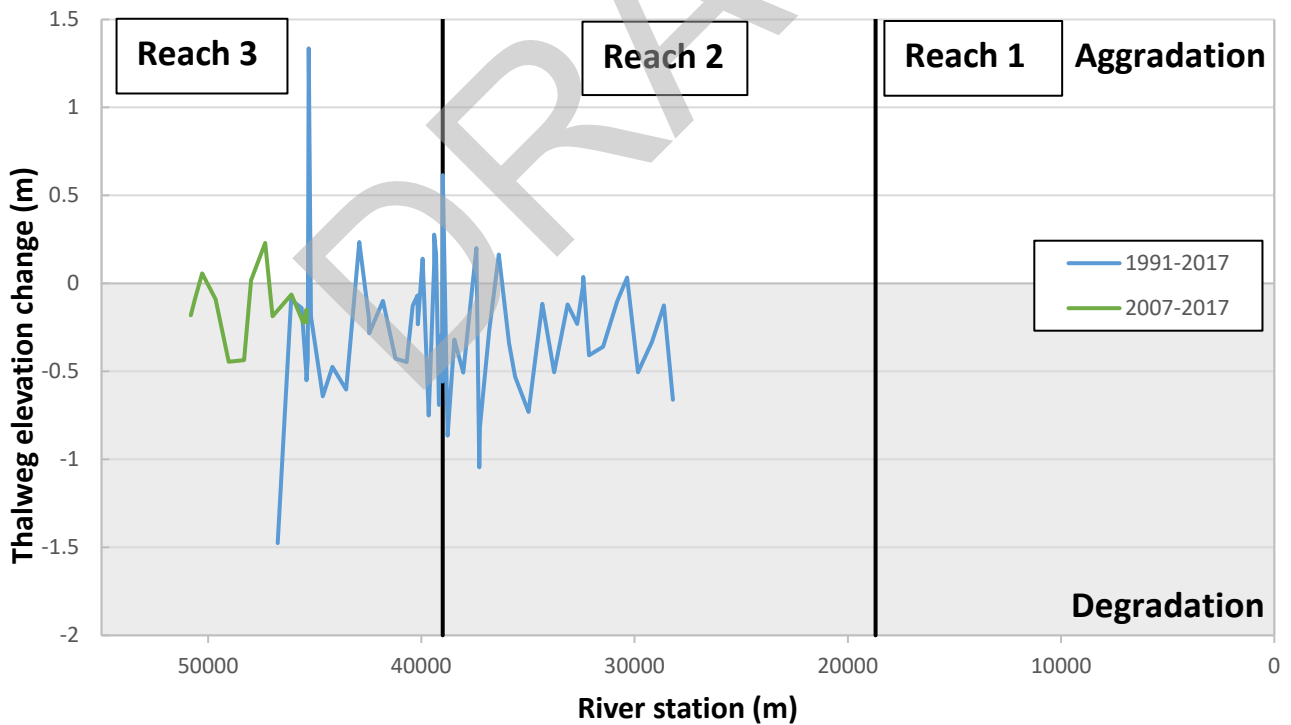
Figure 16: Red Deer River Thalweg Elevation Difference

In Reaches 2 and 3, the thalweg has generally lowered by up to approximately 1 m since the historical period, although in a few locations, the channel aggraded by a few centimetres (Figure 16). Between 1991 and 2017, local aggradation and degradation were both highest in the vicinity of bridges within the City of Red Deer, near the boundary of Reaches 2 and 3 and near Station 46+000. For example, the channel locally degraded approximately 1.5 m at a location approximately 1 km upstream of the Highway 2 bridge and aggraded by approximately 1.3 m under the bridge. In surveyed sub-reaches not near bridges, the channel typically degraded by up to approximately 0.5 m. Thalweg data is available for both 1991 and 2007 at locations just upstream of the Highway 2 bridge. Degradation between 2007 and 2017 was less than 0.25 m, suggesting that the bed in that location may be becoming relatively stable.

The sections of Reaches 2 and 3 where thalweg data is available are experiencing net losses of approximately 128 and 86 m³ of sediment per unit channel width per year, respectively (Table 7). These changes are consistent with anticipated patterns of river evolution for this region. Over the long term (thousands of years), the Red Deer River valley has been experiencing a net reduction of sediment as the river has cut into relict glacial and deglacial surfaces. Degradation over the past several decades may be a result of a loss of sediment supply caused by trapping on the upstream side of Dickson Dam.

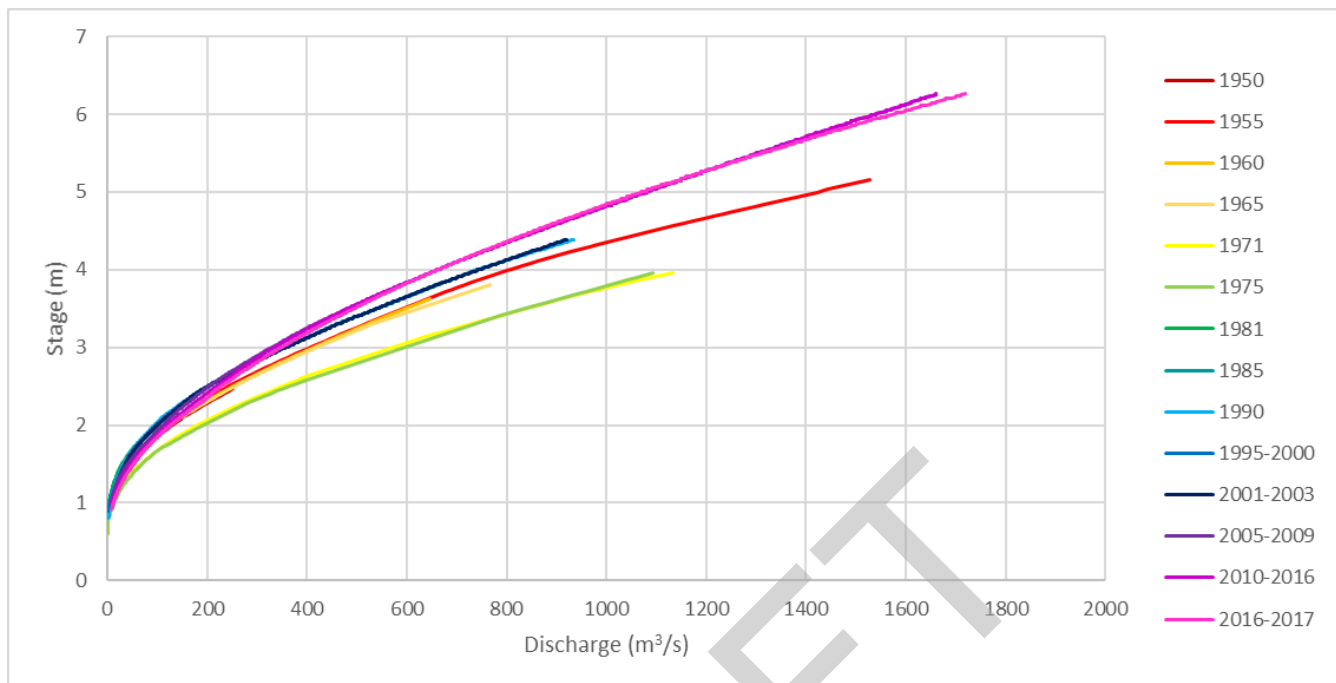
Figure 18: Rating Curves for Red Deer River at Red Deer

There was an upward shift in the upper tail of the rating curves between 2003 and 2005. Possible causes of the shift include channel narrowing or aggradation. The shift is only noticeable for flows above approximately 350 m³/s, so it is likely that the shift is due to channel narrowing, as aggradation would conceivably affect stages at lower discharges. Channel narrowing was observed over many parts of the reach.

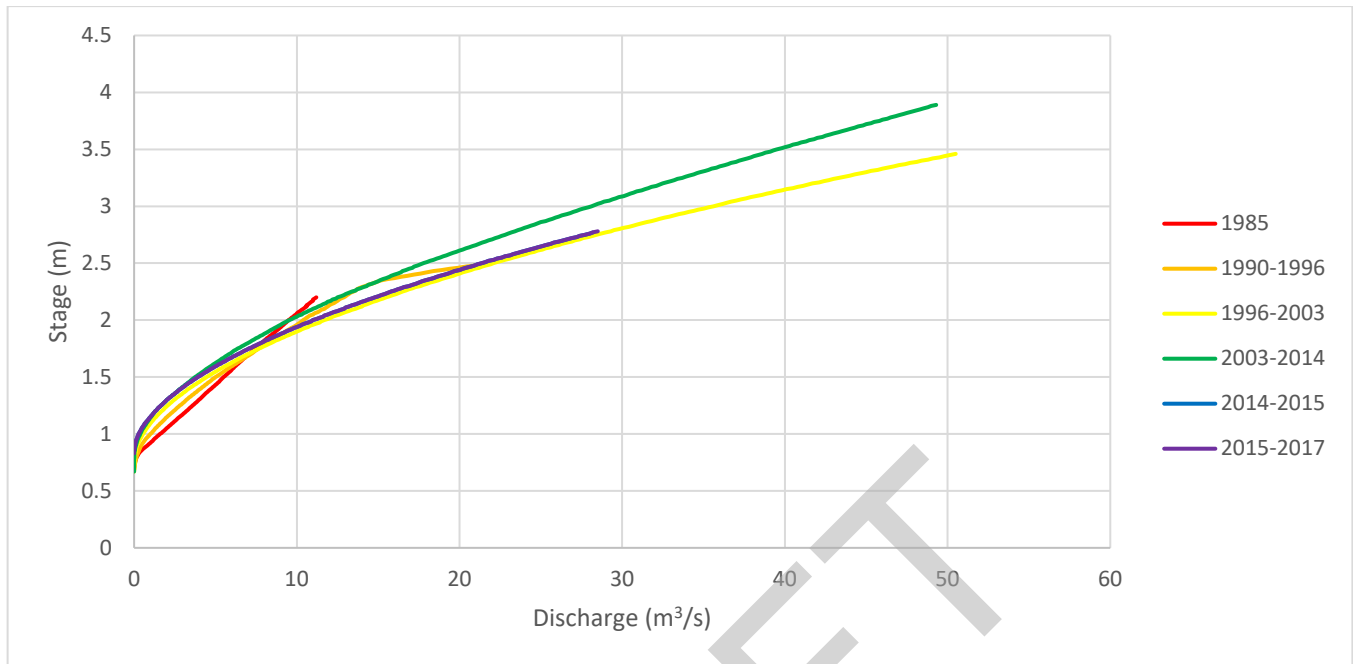
Figure 19: Rating Curves for Waskasoo Creek at Red Deer

Between 2003 and 2017, there was a downward shift in the rating curve which could represent channel widening or degradation. As the elevation for most of reach has remained relatively stable, channel widening is the most likely cause. Widening may have been a result of anthropogenic reworking of the channel rather than bank erosion.
