Channel Stability Investigation Report

Upper Red Deer River Hazard Study

1783057-055-R-Rev0

July 2019

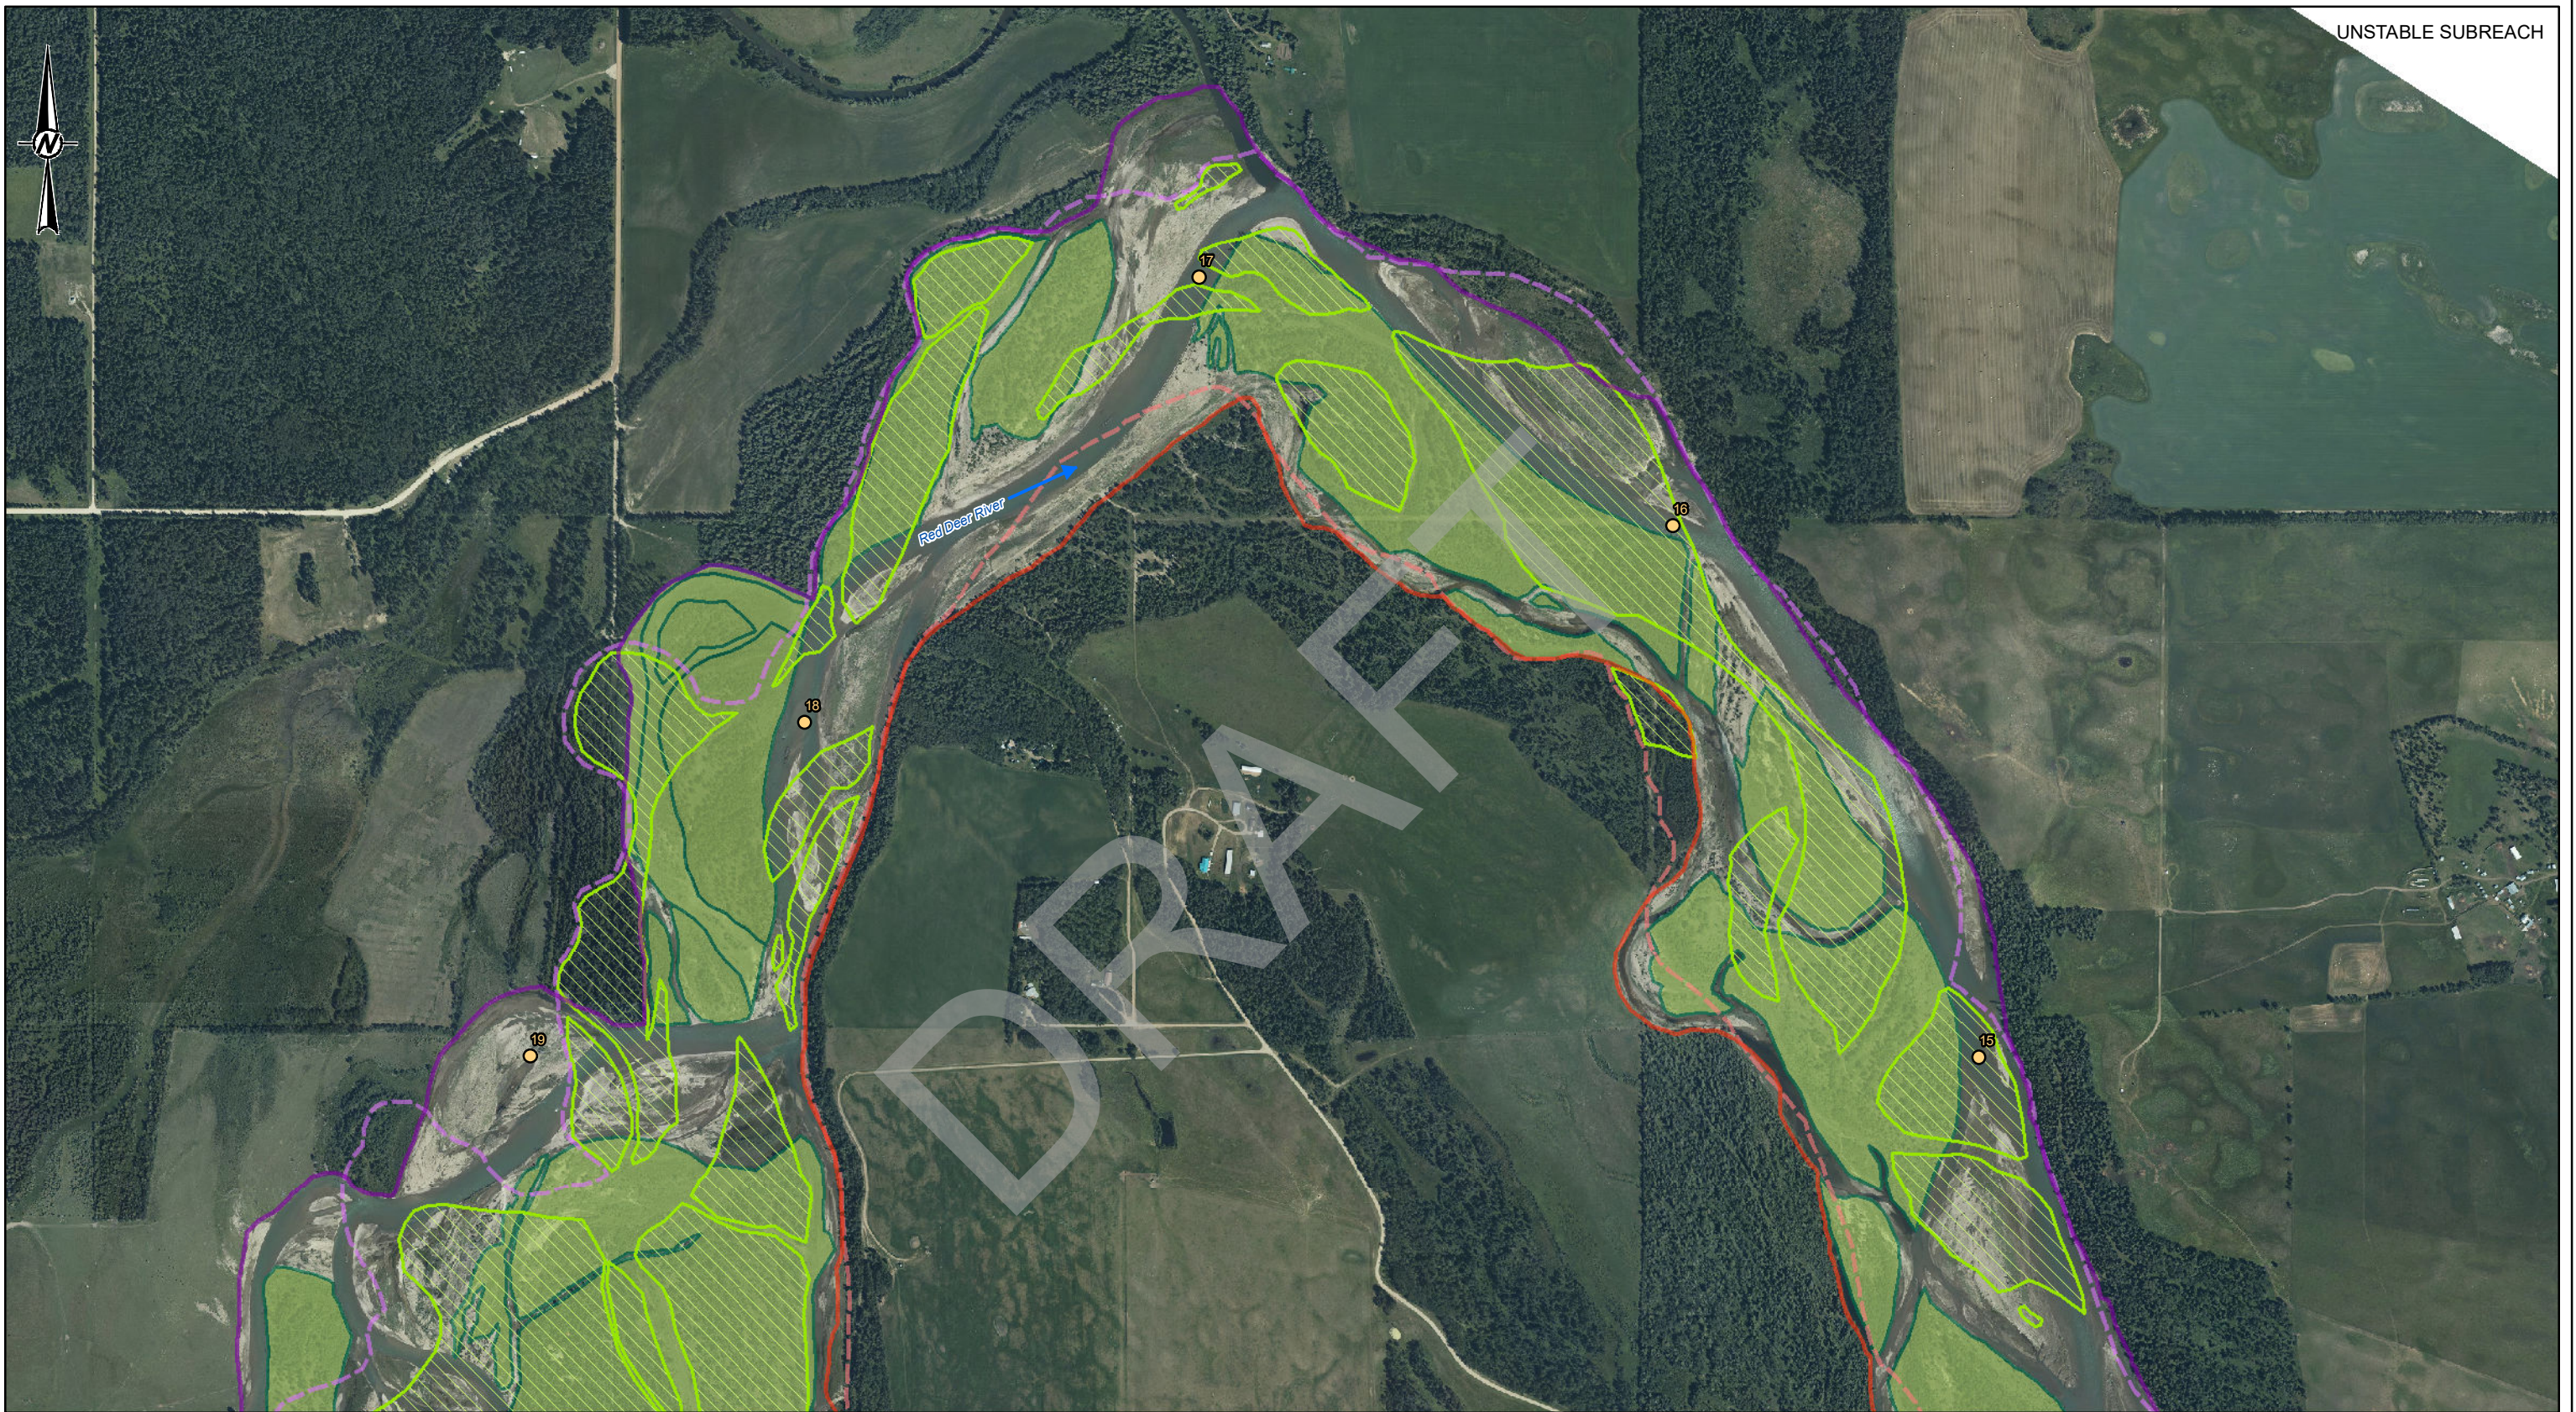
PROJECT NO. 1783057 CONTROL 8000 REV. 0 FIGURE 4

A subset of this reach is presented in Figure 4. The dominant channel has migrated up to 300 metres (m) over the observed period, and the channel corridor widened up to 300 m due to the emergence of a new sub-dominant channel.

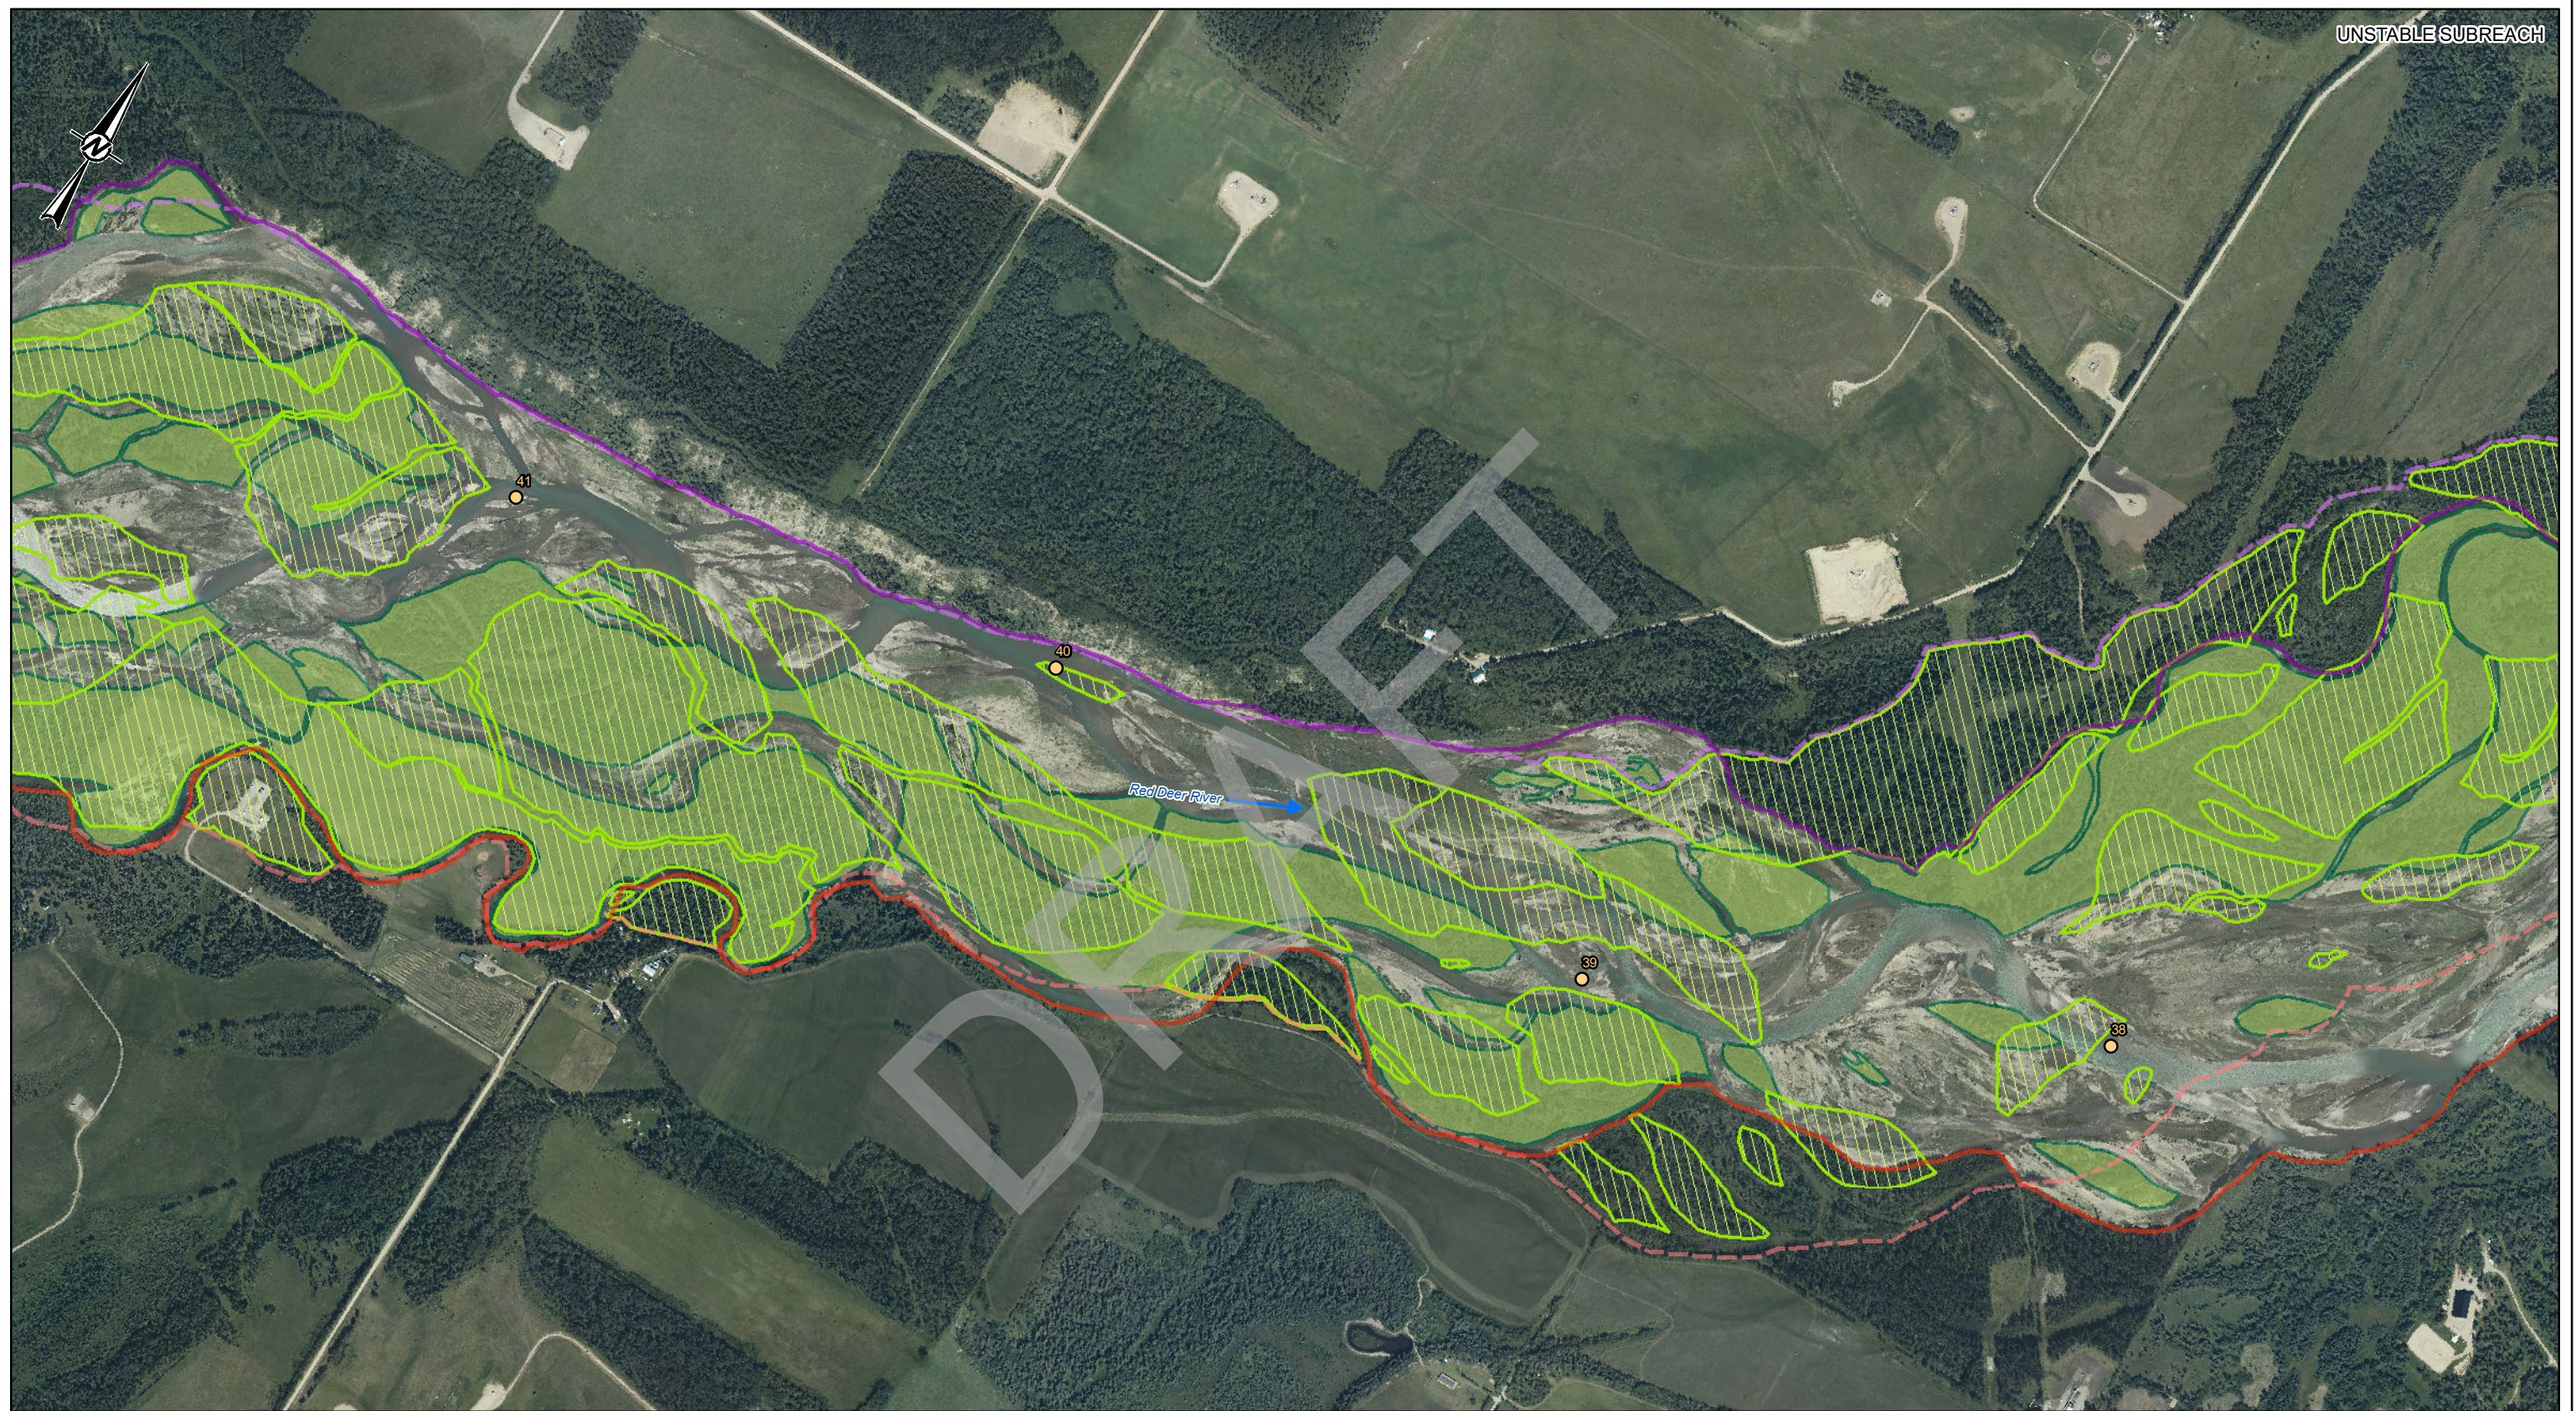
TITLE
CHANNEL BANK COMPARISON OF REACH 3 - UPPER RED DEER RIVER FROM STN 23+600 TO JAMES RIVER CONFLUENCE - REPRESENTATIVE SUBREACH 2 OF 2

A sub-reach experiencing less lateral movement of the channel corridor is presented in Figure 6. This sub-reach is constrained by bluffs on the outer (left) bank, and the channel corridor margins remained relatively consistent over the observed period except for some minor fluctuations on the right bank due to the creation and abandonment of sub-dominant channels. The general orientation of the dominant channel has remained relatively consistent over the observed period, although channel migration of up to 120 m and avulsions on sub-dominant channels were observed.

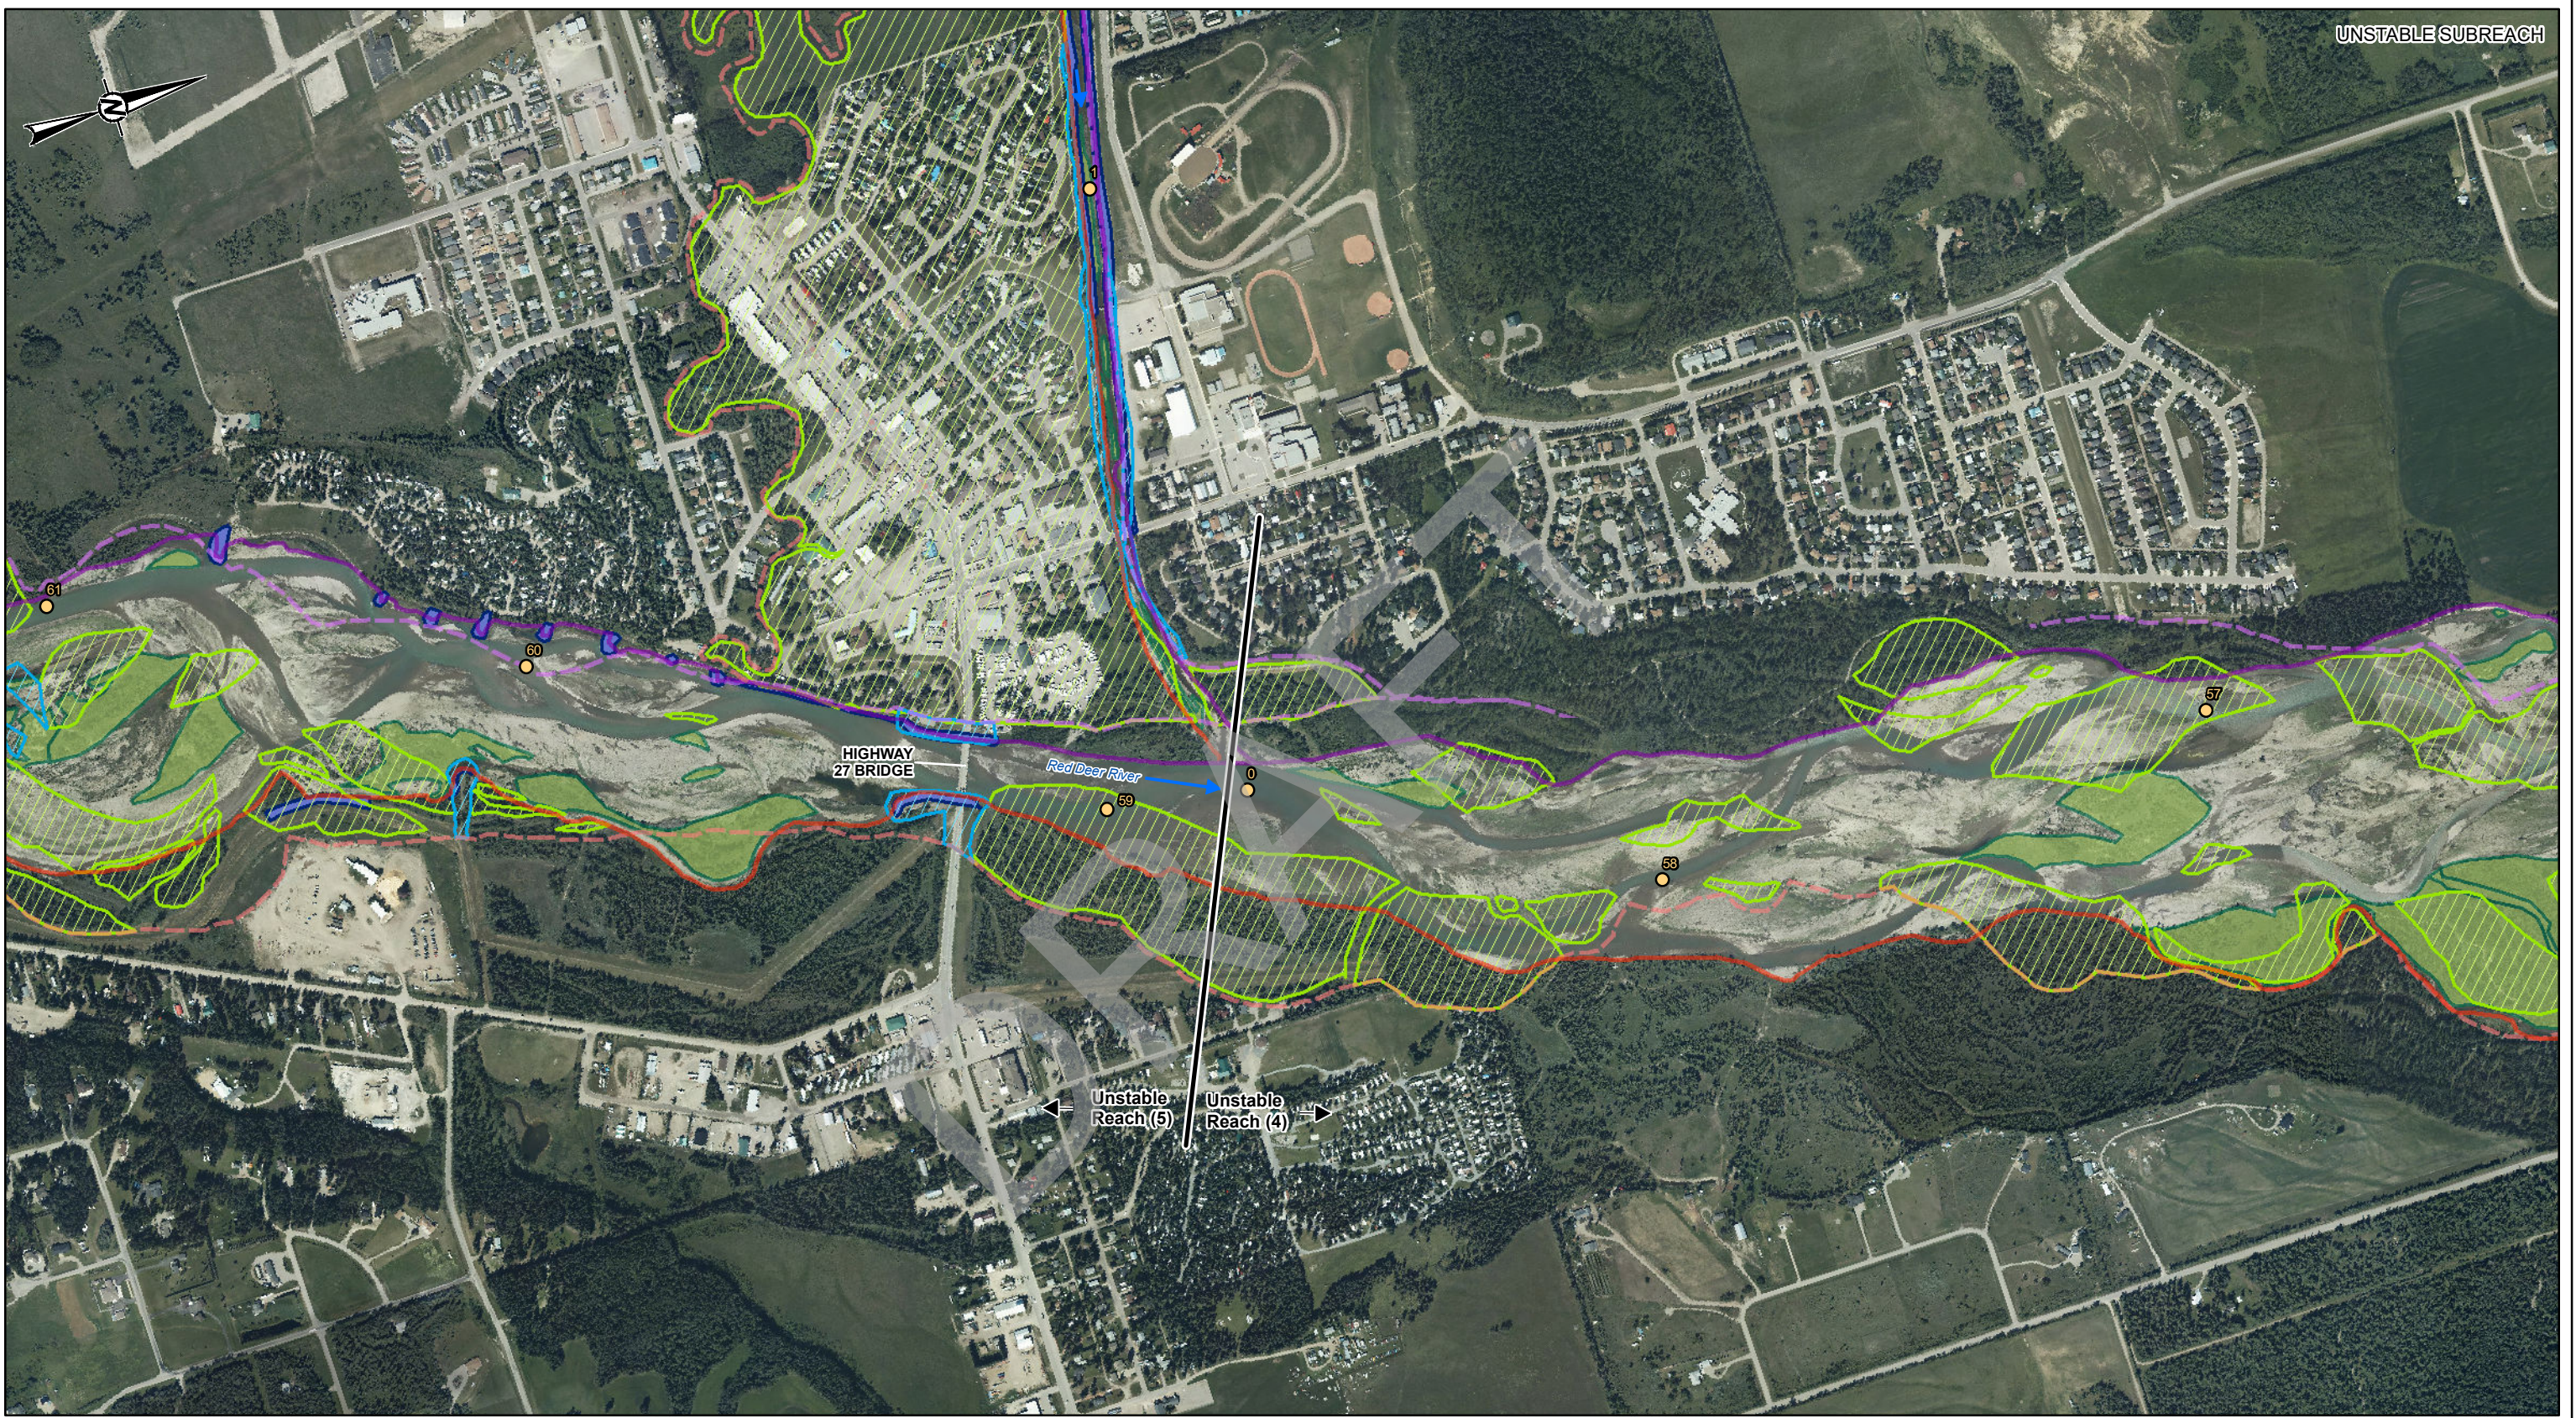
TITLE
CHANNEL BANK COMPARISON OF REACHES 4 AND 5 - UPPER RED DEER RIVER IN THE VICINITY OF SUNDRÉ - REACH 4 REPRESENTATIVE SUBREACH 2 OF 2 AND REACH 5 REPRESENTATIVE SUBREACH 1 OF 3

A sub-reach highlighting confined conditions at the upstream end of the reach is presented in Figure 8. The channel corridor narrowed by up to approximately 200 m, but the dominant channel migrated approximately 100 m to the east. The greater majority of the vegetated islands were scoured away during the observed period.

Downstream from the juncture of the northern and southern forks, the channel corridor becomes confined, apparently due to the Highway 27 bridge. A sub-reach highlighting these conditions is presented in Figure 8. Bank protection is present on both sides of the channel corridor. A new sub-dominant channel has formed on the right bank approximately 350 m upstream of the Highway 27 bridge. Channel morphology in the reach appears to be more braided in the modern period than in the historic period, and the channel corridor has shifted to the west approximately 50 m. The dominant channel has migrated across the channel corridor in multiple locations, including under the bridge.

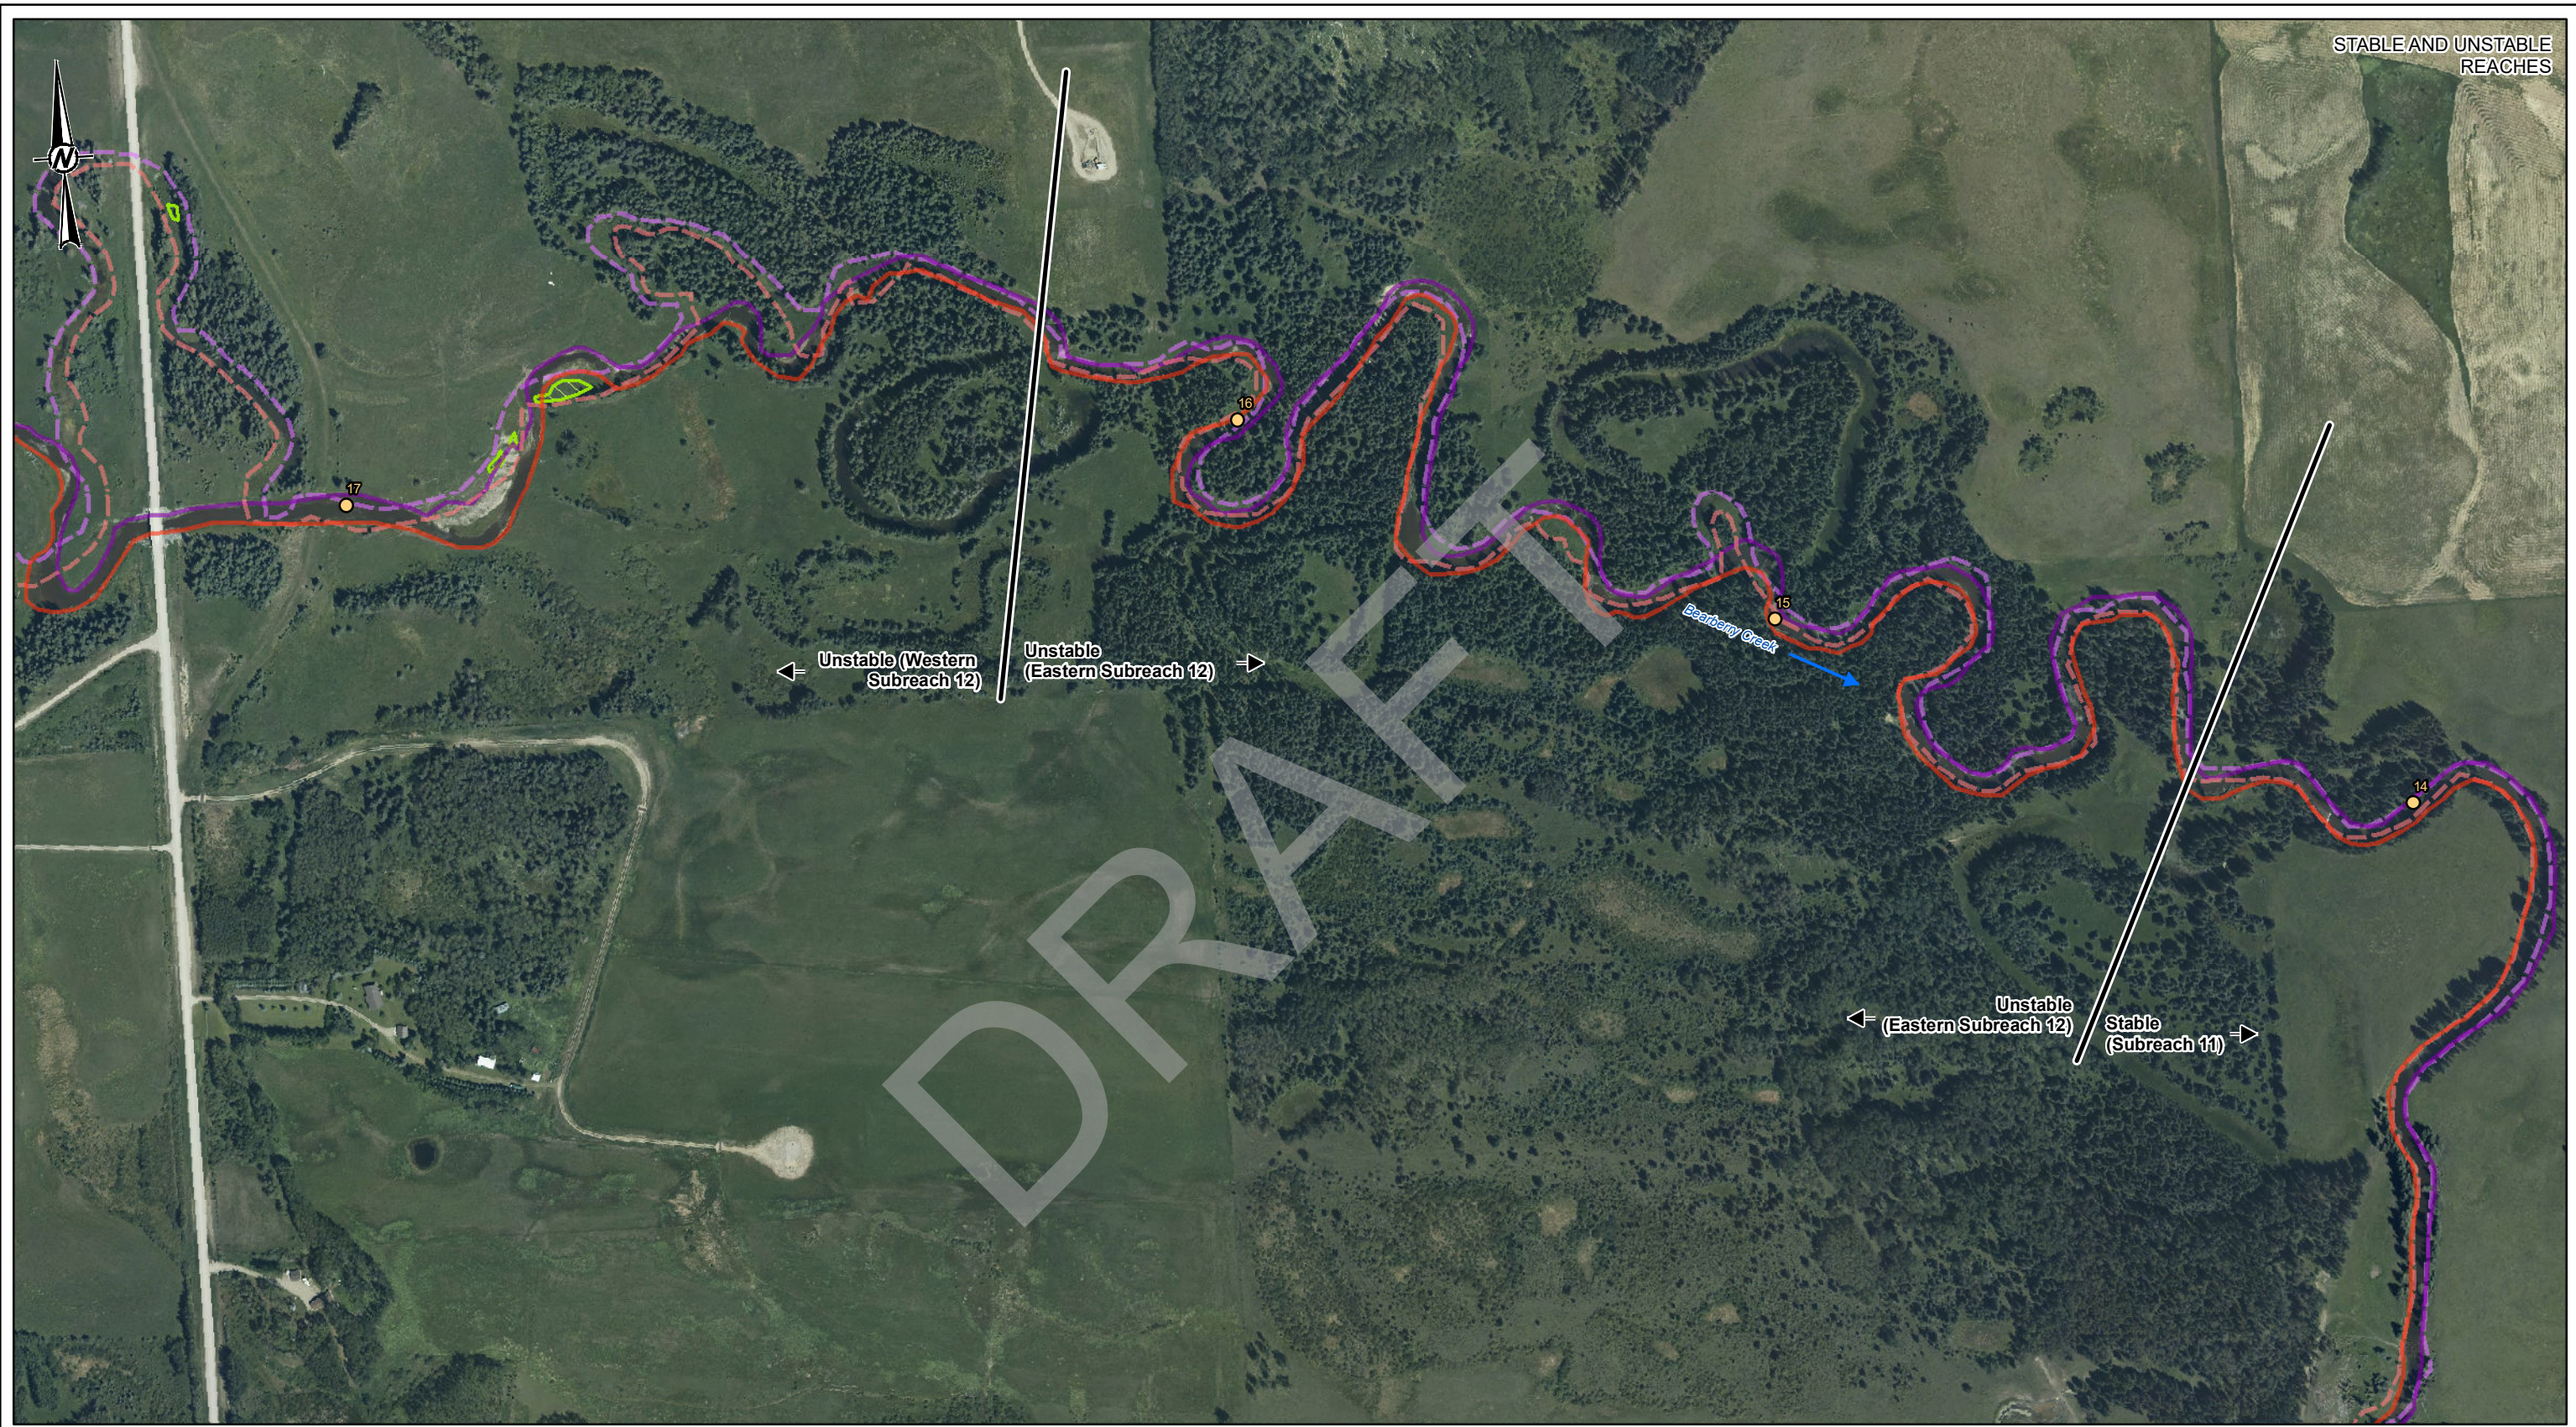
TITLE
CHANNEL BANK COMPARISON OF REACHES 11 AND 12 - BEARBERRY CREEK UPSTREAM OF STN 14+200

Reach 11 of Bearberry Creek is characterized by a single-threaded, meandering channel with a low sinuosity, and the channel alignment has remained approximately stable over the observed period. There are no apparent bars or islands present. This reach is considered stable.

Reach 12 of Bearberry Creek is single-threaded with a torturous meandering planform. Extensive migration at meander bends as well as avulsion due to meander bend cut-off were frequently observed. Islands and side bars are rare. This reach is considered unstable.

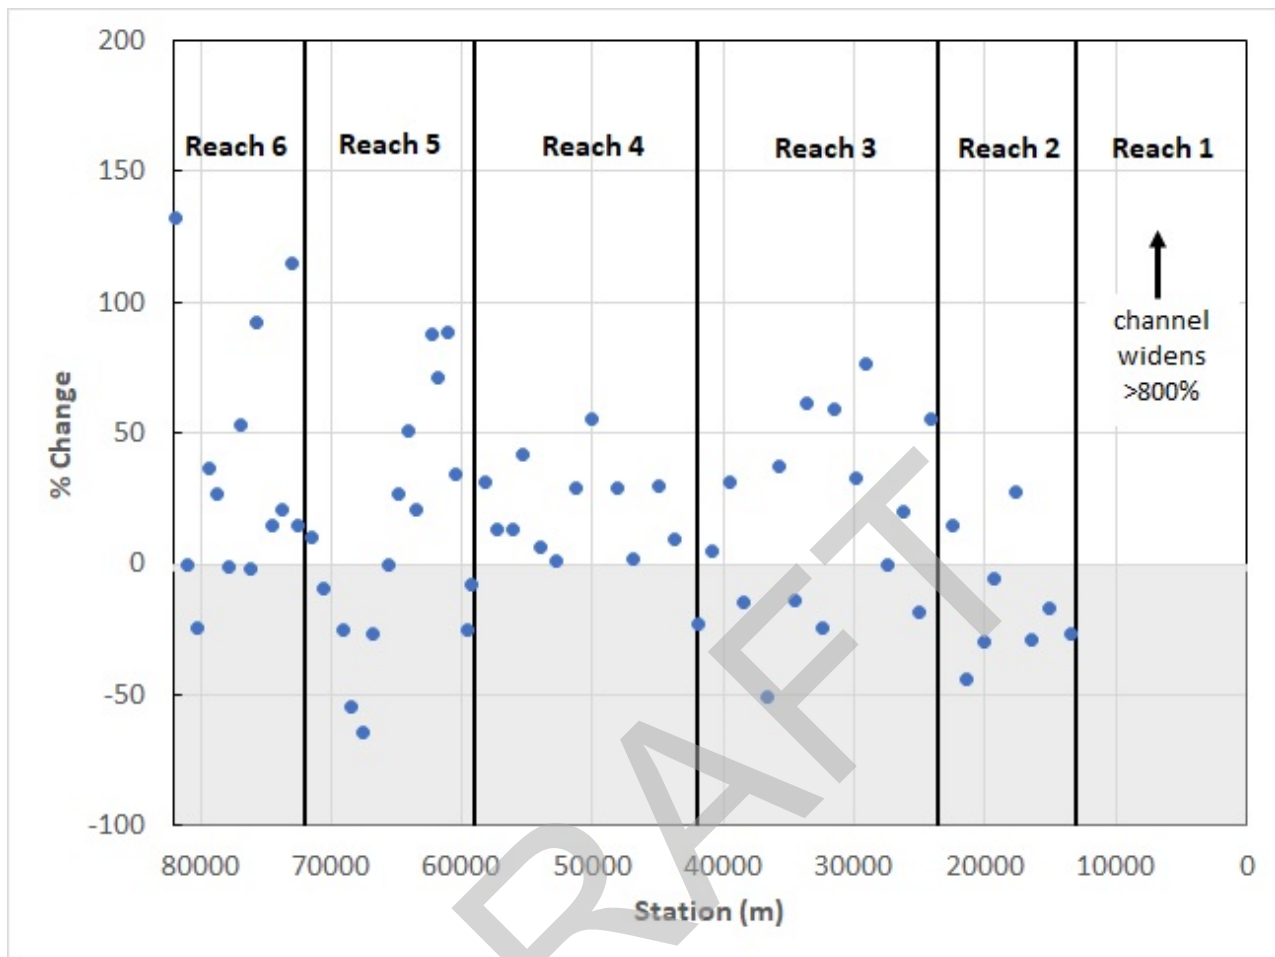
Figure 15: Change in active channel width on Upper Red Deer River, early 1960s-2018. The active channel width is defined as the sum of all portions of the channel that are not fully vegetated.

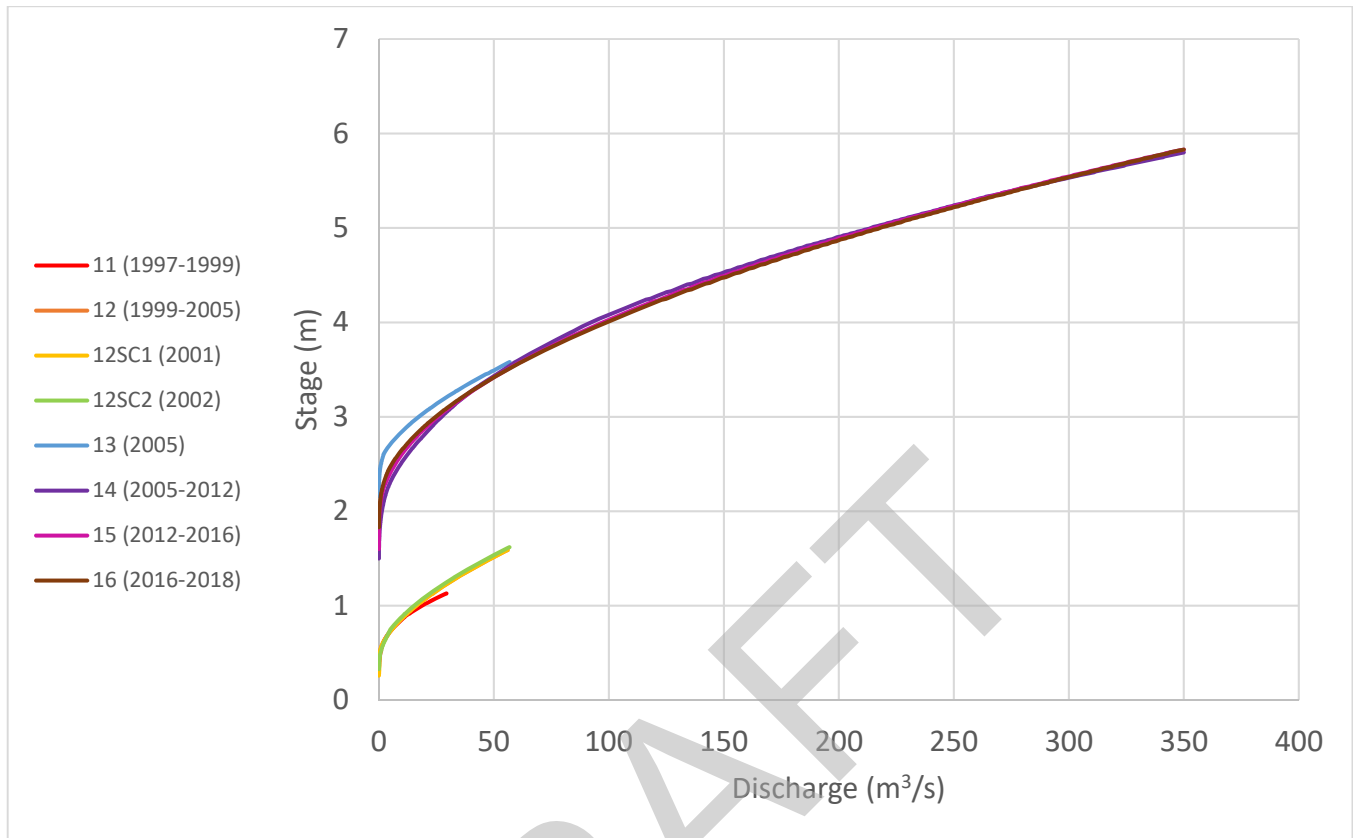
Figure 20: Rating curves for Bearberry Creek near Sundre

Between 2005 and 2012, the stage lowered relative to discharge. This suggests that either channel degradation or channel widening occurred. The consistent channel lowering identified in the thalweg data suggests that degradation is the likely cause for the rating curve shift.
