## APPROACH FILL DESIGN OF NORTH SASKATCHEWAN RIVER BRIDGE

A.F. Ruban, EBA Engineering Consultants Ltd., Edmonton, Alberta, Canada

### ABSTRACT

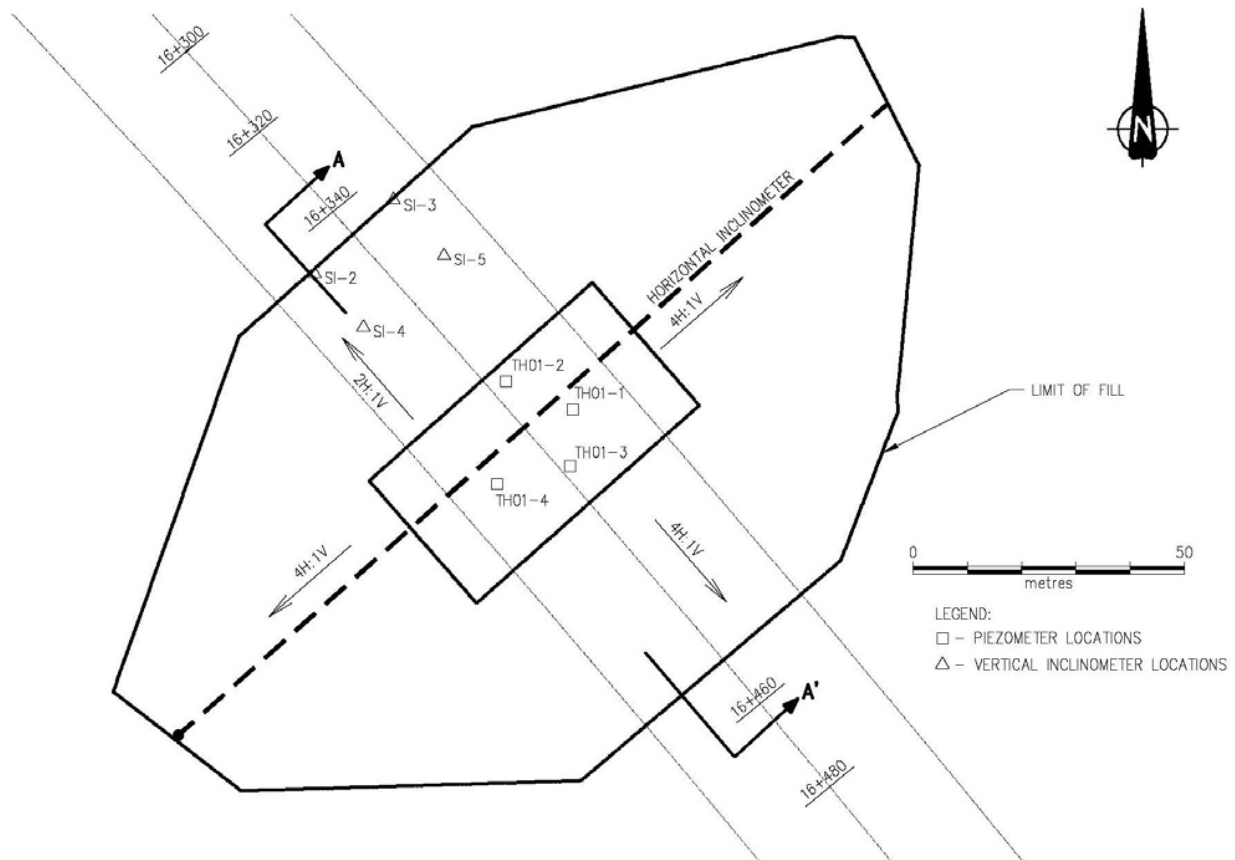
Figure 4. Test Fill Instrumentation Layout

The test fill was constructed to coincide with the footprint of the roadway embankment for the east approach fill. To ensure that the test fill did not generate a deep-seated failure in the bedrock, it was decided to maintain the toe of the test fill approximately 50 m from the riverbank. Sideslopes of the test fill of 4H:1V were proposed with a headslope of 2H:1V. Figure 4 presents a plan of the proposed test fill and the instrumentation, which included: eight pneumatic piezometers in the bedrock, eight pneumatic piezometers in the floodplain deposits, eight pneumatic piezometers in the embankment fill, one horizontal inclinometer, and four vertical inclinometers.

Instrumentation was installed at strategic times during the fill construction. Prior to fill placement eight pneumatic piezometers were installed in the native floodplain deposit and eight pneumatic piezometers in the underlying bedrock. Piezometer leads were extended to the north side of the test fill to a readout box. The lower portion of the test fill was placed to a height of approximately 1.5 m, at which time a trench was constructed across the middle of the test fill for the installation of a horizontal inclinometer, which was installed to monitor the settlement of the test fill.

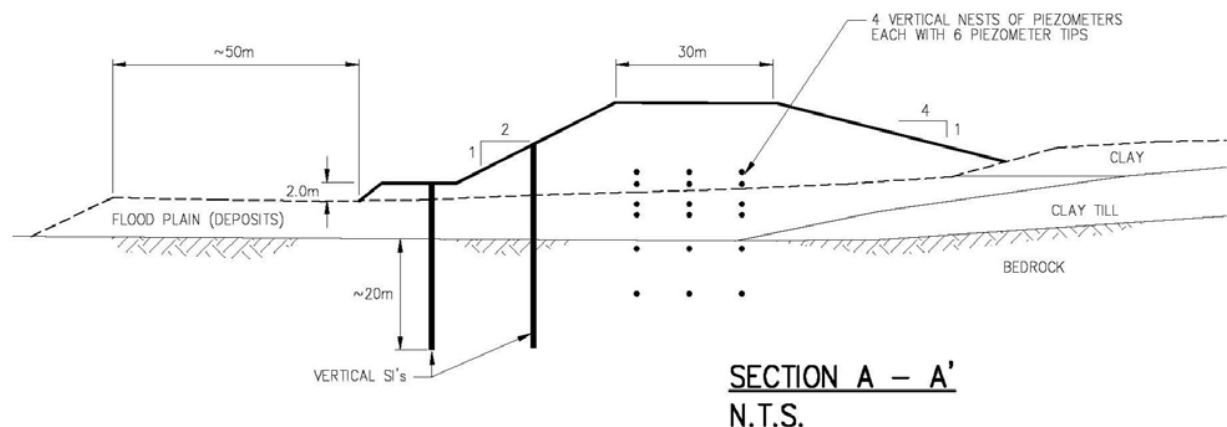
Figure 5. Section for Test Fill Instrumentation

Two vertical inclinometers were installed near the toe of the test fill to a depth of approximately 20 m into bedrock. With the fill height at approximately 3 m, eight "drive point" pneumatic piezometers were installed within the embankment fill. The final two vertical inclinometers were installed when the fill height reached approximately 8 m. Figure 5 presents a section through the test fill illustrating the piezometer tip locations and vertical inclinometers.
