The use and limitations of modern technologies for slow, vegetated landslide monitoring – Chin Coulee Landslide

Evan Deane, Renato Macciotta, Michael Hendry
University of Alberta, Edmonton, AB, Canada
Chris Gräpel
Klohn Crippen Berger, Edmonton, AB, Canada
Roger Skirrow
Alberta Transportation, Edmonton, AB, Canada

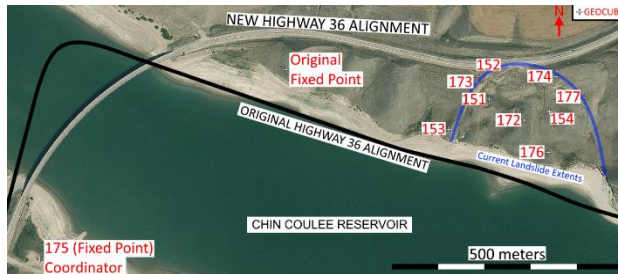
Figure 8. GPS Unit Location on Chin Coulee (base imagery from ESRI, 2019)

A differential GPS system consisting of ten Geocubes™, an all-in-one differential GPS system, was installed on the Chin Coulee landslide. This system is similar to systems previously installed on the 10-Mile and Ripley slide in British Columbia (Rodriguez et al., 2018) and consists of a coordinator, which acts as a central processing hub for the system, a “fixed point”, and nine mobile points strategically placed around the landslide. Figure 8 shows the location of the ten GPS units, as well as the coordinator. The “fixed point” and coordinator are approximately 950 m away from the remaining GPS units.

The GPS system on Chin Coulee was installed in June of 2018 and continuous recording began on July 11th, 2018, following relocation of the fixed point (see Figure 8).

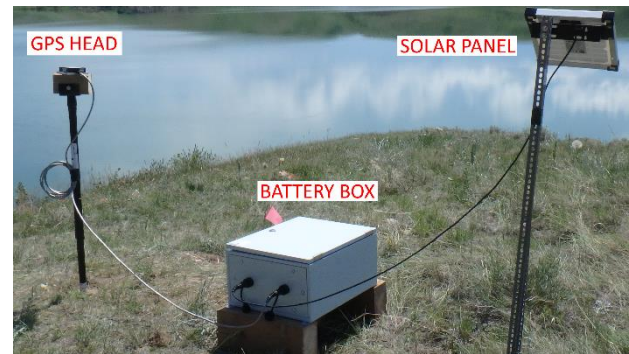
Figure 9. GPS and Battery Box Setup on Chin Coulee

Previous differential GPS system installations on 10-Mile slide and Ripley slide employed the use of slotted steel angle for GPS posts, however on Chin Coulee, hand augered deck screw piles were used. Each GPS unit was equipped with a 10-Watt solar panel and two 12-Volt, 100 Ah batteries. This power setup ensured that system power would be available all year round. Figure 9 shows a typical GPS and battery box setup.

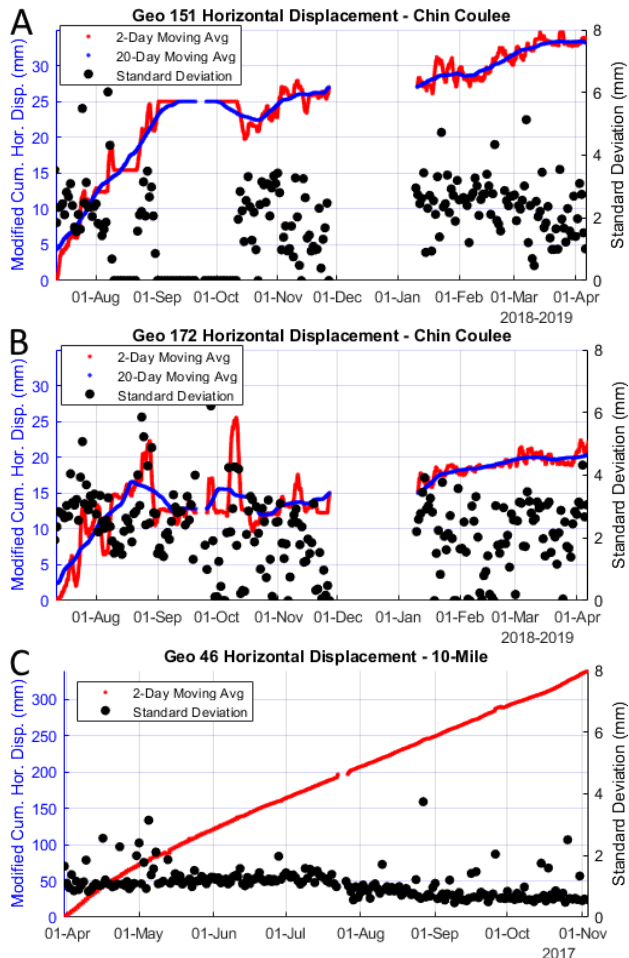
Figure 10. GPS 151 (A) and 172 (B) on Chin Coulee and GPS 46 (C) on 10-Mile

GPS systems have an inherent limit in point accuracy due to atmospheric and local effects. For the GPS units used on Chin Coulee, 10-Mile, and Ripley slide, the manufacturer specified precision is typically 1 – 2 mm (Ophelia-sensors, 2018). Based on a 24-hour moving window, standard deviation of Northing and Easting is typically 1 – 2 mm on 10-Mile. On Chin Coulee, a 24-hour moving window has a standard deviation of 2 – 4 mm (black scatter points in Figure 10).

Figure 10 highlights the varying levels of movement and standard deviation of movement in three GPS units on Chin Coulee and 10-Mile. 10-Mile slide data runs from April to November of 2017. Chin Coulee data was taken from a 9-month data set running from July of 2018 to April of 2019, notably a longer data set than LiDAR data comparisons shown in later sections.

Displacement values shown in these plots are not a standard cumulative displacement. Displacement is determined by computing the Euclidian distance from the initial position to the current position. As such, negative movements are possible in the case of movement back towards the initial position.

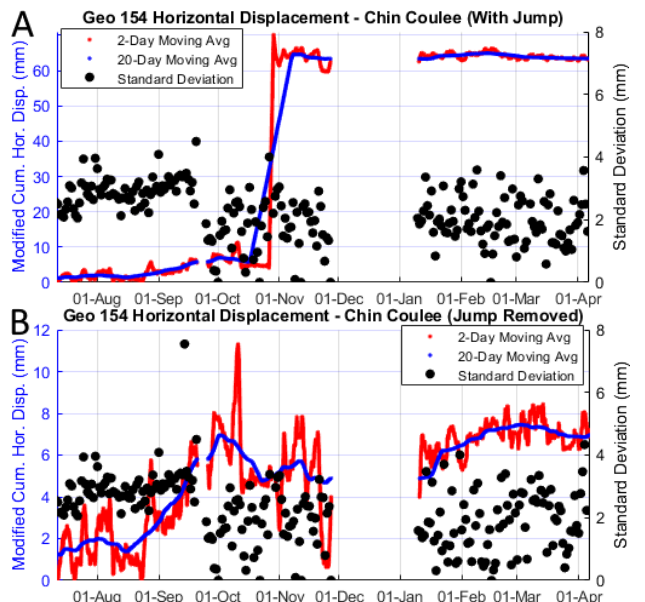
Figure 12. GPS Unit 154 on Chin Coulee (A) With Jumps (B) Jumps Removed

These events impact the expected magnitude of yearly displacement for Chin Coulee, and lead to inaccuracies in displacement direction. Figure 12 and Figure 13 show such jumps on GPS units 154 and 174 on Chin Coulee. Similar jumps were present on GPS units 153 and 176.

Removal of these jumps was completed by removing data from the beginning of the sudden movement until the end of the sudden movement and fitting the remaining data to the same value. Displacement vectors associated with the corrected GPS movement data is shown in Figure 14. Removal of these jumps leads to a much more consistent amount of movement throughout the slide and eliminates movement in unexpected directions from all but GPS unit 177, which did not contain any jumps in the data set.

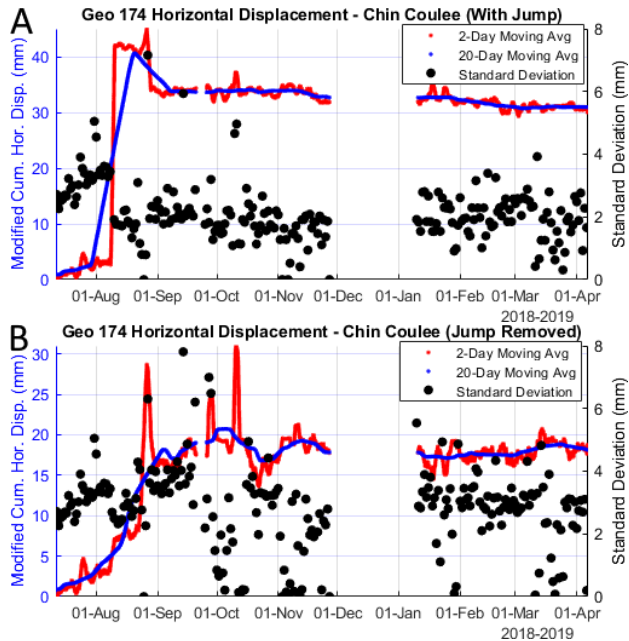
Figure 13. GPS Unit 174 on Chin Coulee (A) With Jumps (B) Jumps Removed
