**EFFECT OF COAL CONTAMINATED
AGGREGATE ON ASPHALTIC CONCRETE
PAVEMENT PERFORMANCE**

**Vishnu A. Diyaljee
Assistant Director
Geotechnical Services Section
Materials Engineering Branch
4th Floor, Twin Atria Building
4999 - 98 Avenue
Edmonton, Alberta
T6B 2X3**

Transportation Research Board

68th Annual Meeting

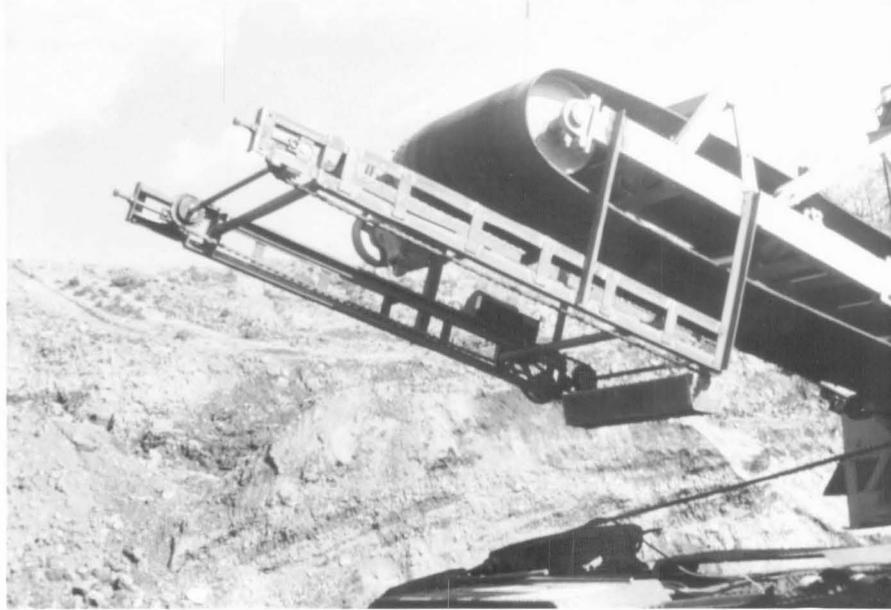
Figure 2: Section of Workable Pit Area

3. The area identified for quarrying was a narrow bank of high ground at the east fringe of the pit area. The workable gravel seam was 2 to 4 m in thickness and was located below 6 to 8 m of clay overburden. Medium to coarse sand existed below the gravel. Figure 2 shows a section of the workable pit area.

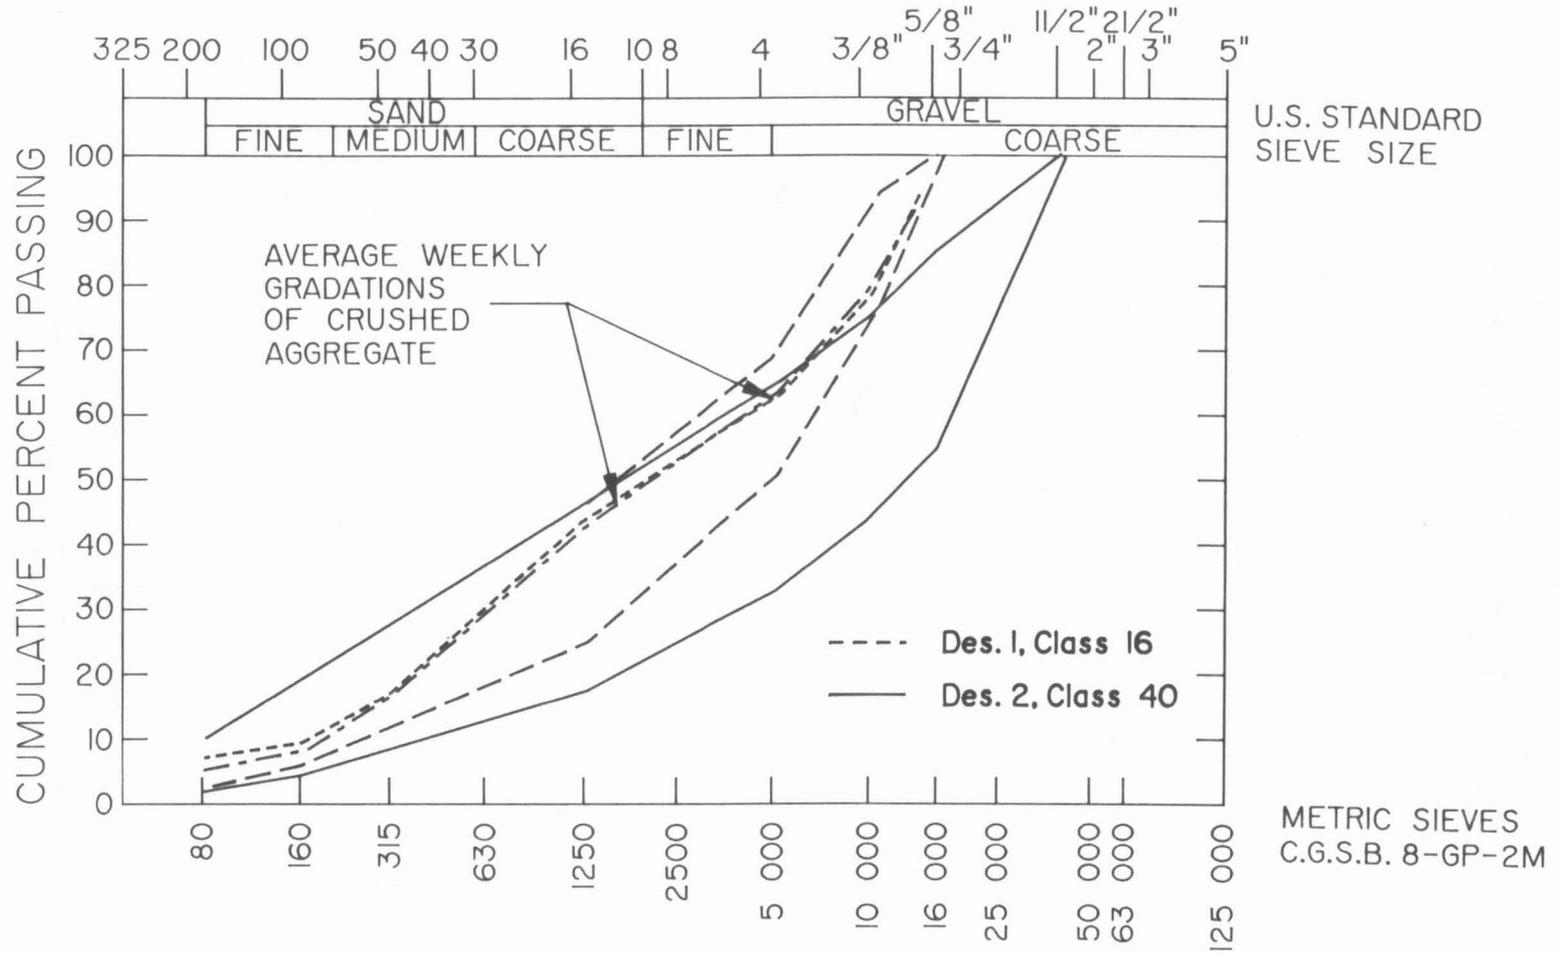
Figure 3: Aggregate Gradation Specifications

Production of Designation 1 Class 16 material from the contaminated source resumed on October 7, 1983. The Supplier continued to produce and "all-in" aggregate satisfying the gradation and fracture specifications. The weekly average gradation up to the completion of crushing is shown on Figure 3.

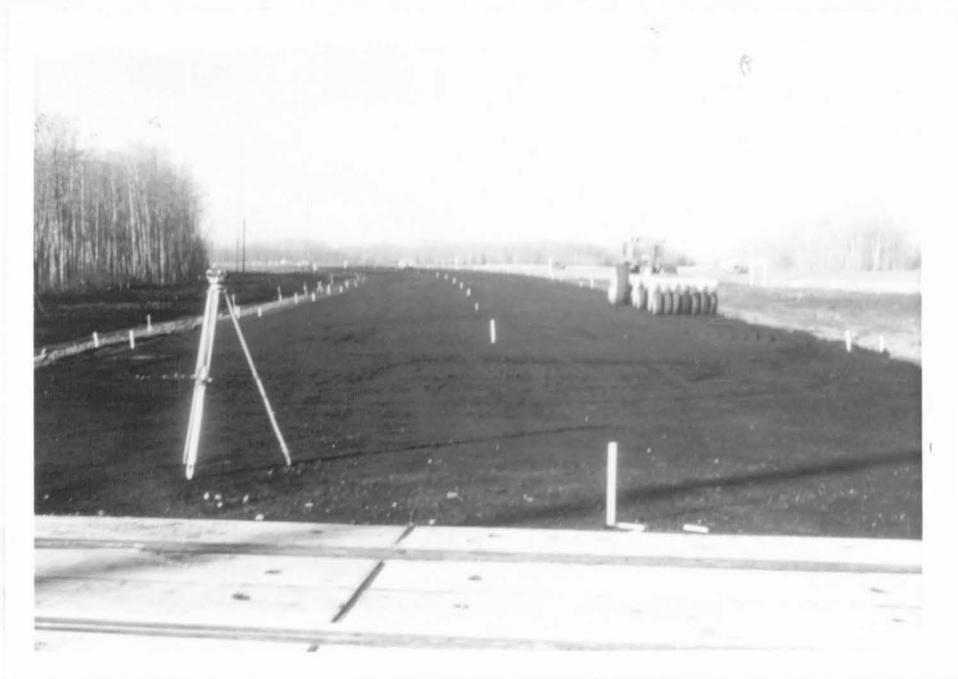
The inspection of the aggregate stockpile revealed the presence of finely divided particles of coal which gave the stockpile a very dark appearance resembling from a distance an oilbound aggregate stockpile. Figure 4 shows the appearance of the Designation 1 Class 16 material when laid as base course on the roadway.

Figure 4: Appearance of Designation 1 Class 16 Material as Base Course

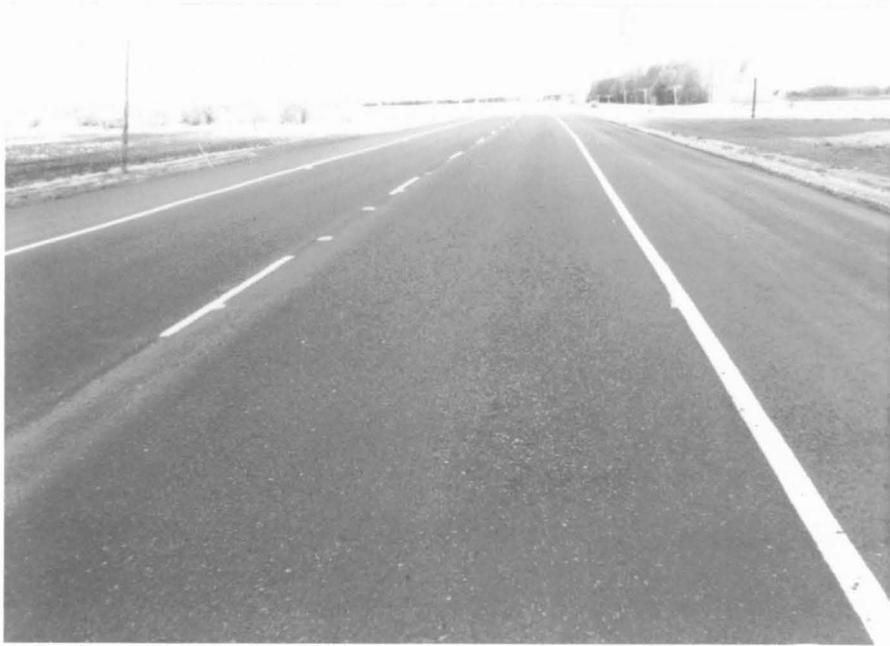
The loss of fine aggregate was evident throughout the entire roadway length. This loss gave the pavement a very coarse textured appearance which was very pronounced along wheel paths and at the intersection of Hwy. 28:04 and SR 827:02. The appearance of the pavement resulting from this loss of fine aggregate is illustrated by Figure 5.

Figure 5: Pavement Surface Texture Due to Loss of Fine Aggregate

On May 7, 1984, a further inspection of the roadway was undertaken by the Department's Surfacing Consultant. Based on his observations, it was recommended that SR 827:02 and SR 644:02 should be fog sealed immediately with an SS-1 emulsion at an effluent rate of 0.5 kg/m^2 . Further, it was recommended that all roadways should be scheduled for seal coating in the 1985 construction program.

Fog sealing of the secondary roadways was done in June 1984 with the application of the single surface treatment to all roadways during May-June 1985. Prior to the application of the surface seal coat to Hwy. 28:04, the slipped areas were removed and repaved. Since the application of the seal coat no further surface distress has been reported.

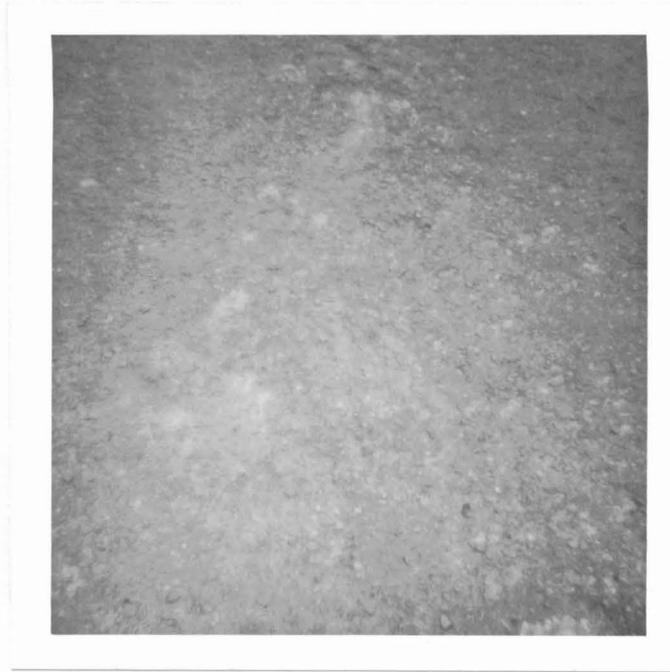
The loss of coarse aggregate particles from the pavement surface giving the mat a pitted or pock-marked appearance was also quite evident. This distress manifestation was distinct from the loss of fine aggregate and from the ravelling that occurred at the tapers. On close visual and surficial examination of the pavement it was found that some of the coarse aggregate particles could be readily removed with a penknife using moderate pressure. Some of these particles were associated with poor aggregates such as chert and clay ironstone, typically found within the Saskatchewan gravels. Figure 6 depicts the pitted or pock-marked appearance of the pavement surface.

Figure 6: Pitted or Pock-marked Appearance Due to Coarse Aggregate Loss

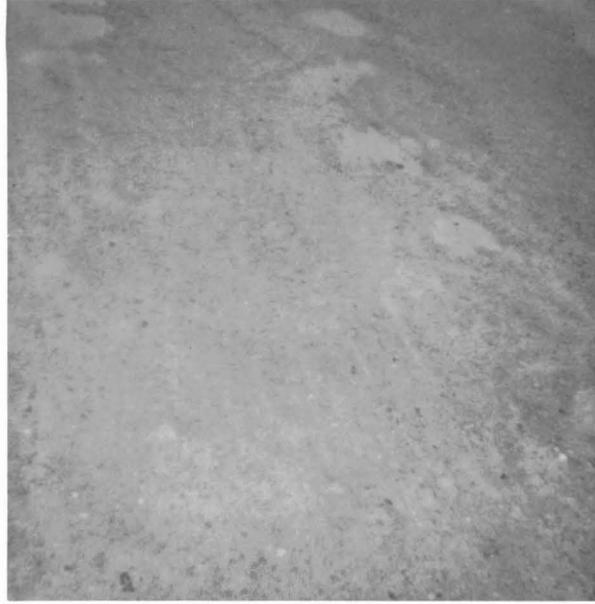
In the Town of Thorhild the loss of fine aggregate was extremely severe resulting in a very rough textured pavement surface as shown by Figure 7. Random pavement cracks, similar to those observed on Hwy. 28:04, were also observed at isolated sections.

Figure 7: Severe Ravelling

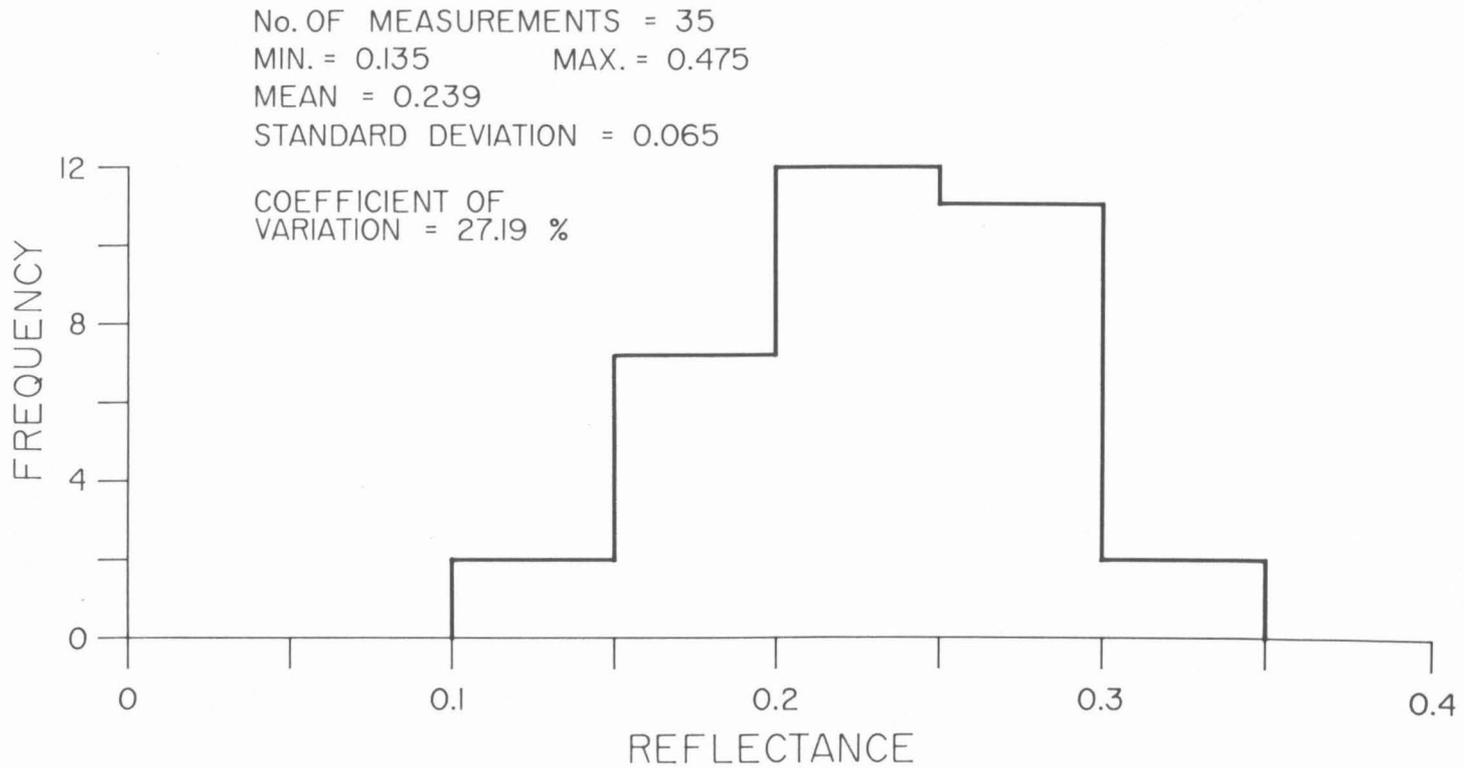
Figure 8: Reflective Diagram - Coal Petrography

The results of the petrographic analysis are summarized in Figure 8 as a plot of frequency versus reflectance. This data was obtained from a 35 point vitrinite analysis. As shown, the reflectance ranges from a minimum of 0.135 to a maximum of 0.475 with a mean of 0.239. On the basis of these results the coal can be ranked as "peat" according to the German and North American (ASTM) classifications. A characteristic feature of the rank of this coal is its bed moisture which is about 75%.
