HIGHWOOD RIVER

Channel Stability Assessment

Report Number: 1536669.7000_Rev.0

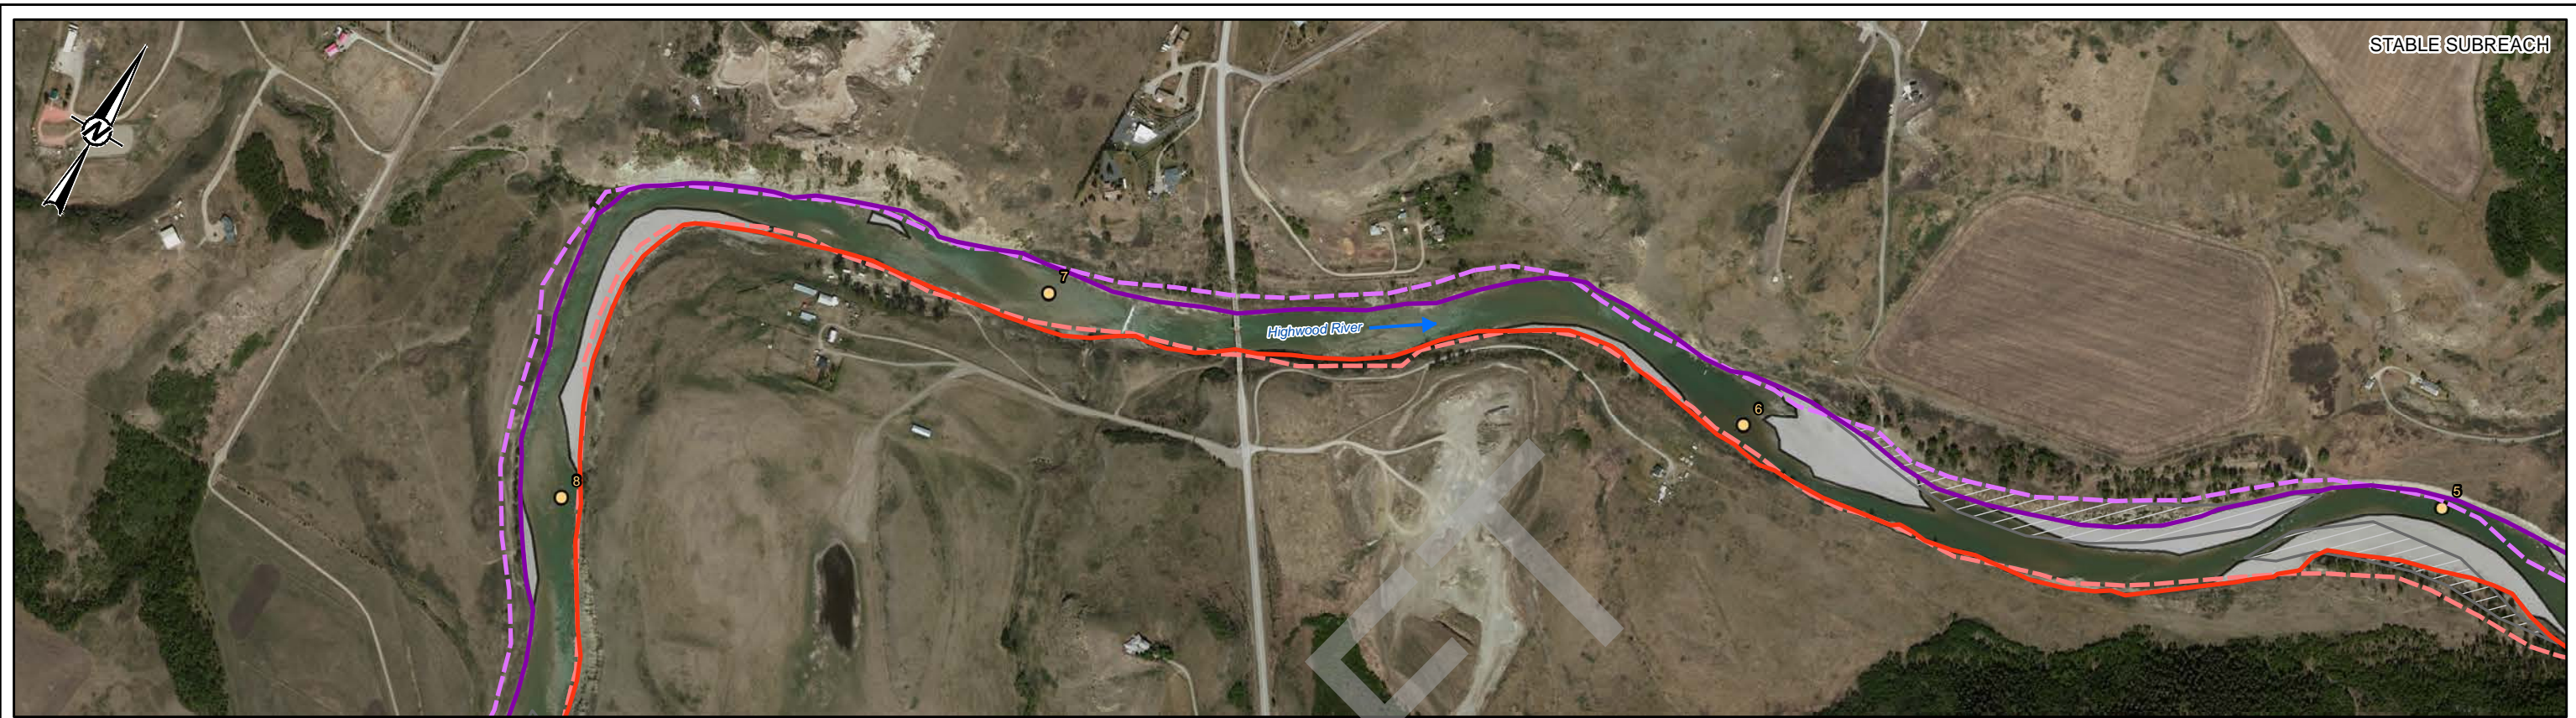
PROJECT
SHEEP RIVER TO BOW RIVER CONFLUENCE CHANNEL BANK COMPARISON - REPRESENTATIVE SUBREACHES

STABLE SUBREACH

UNSTABLE SUBREACH

- Reach 1 is typically defined by a stable planform with limited areas of instability. A representative portion of Reach 1 stable sub-reach is shown in Figure 3. This sub-reach shows limited lateral migration of the channel. Several point bars are present in both the historical and current datasets with more side bars present in the 2016 dataset. The observed historical point bars have typically expanded slightly and shifted slightly downstream to their current positions.

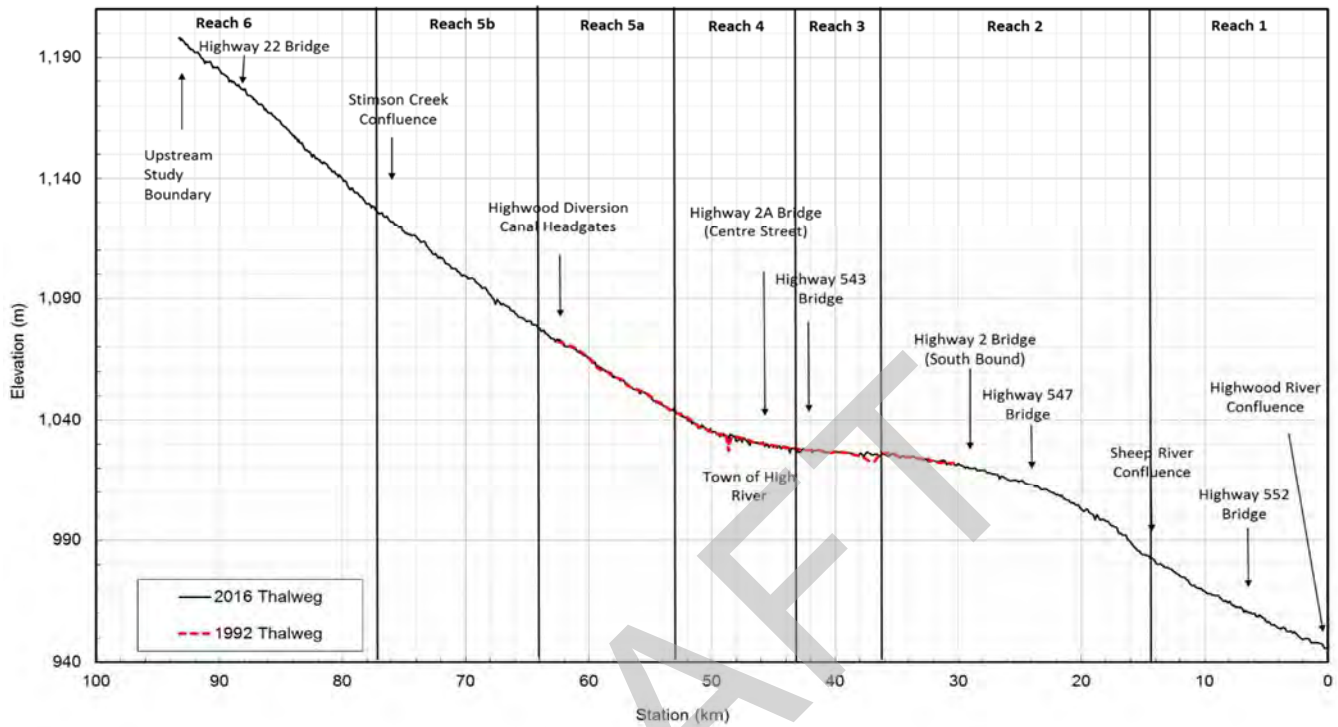
Figure 12: Highwood River Thalweg Comparison

According to Ritter et al. (1995), thalwegs exhibiting a concave-upward profile shape are typical of a stream reach in equilibrium. Figure 11 shows an example of a typical concave-upward thalweg for comparison. The plots for both the 1992 and 2016 thalwegs do not follow a monotonically decreasing concave-upward profile indicative of generally stable conditions. Inspection of the thalweg for each reach suggests that Reaches 1, 5a, 5b and 6 on Highwood River follow a general concave-upward trending profile with slopes typically decreasing in steepness from the upstream boundary to the river mouth. Reach 6 at the upstream boundary has a slope of 0.0045, while Reach 1 at the downstream boundary has a slope of 0.0025. Reaches 2 to 4 do not follow this trend, as shown in Figure 12. Reach 2 with a slope of 0.0019 has a slightly gentler slope than Reach 1, but steeper than Reach 3. Detailed inspection of the thalweg along Reach 3, shows a highly undulating river bed which trends downward at a very gentle slope of 0.0003. Reach 4, has a slope of 0.0015 and also has a highly undulating bed.

The observed deflection of the thalweg profile along these three reaches suggests the potential for a stream not in equilibrium and/or subject to instability from the community of High River downstream to the Sheep River confluence. The presence of a region of decreased slope from the Highway 2A Bridge (km 48.7; Reach 4) to the Highway 2 Bridge (km 30.7; Reach 2) suggests that this reach is prone to aggradation and channel instability due to the reduced capacity to transport sediment through the flatter slope section between the steeper upstream reaches to the steeper downstream reaches. This is evident in areas of net bed accretion as shown in Figure 13 from approximately km 32 to 34 and km 38 to 40.

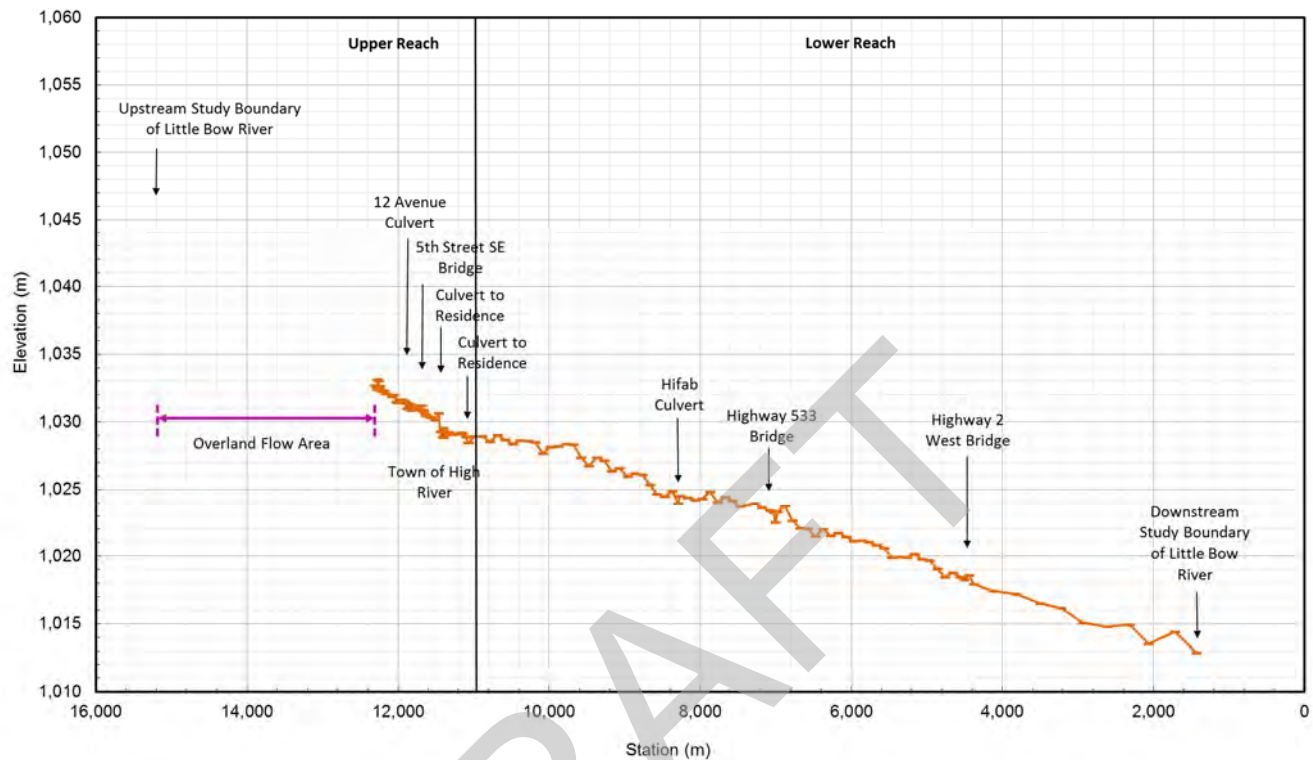
Figure 14: Little Bow River 2016 Thalweg

A thalweg comparison could not be conducted for Little Bow River, but the 2016 surveyed thalweg is shown in Figure 14. Little Bow River originates in the Town of High River and flows towards the south. Water in the river is redirected from Highwood River into Little Bow Canal which discharges into the main channel at approximately Km 11 (as shown in Figure 2e and Figure 10). The slopes for the upper (Reach 8) and lower (Reach 7) reaches are 0.0031 m/m and 0.0016 m/m, respectively. The undulating thalweg morphology with an approximately linear (consistent) slope within the study area (see Figure 14) suggests that this channel could be non-alluvial, where the river channel has not developed in sediments carried by the river itself, or a former outwash channel shape. If the latter then the channel slope and thalweg profile could be relict features of processes no longer operating in the modern environment.

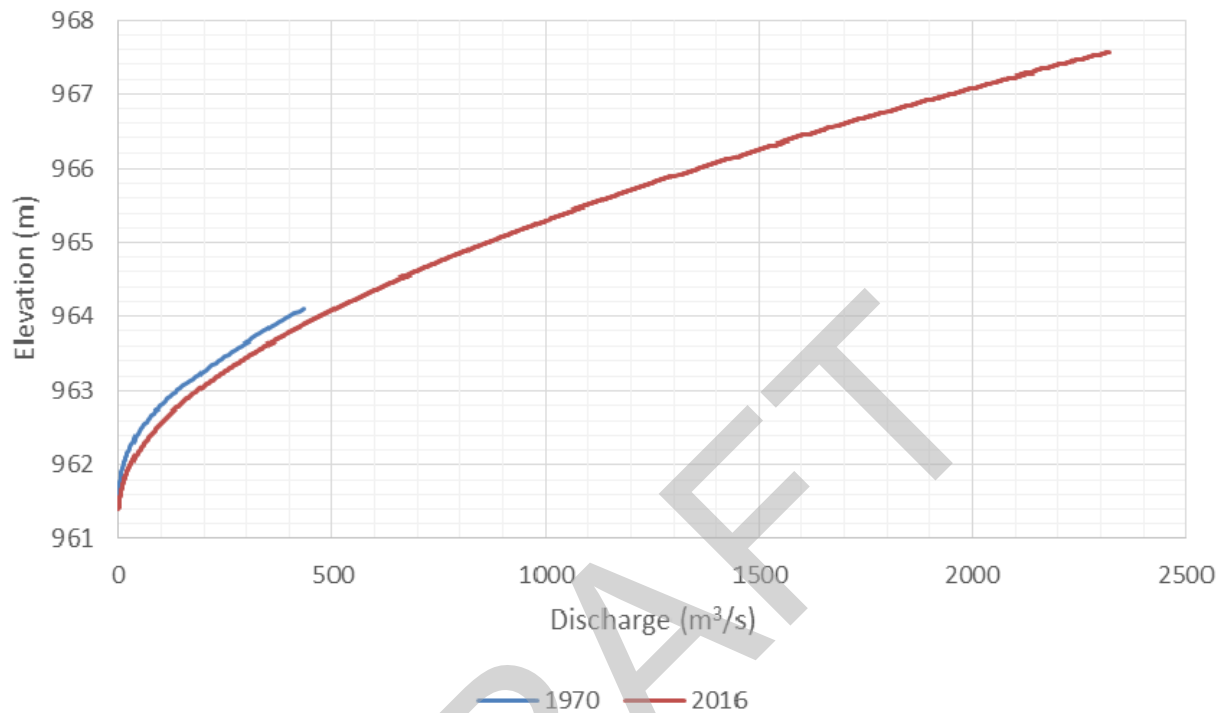
Figure 16: Highwood River near the Mouth (Station 05BL024)

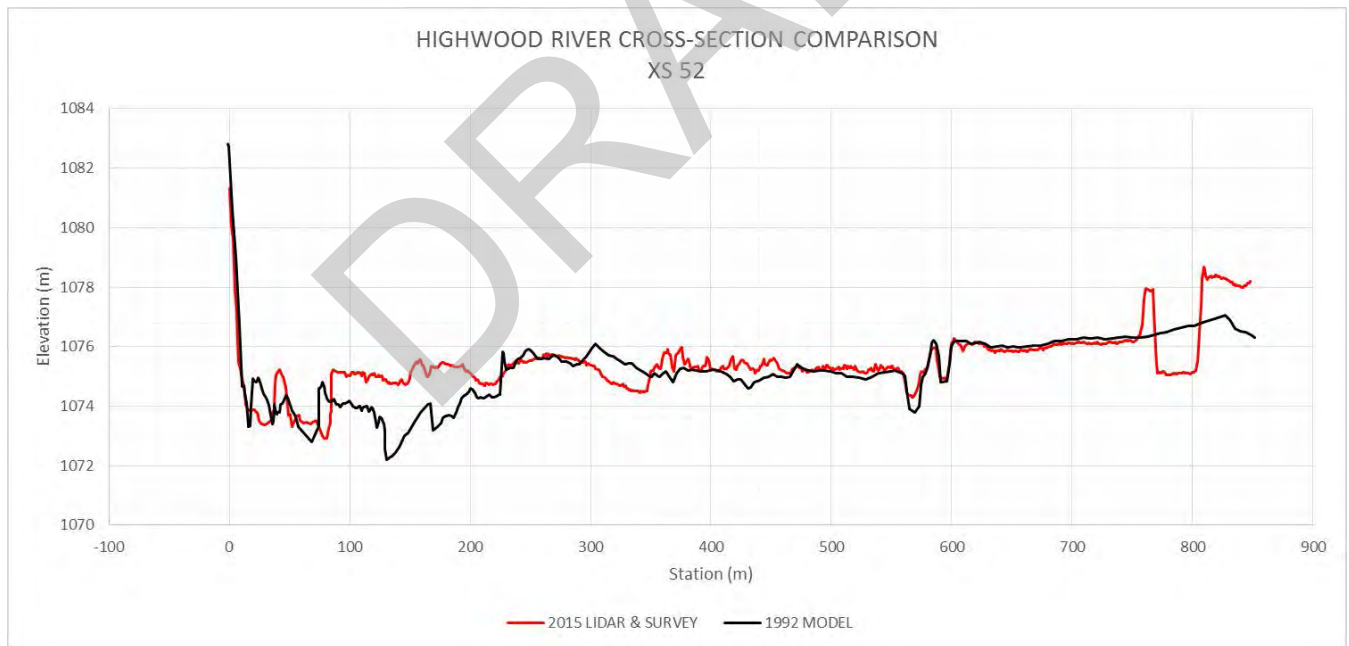
Figure A28: Highwood River Cross-Section 52 Comparison: 1992 Model and 2015 LiDAR and Survey.
