HIGHWAY 63:11 TWINNING NORTH OF ATHABASCA RIVER BRIDGE IN FORT MCMURRAY, ALBERTA: PINCH POINT WEST PILE WALL

Tarek Said Abdelaziz, Donald Proudfoot

Thurber Engineering Ltd., Edmonton, Alberta, Canada

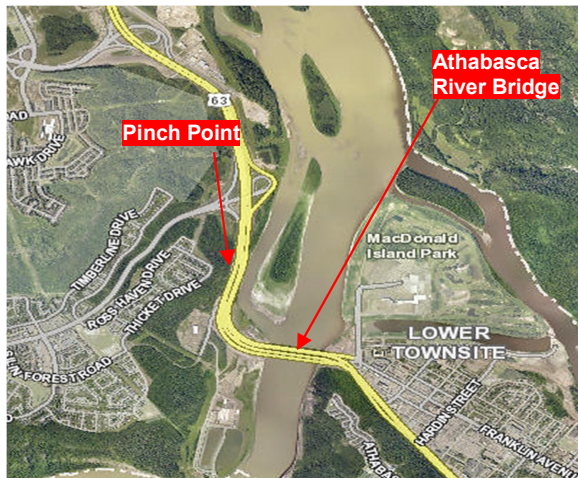
Figure 1. Satellite image showing site location

eroded bank of the Athabasca River to the east. This existing geographic constraint created a physical “Pinch Point” that governed the highway upgrading design. Figure 1 presents a satellite image of the project site.

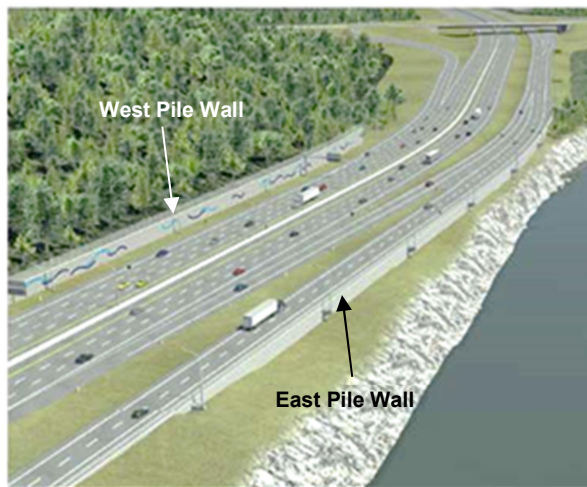
Figure 2. Artistic depiction of upgraded Hwy 63 and East and West Retaining Walls, looking north

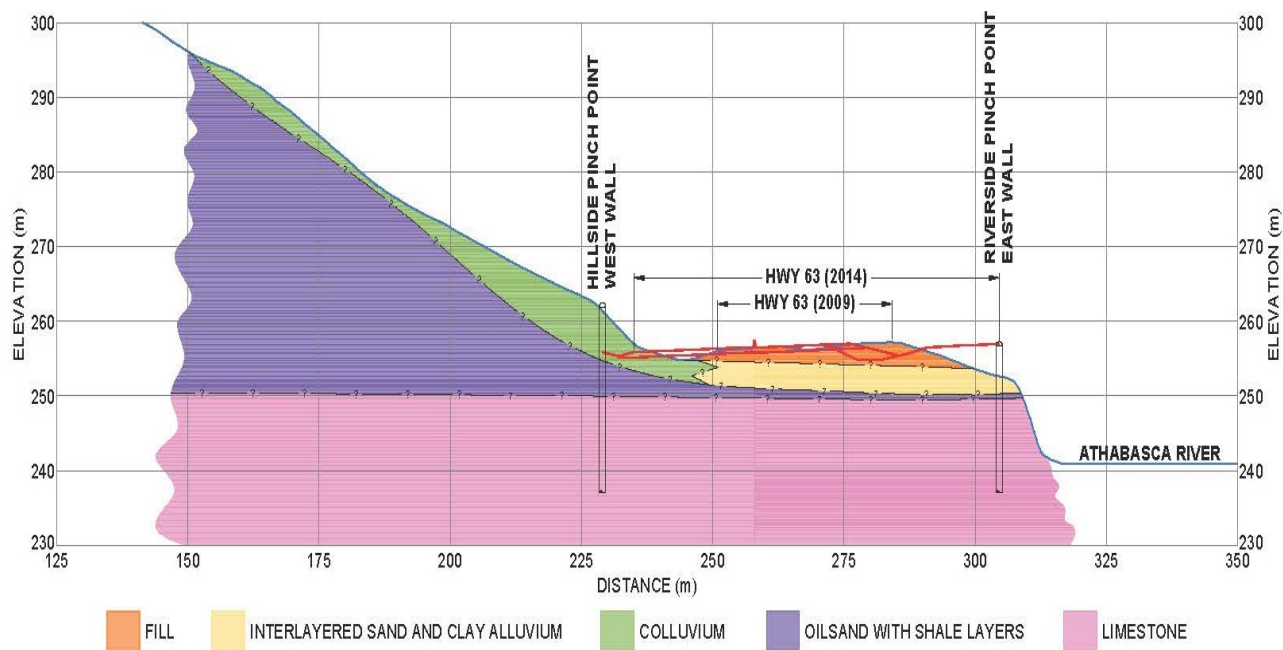
Figure 4. Simplified stratigraphic cross section at the Pinch Point location

A geotechnical investigation, consisting of auger and core holes and installation of slope inclinometers and piezometers, was carried out by Thurber Engineering Ltd. between 2006 and 2008. The study characterized the sub-surface conditions and provided design recommendations for the walls. A shaded relief plan showing the old and upgraded highway alignments and the wall locations is presented in Figure 3. A simplified stratigraphic cross section at the pinch point location is also presented in Figure 4.

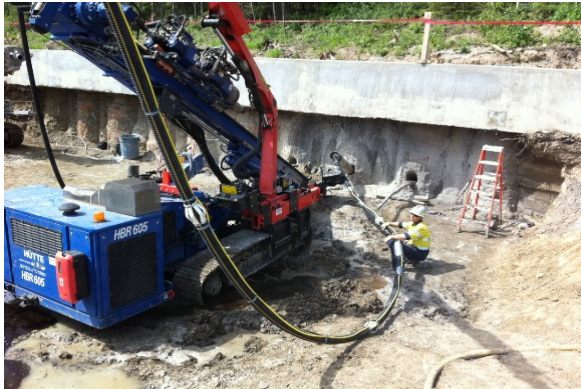
Figure 8. Lowering the stand tendon assembly into the anchor hole

The anchor assembly was lowered into the drilled holes as shown in Figure 8. The production anchors were grouted in two stages. The first stage included grouting the anchor corrugated sheathing in the free zone to about 2 m below the face of the pile, followed by cutting the individual Polyethylene smooth sheathing for each of the strands to 25 mm below the pile face. After completing the lock off, the jack was removed and the second stage of grouting was completed through the grout hole in the bearing plate to fill the annulus between the trumpet and the anchor hole. This process was followed by injecting grease into the trumpet and the installation of a plastic protective cap.

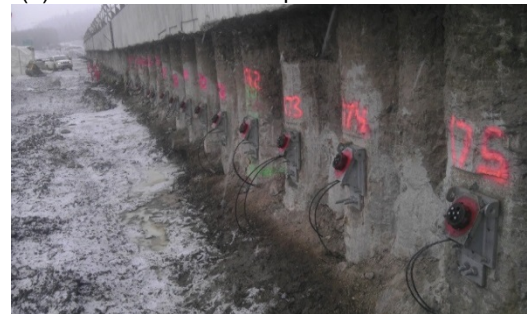
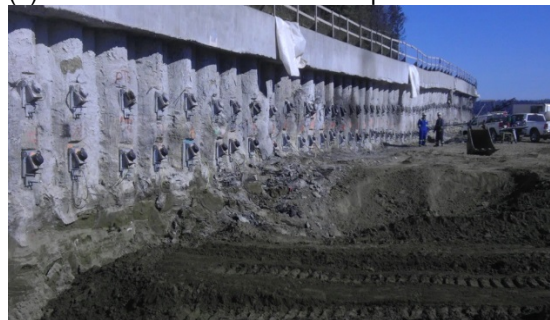
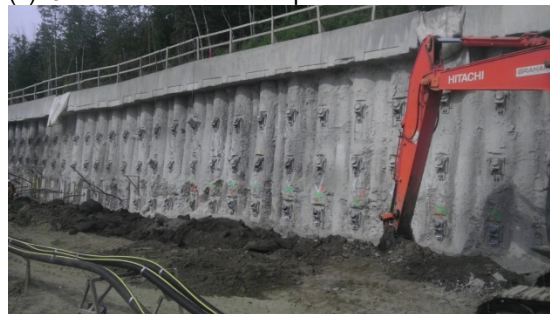
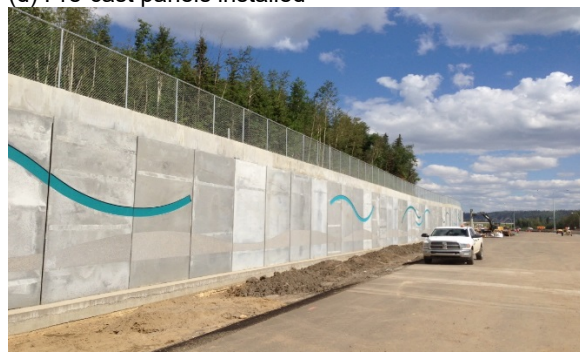
(a) 1st row of anchor completed

(b) 1st and 2nd rows of anchor completed

(c) 3rd row of anchors completed

(d) Pre-cast panels installed

Figure 9. Selected photographs during wall construction

segments of the wall. The difference between the interim lock off load and the wedges seating load was mainly the 6.5 mm seating loss and the thickness of the shims was calculated based on the difference between the final lock off load and the seating load based on elasticity theory. Selected photographs of the wall construction are presented in Figure 9.

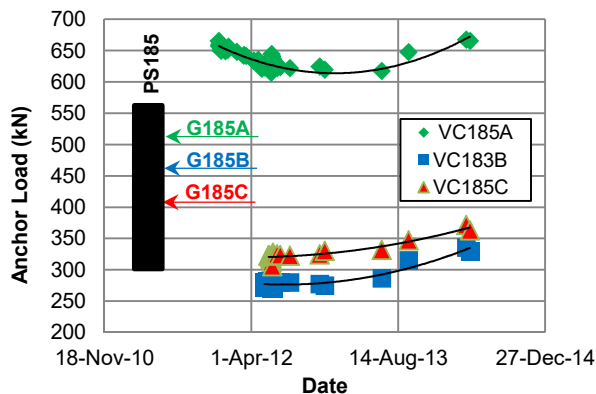
Figure13. Variation in G185A to C load versus time

Figure 13 shows the variation of G185 A to C loads with time. The graph shows that the three levels of anchors were not installed simultaneously. G185A was installed in late 2011 while G185B and C were installed in mid 2012.

G185A displayed a reduction of the anchor load by up to 6 percent prior to locking off G185B. However, the initial reduction in anchor loads has been observed in similar pile wall projects. After locking off all anchors, the anchor

loads increased by 30 to 50 kPa between 2012 and 2014. This indicated that the ground anchors restrained the wall from further downslope movement. Since the lock off loads were about 60 percent of the design loads, there was no concern with regard to the increases in the anchor loads.
