Innovative Structural and Geotechnical Strategies:  
Crossing Unstable River Valleys in Northern Alberta

Paper prepared for presentation at the  
Bridges – Successes: Let's Build on Them (B) Session  
of the 2011 Annual Conference of the  
Transportation Association of Canada  
Edmonton, Alberta

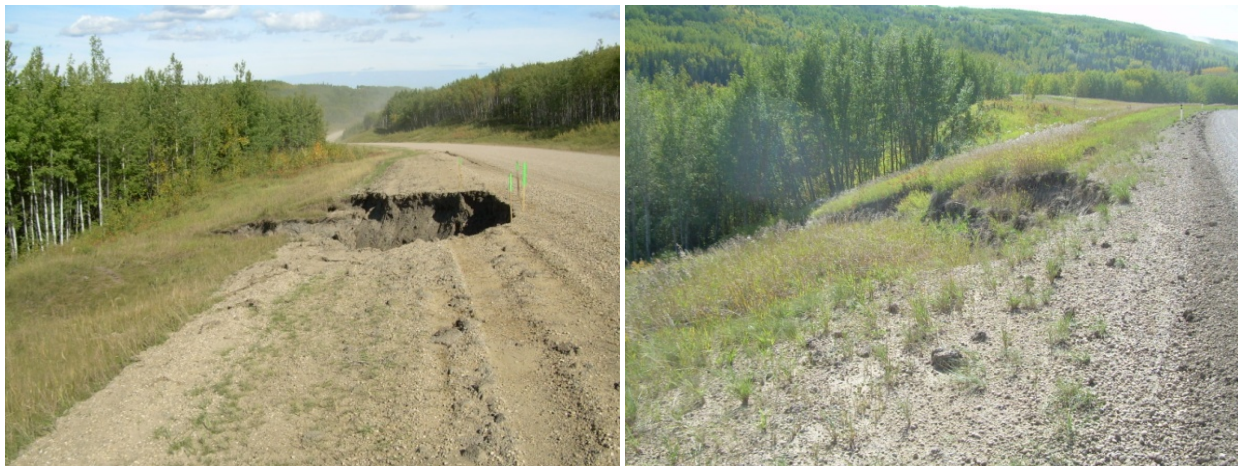
Figure 1: Typical Slides along Existing Highway 727 Requiring Repair

Geotechnically unstable, these valleys have experienced regular slide activities along the highway for over 30 years. Repair and maintenance measures have not been able to resolve the geotechnical instabilities, and slide movements were occurring at an increasing rate. Figure 1 shows examples of typical slides along the existing highway which have required repair. In addition to the slide activities, the existing Ksituan River and Howard Creek culverts below the highway were undersized to accommodate drift, in very poor condition, and prone to log jamming and flooding.

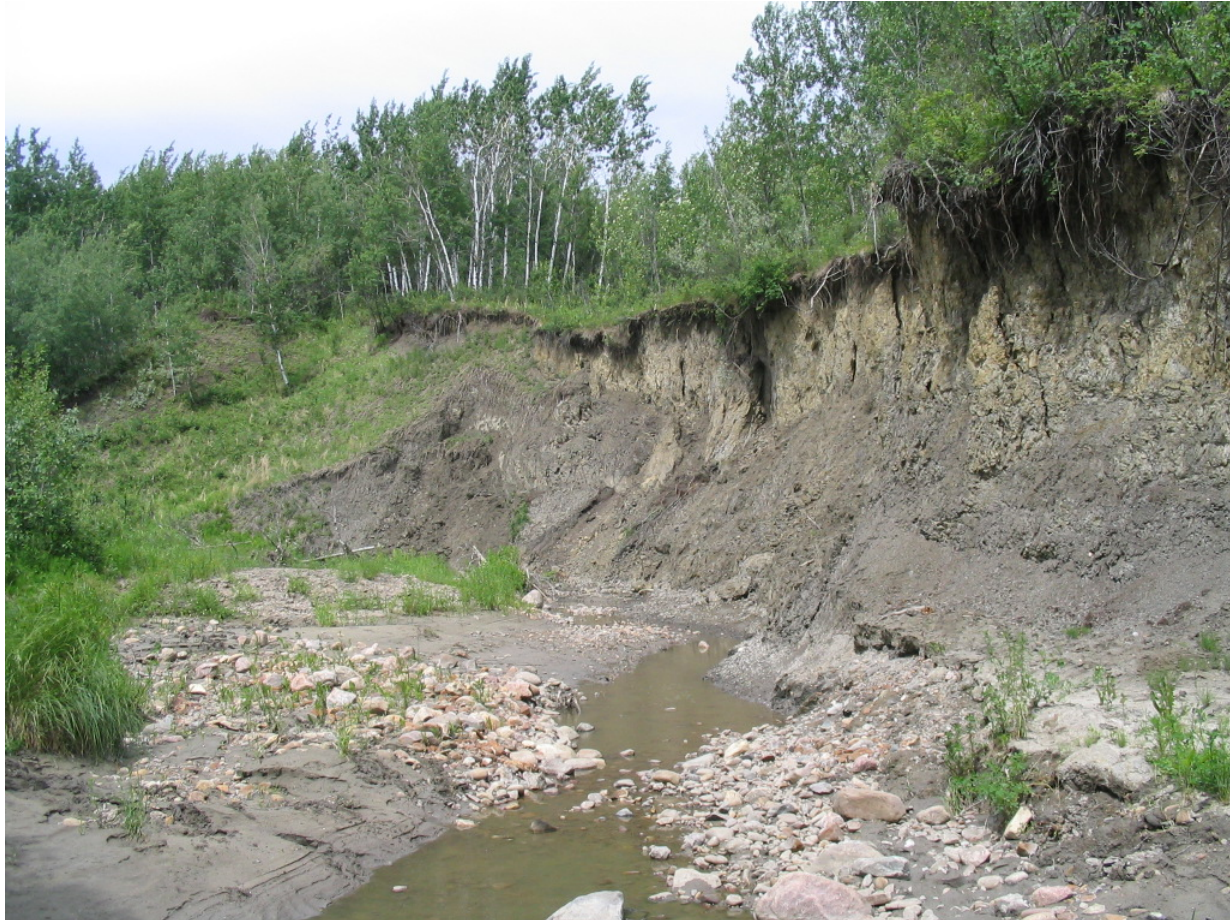
Figure 2 – Existing Site Conditions at Howard Creek

team in 2006. The additional investigation included drilling numerous test holes within the Ksituan River and Howard Creek valleys and the proposed upland approach cut sections. Figure 2 shows the typical site conditions at the Howard Creek prior to construction, including a very steep bank showing evidence of slide failures. Drill rig access to the sites required clearing and construction of access roads, benches, and drill pads in the valley sections.

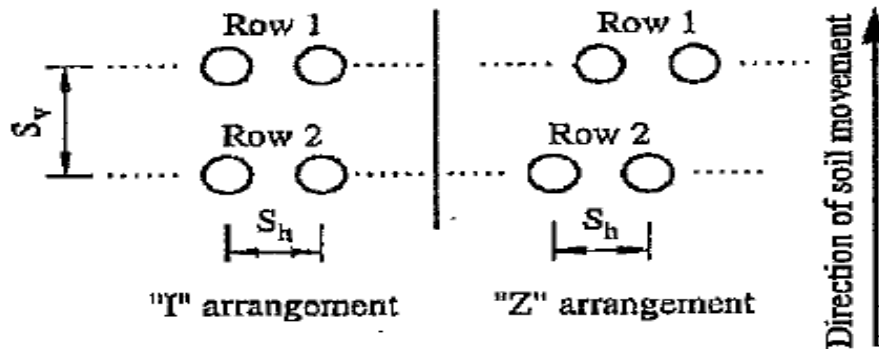
Case	$S_h/D$	$S_v/D$	$F_p$	
			Row 1	Row 2
Z-1	3	3	1.200	1.100
Z-2	3	6	1.400	1.200
Interpolated	4	3	1.300	1.133
Z-3	6	3	1.100	1.000

Figure 5: Pile Arrangement and Dimensionless Force Distribution on Piles. (Extract from Chen and Poulos, 1997)

The shear piles were required resist unfactored lateral forces parallel to the direction of the streambed of 300 kN/m at Ksituan River and 500 kN/m at Howard Creek. The piles were designed in pairs and the forces in the piles were estimated based on the work by Chen and Poulos, 1997 (1) for piles arranged in two infinitely long rows. The force distribution on the piles,  $F_p$ , was linearly extrapolated from values given by Chen and depended on the spacing between rows of piles  $S_v$ , the horizontal spacing between piles  $S_h$ , and the pile diameter  $D$ .

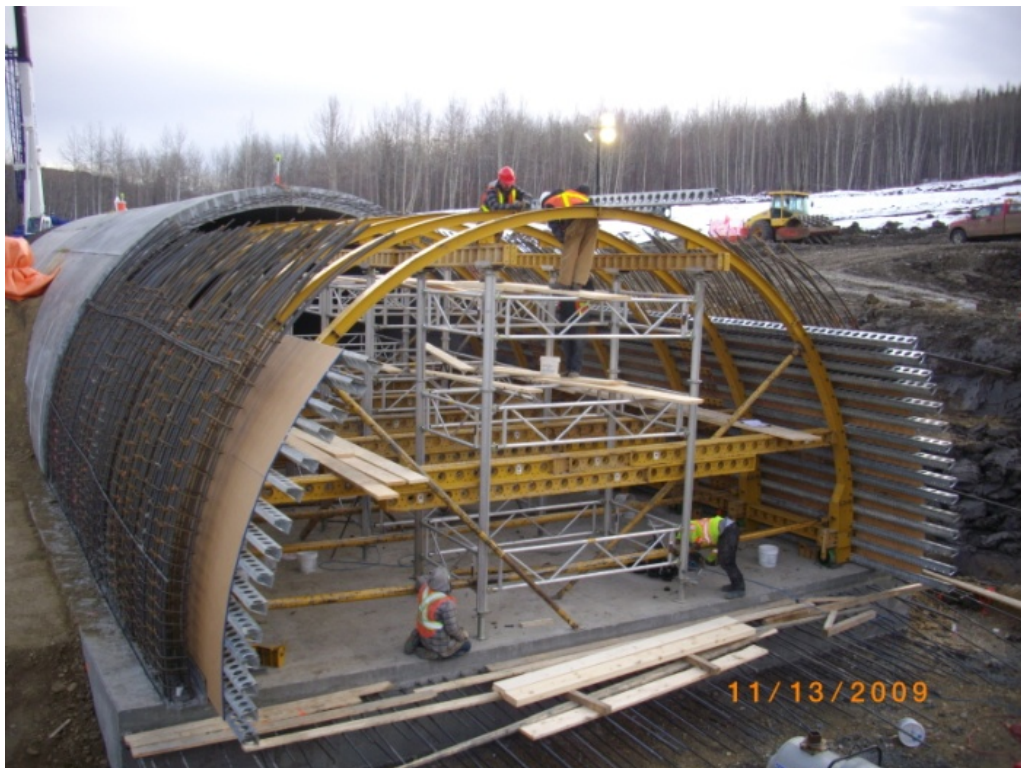
Figure 10: Setting Steel Arch Formwork and Scaffolding on Completed Base Slab

Due to the unstable nature of the existing valleys, limits were placed on the size and proximity of excavations that could be open at the same time and the culverts had to be constructed in stages in order to maintain some support to the valley slide blocks. The Contractor constructed diversion pipes and cofferdams to handle water flow so that a shallow berm could be constructed in the river/creek bed to buttress the slopes. The culverts could then be constructed in 12 m long segments involving excavating, forming, pouring, and backfilling each segment before the next adjacent segment was started. The construction sequence at each site started with the centre segments of the culvert. After the centre two segments were completed and backfilled separately, the Contractor was permitted to work on two segments simultaneously at opposite ends of the culvert. Taking advantage of this, the Contractor staggered the use of the steel arch form such that both ends of each culvert could be built as quickly as possible. The base slab was constructed at one end of the culvert while the arch section was constructed at the opposite end. After the arch section was cast and sufficient curing time had elapsed, the forms were then moved to the recently completed base slab and the process repeated. Figure 7 shows the arch formwork and scaffolding being relocated and set up on a recently completed base slab. The last segments to be completed at each culvert were the inlet and outlet structures. Even with this sequential approach to construction limiting the size and number of open excavations, local slide movements exceeding 1 m per year were recorded.

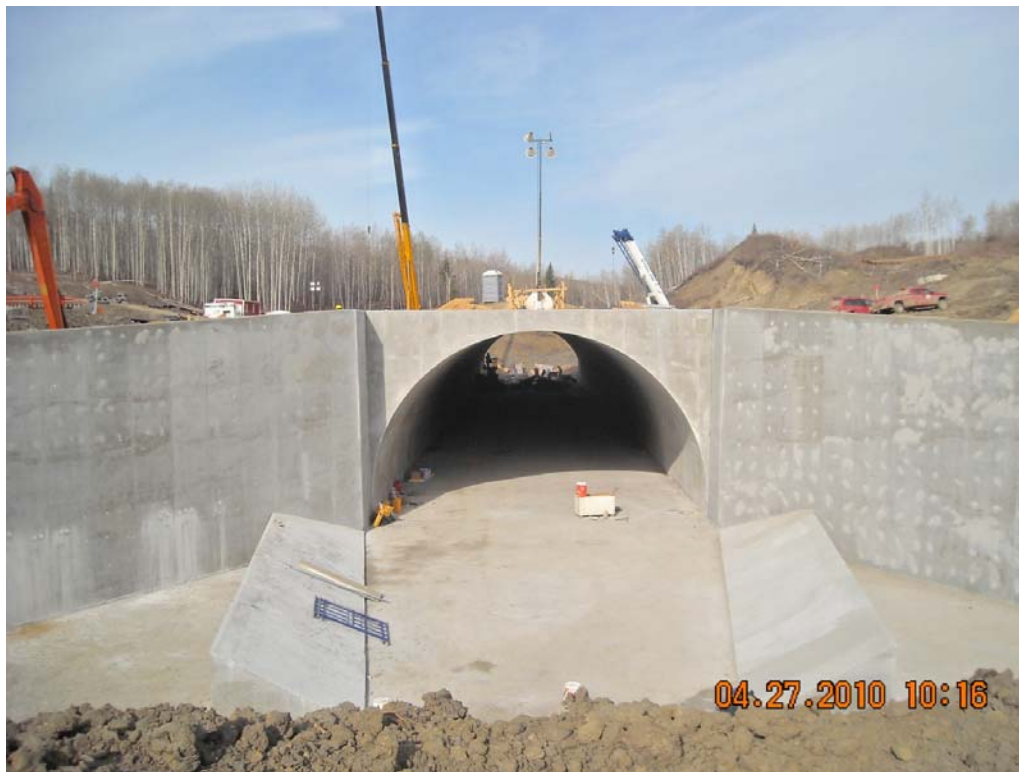
Figure 11: Nearly Completed Ksituan River Culvert

At the peak of production, large concrete pours were occurring daily. To maintain this pace, the Contractor worked on both the Ksituan River and Howard Creek Culverts simultaneously, and utilized day and night reinforcing steel tying and placing crews. To further increase the speed of reinforcing steel placement, the cages within the arch section of the culverts were pre-tied off-site and lifted into place by crane. Despite losing close to four weeks of productive time due to extremely cold weather in December, the concrete work was completed in roughly eight months. Figure 8 shows the nearly completed Ksituan River culvert.

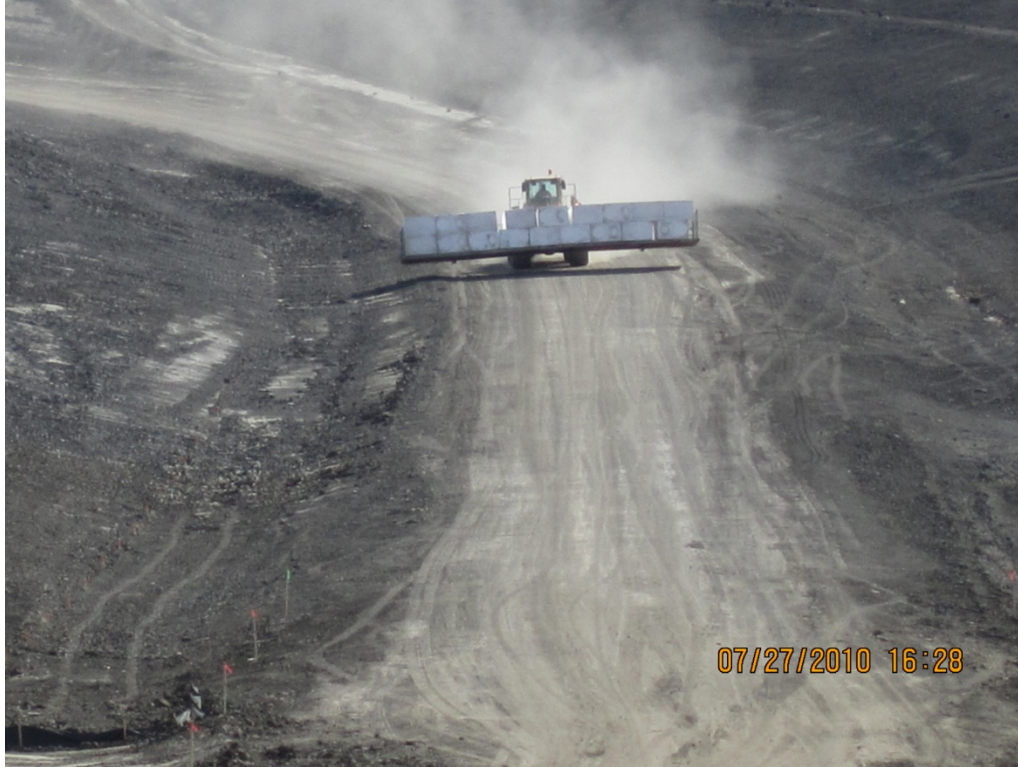
Figure 12: Wheel Loader with Attachment Transporting EPS Geofoam for Placement

Although the low density of the EPS Geofoam made it an ideal lightweight fill material, its corresponding large volume made it very difficult to handle and manoeuvre. To minimize handling time, the Contractor developed an attachment for a wheel loader that could carry multiple blocks from the stockpile to their final placement location. Figure 9 shows the attachment which was an engineered rig mat with a railing system to secure the load. Able to carry 52 m<sup>3</sup> per load, this attachment helped the Contractor place the EPS Geofoam at a rate of up to 500 m<sup>3</sup> per day, placing all the required lightweight fill material in slightly over two weeks.
