**Golder Associates Ltd.**

**Fort McMurray River Hazard Study  
Report on 1875 Ice Jam Flood Assessment**

This memorandum report documents the methodology and results of the 1875 Ice Jam Flood Assessment, which is part of the ice jam flood assessment component of the study. The assessment was conducted in consultation with Mr. David Andres, who provided invaluable guidance and input to the assessment.

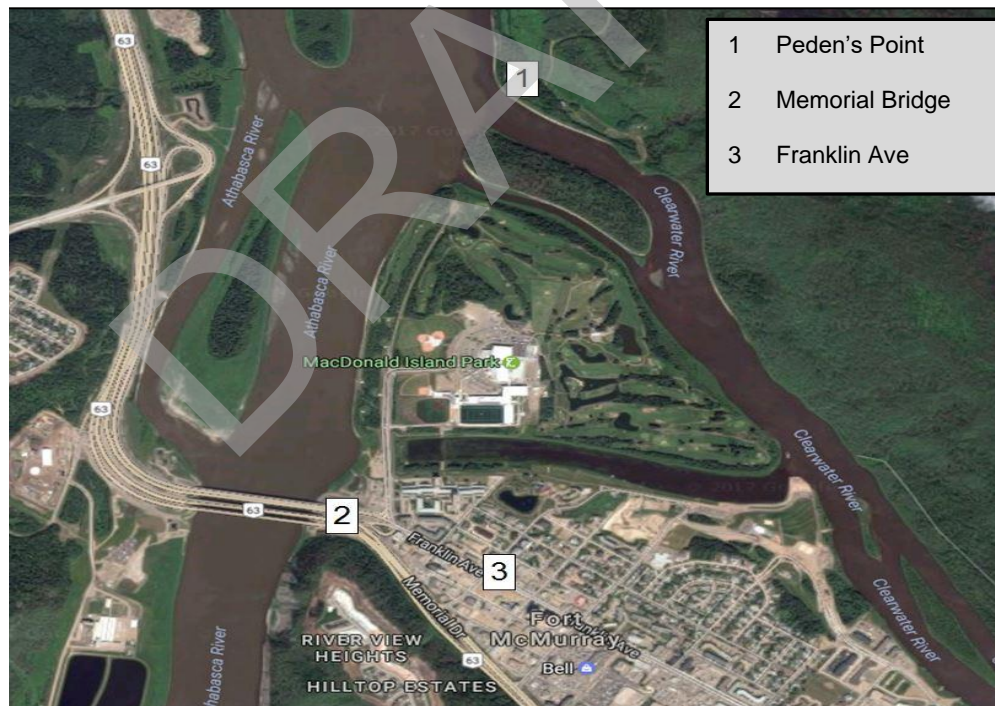
**Figure 2-1: Historical HBC Post Locations (map: Google Earth)**

This evidence would place the post at approximately Location 2 as shown in Figure 2-1.

Therefore, in summary, the HBC post was likely located at Location 2 shown in Figure 2-1. The ground elevation of the post was likely close to the level reported in the Blench study, and for the purpose of this assessment can be assumed to have been el. 250.85 m in 1875.

- The HBC post was likely located at Location 2 of Figure 2-1 in 1875. This position has been established independently through a review of Mr. Moberly's letters, discussions with staff at the Fort McMurray Heritage Society and the staff at the HBC Archives, an archived map showing the post location, and an historical photo of the post.

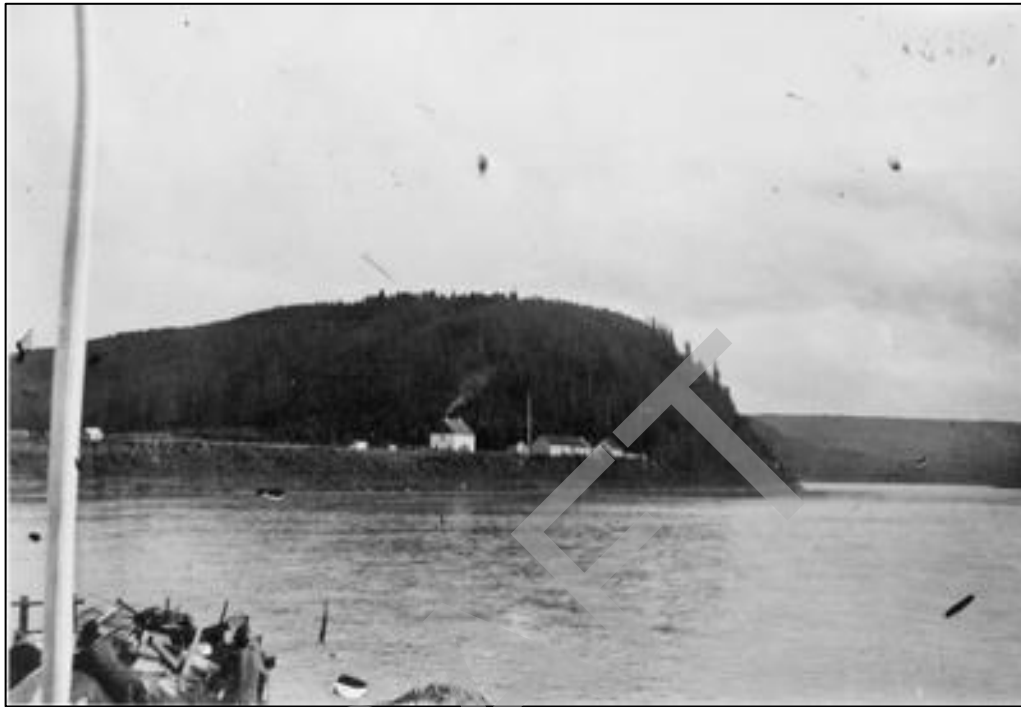
Figure 2-4: Photo of HBC Post in early 1920s (U of A Archives)

The team was able to obtain a telling photo of the HBC post (circa 1920's) from the University of Alberta archives, taken from a vantage point on the Athabasca River as a boat approached the post from downstream. This photo is shown in Figure 2-4. The high ridge immediately behind (and south of) the post is evident – consistent with what is there today. For comparison, an image of that area from a similar vantage point in the DTM developed for this project (collected in 2016) is shown in Figure 2-5. The DTM shown in this image was developed based on the current survey data, but major man made features (such as the Memorial Bridge abutments) have been removed to better represent the topography in 1875. The view is very similar, providing further evidence that Location 2 was the very likely position of the HBC post at the time of the flood.

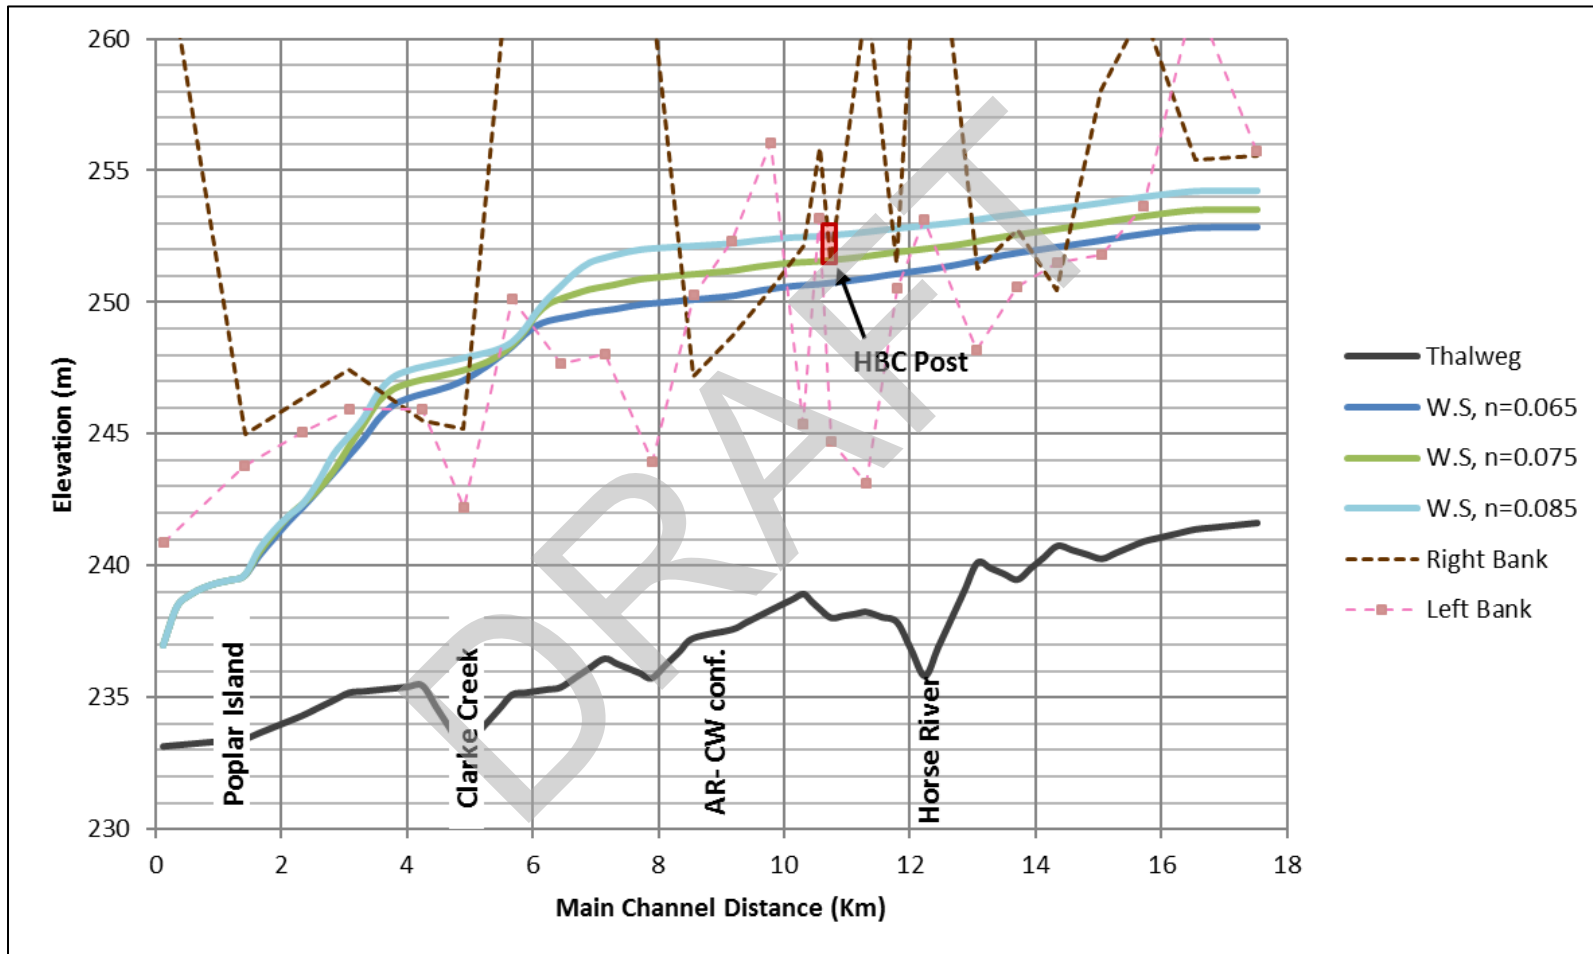
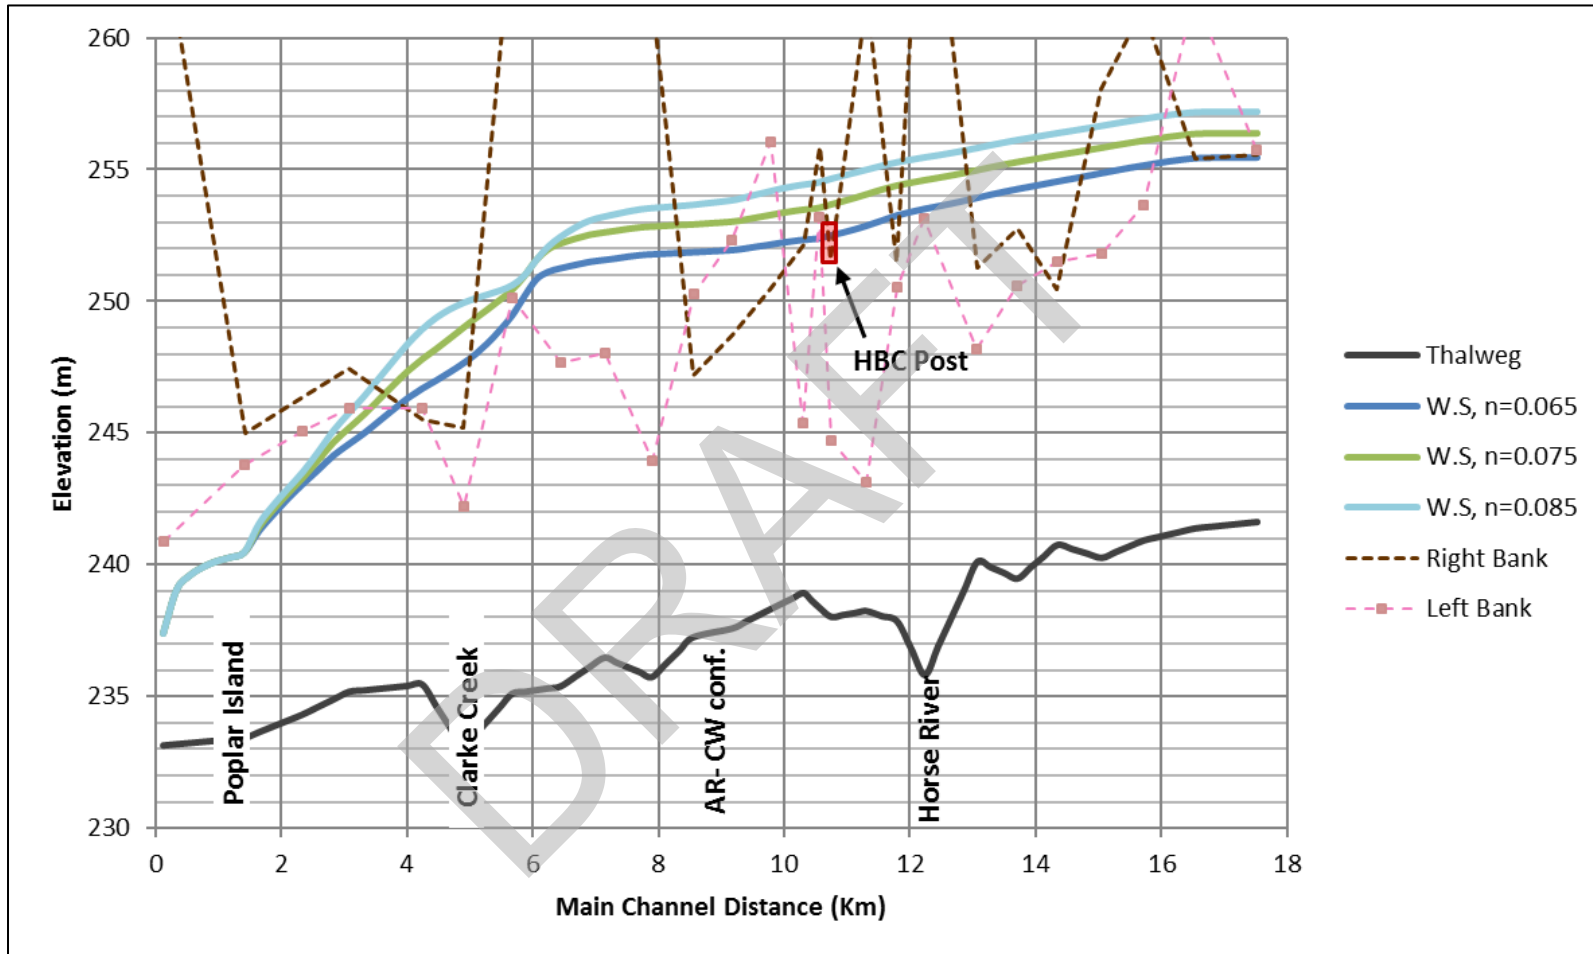
Figure 3-1, Figure 3-2, Figure 3-3 and Figure 3-4 illustrate the resulting water surface profiles for flows of 2500 m<sup>3</sup>/s, 3000 m<sup>3</sup>/s, 3500 m<sup>3</sup>/s, and 4000 m<sup>3</sup>/s respectively for a case in which the toe of the jam is at the most downstream location. In each Figure, for context, the red box shown represents the range in water levels previously estimated in the Blench report.

Figure 3-1: WSE Profile for Toe Location 1 (9.5 km downstream of fort location),  $Q = 2500 \text{ m}^3/\text{s}$

Figure 3-2: WSE Profile for Toe Location 1 (9.5 km downstream of fort location), Q = 3000 m<sup>3</sup>/s

Figure 3-3: WSE Profile for Toe Location 1 (9.5 km downstream of fort location),  $Q = 3500 \text{ m}^3/\text{s}$

Figure 3-4: WSE Profile for Toe Location 1 (9.5 km downstream of fort location),  $Q = 4000 \text{ m}^3/\text{s}$

In reviewing these charts, the ice jam appears to have reached an equilibrium thickness at the post location for either of the assumed jam initiation points. The equilibrium jam thickness for these runs was approximately 5 m. Where the jam covered areas of the floodplain, the thickness of the jam restricted flow movement on the floodplains, and therefore almost all conveyance continued to be in the main channel of the river. The findings of this preliminary study indicate that the model predictions are consistent with the water surface elevation range established through our review of the archival record. Ice jam formation at either toe location could have led to these types of levels for various combinations of assumed ice jam roughness and river flows.

However, it is our opinion that the most probable combination of parameters creating the 1875 event would involve a scenario involving higher than normal river flows, the higher end of the roughness range (based on an assumption that the ice was not significantly deteriorated at breakup), and formation at a downstream toe location (resulting in an equilibrium thickness and water surface profile at both the Fort location and the Clearwater confluence). Considering a “best estimate” water level at the Fort location of approximately el. 252.5 m (based on historical data), this would mean that flows at the time of the event may have been approximately 2500 m<sup>3</sup>/s at the peak of the event (based on Figure 3-9). Given the expected slope of the ice jam, the water level at the Athabasca-Clearwater confluence would be approximately 0.5 m lower, at el. 252.0 m.

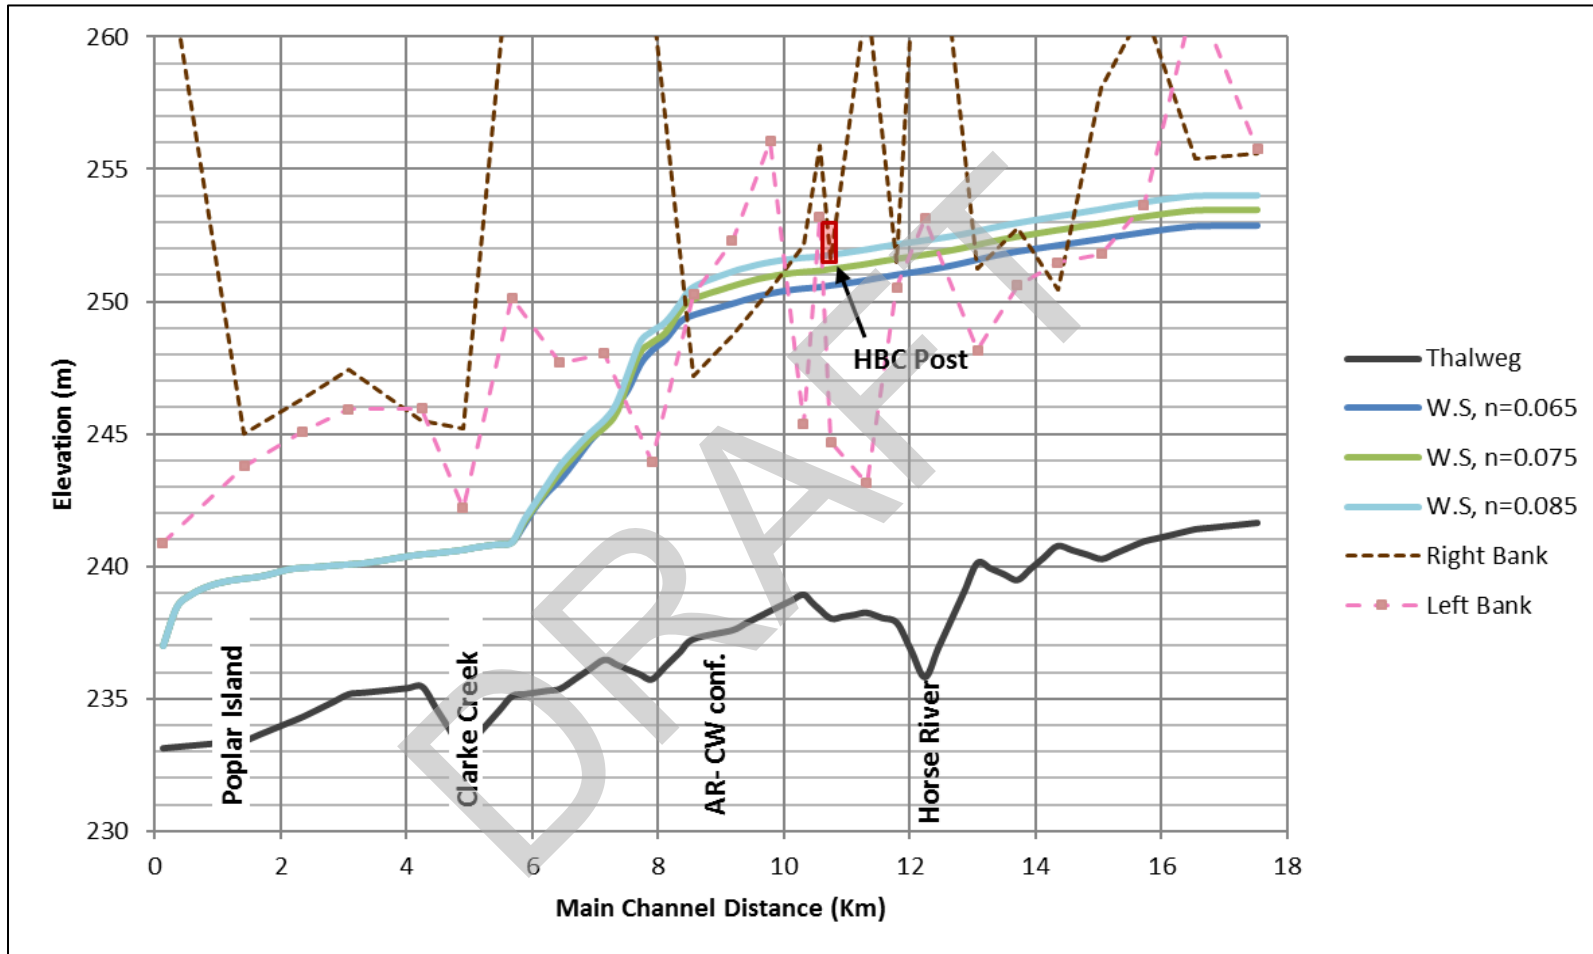
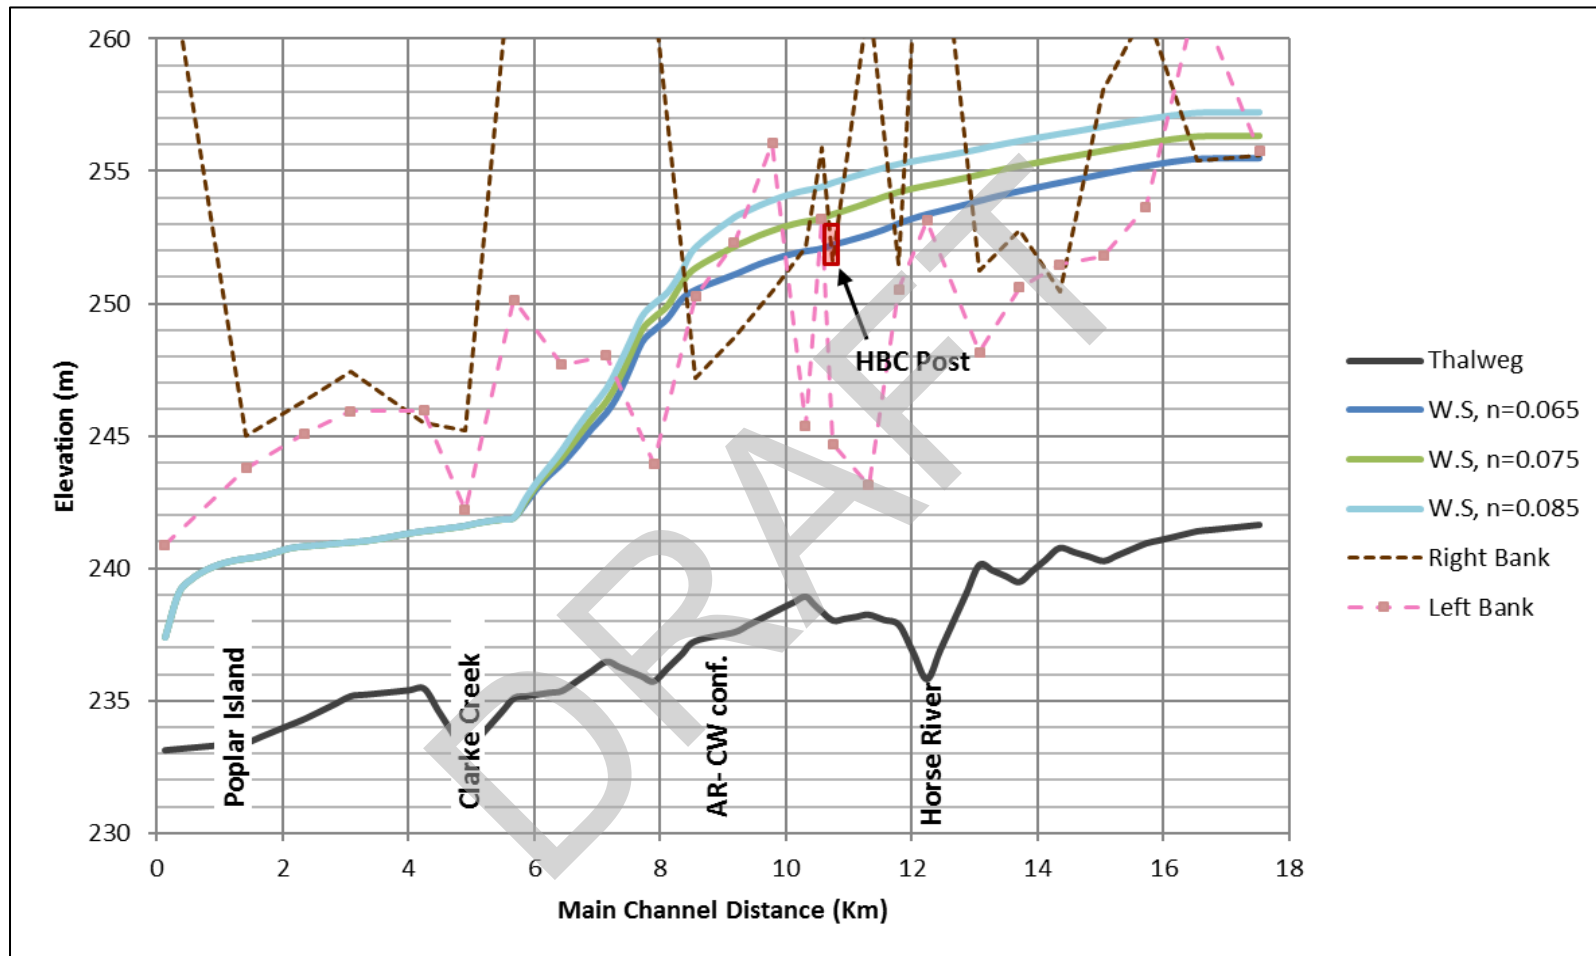
Figure 3-5, Figure 3-6, Figure 3-7 and Figure 3-8 illustrate the resulting water surface profiles for flows of 2500 m<sup>3</sup>/s, 3000 m<sup>3</sup>/s 3500 m<sup>3</sup>/s, and 4000 m<sup>3</sup>/s respectively for a case in which the toe of the jam is at the more upstream location (3 km downstream of the confluence).

Figure 3-5: Toe Location 2 (5.5 km downstream of fort location),  $Q = 2500 \text{ m}^3/\text{s}$

Figure 3-6 : Toe Location 2 (5.5 km downstream of fort location),  $Q = 3000 \text{ m}^3/\text{s}$

Figure 3-7: Toe Location 2 (5.5 km downstream of fort location), Q = 3500 m<sup>3</sup>/s

Figure 3-8: Toe Location 2 (5.5 km downstream of fort location),  $Q = 4000 \text{ m}^3/\text{s}$
