## FORT MCMURRAY RIVER HAZARD STUDY

# Channel Stability Investigation Report

**Report Number:** 1662603\_R0009, Rev.0

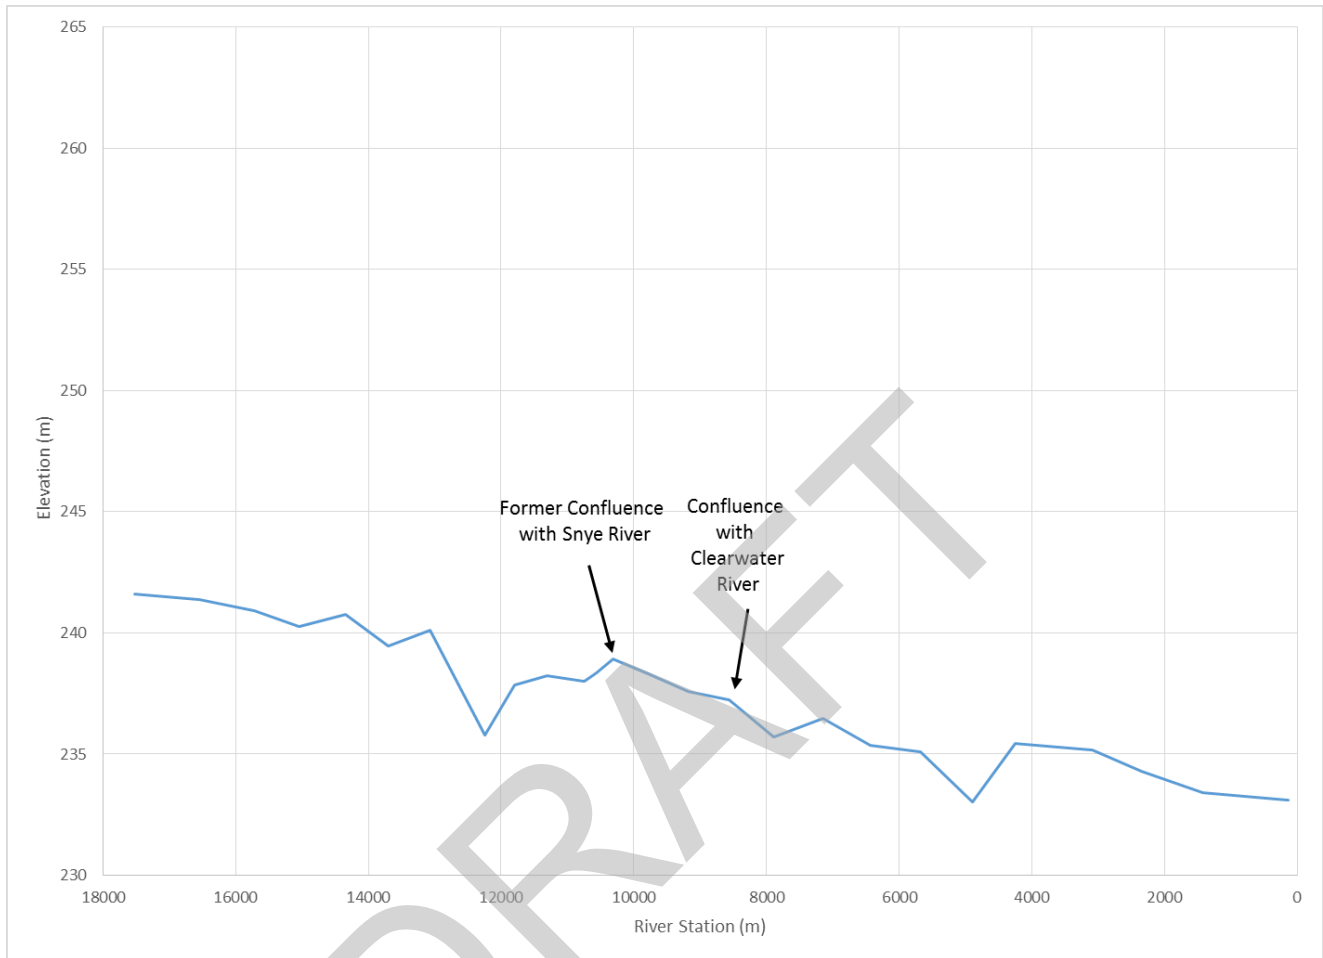
Figure 8: Athabasca River Thalweg (surveyed in 2016)

The slopes for the Athabasca, Clearwater and Snye Rivers are -0.0005, -0.0002 and -0.0008, respectively.

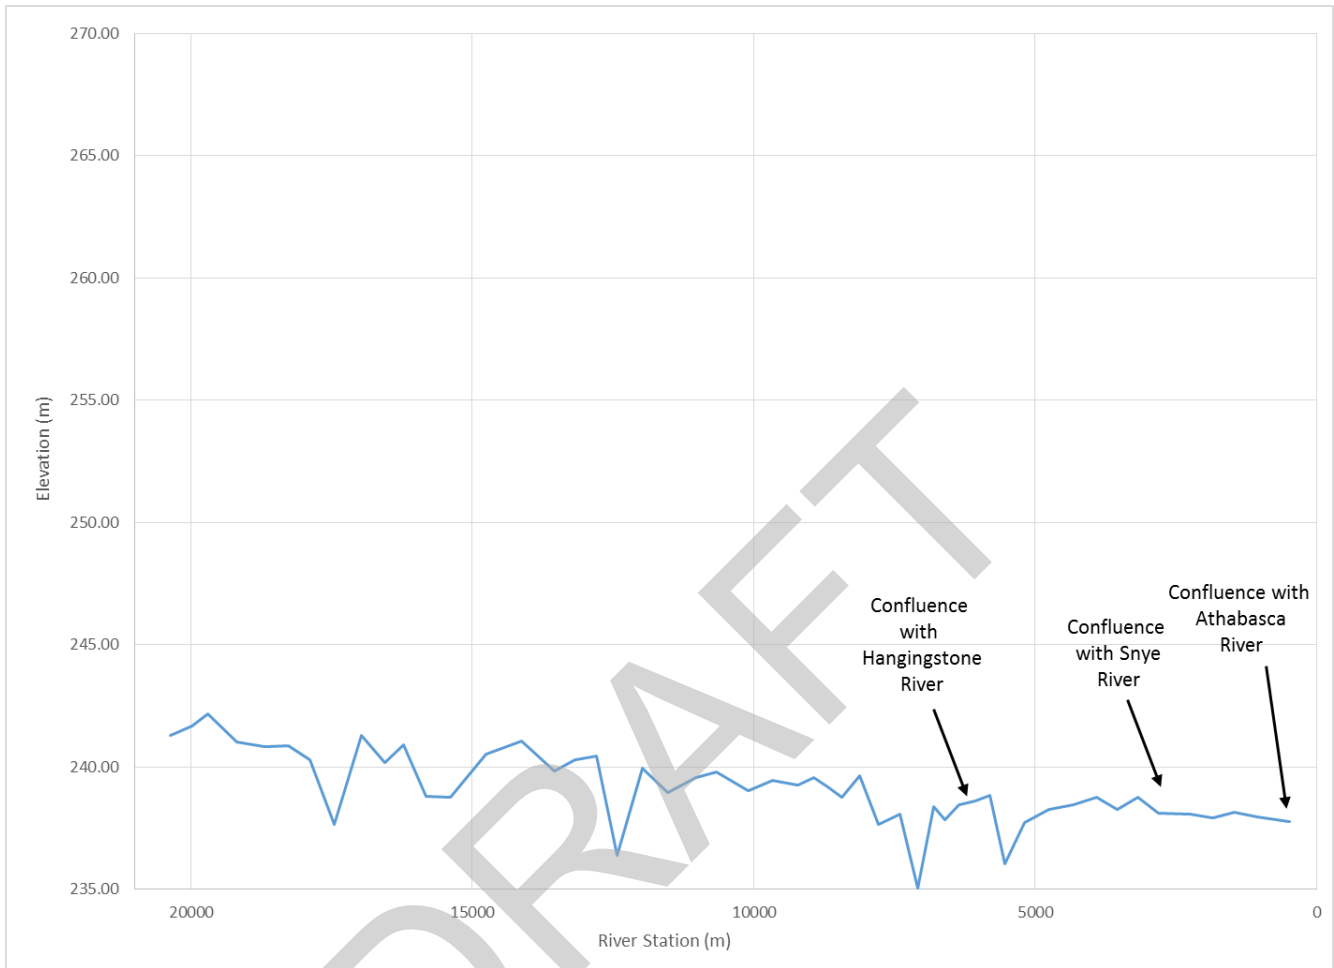
Figure 9: Clearwater River Thalweg (surveyed in 2016)

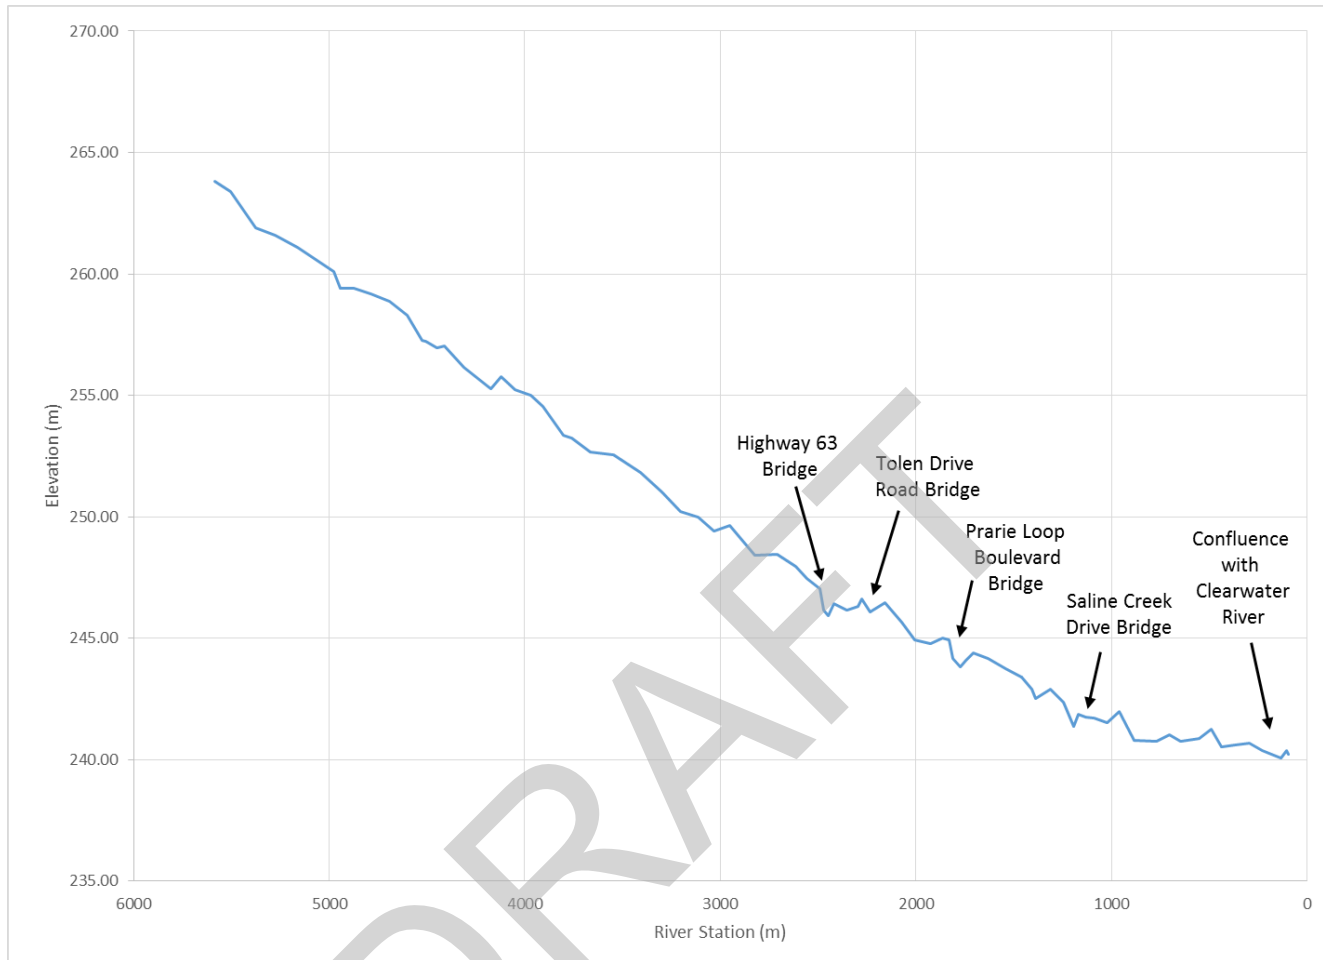
Figure 10: Hangingstone River Thalweg (surveyed in 2016)

Inspection of the thalweg for each of the subreaches suggests that the Hangingstone River, within the study area, follows a general concave-upward trending profile with slopes typically decreasing in steepness from the upstream boundary to the river mouth. The Hangingstone River, at the upstream boundary, has a slope of -0.005, while at the downstream boundary has a slope of -0.0018.

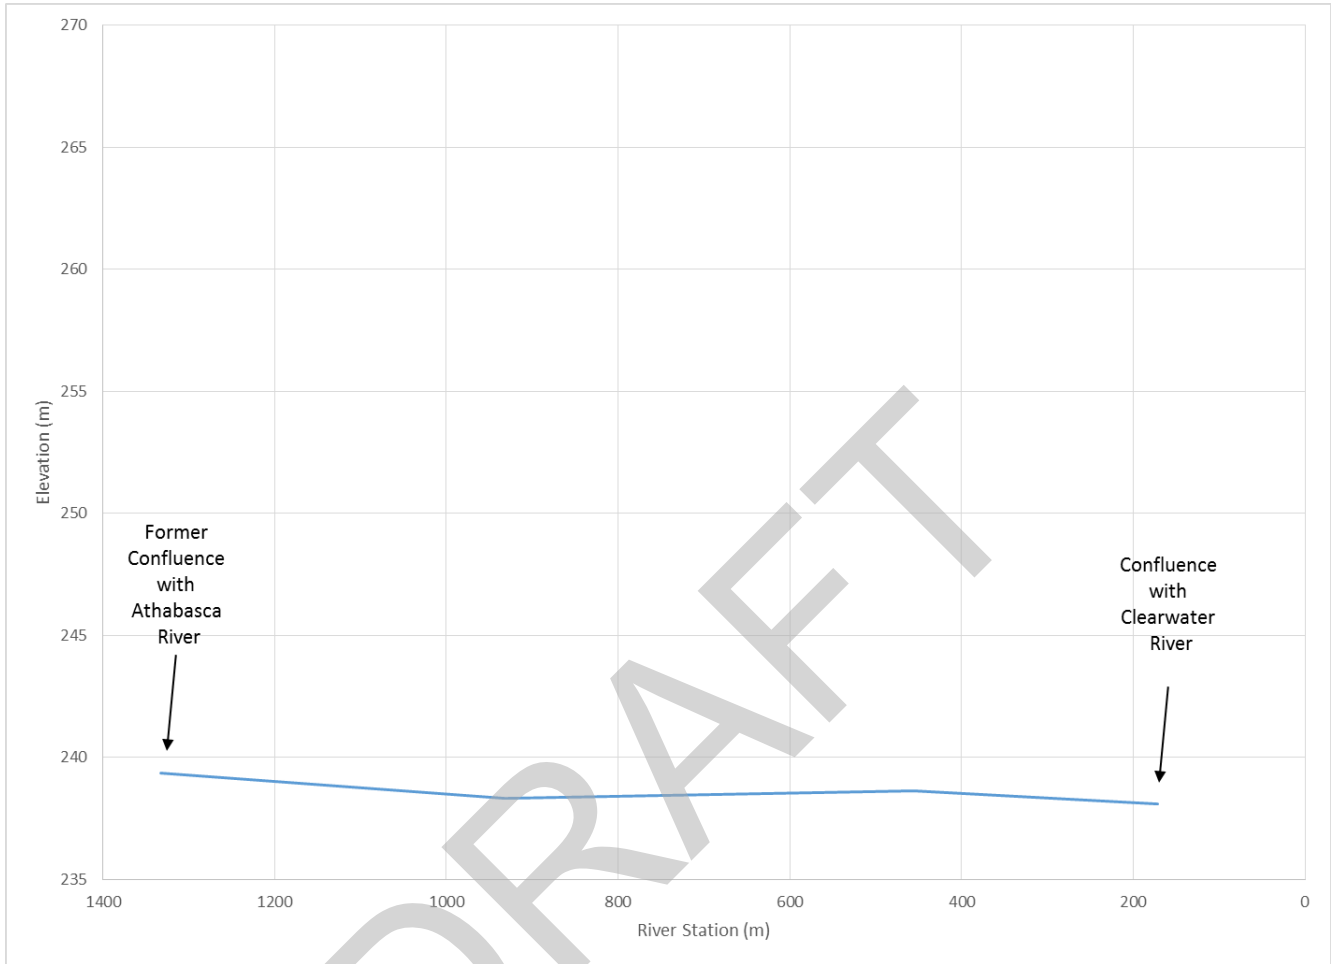
Figure 11: Snye River Thalweg (surveyed in 2016)

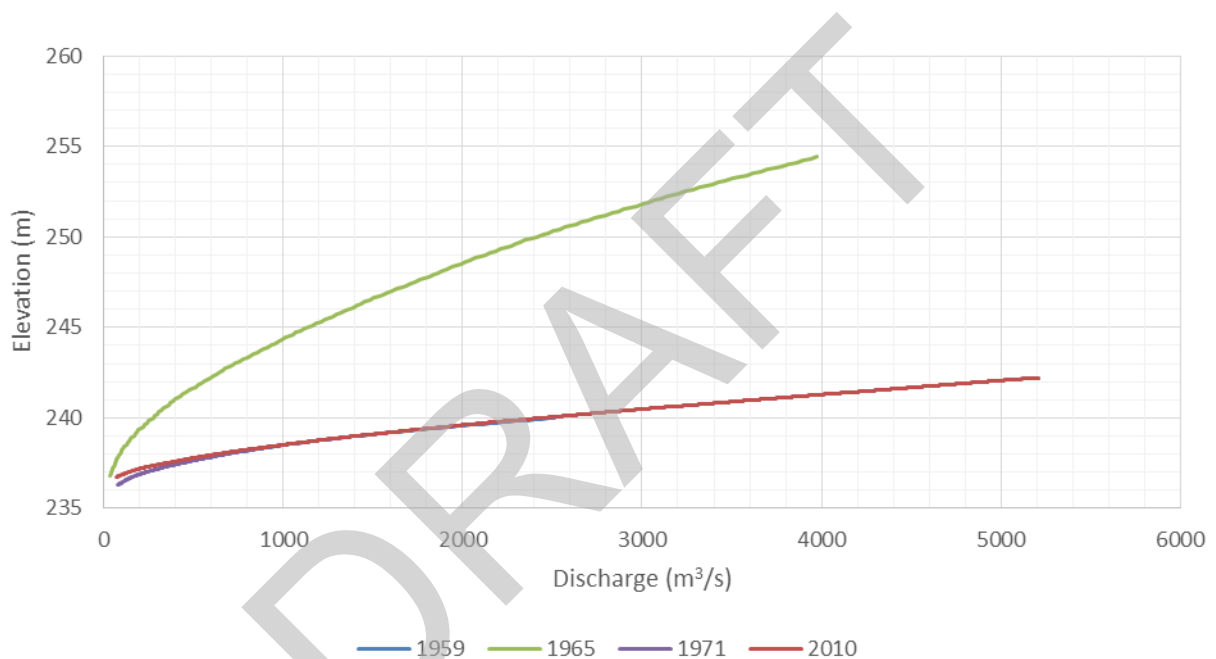
Athabasca River below McMurray (WSC Station No. 07DA001) is located along Reach 1, approximately 5 km downstream of the confluence with the Clearwater River. The rating curves for this station are shown in Figure 12. The observed change in the rating curve from 1971 to 2010 (Figure 12) suggests the river channel has not changed over the two time periods because the same water surface elevation in 1971 conveys the same discharge in 2010.

Figure 12: Rating Curve for WSC Station No. 07DA001 (Athabasca River below McMurray)

- Notes:
- (1) This gauge was moved in 1962 and resurveyed in 1965 which has caused vertical shifts in the datum.
  - (2) Curves for 1971-1999 and 2010-2016 are on the same datum.

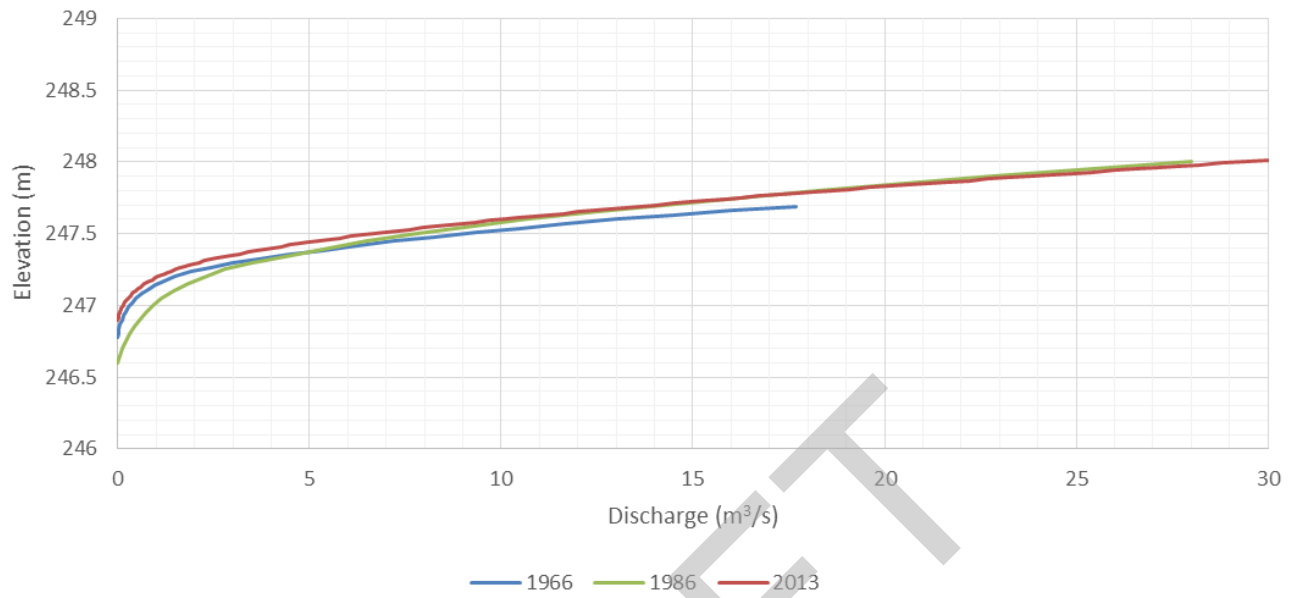
Figure 14 shows the rating curves for Hangingstone River at Fort McMurray (WSC Station No. 07CD004), located along reach 3 approximately 2.5 km upstream from the confluence of the Clearwater River, near the Highway 63 bridge. The change in the rating curve at lower discharge levels ( $<12 \text{ m}^3/\text{s}$ ), as shown in Figure 14, suggests narrowing or shoaling (accretion) of the channel because the same water surface elevation in 1986 and 2013 conveys less discharge in 2013. The loss of conveyance is likely narrowing or shoaling of the channel. At discharges greater than  $20 \text{ m}^3/\text{s}$ , the slight change in rating curve suggests minor widening or increase in average depth of the channel as the same water surface in 1986 and 2013 conveys more discharge in 2013. The increase in conveyance at higher discharges is possibly a result of changes in the channel due to construction of the southbound Highway 63 Bridge. Construction of the bridge may have required widening the bridge span and upper channel banks to allow for channel migration. A widening of the channel of 5 m was observed at the bridge during the channel bank comparison.

Figure 14: Rating Curves for WSC Station No. 07CD004 (Hangingstone River at Fort McMurray)

- Notes:
- (1) This gauge was moved in 1985 which has caused vertical shifts in the datum.
  - (2) Curves for 1986 and 2013 are on the same datum.

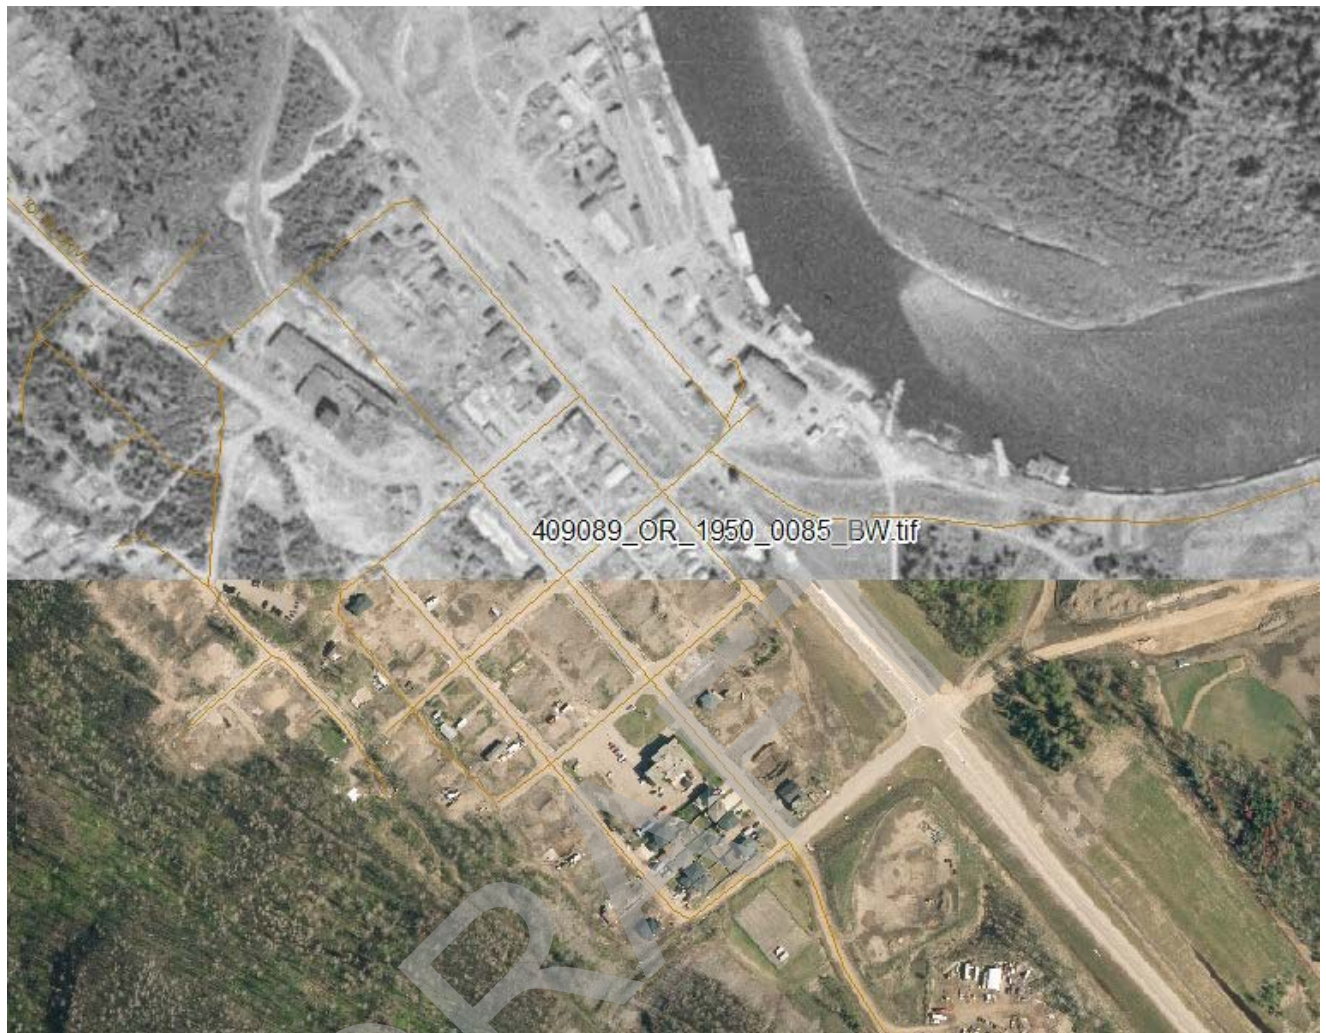
*Figure 2: Example of an Orthomosaic Quality Assurance Check at the 1:5,000 Scale.*

*(The historical orthomosaic (greyscale; at top) is peeled back to reveal the modern landscape (colour image; at bottom). Modern roads from Canvec are overlaid for reference)*
