# MEDICINE HAT RIVER HAZARD STUDY

## CHANNEL STABILITY INVESTIGATION

### FINAL REPORT

**Northwest Hydraulic Consultants Ltd.**  
Edmonton, Alberta

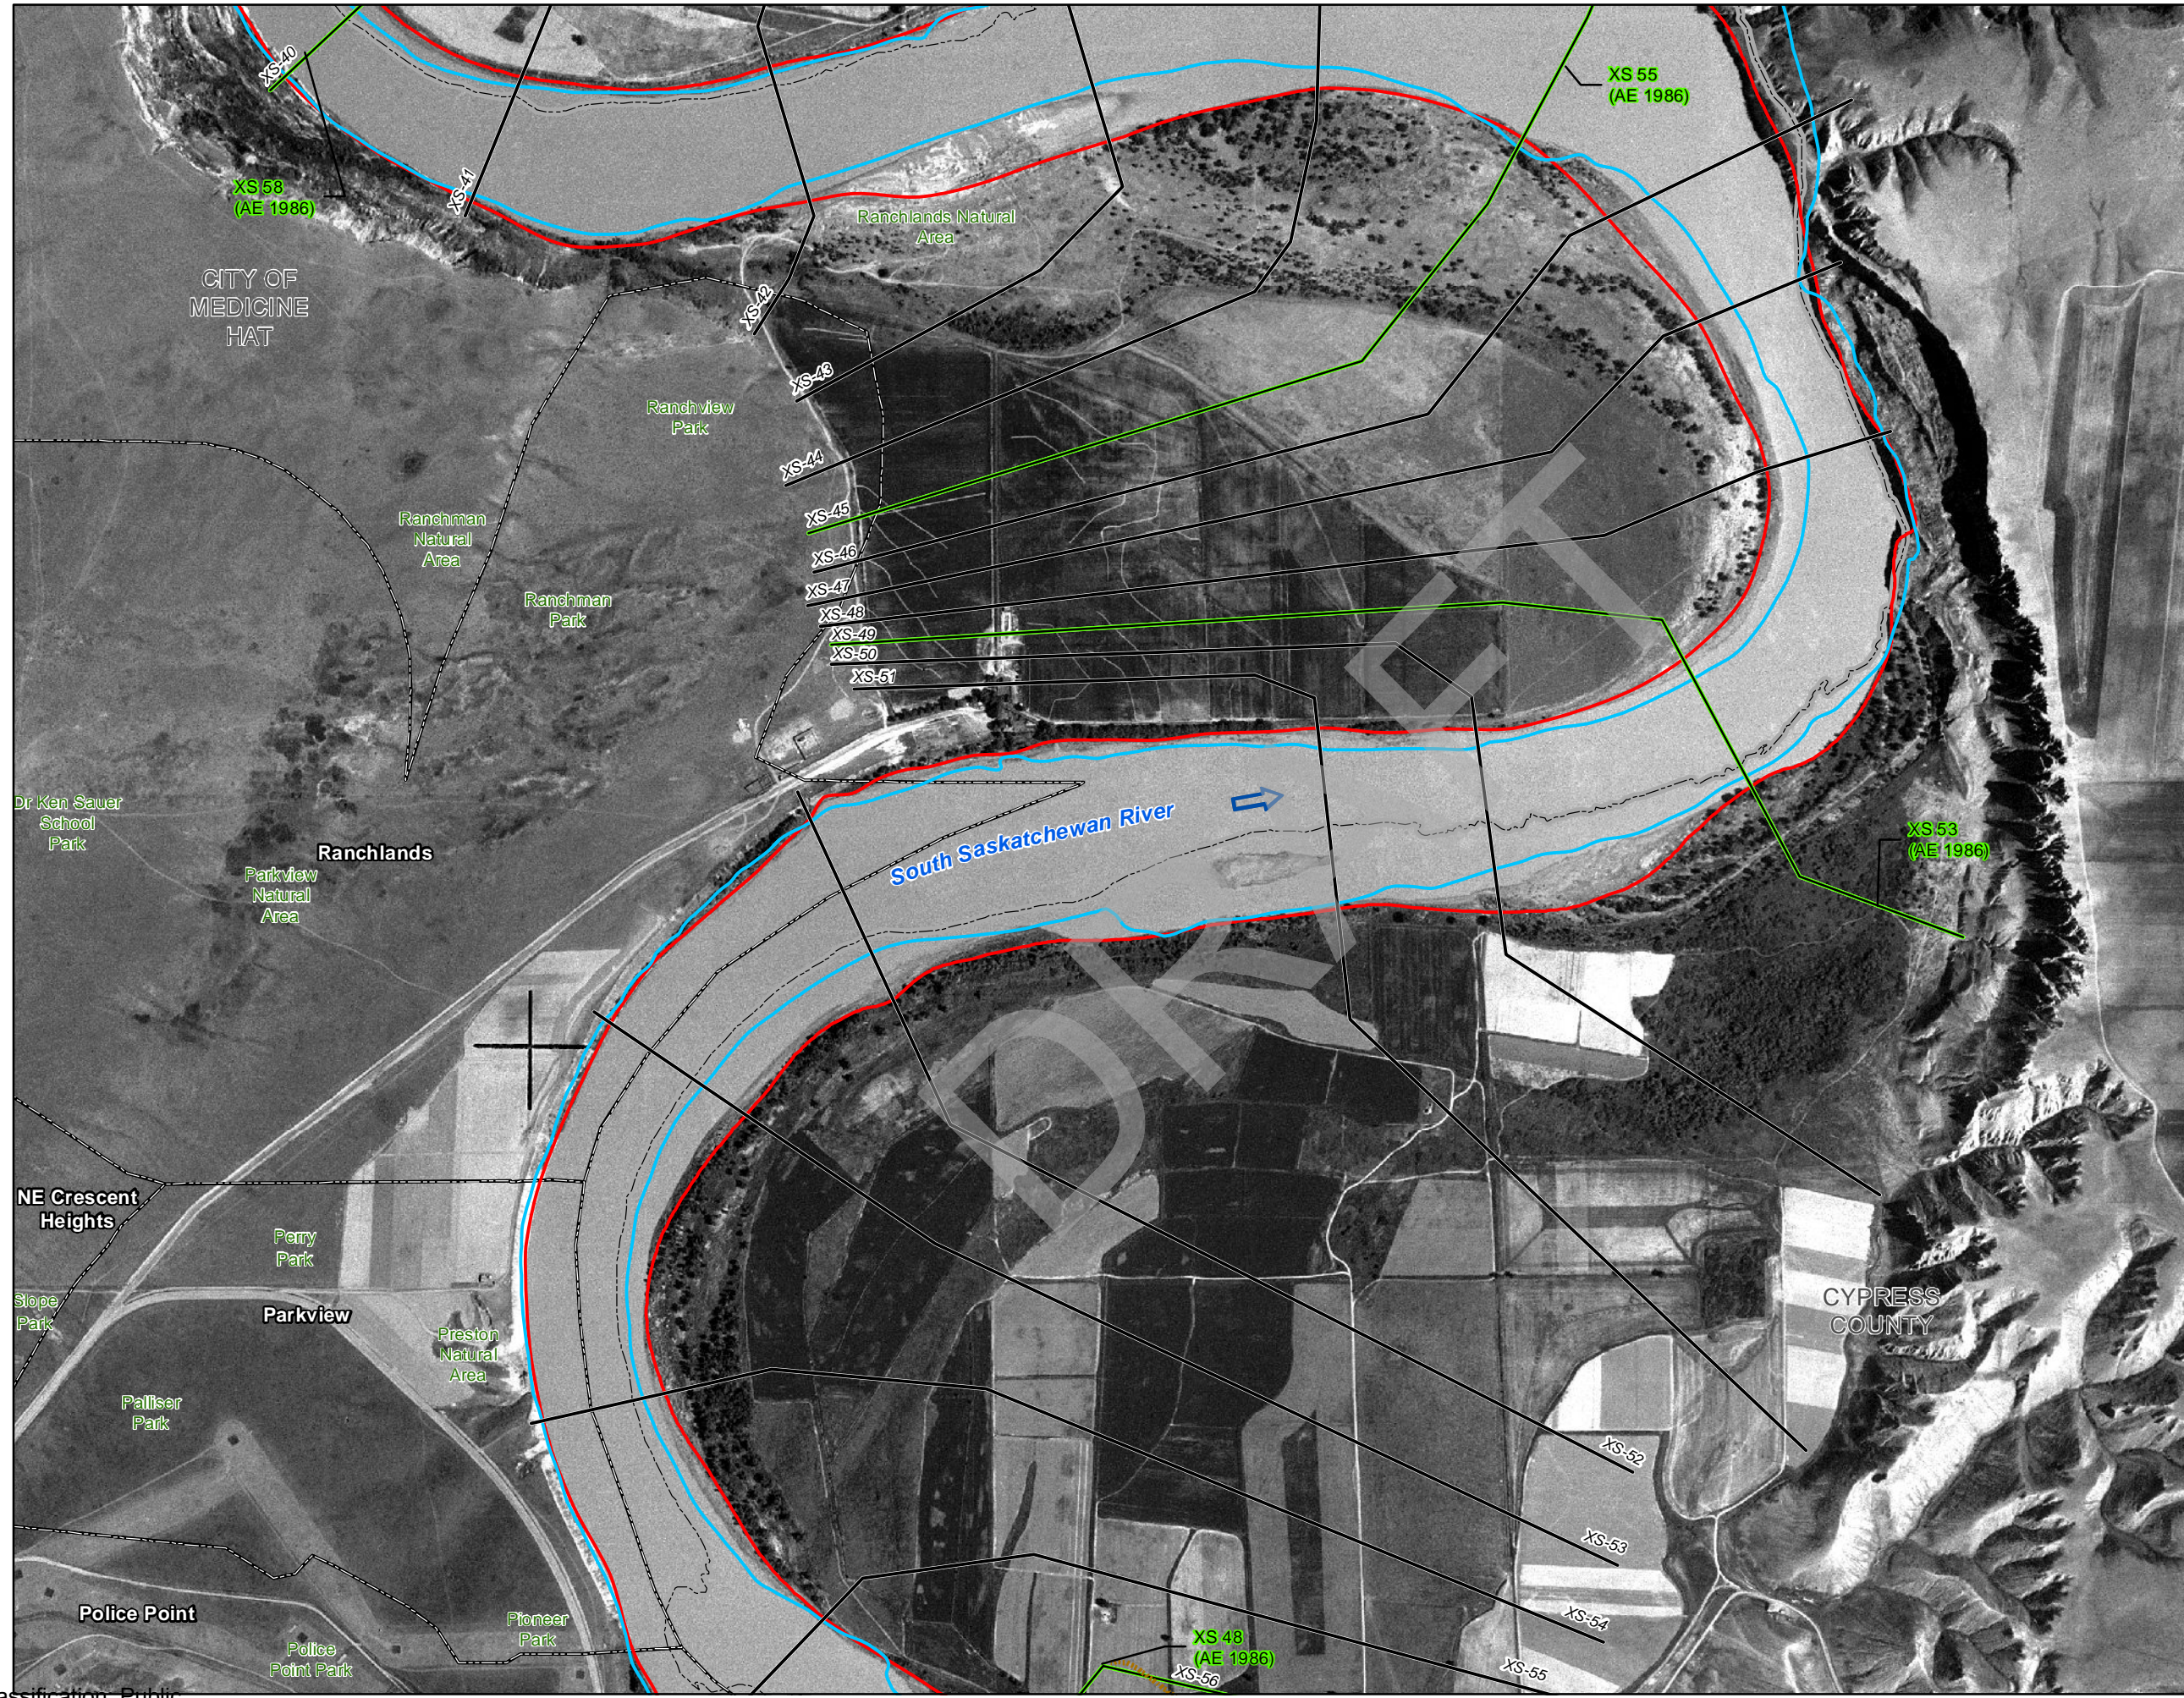
MEDICINE HAT RIVER HAZARD STUDY  
CHANNEL STABILITY INVESTIGATION  
**CHANNEL BANKLINE  
COMPARISON -  
1951 IMAGERY**

Map sheets show the delineated banklines superimposed on the 1951 (**Figure 3**) and 2018 (**Figure 4**) aerial images. Map sheets referred to in this section apply to either series. A commentary on the observed channel stability of the study reaches is provided below.

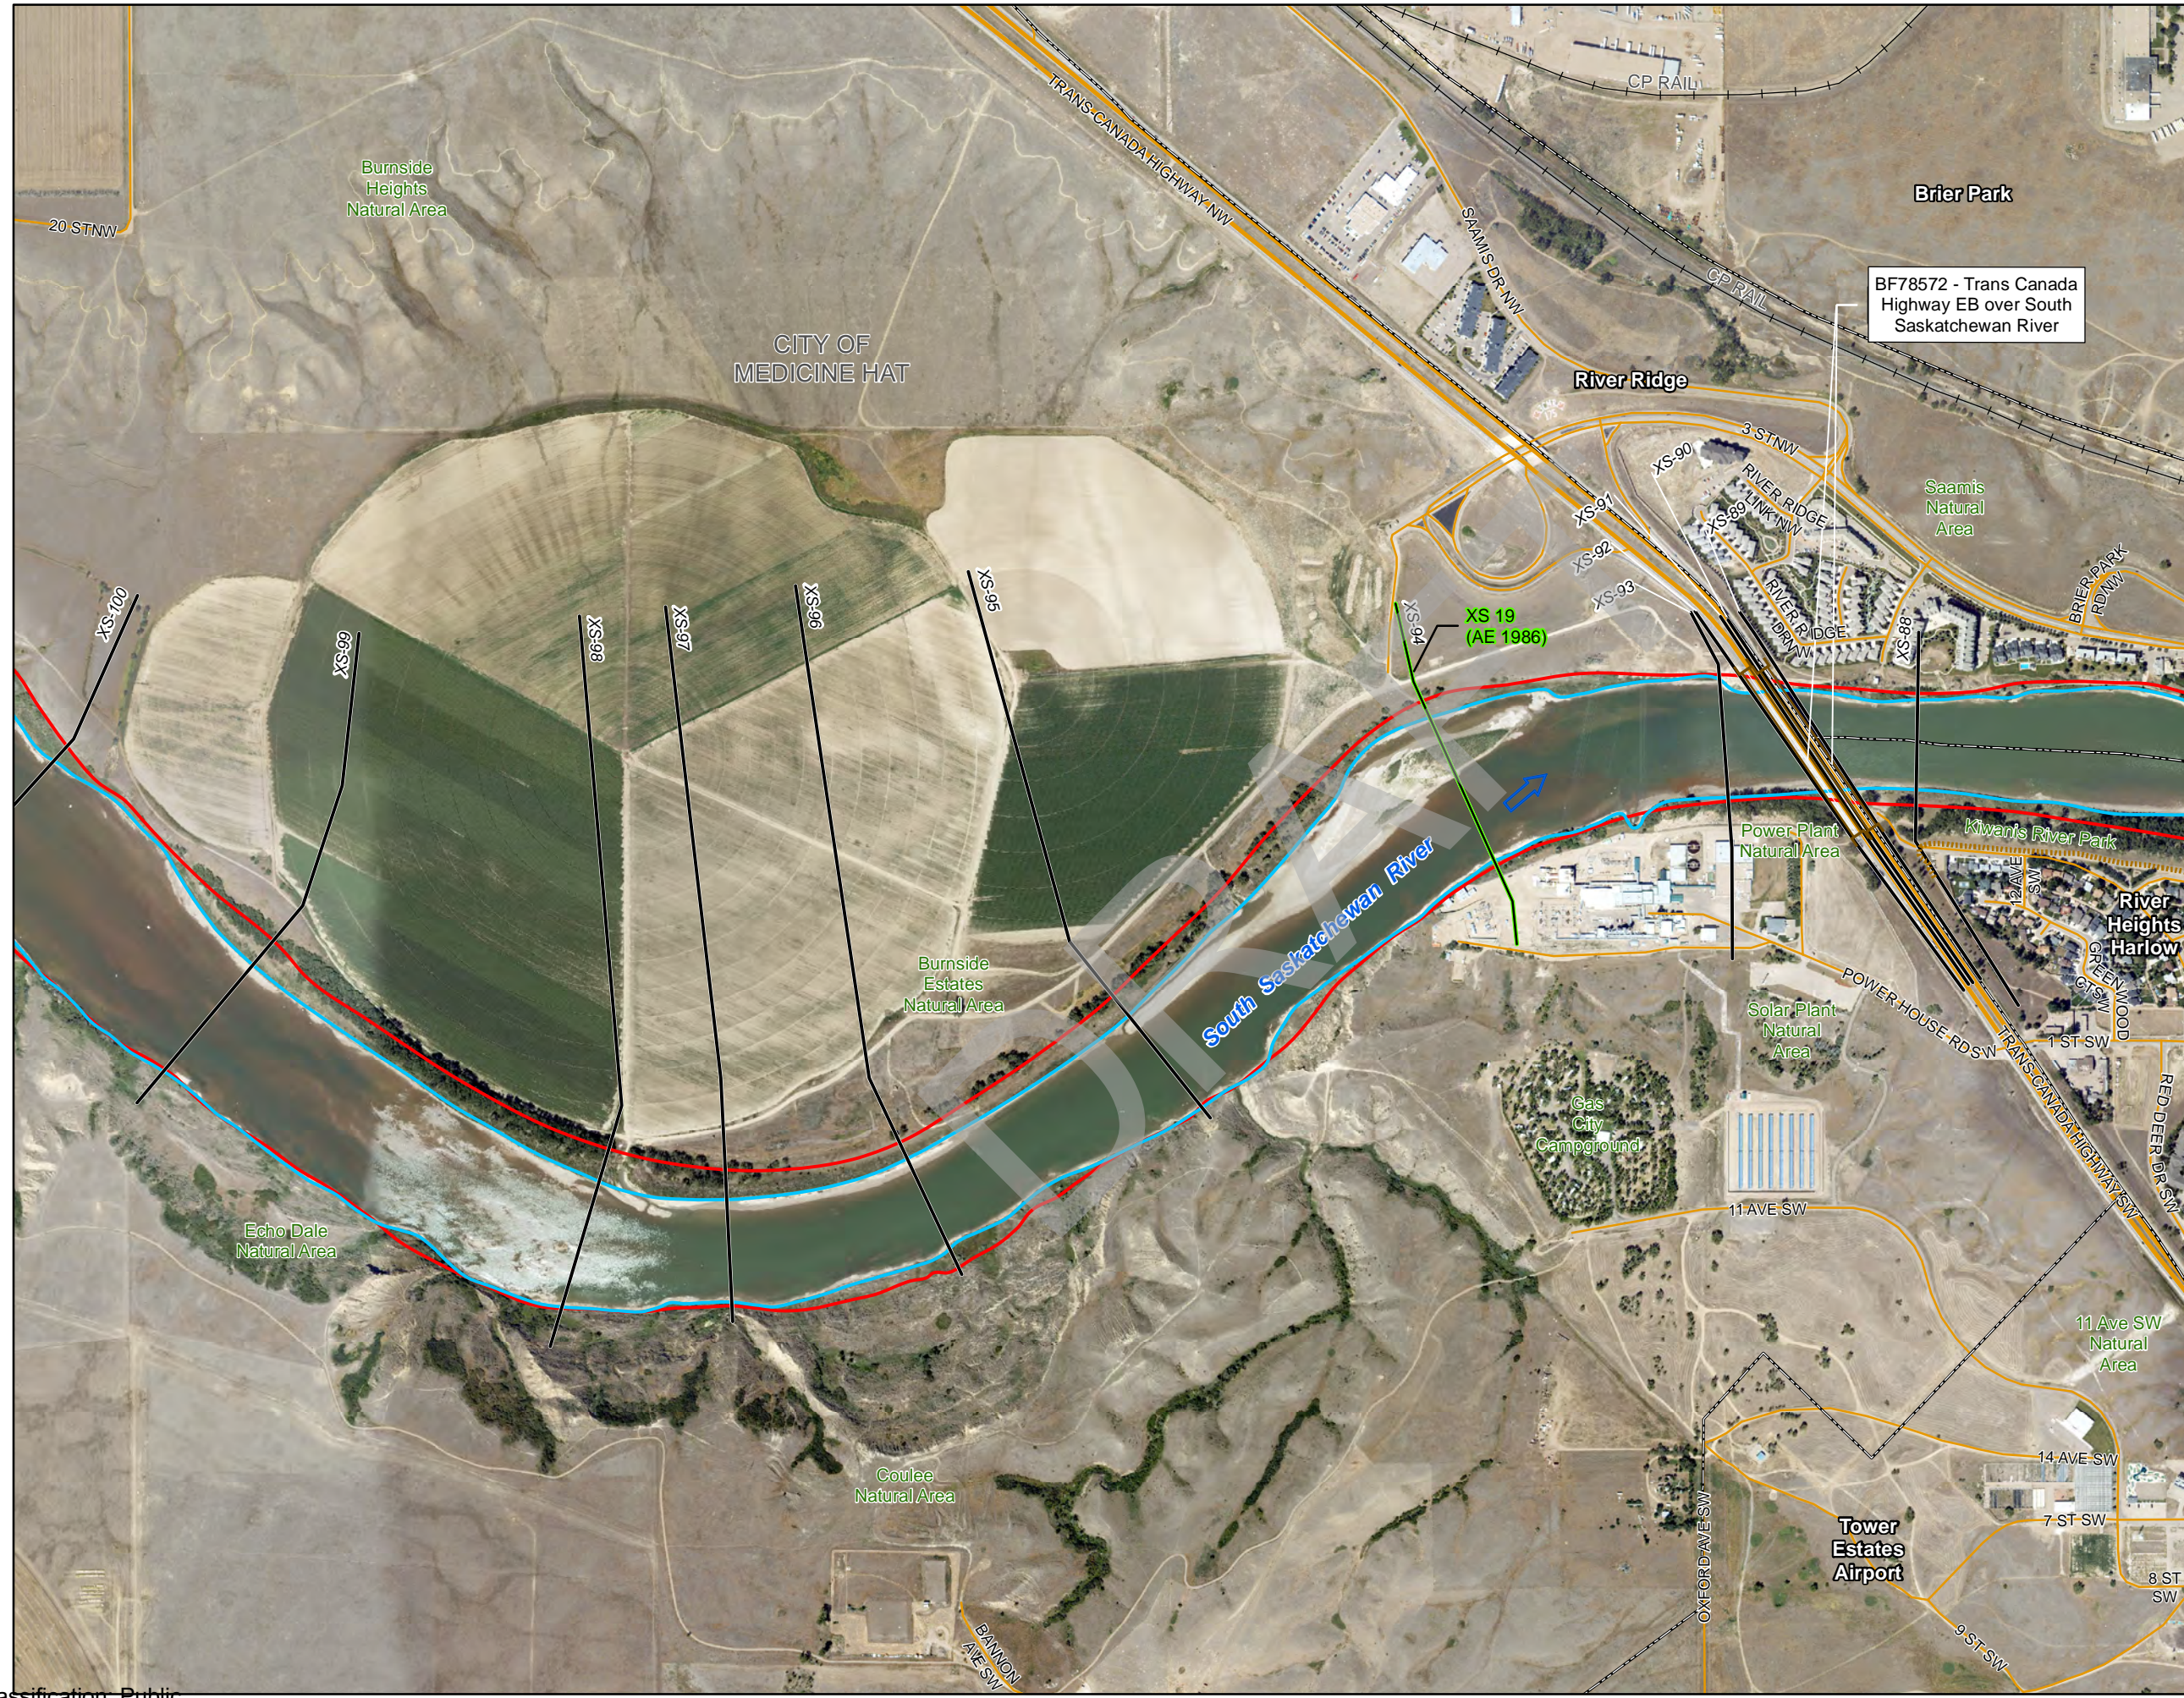
MEDICINE HAT RIVER HAZARD STUDY  
CHANNEL STABILITY INVESTIGATION  
**CHANNEL BANKLINE  
COMPARISON -  
2018 IMAGERY**
