SHEEP RIVER HAZARD STUDY, CHANNEL STABILITY INVESTIGATION

February 2019

D.S. MacDonald, B.Sc.
D.P. van Zeyl, M.Sc.
L.A. Penner, M.Sc., P.Eng., P.Geo.
J.D. Mollard and Associates (2010) Limited
Suite 1720, 2002 Victoria Avenue
Regina, Saskatchewan
Canada S4P 0R7

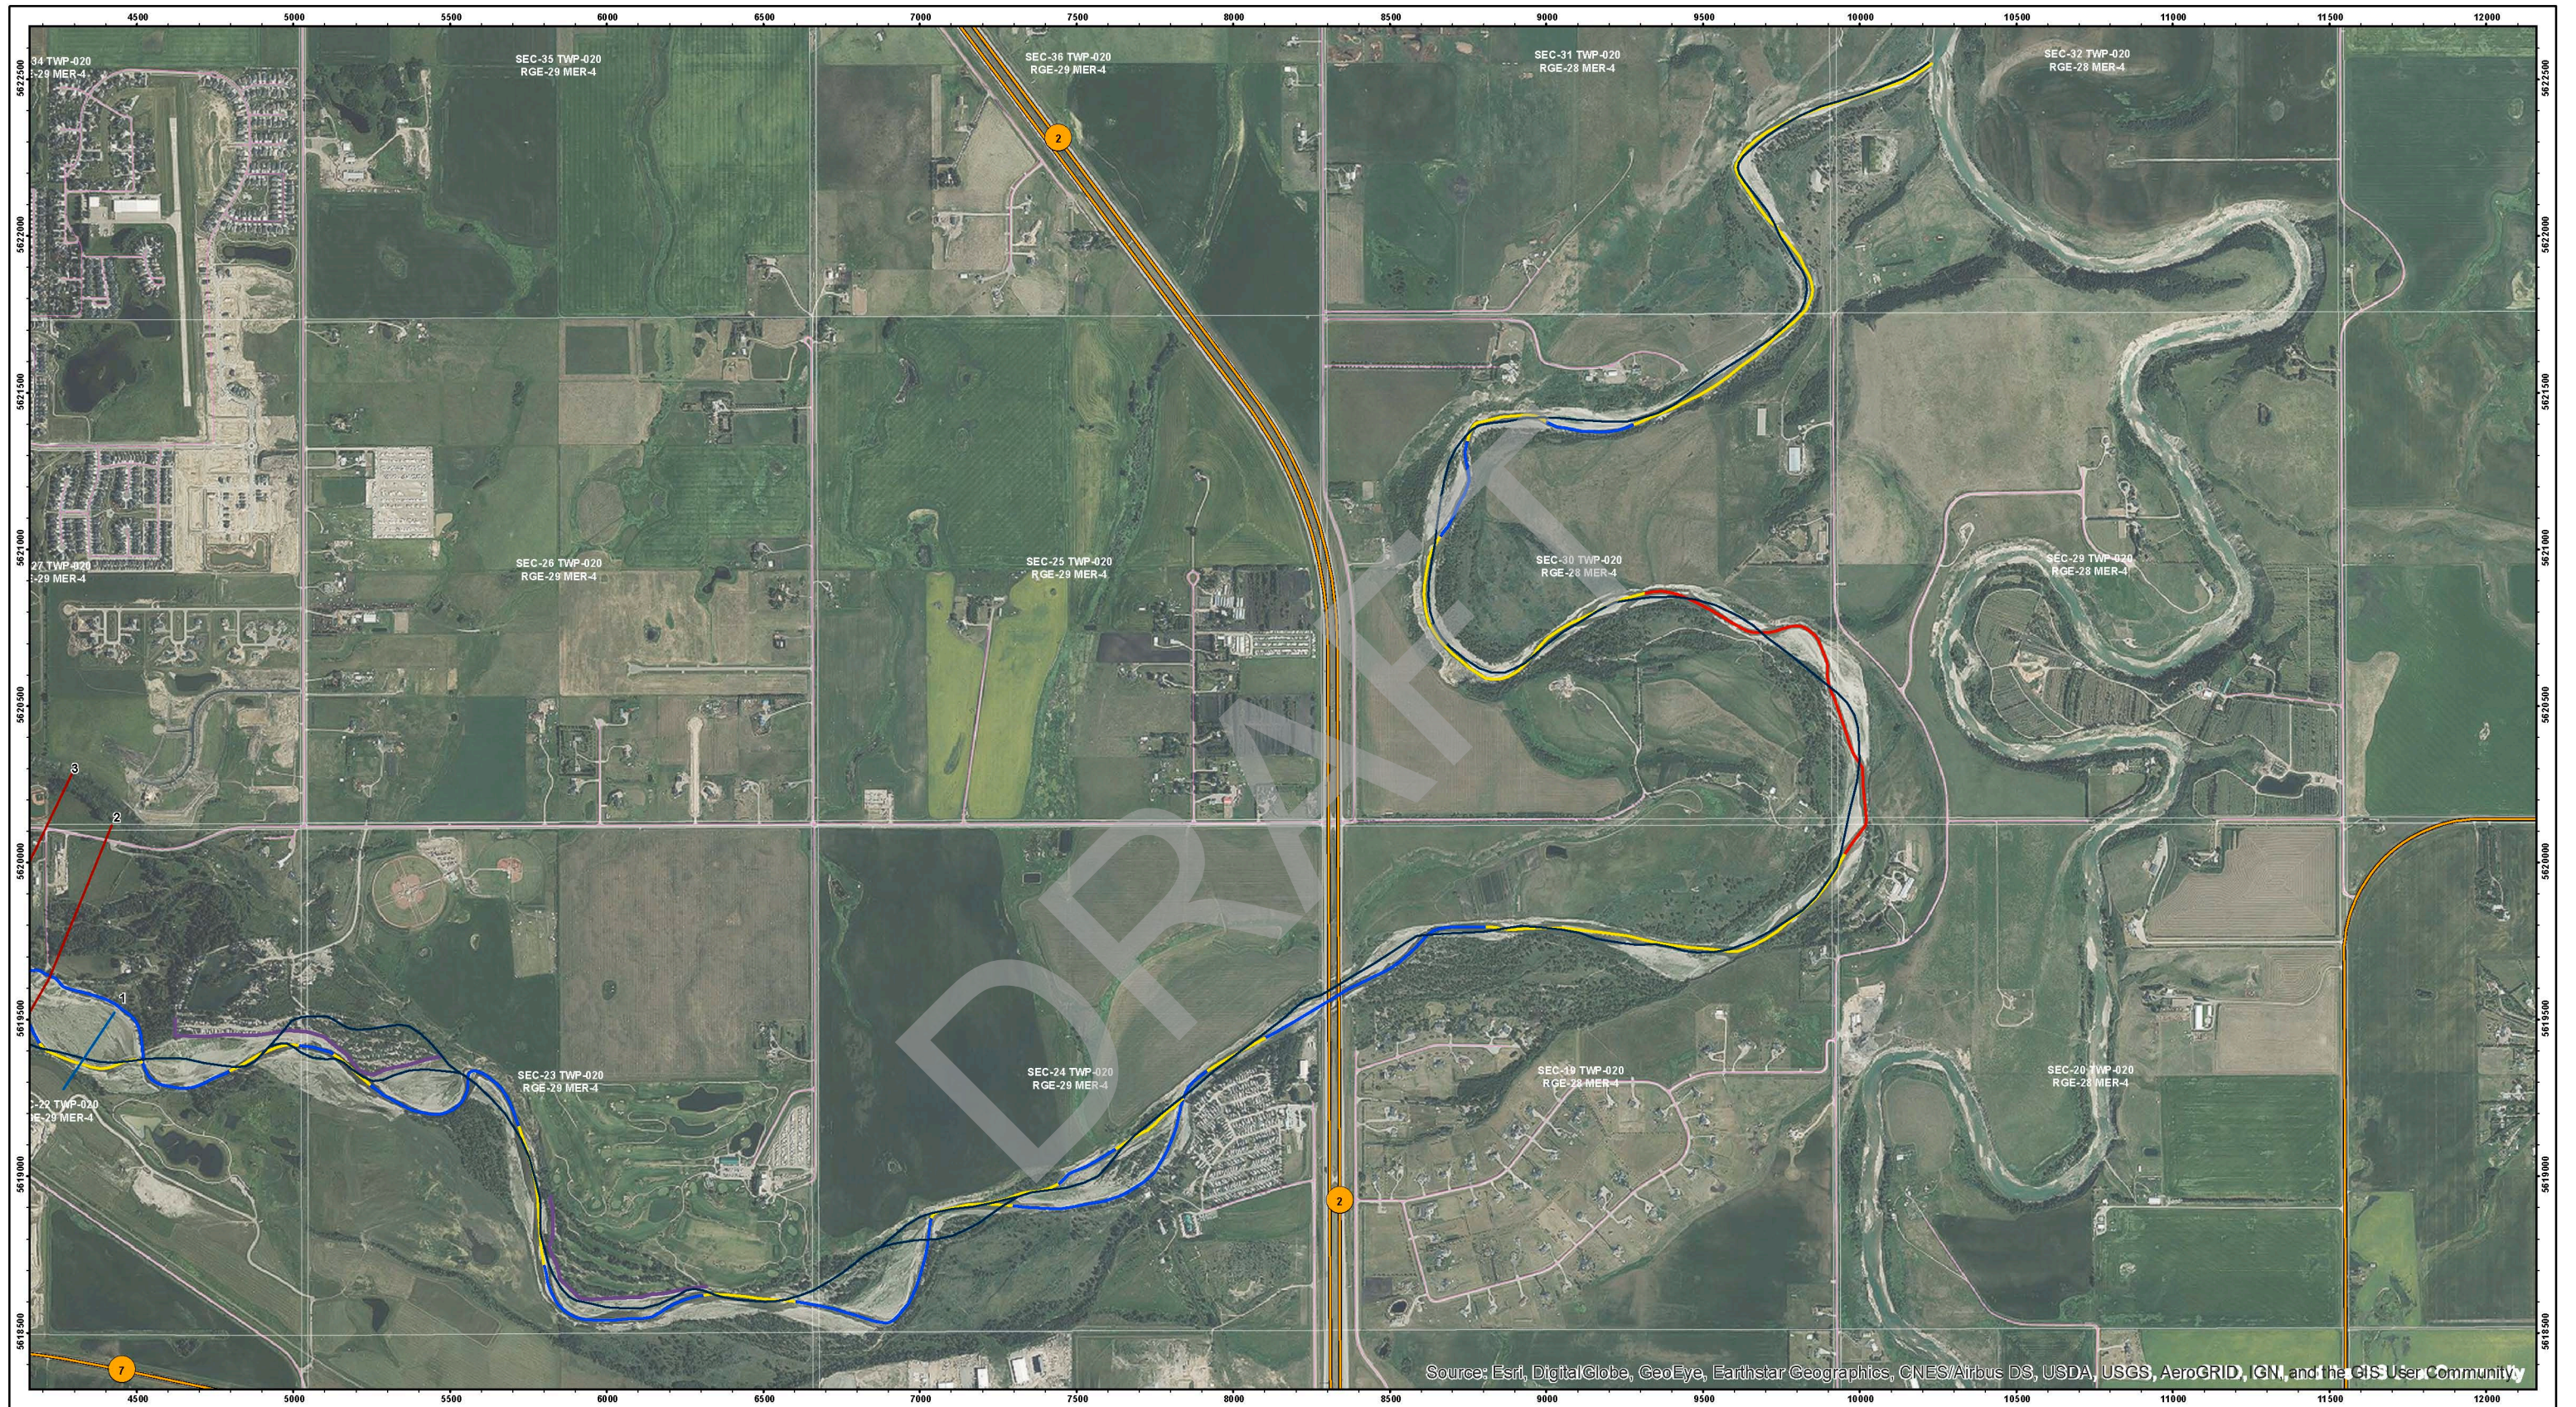
J.D. MOLLARD AND ASSOCIATES (2016) LTD.				
PROJECT: SHEEP RIVER HAZARD STUDY, CHANNEL STABILITY INVESTIGATION				
TITLE: River centrelines, 2016 LiDAR				
DRAWN	DVZ	09 FEB 2019	MAP 13	3TM 114
CHECK	DSM	11 FEB 2019		NAD 1983
REVIEW	LAP	11 FEB 2019		1:20,000

- LEGEND**
- 1951 channel centreline
 - 2015 channel centreline
 - Deviation from 1951 centreline
 - Smallest deviation
 - Large deviation short segments
 - Large deviation long segments
- Cross section classification**
- Class 1A
 - Class 3
- Road
- Highway

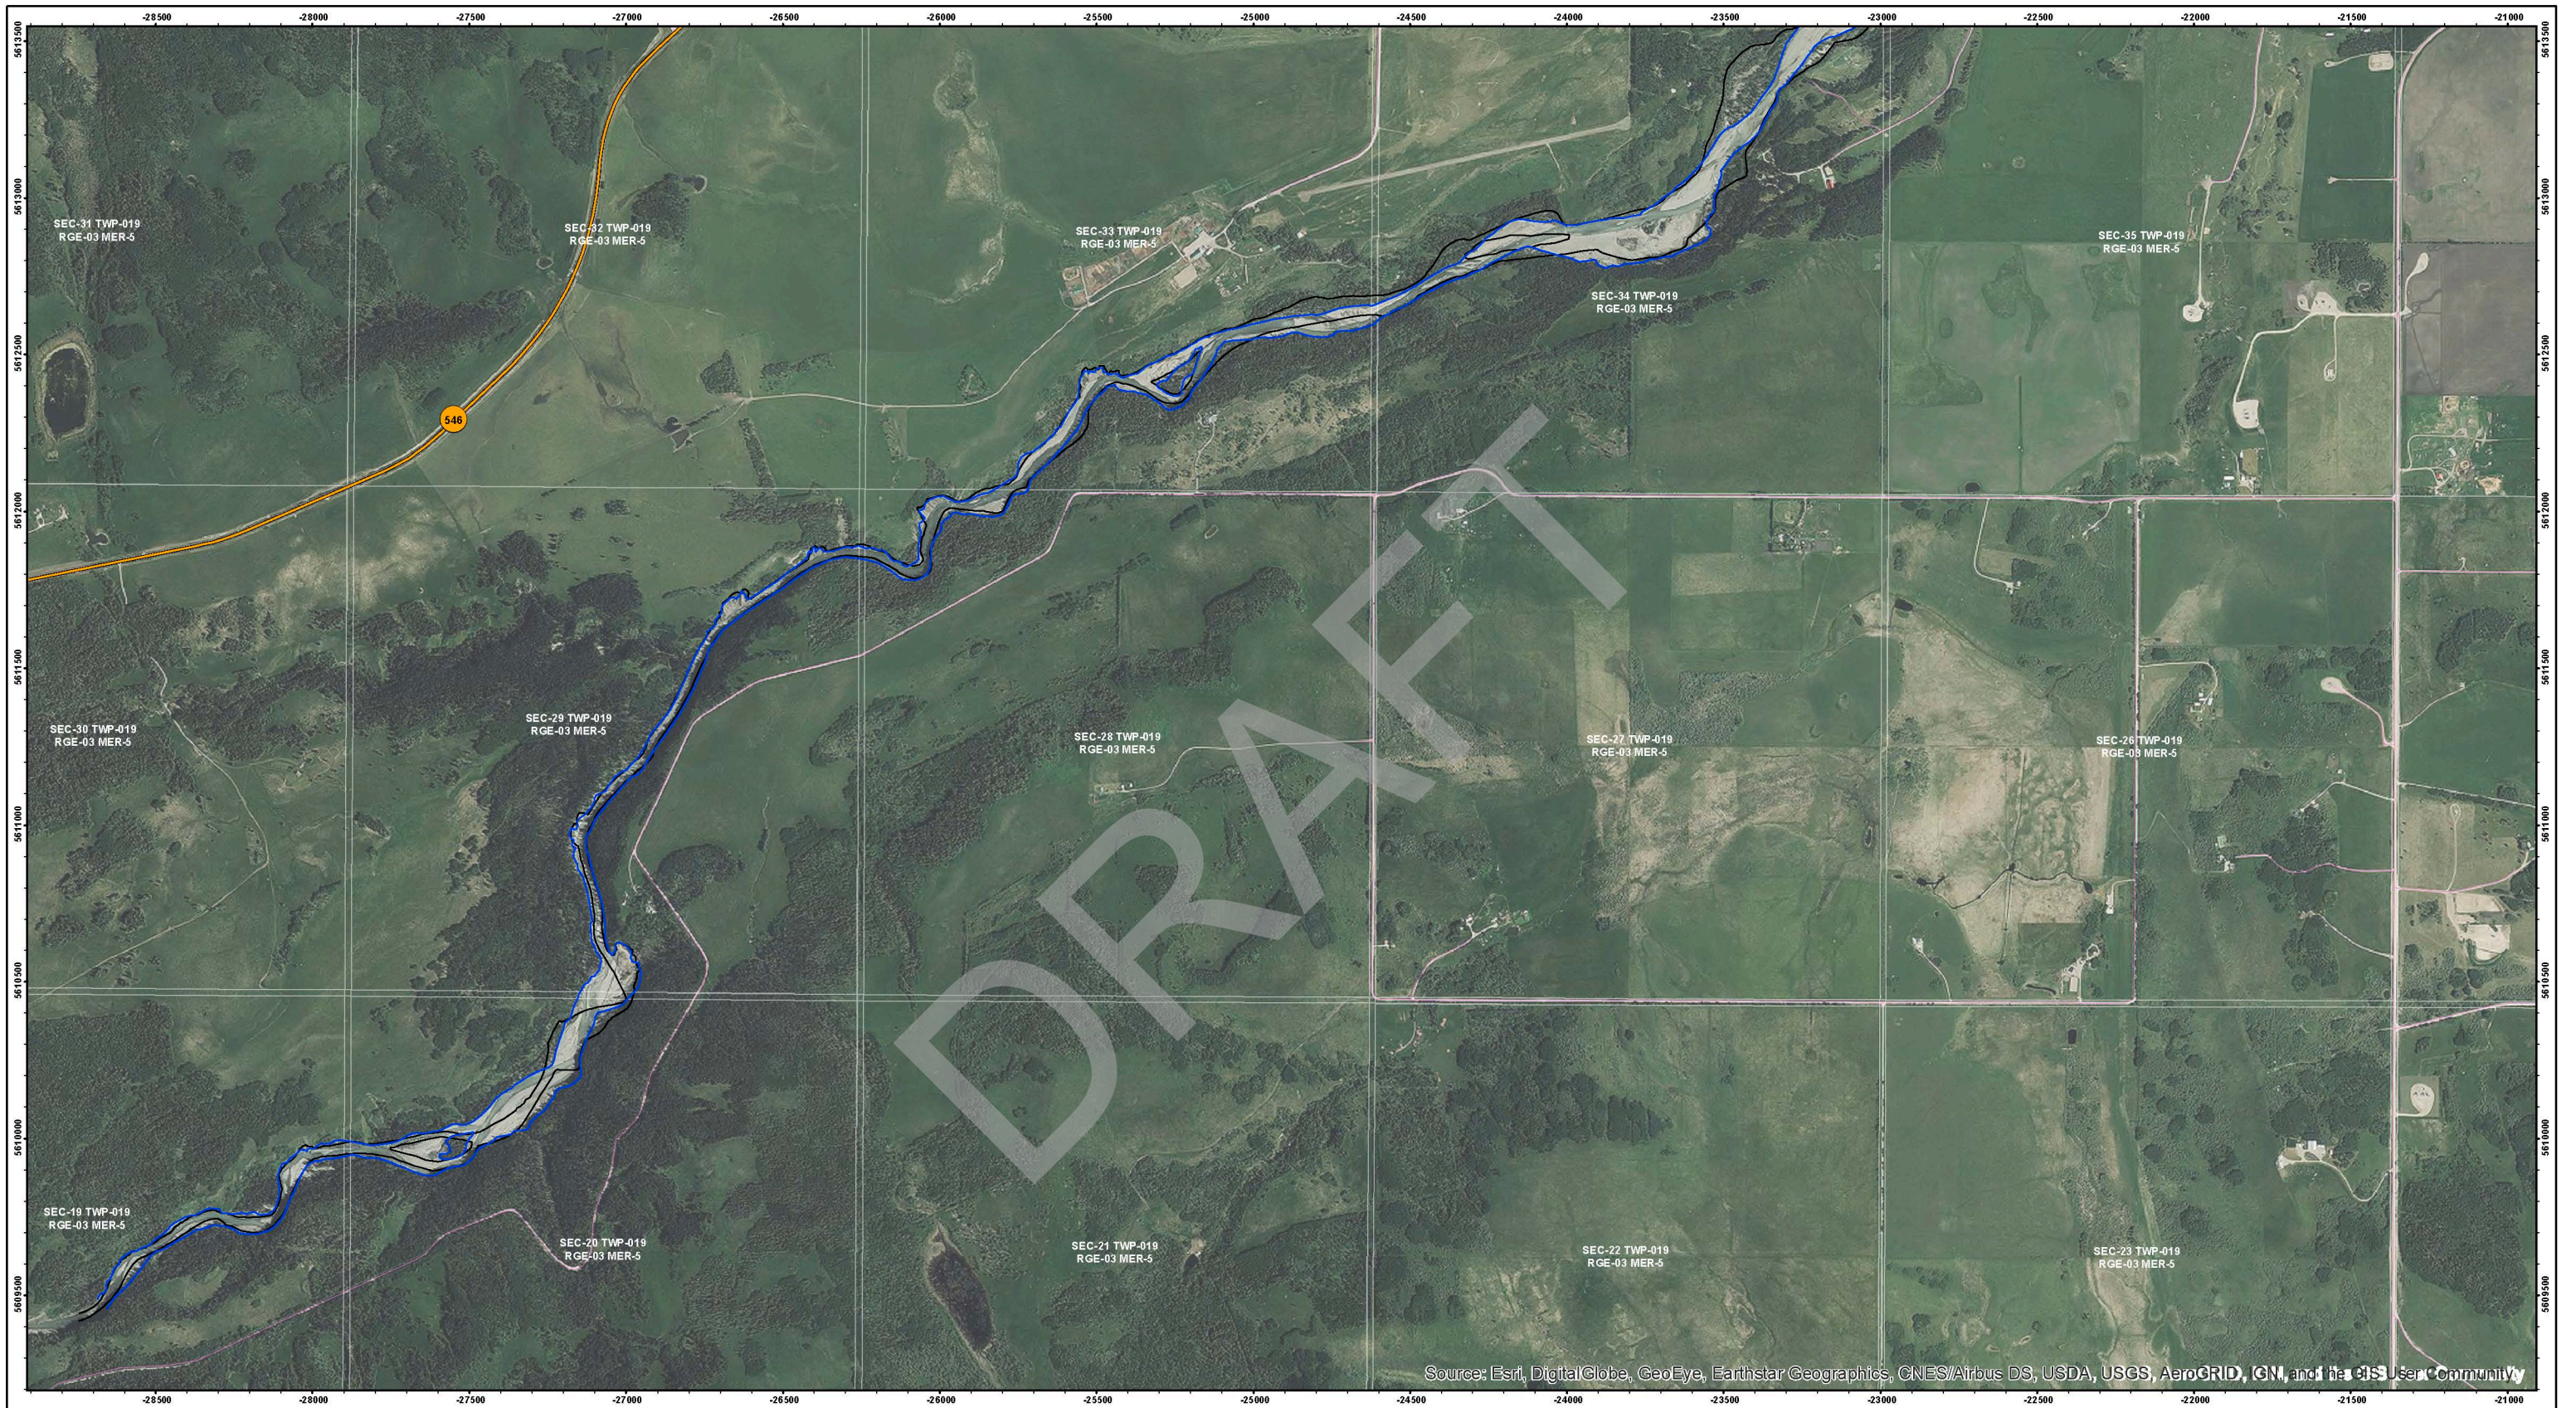
J.D. MOLLARD AND ASSOCIATES (2016) LIMITED				
PROJECT SHEEP RIVER HAZARD STUDY, CHANNEL STABILITY INVESTIGATION				
TITLE River centrelines, 2016 LiDAR				
DRAWN	DVZ	09 FEB 2019	MAP 21	3TM 114
CHECK	DSM	11 FEB 2019		NAD 1983
REVIEW	LAP	11 FEB 2019		1:20,000

- LEGEND**
- Previously mapped 'riverline' 1951
 - Previously mapped 'bankline' 2016
 - Road
 - Highway

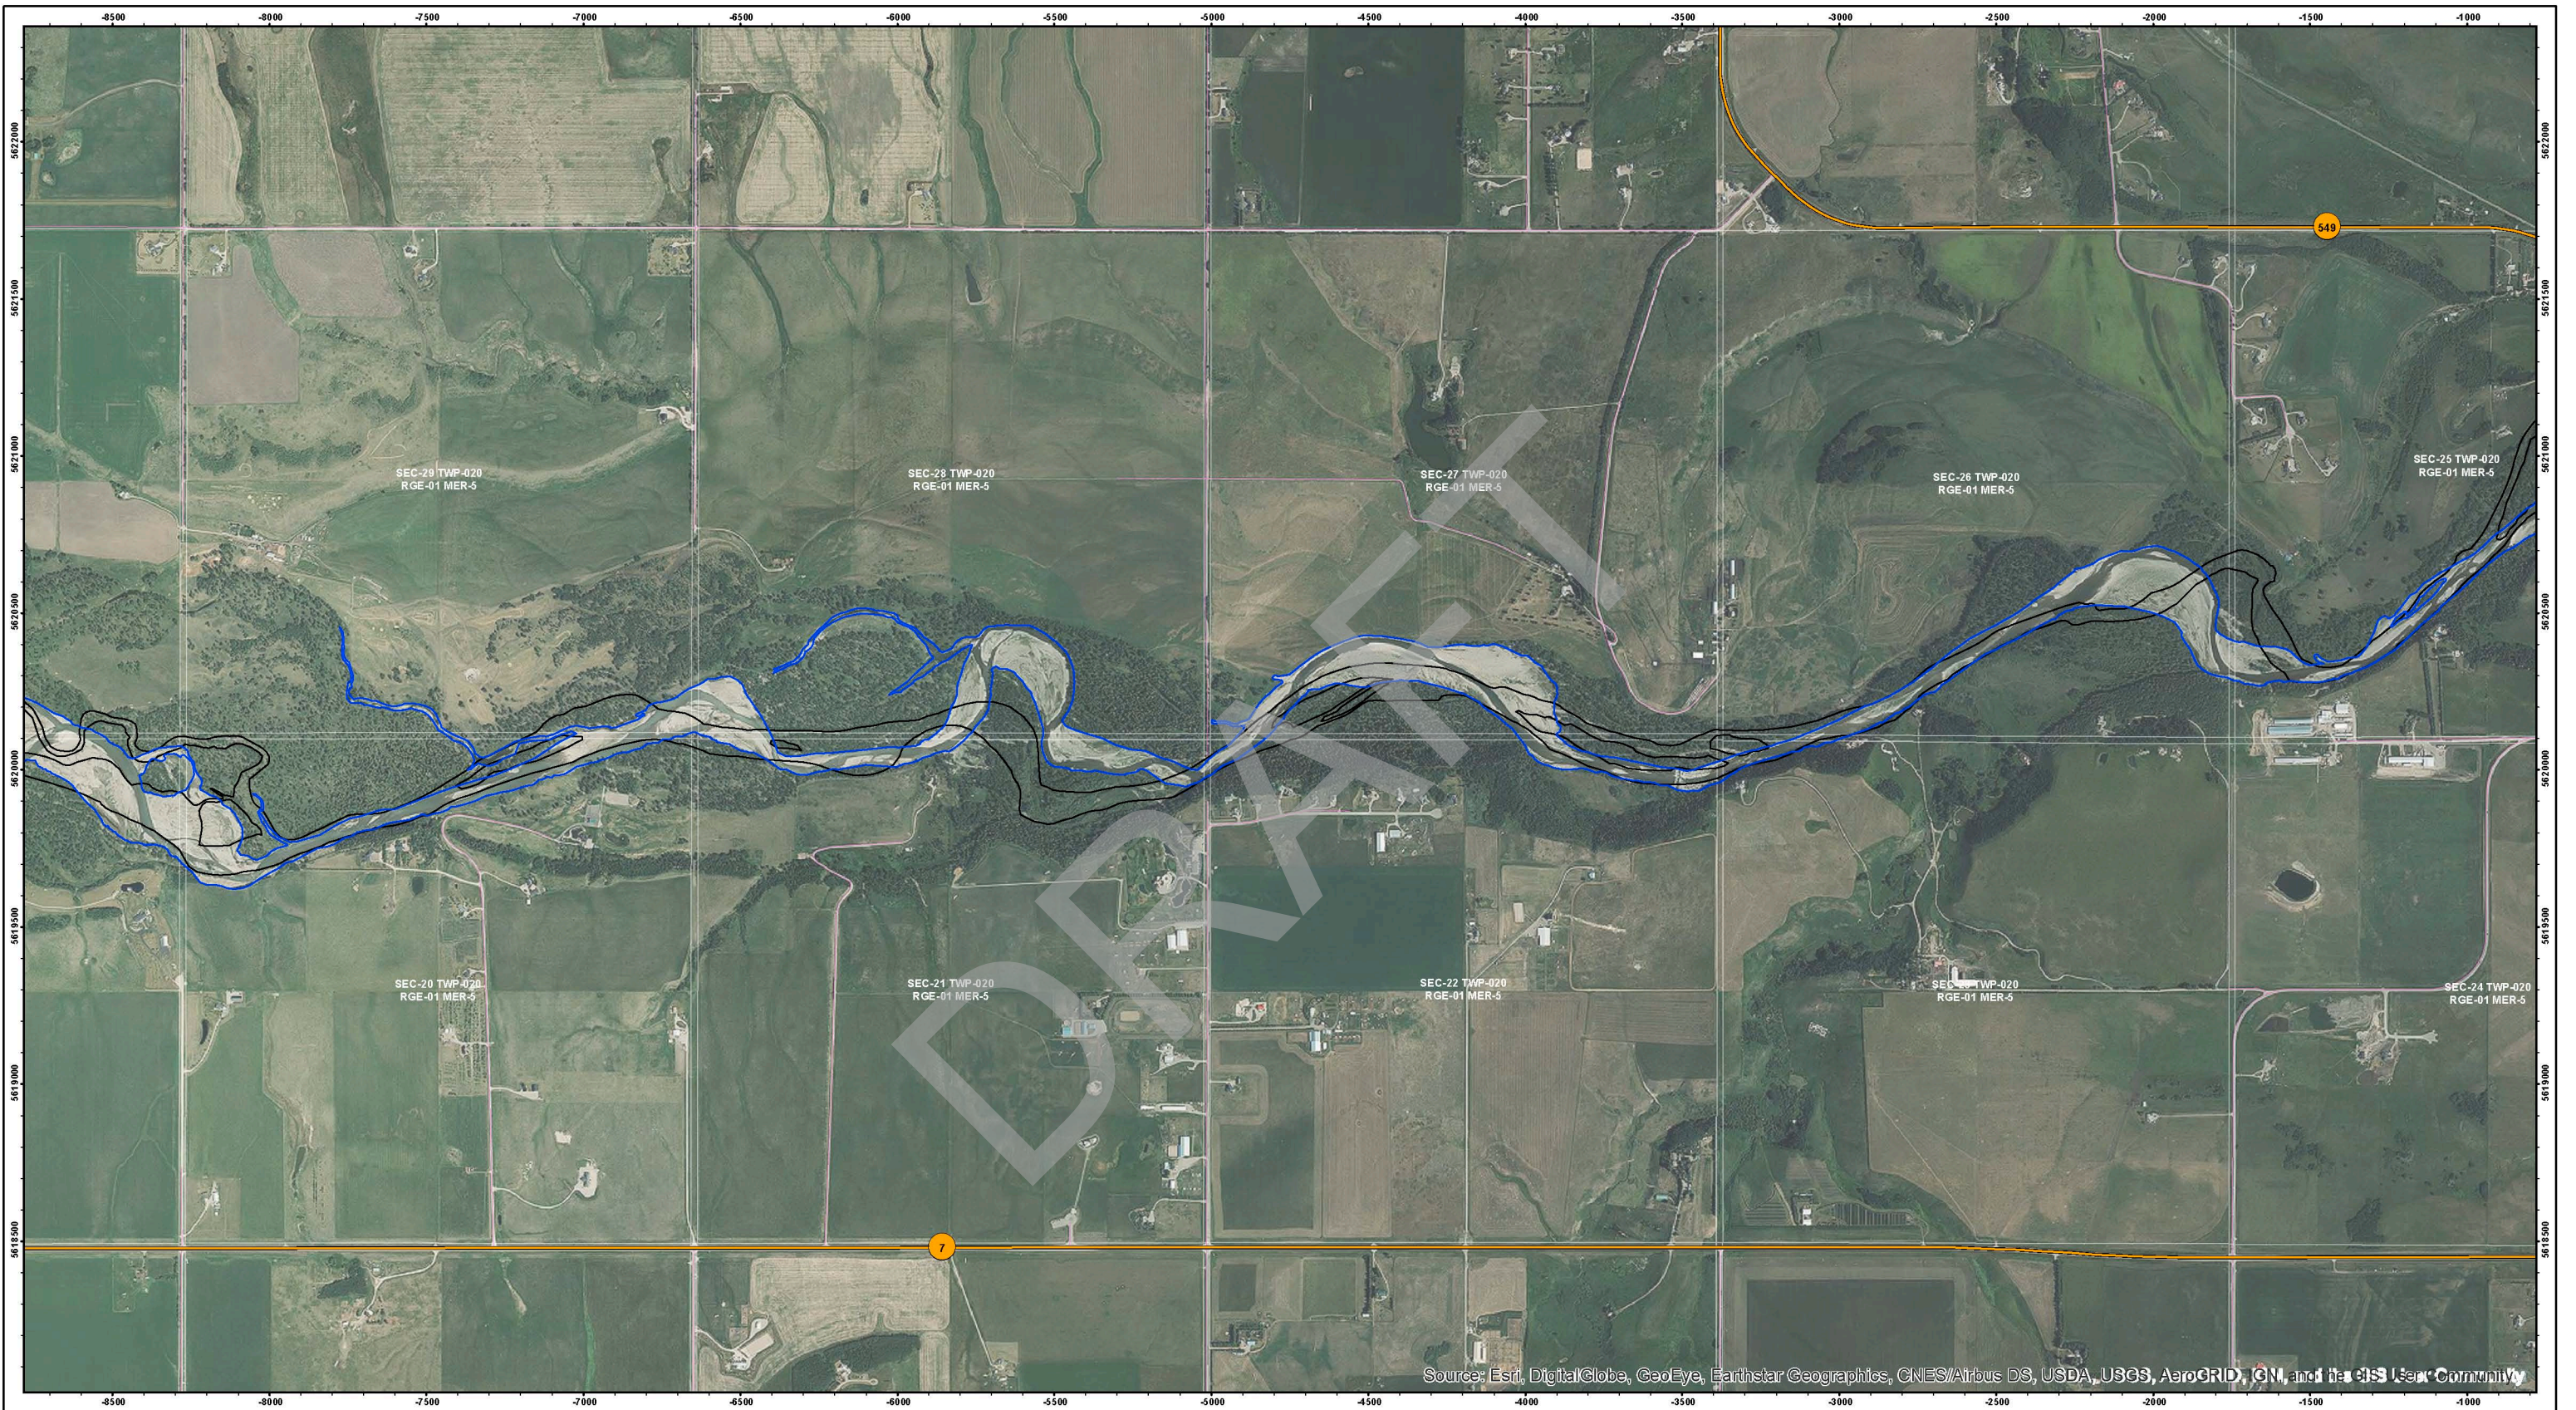
J.D. MOLLARD AND ASSOCIATES 2019 LIMITED				
PROJECT SHEEP RIVER HAZARD STUDY, CHANNEL STABILITY INVESTIGATION				
TITLE Previously mapped banklines, 2015 orthoimagery				
DRAWN	DVZ	09 FEB 2019	MAP 25	3TM 114
CHECK	DSM	11 FEB 2019		NAD 1983
REVIEW	LAP	11 FEB 2019		1:20,000

- LEGEND**
- Previously mapped 'riverline' 1951
 - Previously mapped 'bankline' 2016
 - Road
 - Highway

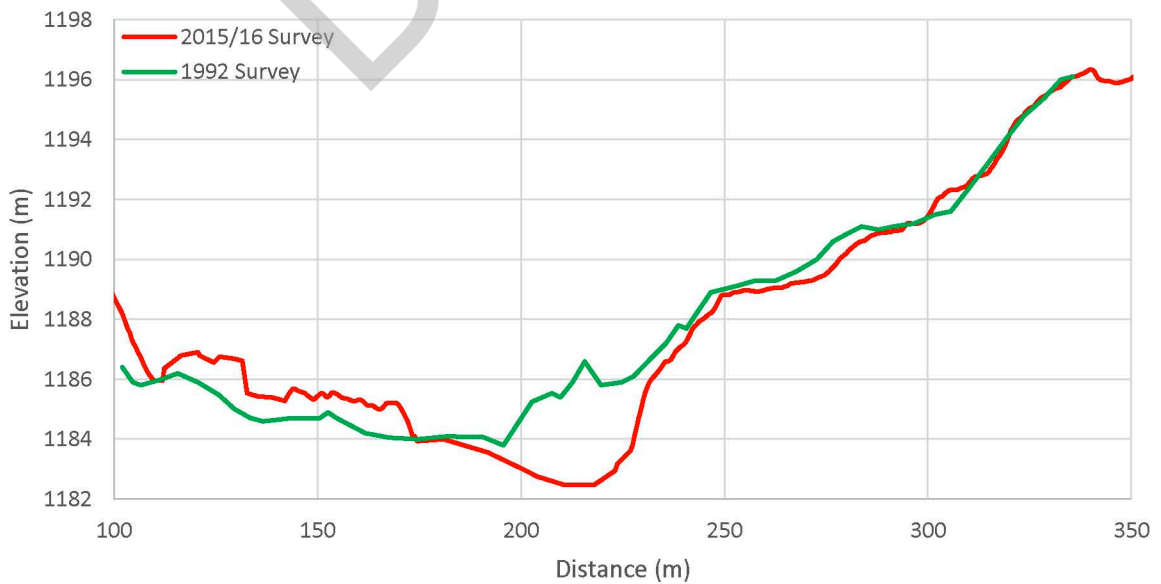
Sheep River St. 43.91 / BD&TV XS 20:
Class 1C

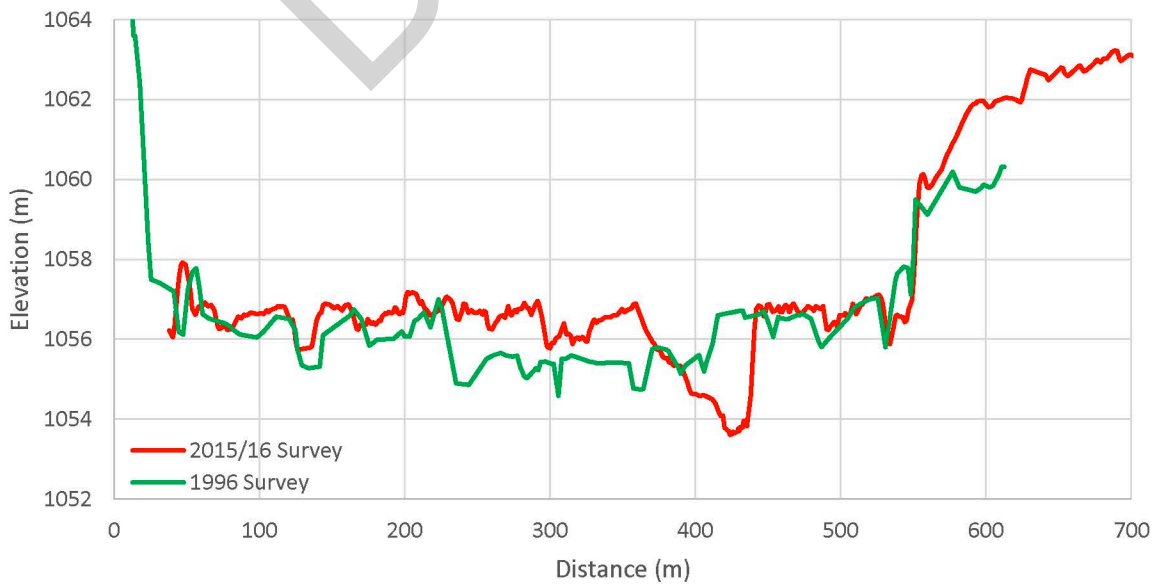
Sheep River St. 16.77 / Okotoks XS 19:
Class 1A

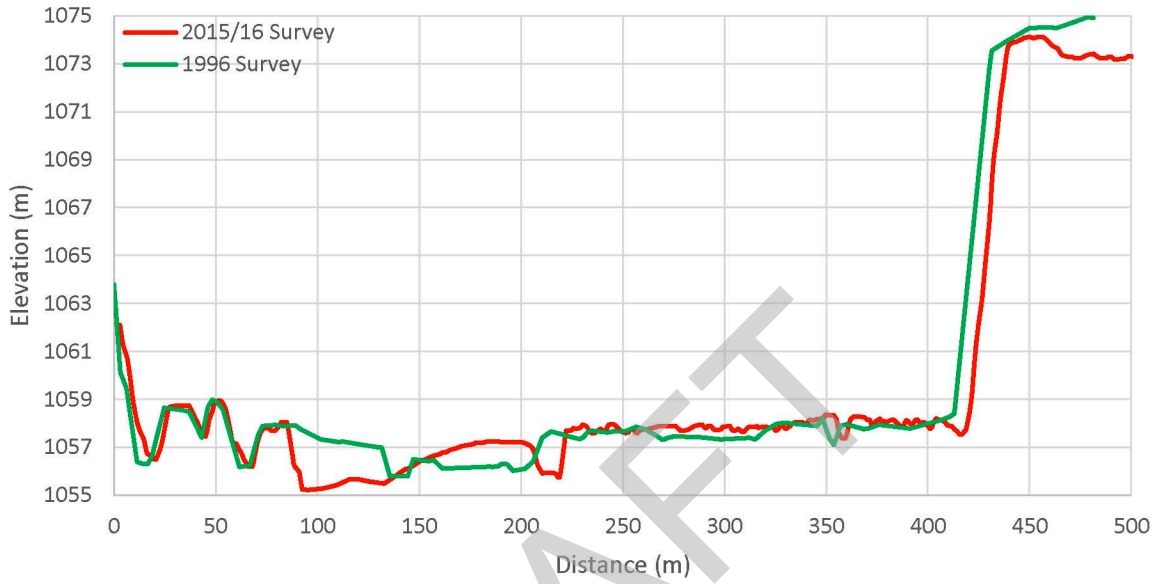
Sheep River St. 17.04 / Okotoks XS 20.1:
Class 1A
