SIKSIKA BOW RIVER HAZARD STUDY

Survey and Base Data Collection Report

Report Number: 1783054.R1.V1

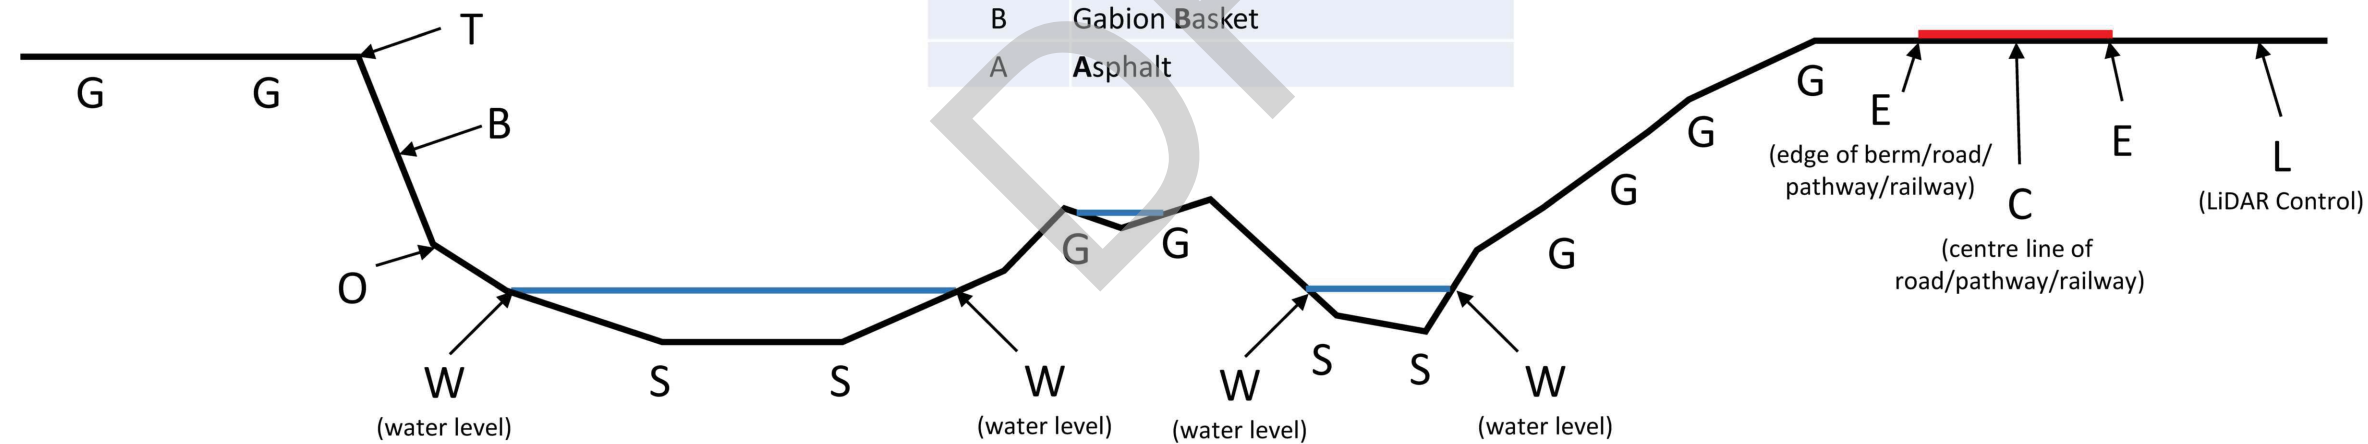
Material Code	
1	Mud/Silt (<0.063 mm)
2	Sand (0.063 mm - 2 mm)
3	Gravel (2 mm - 6.4 cm)
4	Cobble (6.4 cm - 25 cm)
5	Boulder (> 25 cm)
6	Bedrock
C	Concrete
G	Grass
R	Riprap
T	Trees (large, trunk > 10 cm)
W	Willows and Shrubs
B	Gabion Basket
A	Asphalt

Examples	
G2	Ground, Sand
G4	Ground, Cobble
W3	Water Level, Gravel
GG	Ground, Grass
GT	Ground, Trees
CA	Centre Line, Asphalt
BR	Bank, Riprap
LC	LiDAR control, Concrete

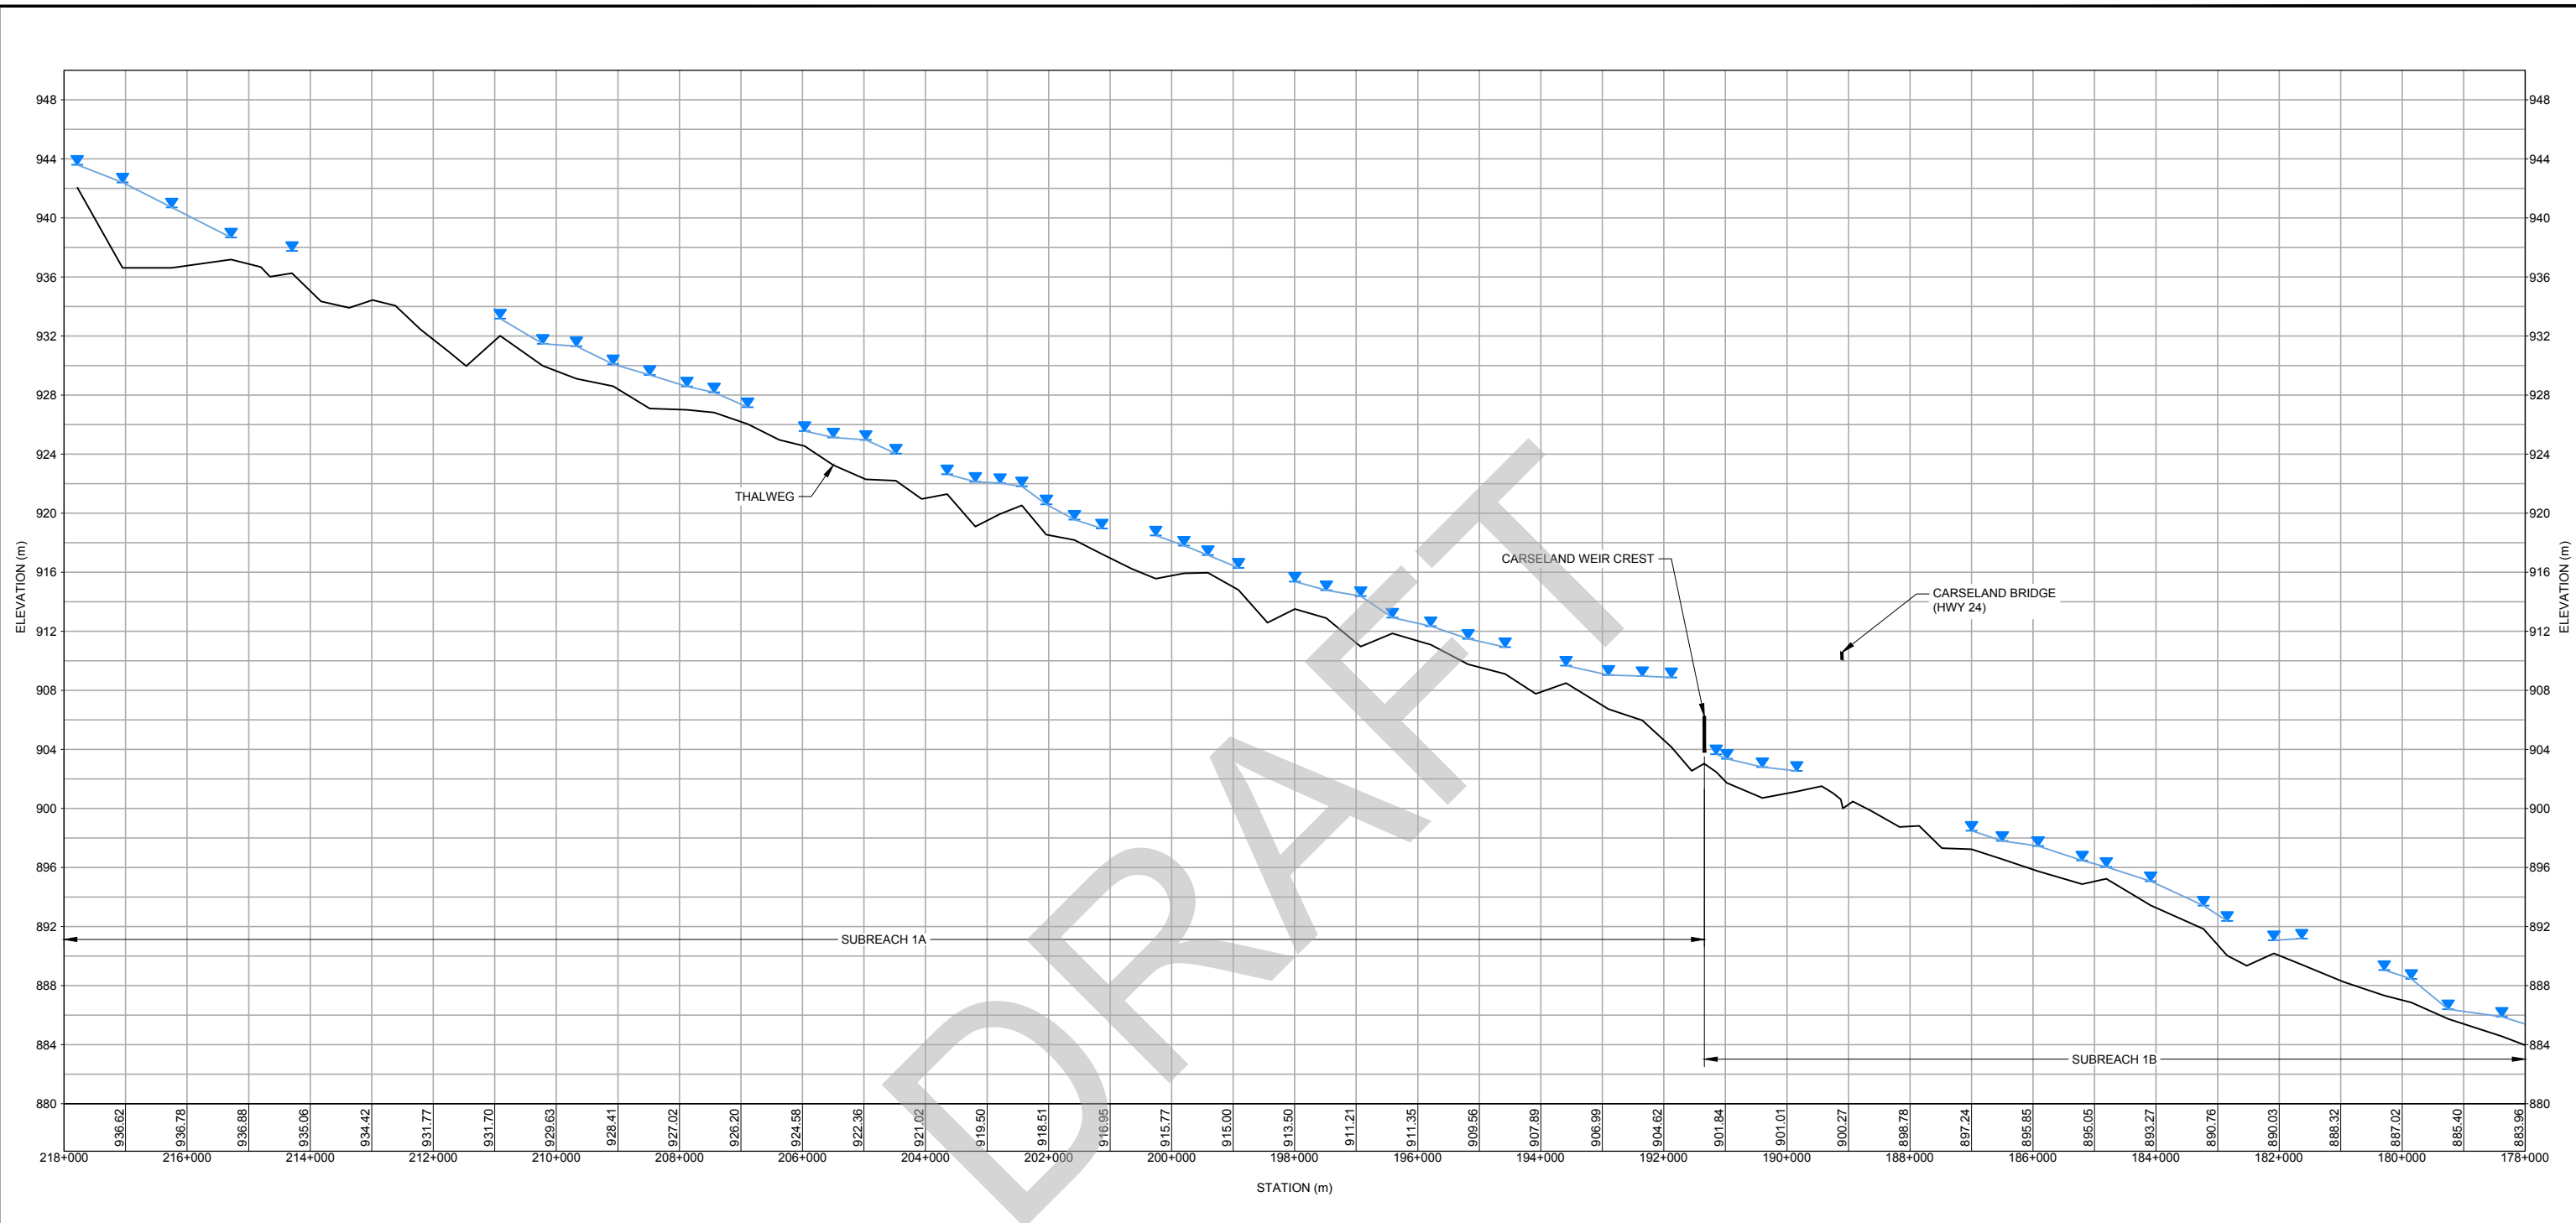
PROJECT No. 1783054 Rev. 0 **FIGURE A-1**

NOTES
 1. SURVEY DATA ALONG SUBREACHES 1A AND 1B WERE COLLECTED BY GOLDER IN 2017 ON SEPTEMBER 12, 14, 15, 16-18 AND OCTOBER 26.
 2. GAPS IN THE WATER SURFACE PROFILE ARE REPRESENTATIVE OF SECTIONS ALONG THE STUDY REACH WHERE BATHYMETRIC DATA COLLECTED BY GOLDER IN 2015 FOR AEP ARE BEING USED TO SUPPLEMENT THE FIELD DATA.

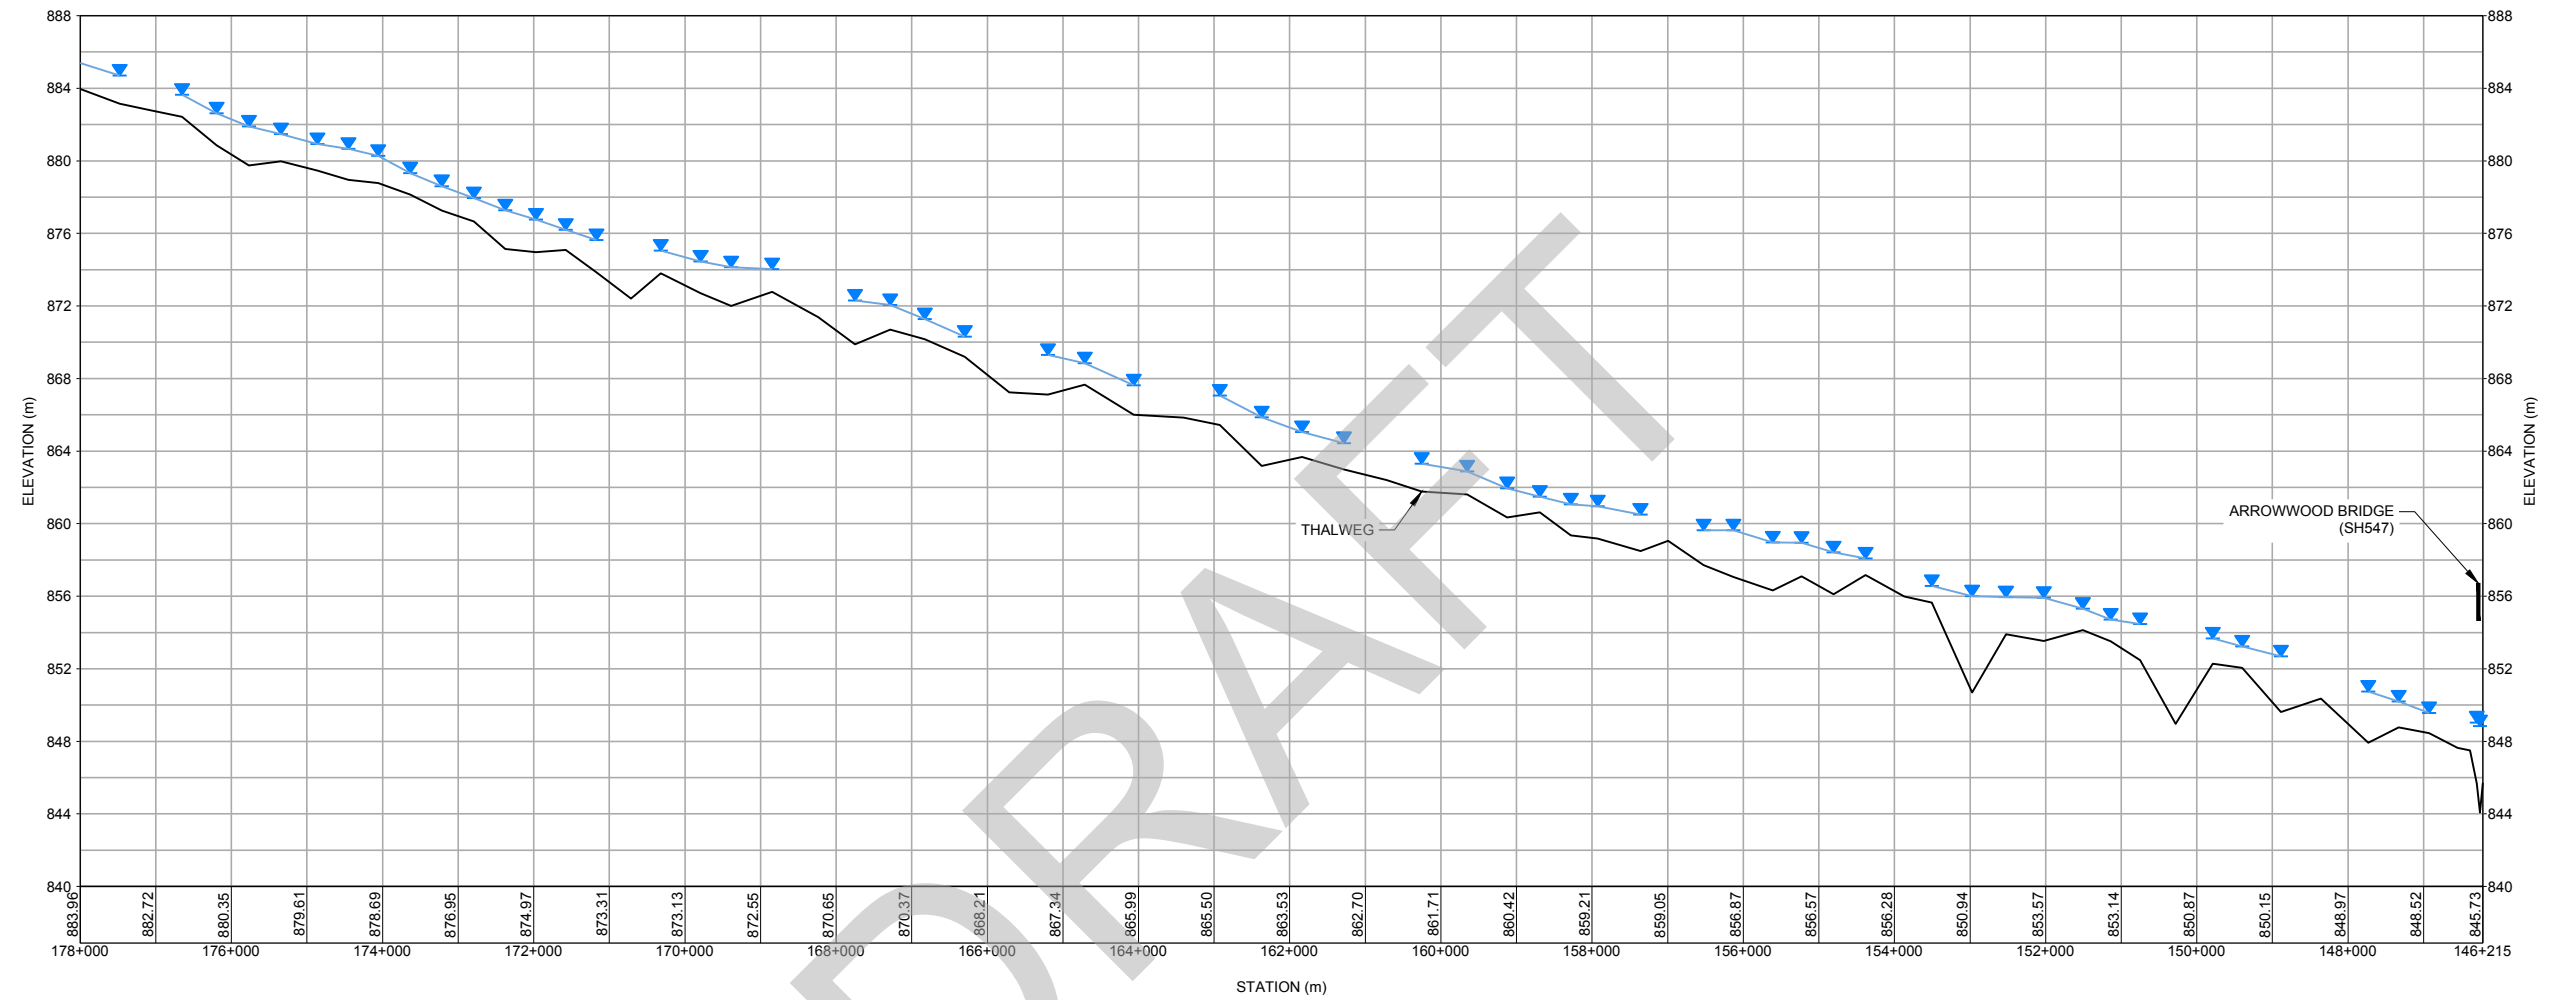
PROJECT No. 1783054
 Rev. 0
 FIGURE A-2

NOTES
 1. SURVEY DATA ALONG SUBREACH 2A WERE COLLECTED BY GOLDER IN 2017 ON OCTOBER 4, 6, 8, 10-12 AND 24.
 2. GAPS IN THE WATER SURFACE PROFILE ARE REPRESENTATIVE OF SECTIONS ALONG THE STUDY REACH WHERE BATHYMETRIC DATA COLLECTED BY GOLDER IN 2015 FOR AEP ARE BEING USED TO SUPPLEMENT THE FIELD DATA.

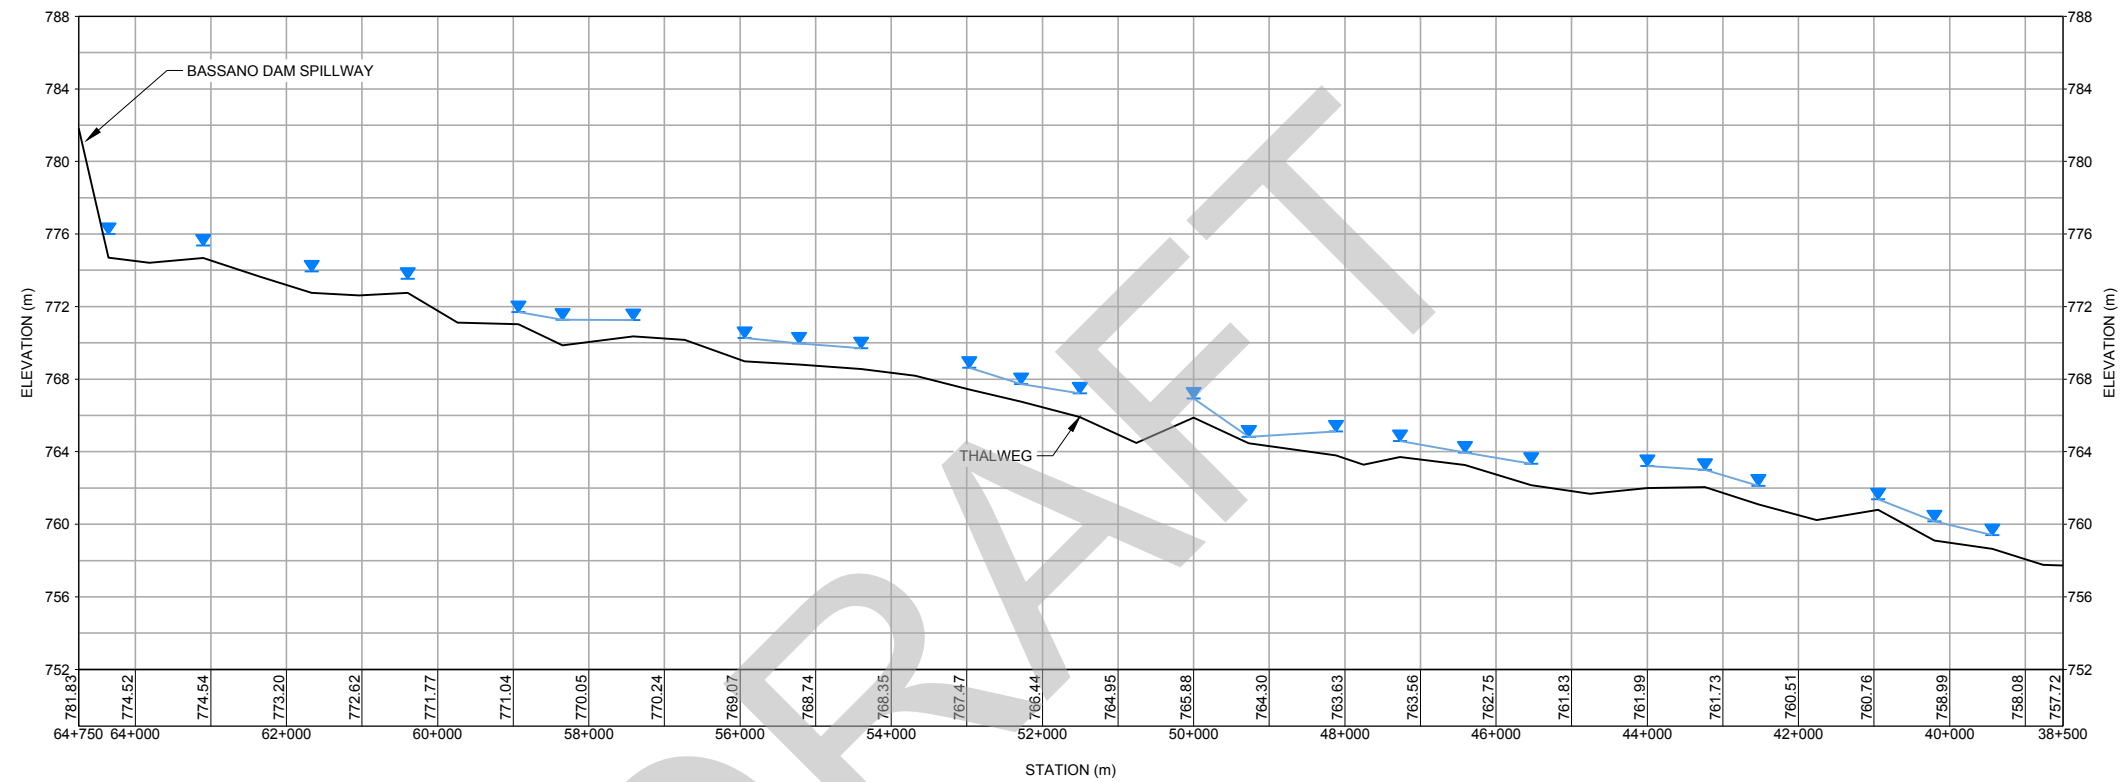
PROJECT No. 1783054
 Rev. 0
 FIGURE A-5

NOTES
 1. SURVEY DATA ALONG SUBREACH 3A WERE COLLECTED BY GOLDER IN 2017 ON SEPTEMBER 20, 25 AND 29.
 2. GAPS IN THE WATER SURFACE PROFILE ARE REPRESENTATIVE OF SECTIONS ALONG THE STUDY REACH WHERE BATHYMETRIC DATA COLLECTED BY GOLDER IN 2014 AND 2015 FOR AEP ARE BEING USED TO SUPPLEMENT THE FIELD DATA.

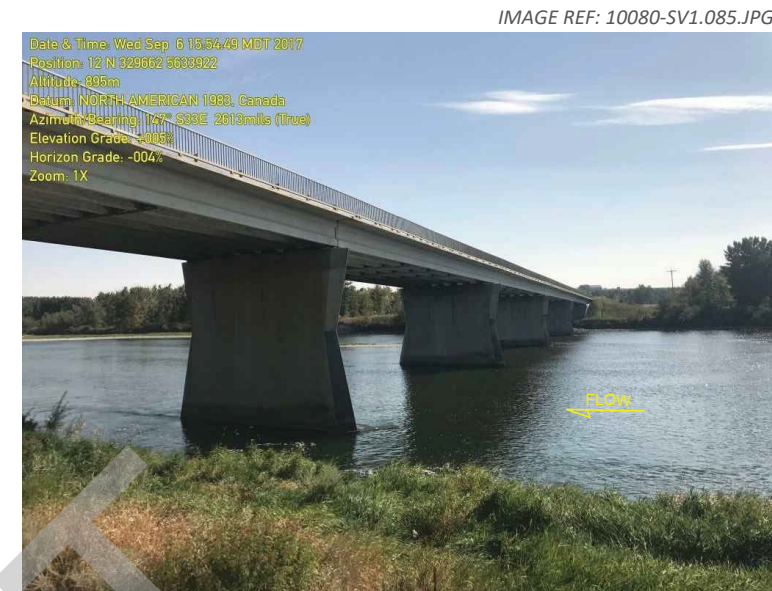
1. View looking downstream from left bank.

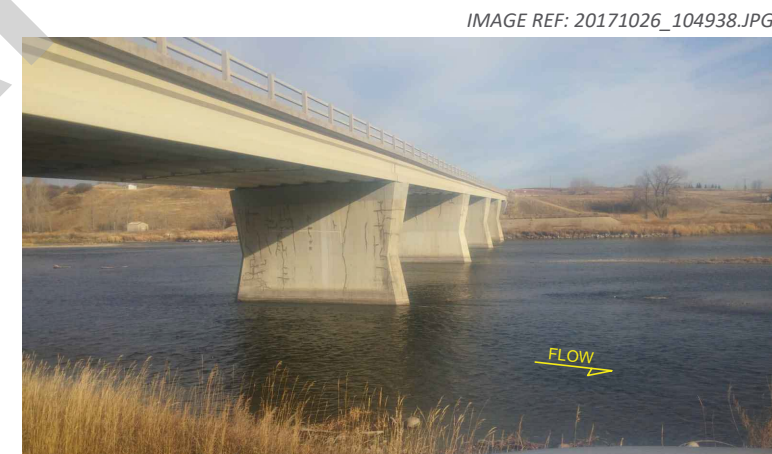
2. View looking across the river from right bank.

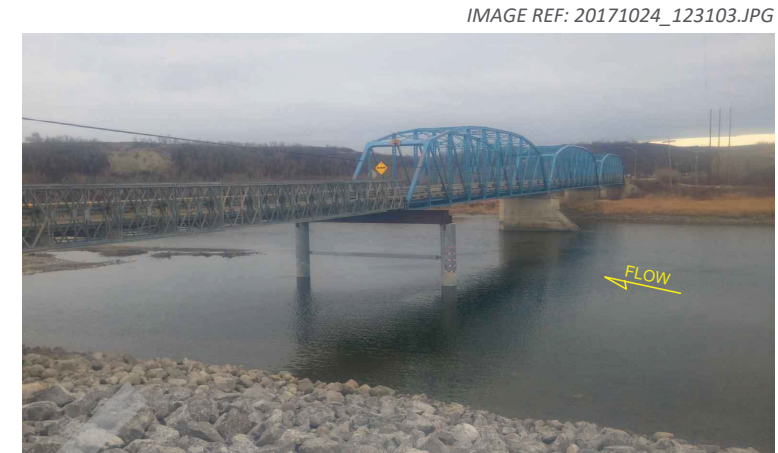
1. View looking downstream from left bank. Note that the construction cofferdam, as shown in the aerial image to the left, had been removed prior to river surveying.

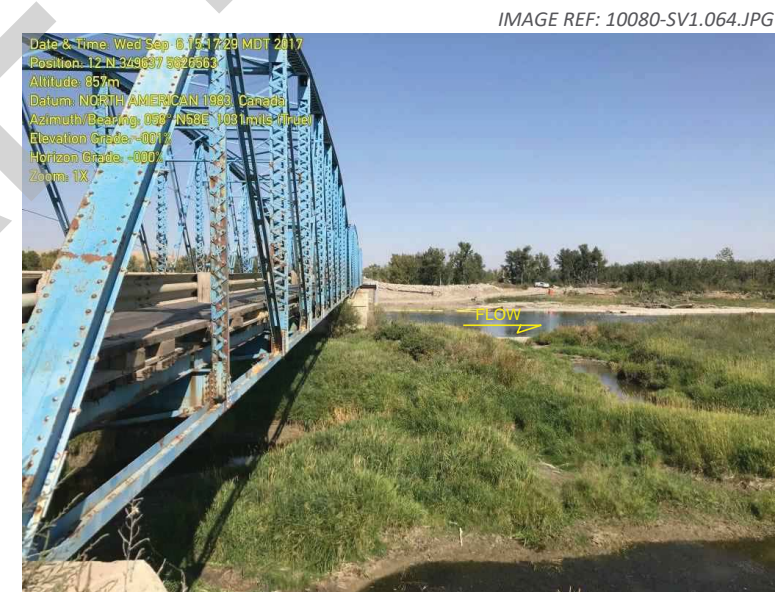
2. View looking across the river from right bank at the bridge abutment.

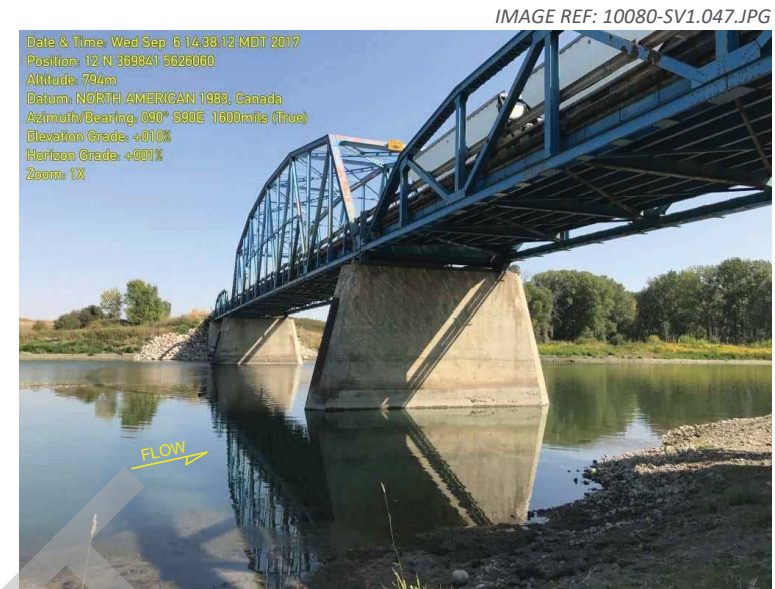
1. View looking across channel from right bank.

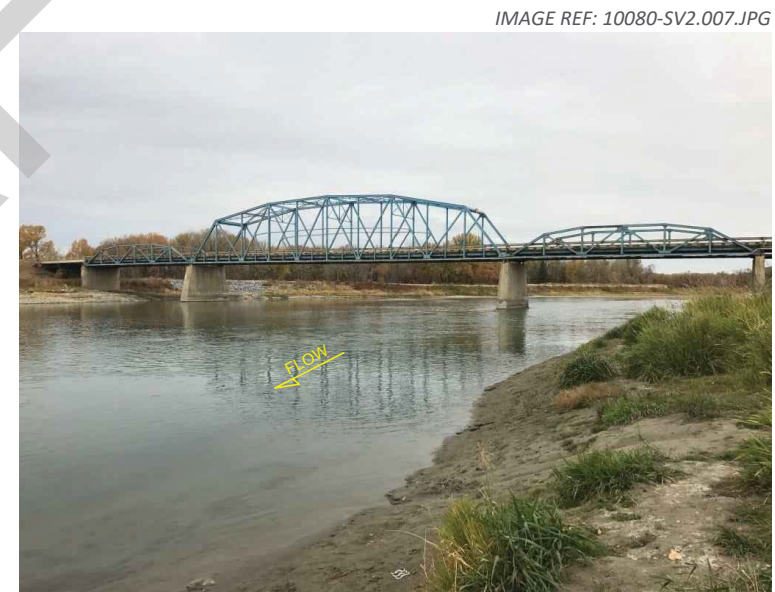
2. View looking upstream from left bank.

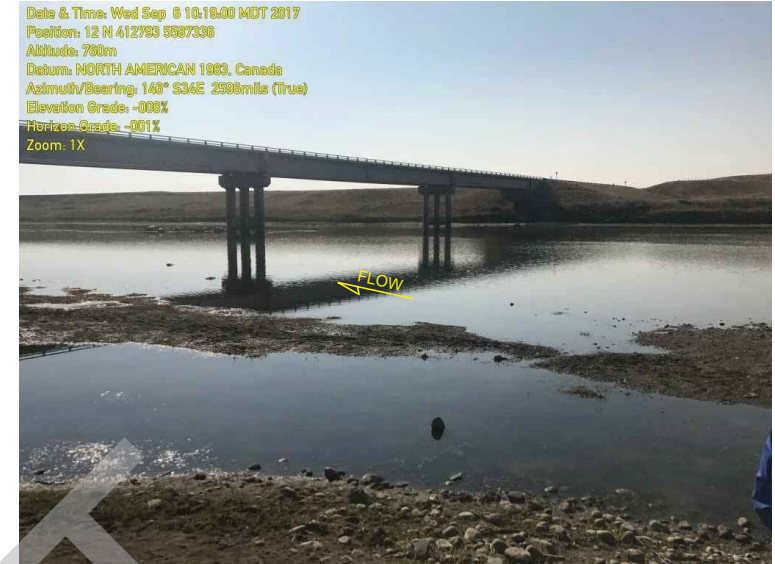
1. View looking downstream from left bank.

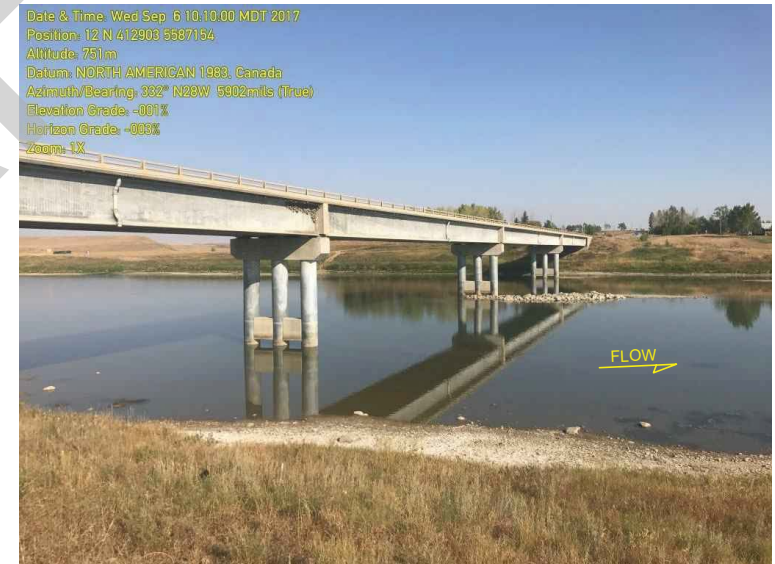
2. View looking upstream from right bank.

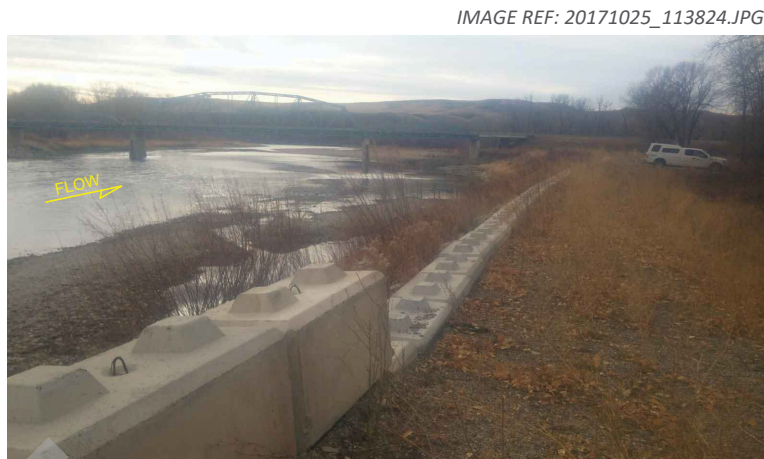
1. View looking downstream at the lower berm near its downstream end. Note SH 842 (Arrowwood) Bridge in the background.

ADJACENT WATERBODY	DESCRIPTION	APPROXIMATE LENGTH (m)	SIDE OF RIVER	TYPE
BOW RIVER	INTERLOCKING CONCRETE BLOCK STRUCTURE SITUATED ADJACENT TO HIDDEN VALLEY RESORT NEAR ARROWWOOD, AB	1540 (UPPER) 500 (LOWER)	RIGHT	BERM

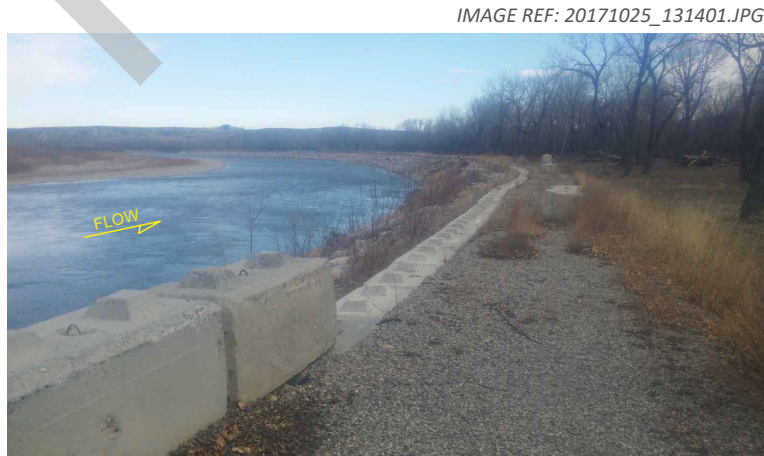
2. View looking downstream at the upper berm midway along its length.

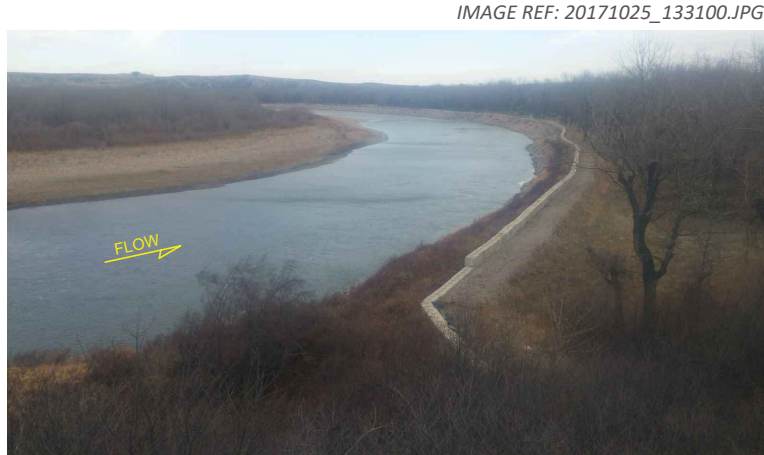
3. View looking downstream from the upstream end of the upper berm.
