## BOW AND ELBOW RIVER HAZARD STUDY

# Channel Stability Investigation Report

**Report Number:** 1536673\_R0007\_Rev. 0

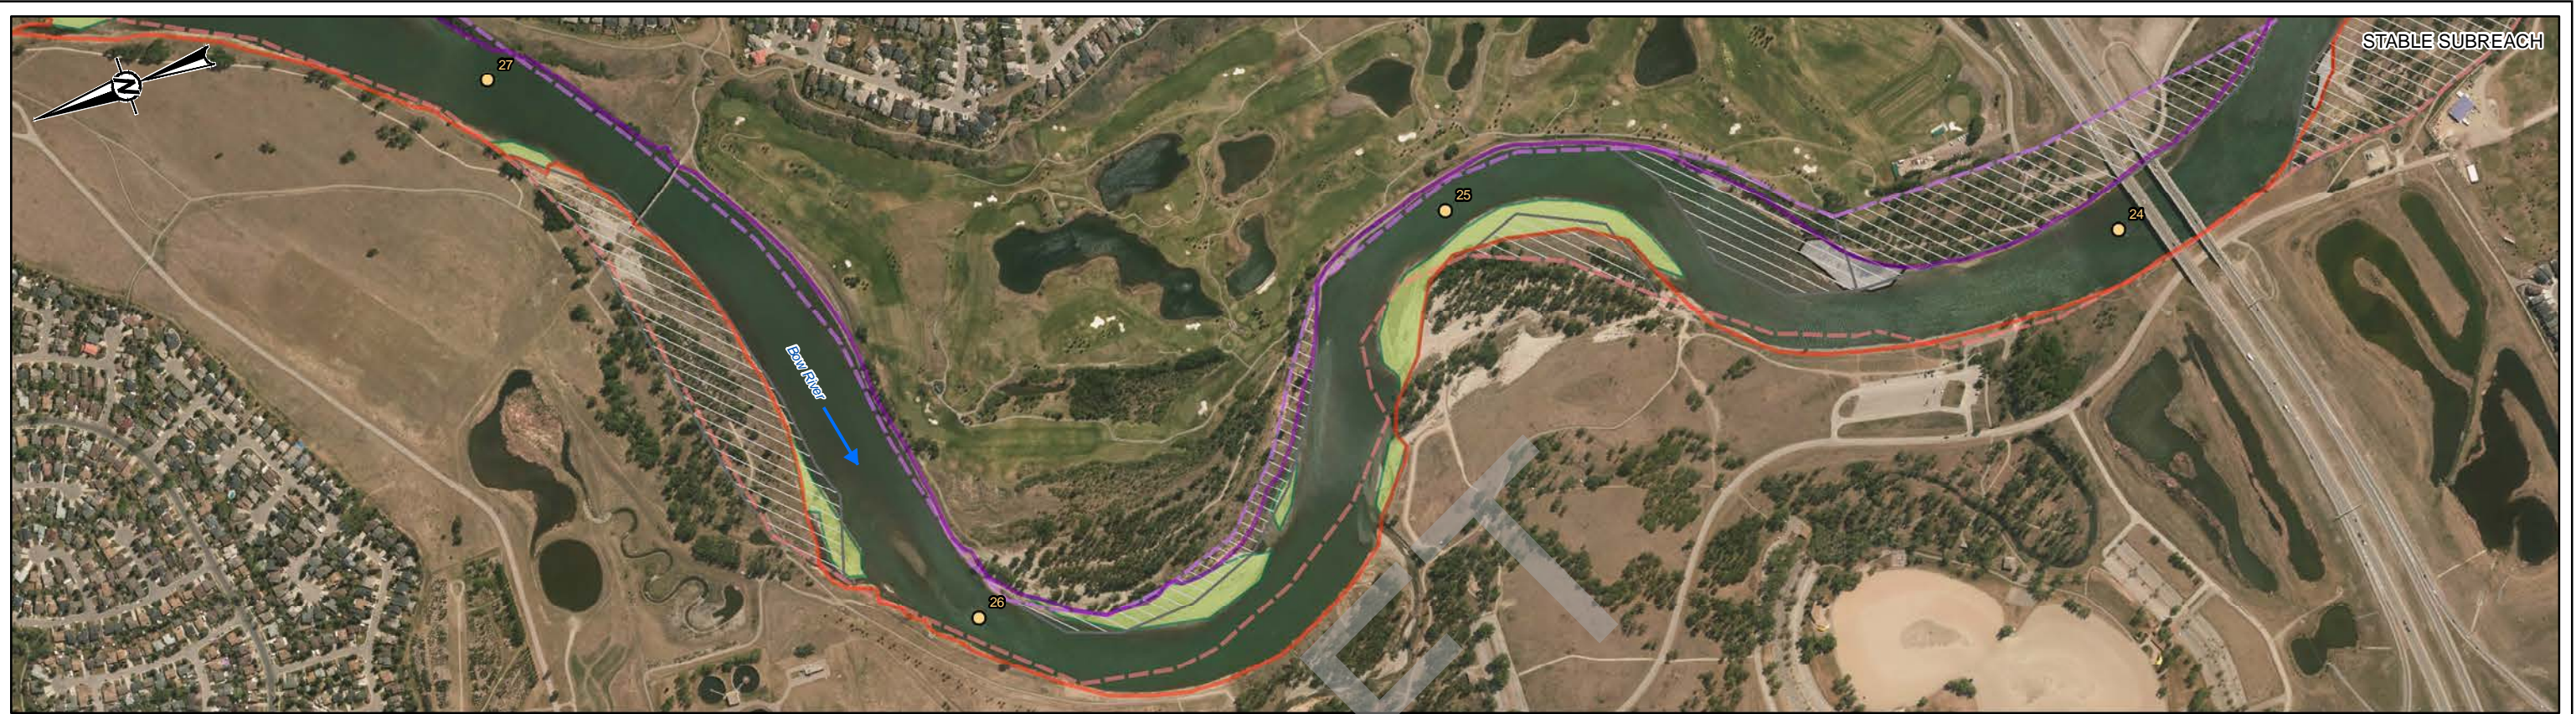
FIGURE **3**

STABLE SUBREACH

UNSTABLE SUBREACH

**TITLE**  
**CHANNEL BANK COMPARISON OF REACH 1 - BOW RIVER FROM ELBOW RIVER CONFLUENCE TO HIGH RIVER CONFLUENCE - REPRESENTATIVE SUBREACHES**

Reach	Representative Subreach (km)	Description
1 – Bow River from Elbow River confluence to Highwood River confluence	24 to 27	<ul style="list-style-type: none"> <li>- Confined floodplain</li> <li>- Single channel</li> <li>- Presence of point and side bars</li> <li>- Irregularly meandering</li> <li>- Stabilization of side bars resulting in the narrowing of the active channel</li> <li>- Limited observed migration of the channel outside of bends of meanders</li> </ul>
	28 to 31	<ul style="list-style-type: none"> <li>- Confined floodplain</li> <li>- Predominantly single channel, some multi-channel sections</li> <li>- Presence of point, mid-channel and side bars</li> <li>- Irregularly meandering</li> <li>- Migration of side bars</li> <li>- Lateral migration of 40 m to 50 m of main channel at meander bends</li> <li>- Development of side channel off main stem</li> <li>- Human development within floodplain</li> </ul>

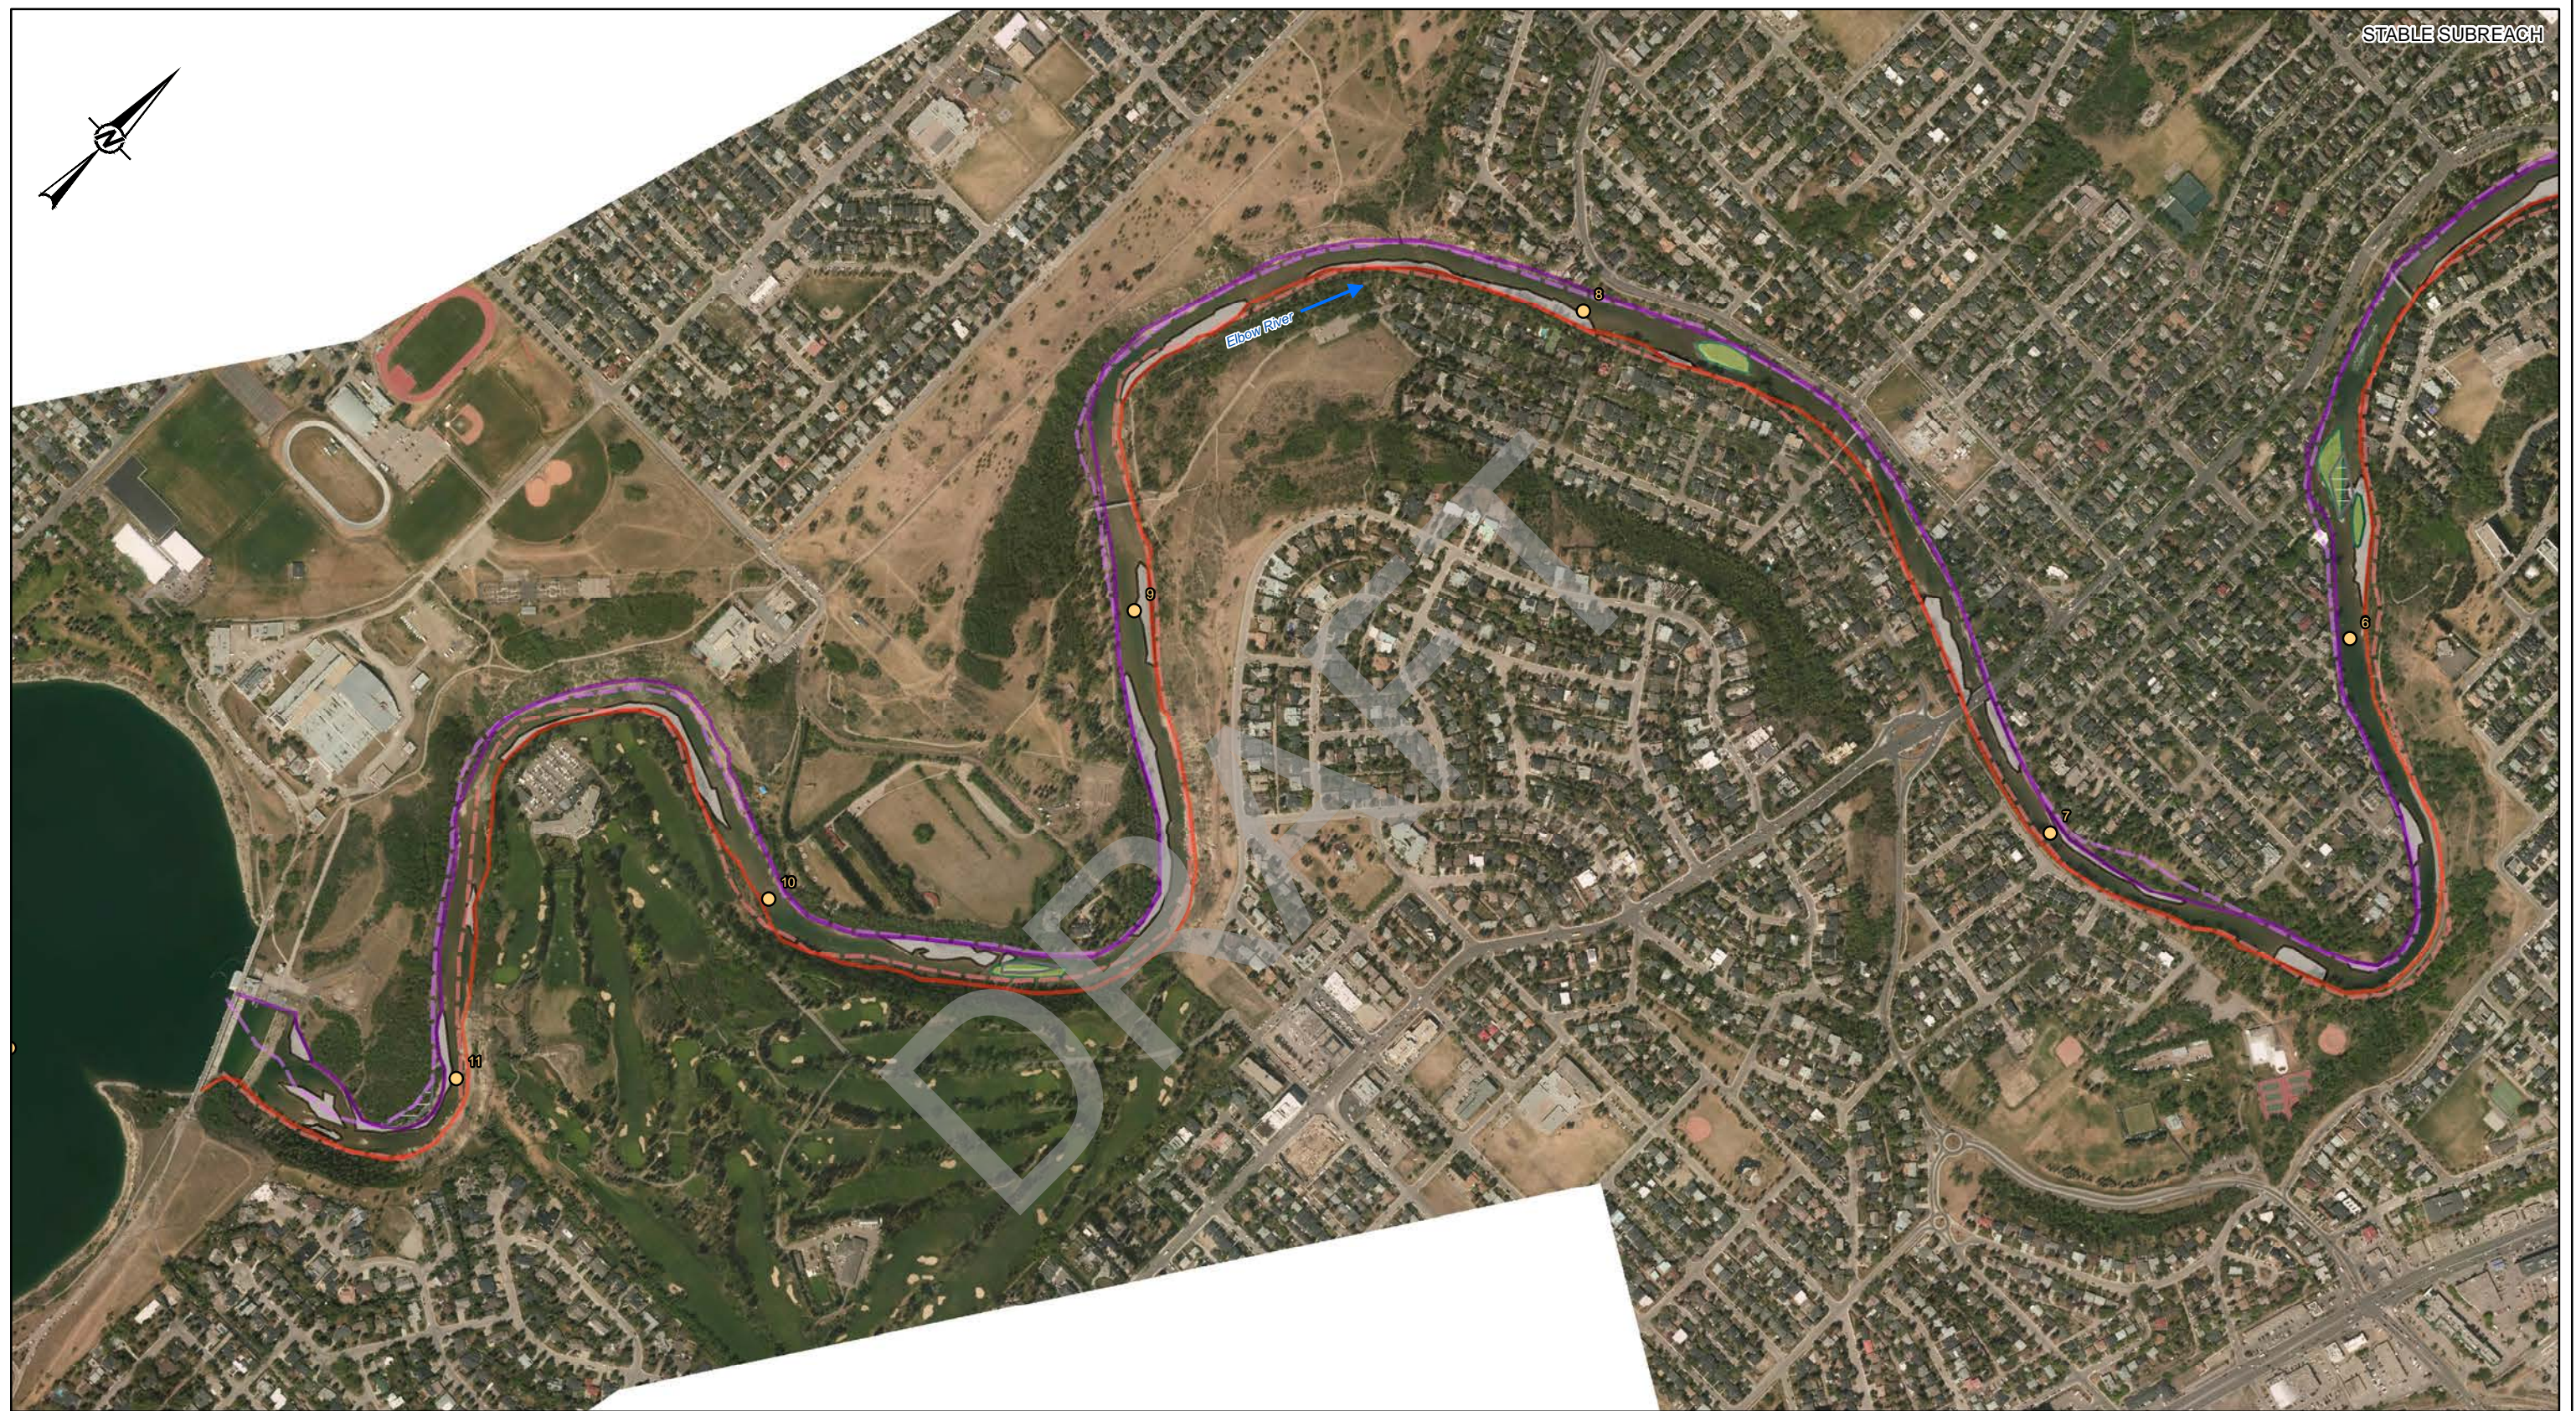
FIGURE **5**

**TITLE**  
**CHANNEL BANK COMPARISON OF REACH 3 - ELBOW RIVER FROM GLENMORE DAM TO BOW RIVER CONFLUENCE - REPRESENTATIVE SUBREACH**

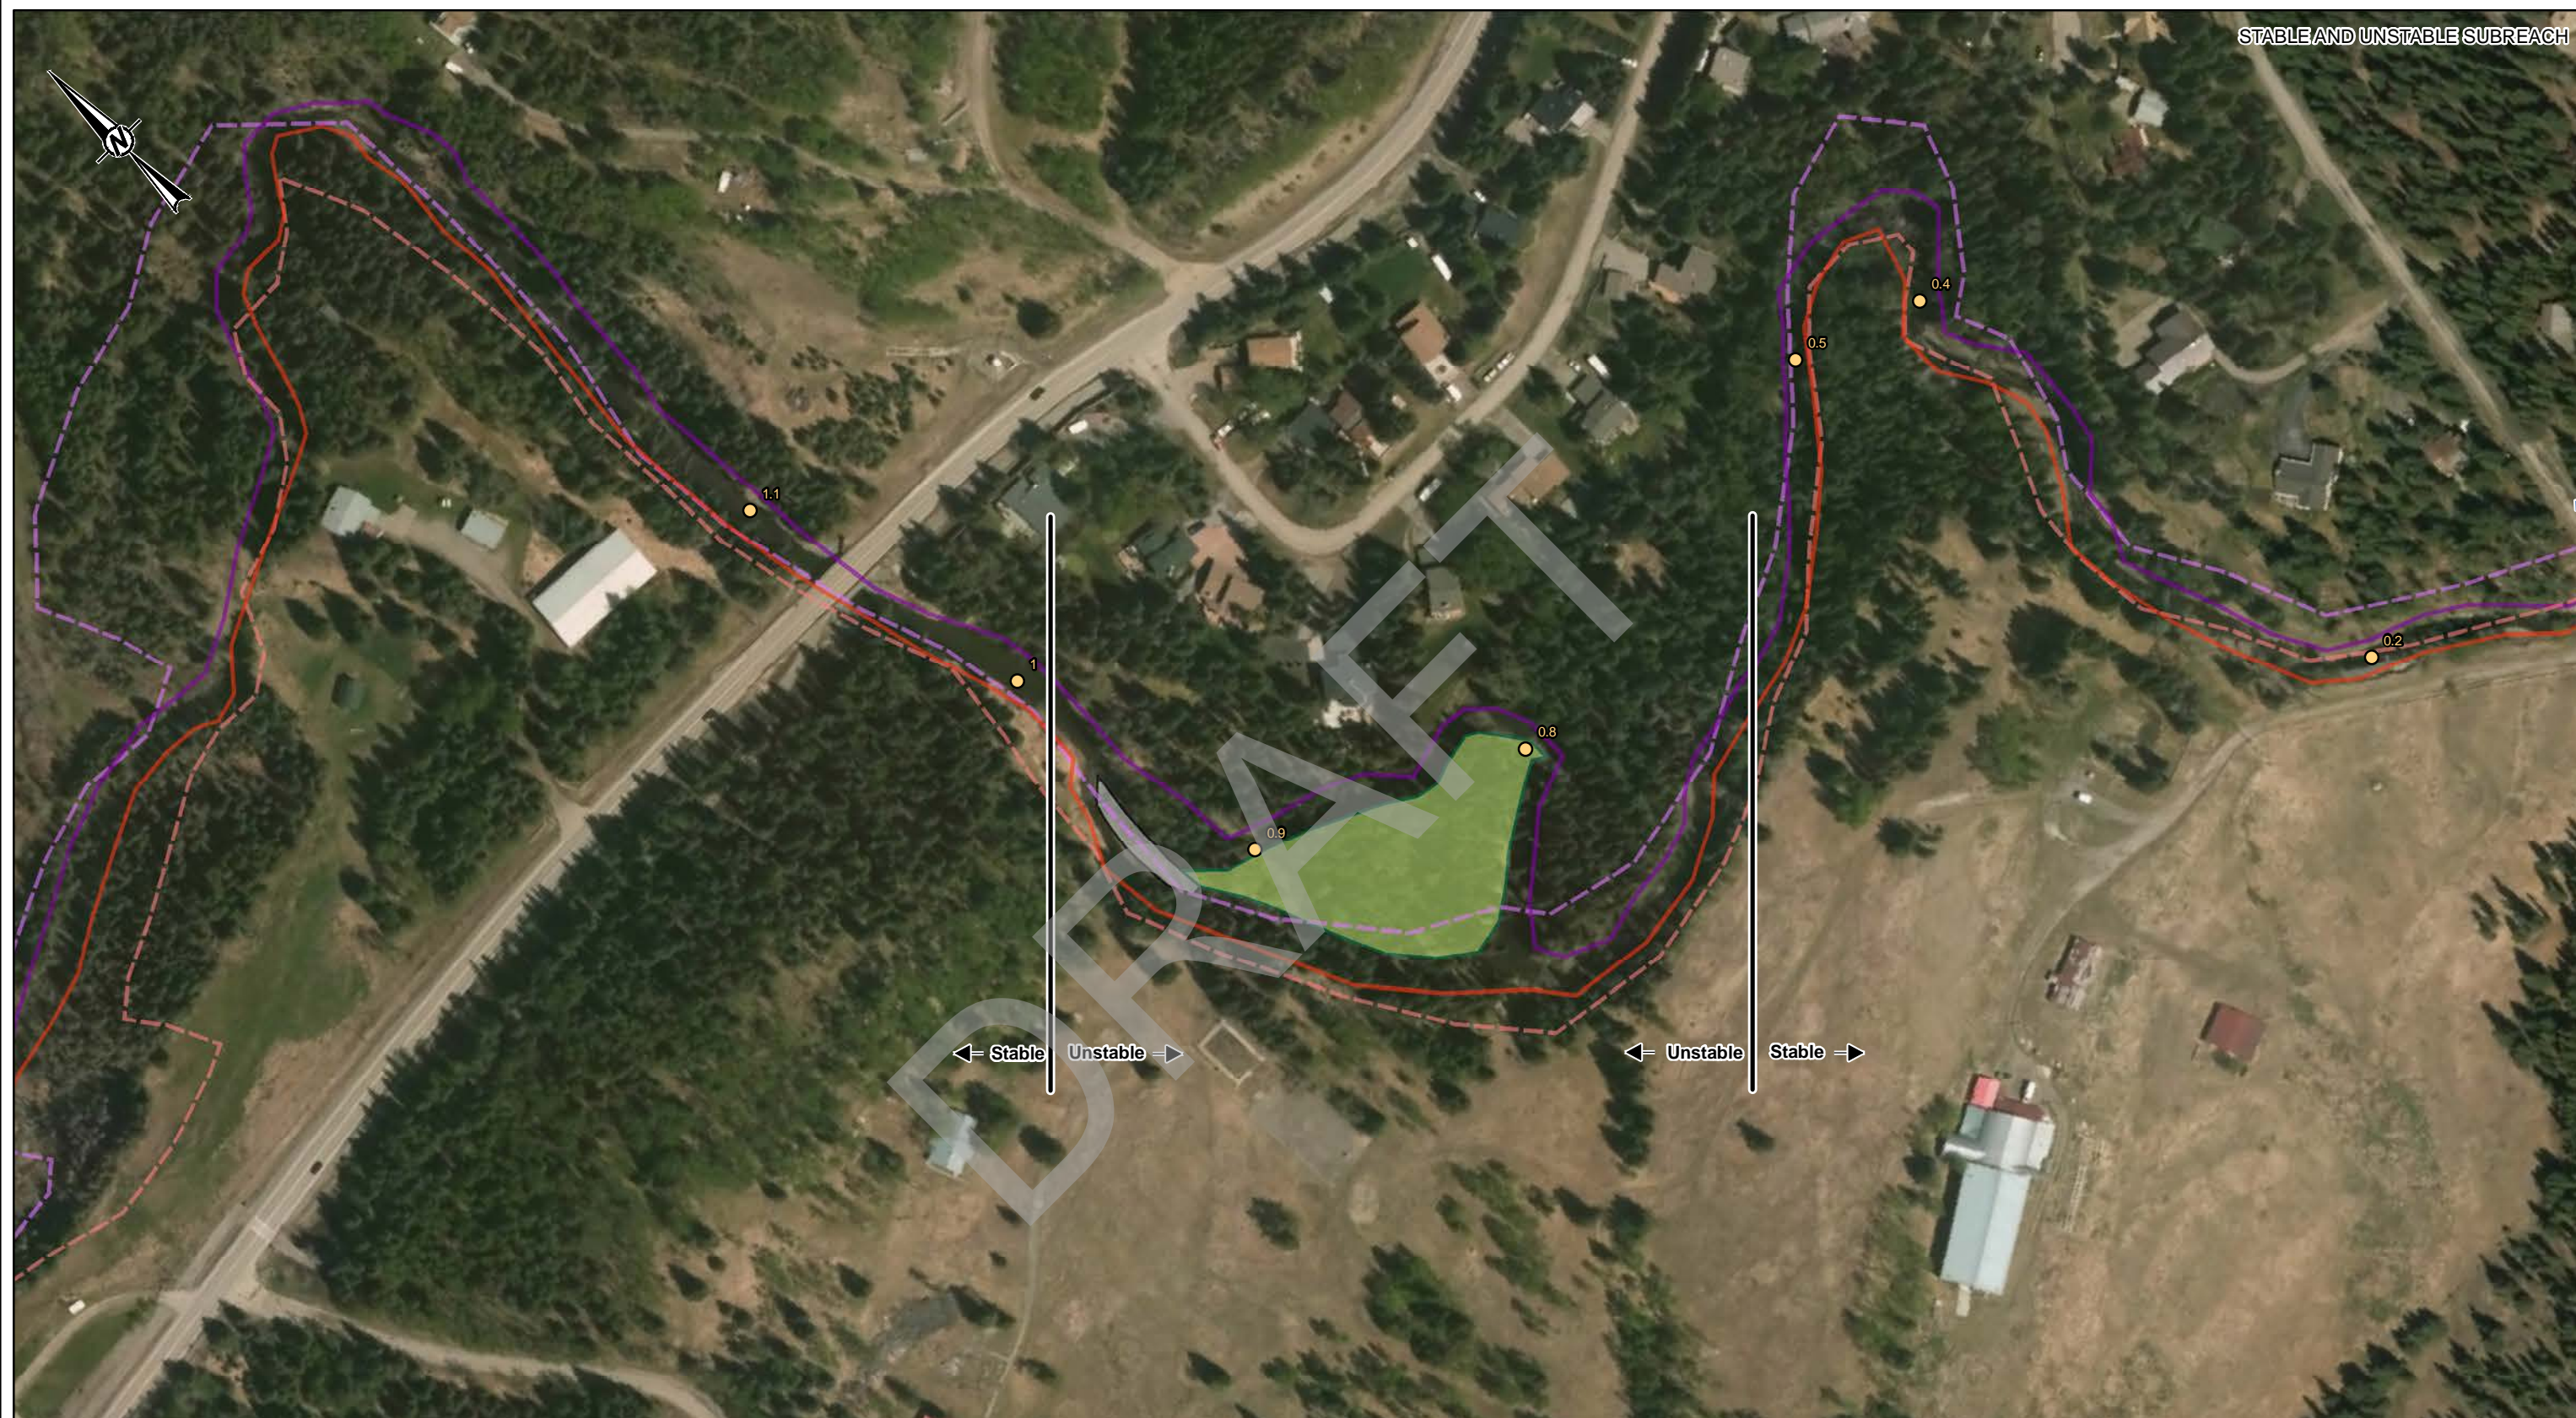
PROJECT NO. 1536673 CONTROL 7000 REV. 0 FIGURE 7

**TITLE**  
CHANNEL BANK COMPARISON OF REACH 5 - BRAGG CREEK - ENTIRE REACH

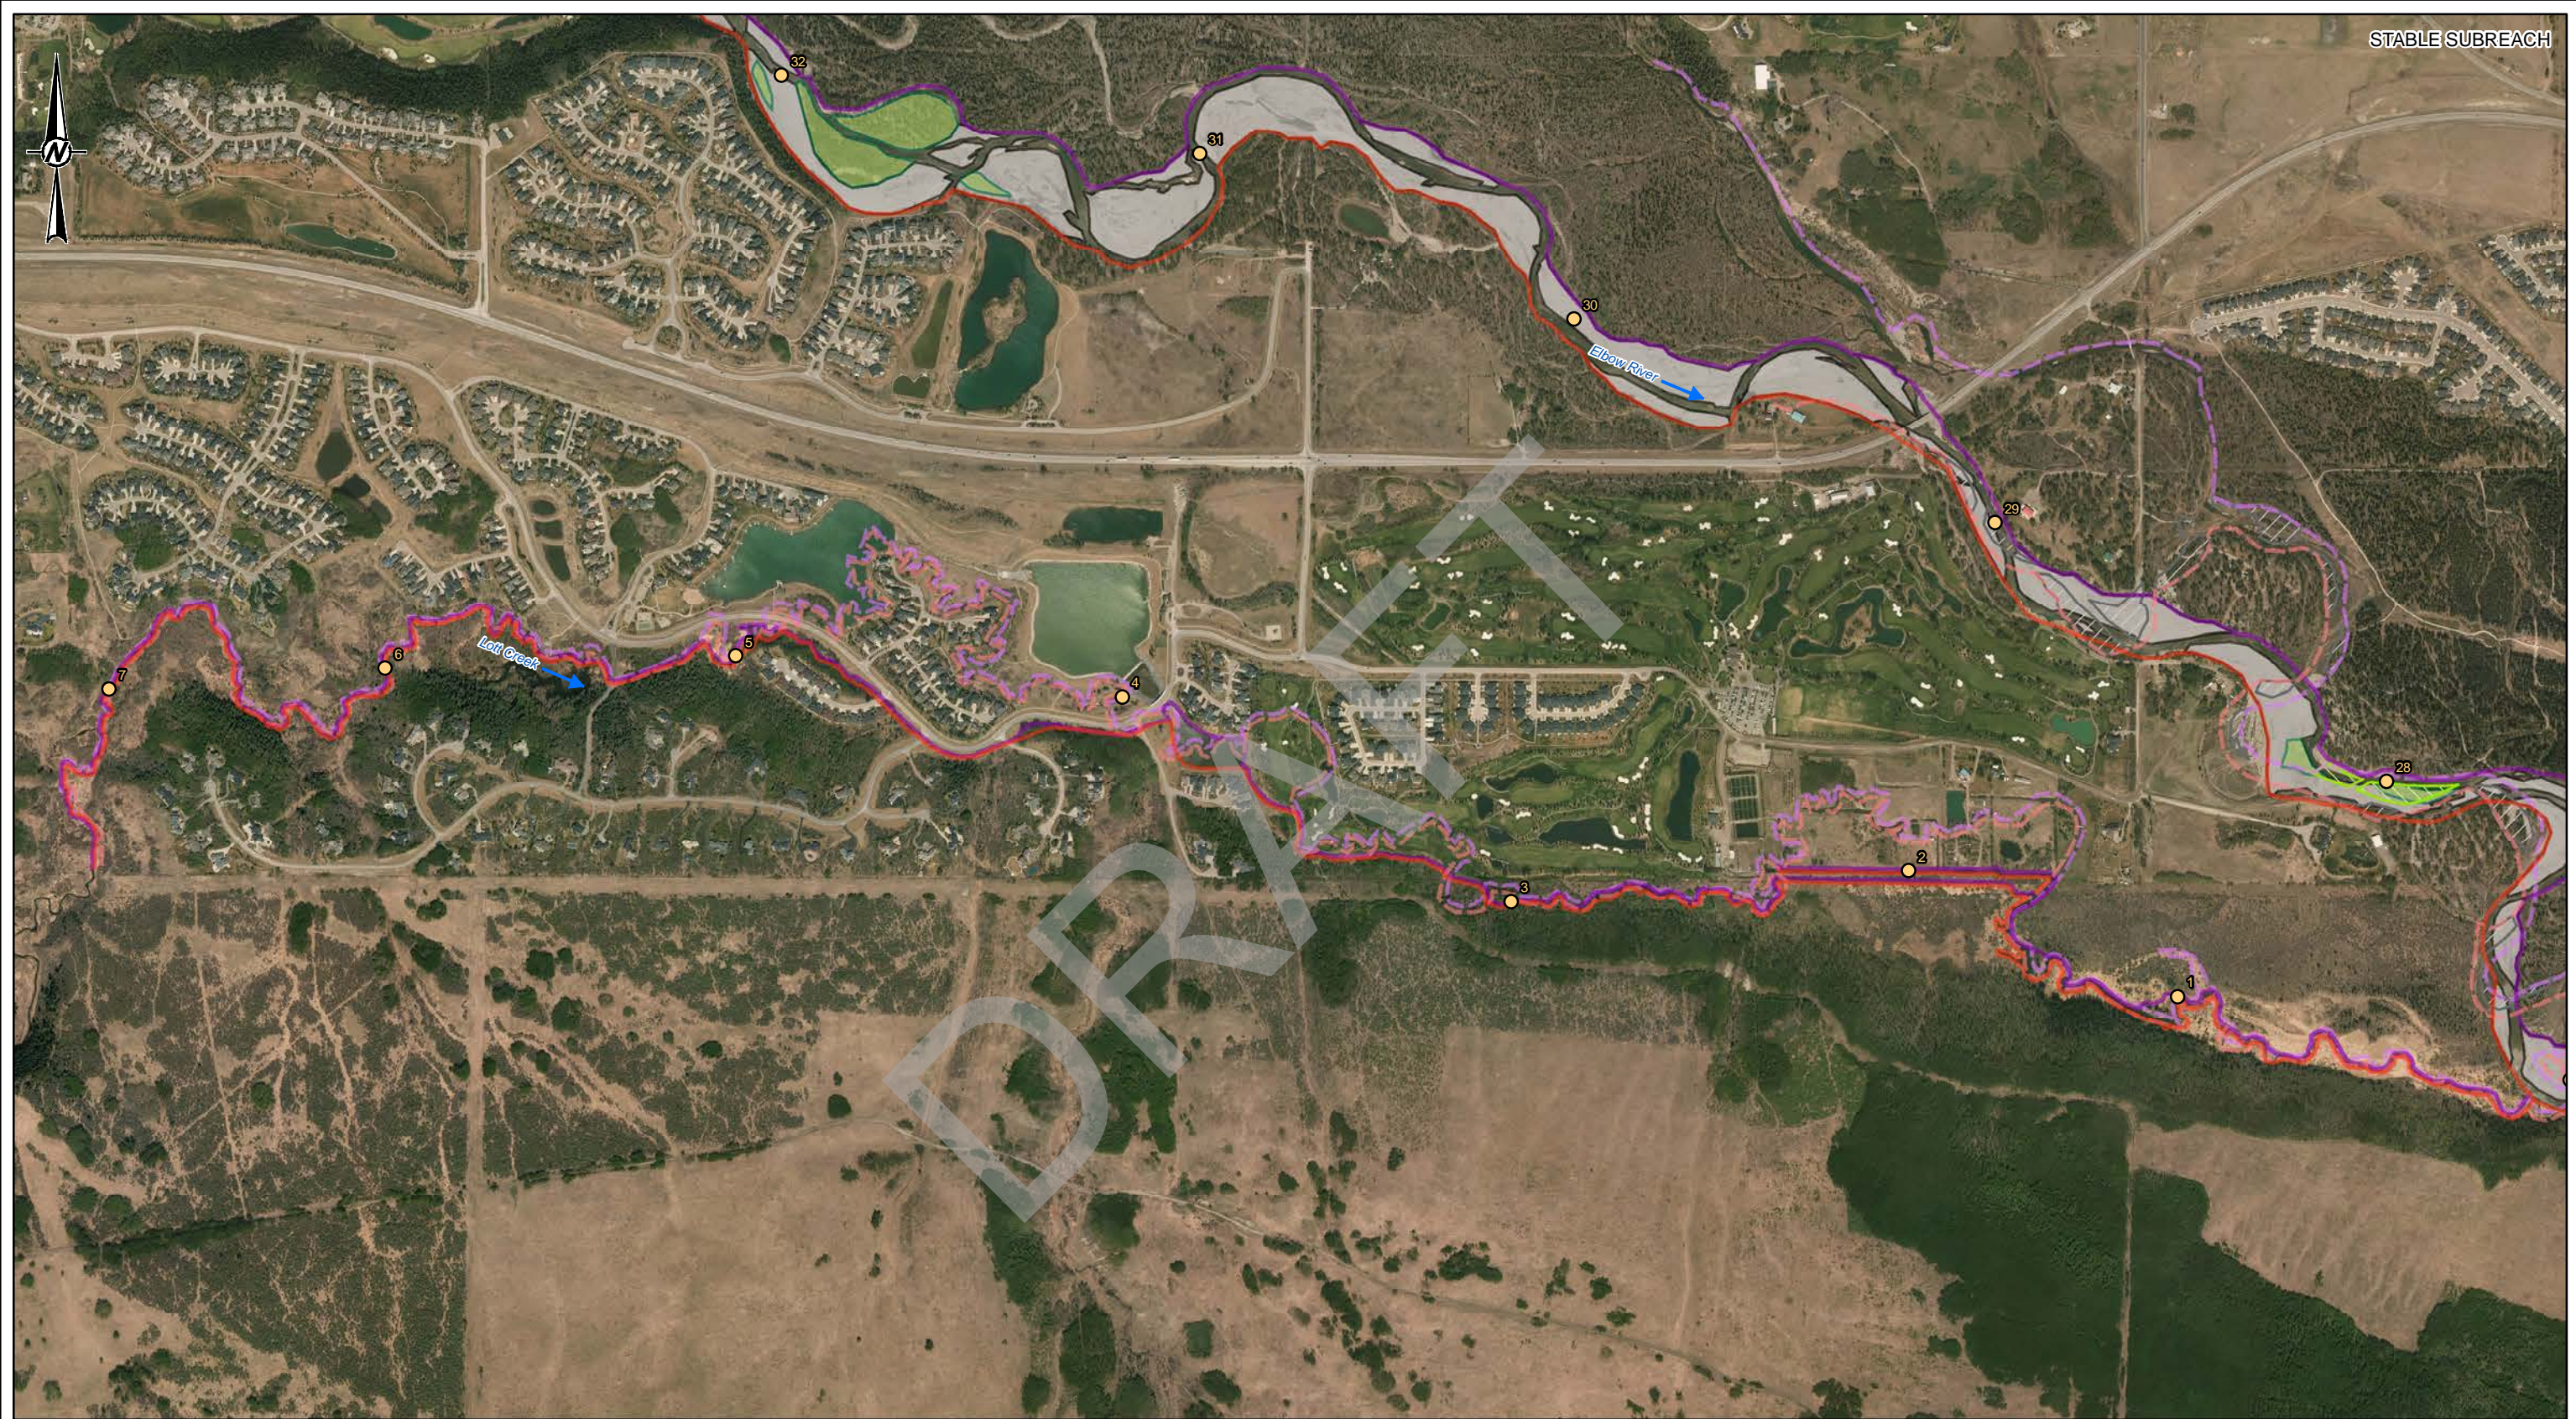
PROJECT NO. 1536673 CONTROL 7000 REV. 0 FIGURE 8

**TITLE**  
CHANNEL BANK COMPARISON OF REACH 6 - LOTT CREEK - ENTIRE REACH

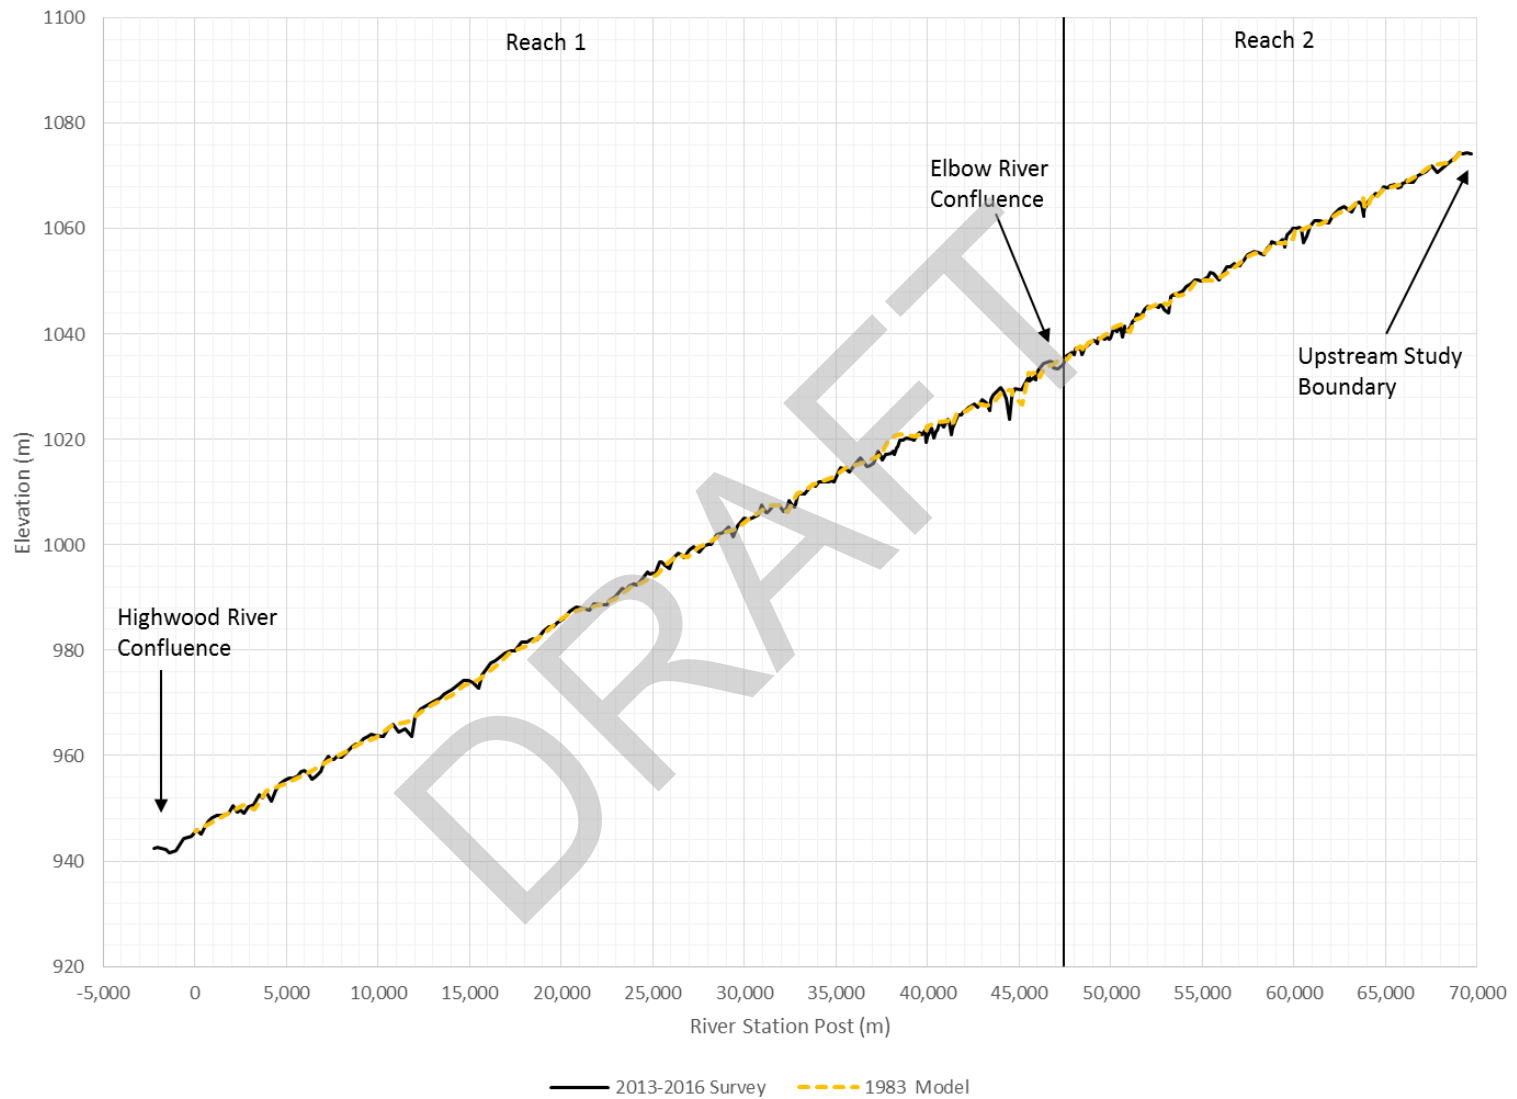
Figure 10: Bow River Thalweg Comparison

A thalweg profile comparison was made using historical data from 1983, 1992 and 1996 hydraulic models and 2013-2016 surveys. Figure 10 through Figure 12 comparison thalweg profiles for the Bow and Elbow Rivers and Bragg Creek. Due to the scales of the figures, detailed changes are difficult to interpret so bed elevation difference plots were created to highlight the measured changes. The bed elevation difference plots are shown in Figure 14 through Figure 16. Positive numbers are indicative of accretion (or aggradation) and negative numbers are indicative of scour (or degradation). Table 7 summarizes changes of reach-averaged slopes and calculated net bed volumes. Historical thalweg data was not available for Lott Creek so a comparison was not completed. Figure 13 shows the recent Lott Creek thalweg for qualitative analysis only.

Typically, thalwegs exhibiting a concave shape are typical of a stream reach in equilibrium (Ritter *et al.* 1995). The plots for the historical and recent thalwegs for the Bow River (Figure 10) and Bragg Creek (Figure 12) are approximately linear (consistent) and do not follow a monotonically decreasing concave profile. The plots for the historical and recent thalwegs for the Elbow River (Figure 11) and the recent Lott Creek thalweg (Figure 13) generally do follow a monotonically decreasing concave profile indicative of generally stable conditions.

The net bed volume changes for the Bow River were calculated where historical thalweg data was available for Reaches 1 and 2. An increase in bed elevation was generally observed along Reach 1 while a decrease in bed elevation was generally observed along Reach 2. Figure 14 shows a relatively even fluctuation between areas of scour and accretion. The total net bed volume along both reaches decreased by about 110 m<sup>3</sup> over the assessment period, which is consistent with a river bed in equilibrium with the flow regime. While small for the overall river length this net decrease that some winnowing of river bed sediments is occurring in Reach 2.

Some aggradation and degradation appears to have occurred upstream and downstream, respectively, of the WID Weir (near KM 45) which may affect flood frequency immediately downstream of the Calgary Zoo (KM 47). A minor increase in riverbed sediment median grain size was recently reported in this area (Klohn 2016), but the change is small and potentially statistically insignificant.

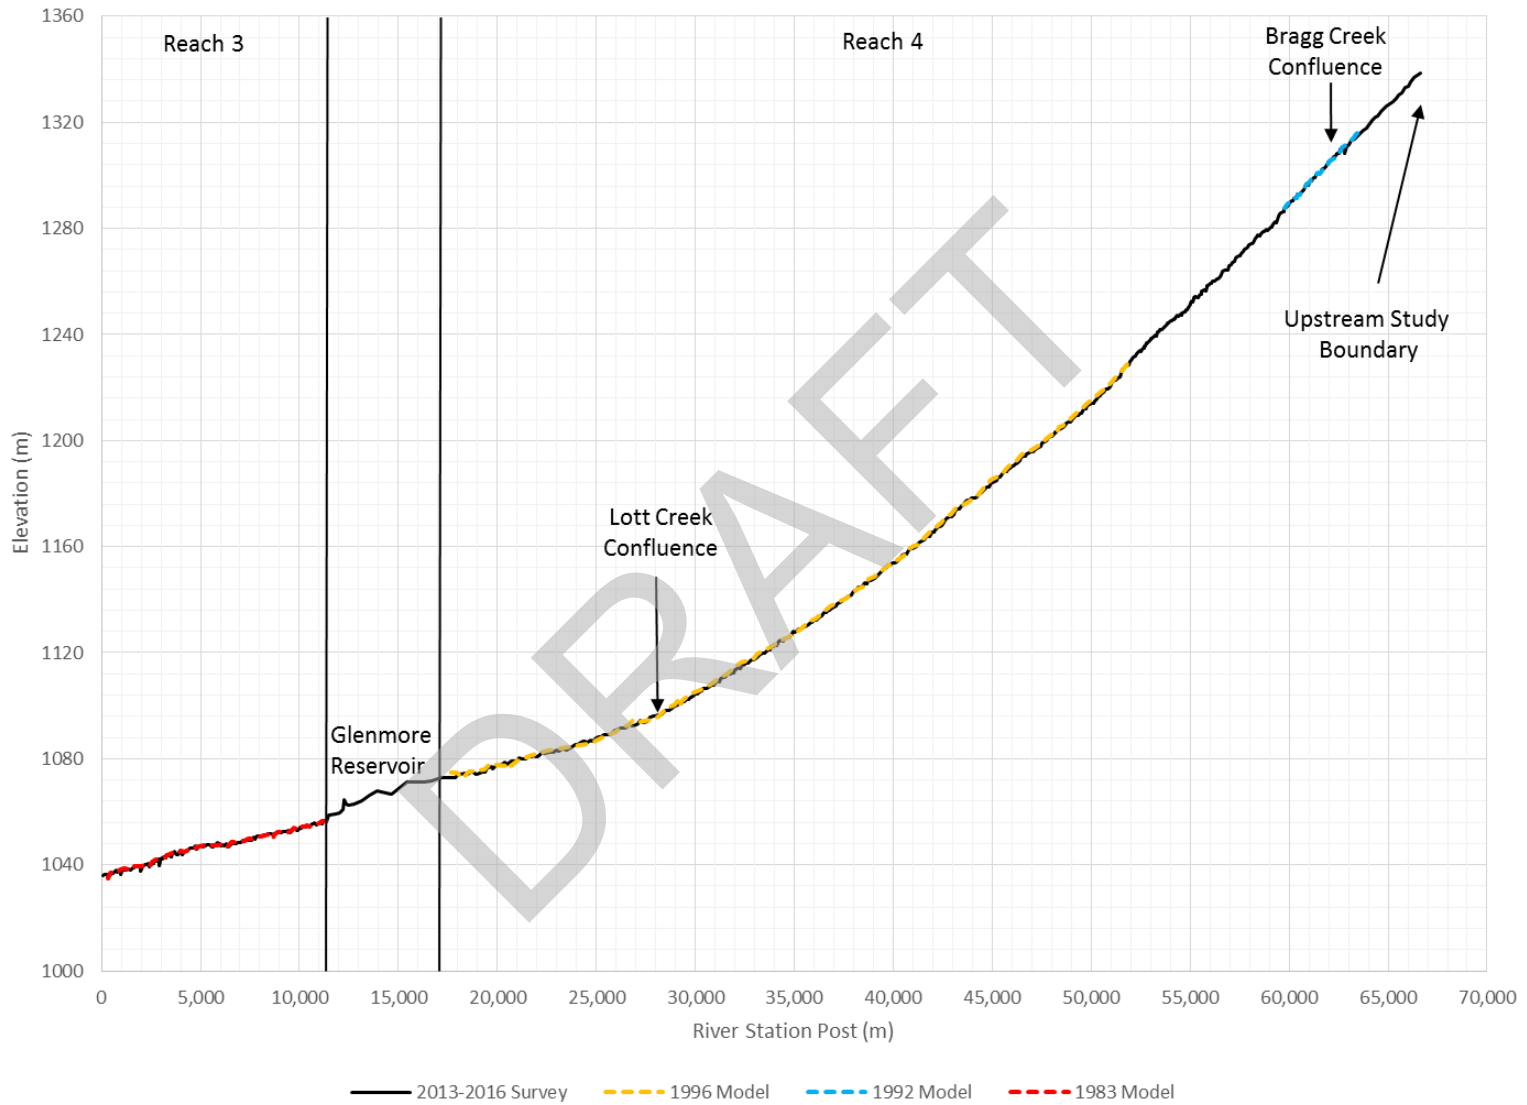
Figure 11: Elbow River Historical Thalweg Comparison

Bed volume change was calculated where historical thalweg data was available for Reaches 3 and 4. A net decrease in bed elevation was observed along both reaches, although the majority of scour appears to be occurring upstream of Glenmore Reservoir (Figure 15). The net bed volume calculated along both reaches decreased by about 19,690 m<sup>3</sup> over the assessment period.

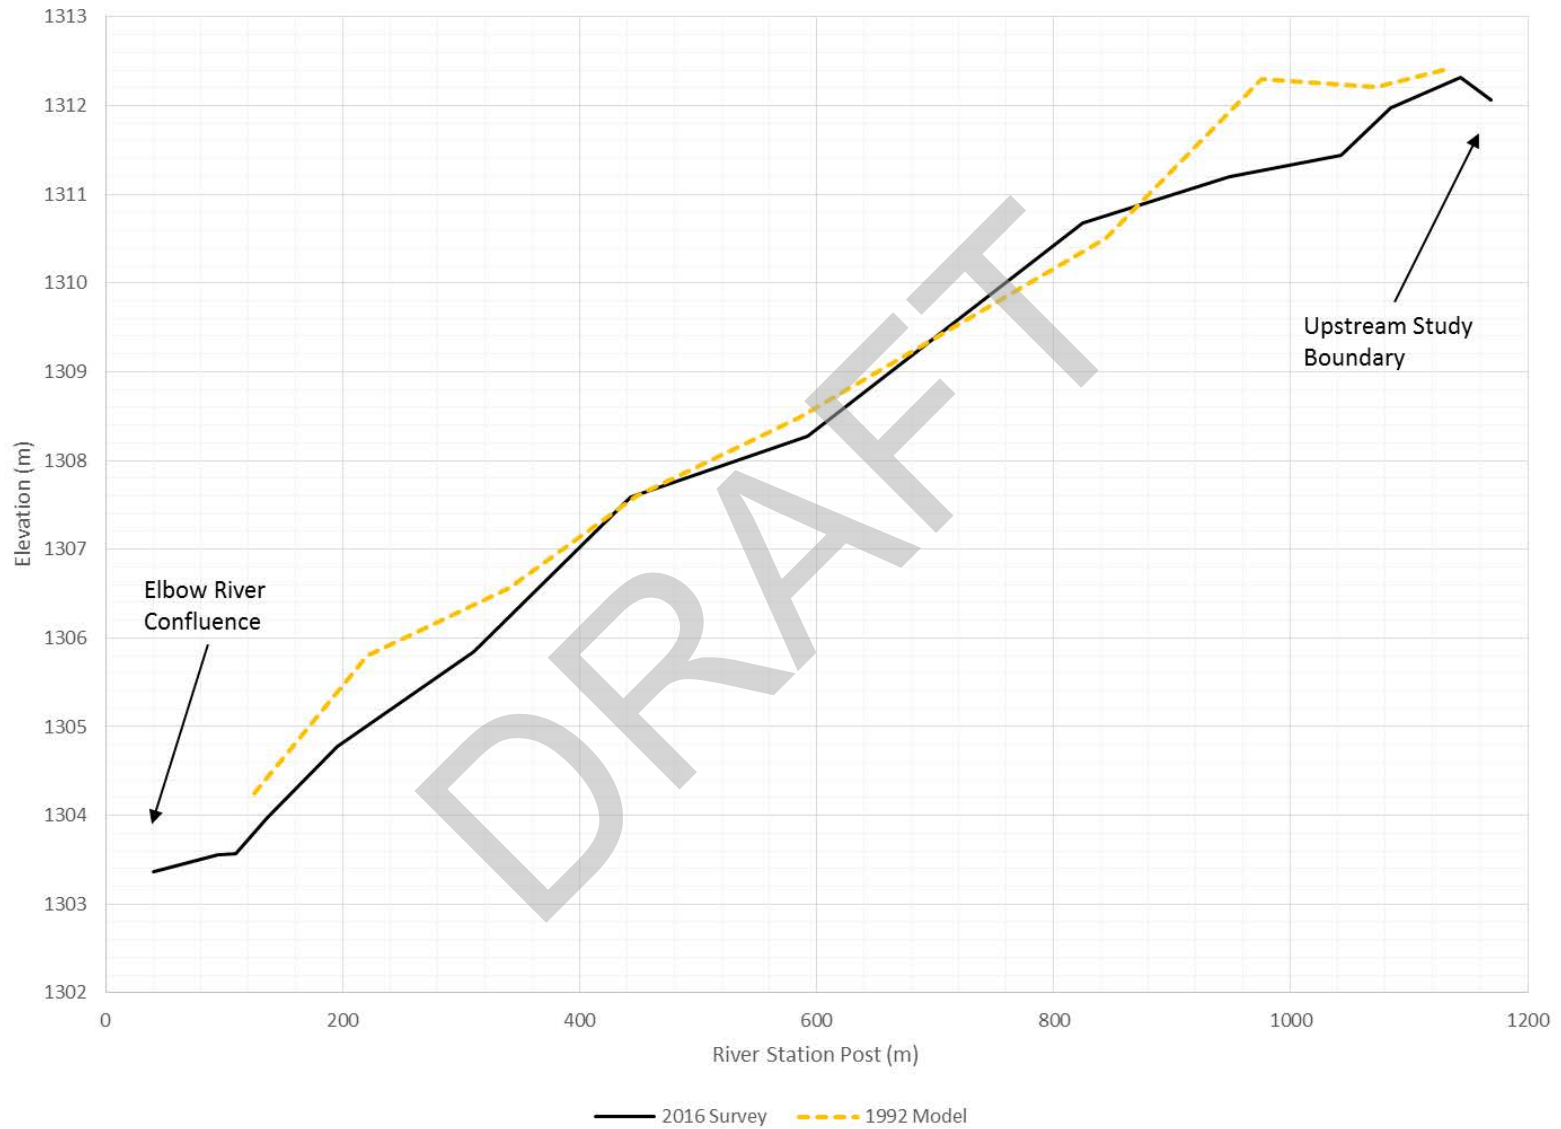
Figure 12: Bragg Creek Thalweg Comparison

The study area contains the most downstream subreach of Bragg Creek, where it flows through its alluvial fan and to the Elbow River confluence. The expected concave thalweg profile could not be observed due to the short reach length, but the linear slope is consistent with slope profiles on alluvial fans.

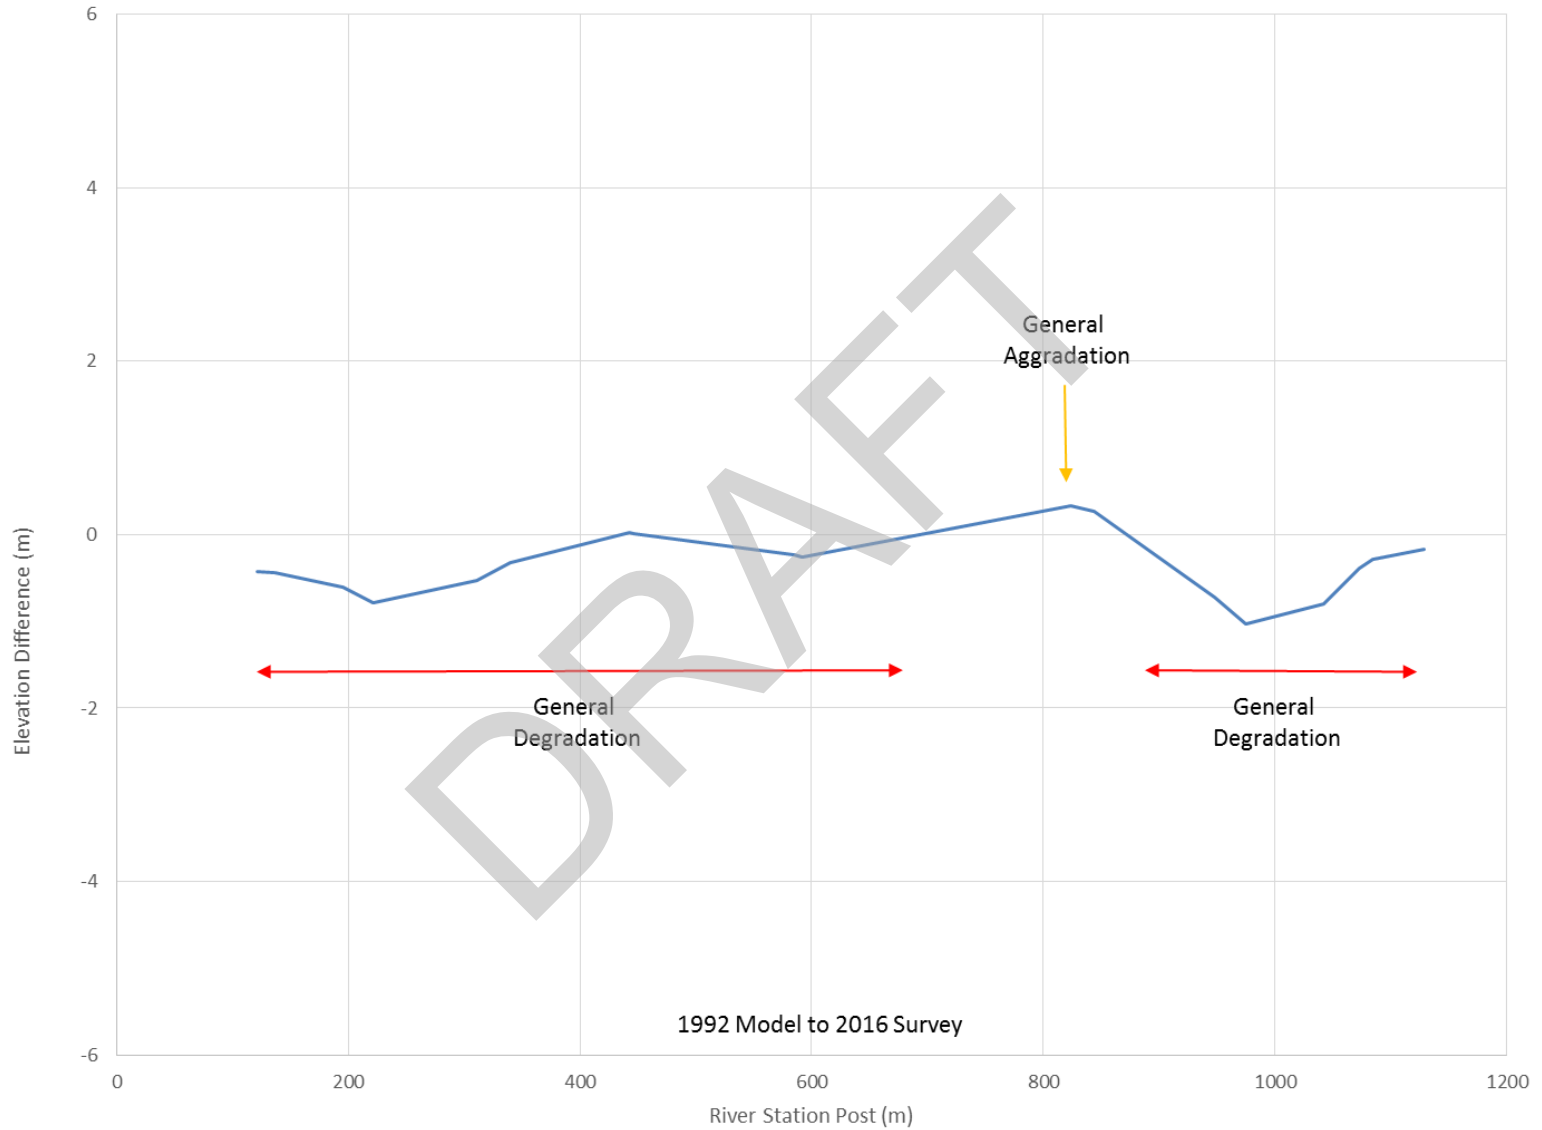
Figure 16: Bragg Creek Thalweg Elevation Difference

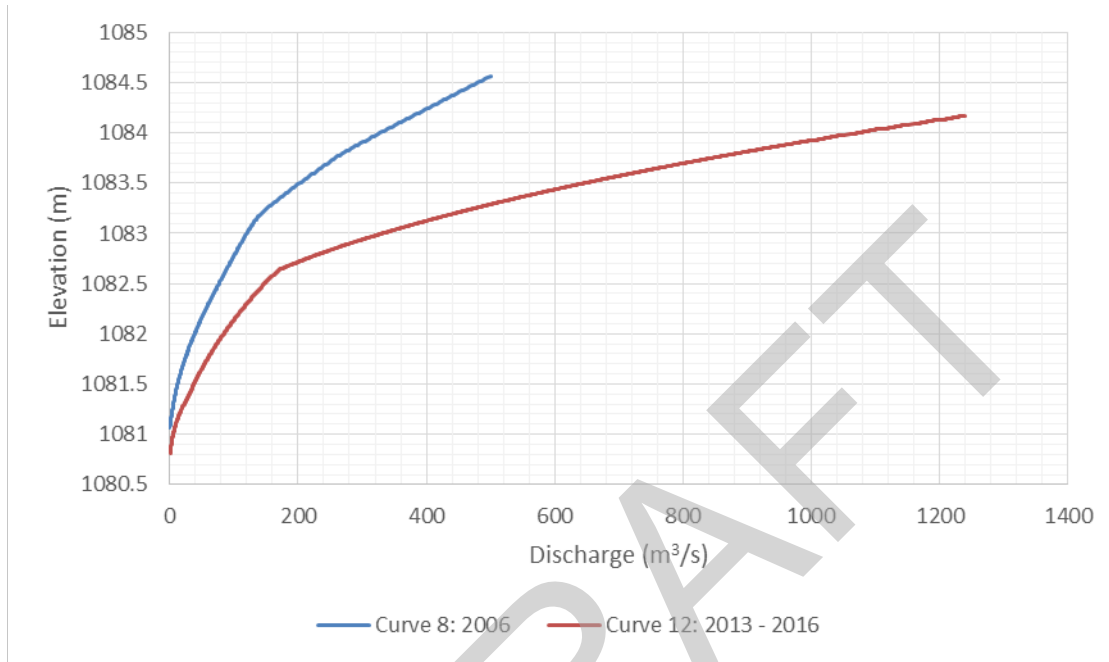
Figure 19 shows the rating curve for Elbow River at Sarcee Bridge (WSC Station No. 05BJ010), located upstream of Glenmore Dam. The change in rating curves between 2006 and 2016 (Figure 19) suggests a widening or deepening of channel (erosion), which was confirmed during the cross section comparison. This suggests that the river flowing at the same water level would convey more flow now than ten years ago, but it may also be possible that the newer rating curve is simply more representative. Regardless, lowering of the bed could be a function of nearby channel engineering or excavation (unlikely to occur at a WSC gauge site).

Figure 19: Elbow River at Sarcee Bridge (WSC Station No. 05BJ010)

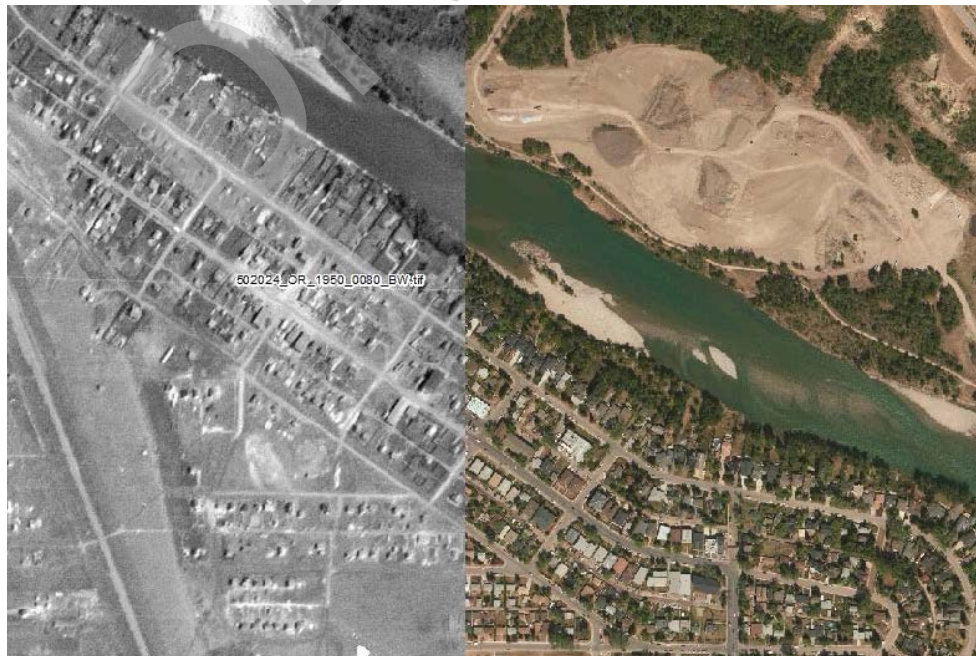
The automated colour balancing used to produce the orthomosaics was not able to completely minimize the appearance of seams between images. Some areas were particularly problematic to correct because the dark corners of the images could not be cropped away (due to low side overlap). In other instances, the existing photogrammetric stretch (inherent in the source data) created oversaturated and overexposed areas, which were problematic to correct via automated means. Additionally, some of the provided images had limited snow cover (e.g., images acquired on April 30, 1950), which further complicated the colour balancing process. Overall, considering the age and variable quality of the provided images, all orthomosaics were assessed to be very good.

*Figure 1: Example of an Orthomosaic Quality Assurance Check at 1:5,000 Scale  
(The historical 1950 orthomosaic (greyscale image; at left) is peeled back to reveal the modern landscape (colour image; at right)*
