FOAM COLUMN INJECTION TO A HIGHWAY EMBANKMENT FOUNDATION - RESULTS OF A FULL SCALE PILOT STUDY

Jermaine Smith, P.Eng. (*Presenter)
Project Engineer
EBA, A Tetra Tech Company

At the 2011 Annual Conference of the
Transportation Association of Canada
Edmonton, Alberta

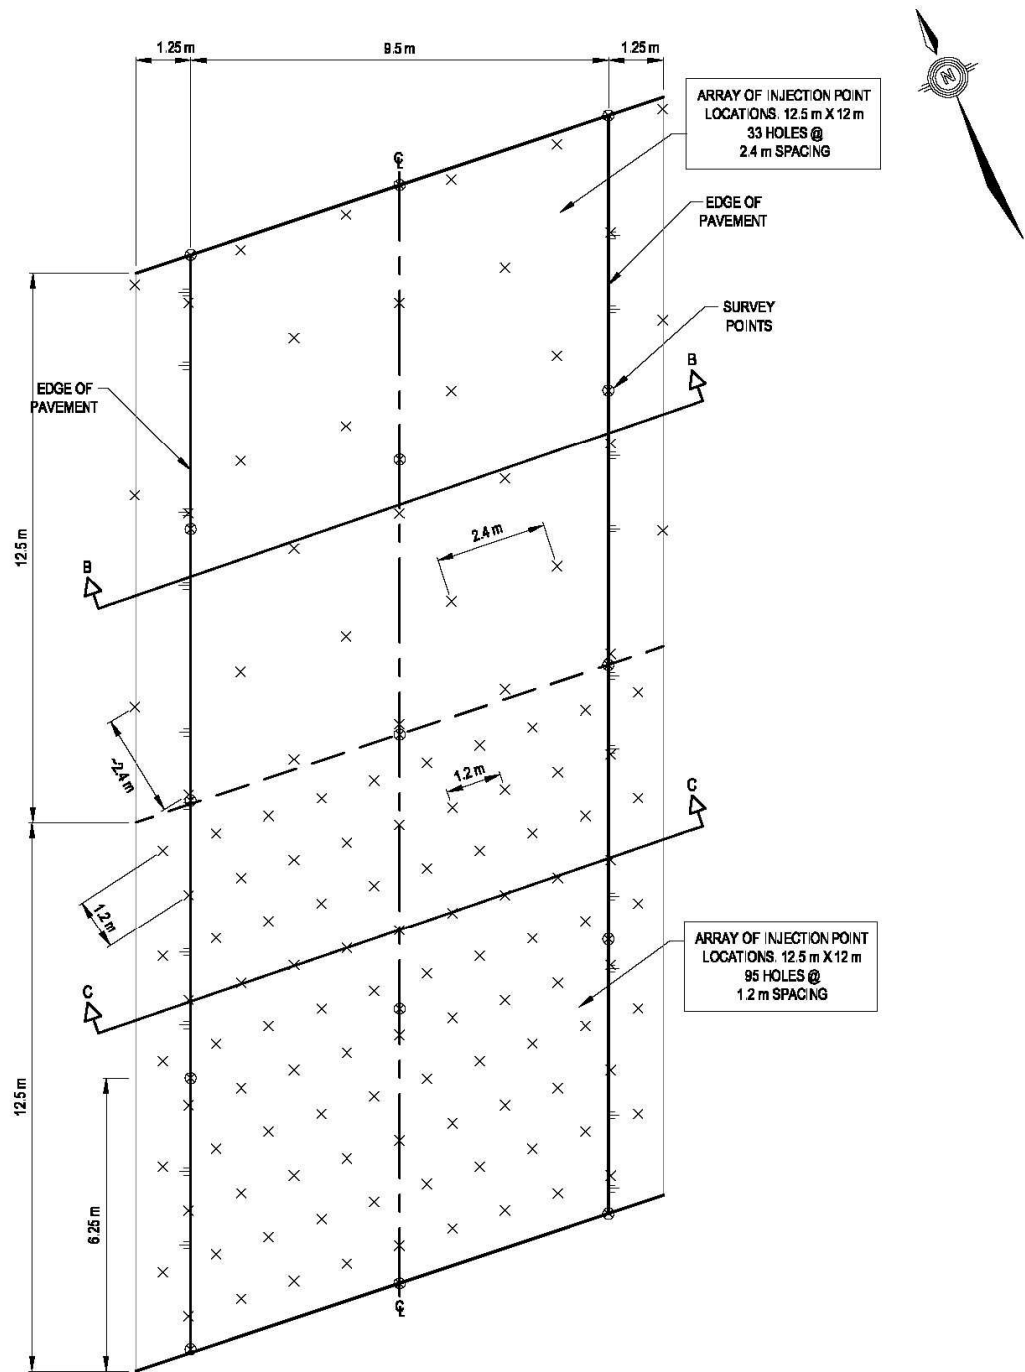
Figure 3. Borehole Layout Plan

As part of the study, two different spacings were selected for the foam injection, as seen in Figures 3 to 5 attached. On the south half of the project, 1.2 m spacing was chosen, and for the north section of the site, 2.4 m spacing was used. The two different spacings were selected to determine if there was any benefit to having a denser spacing of foam columns.

Prior to construction, EBA laid out the injection points as shown in Figure 3 and Photo 2.

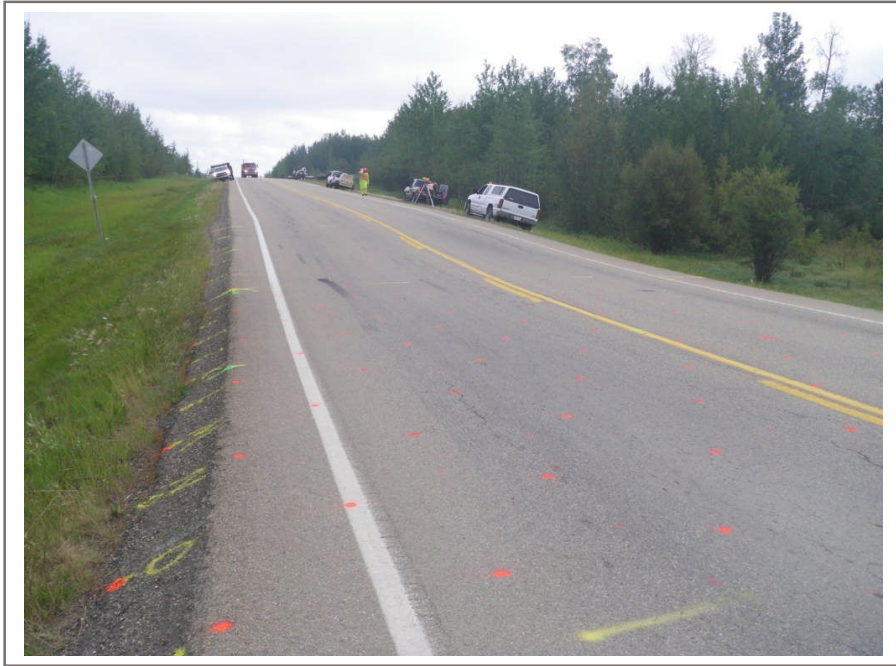
Photo 2. Injection point layout

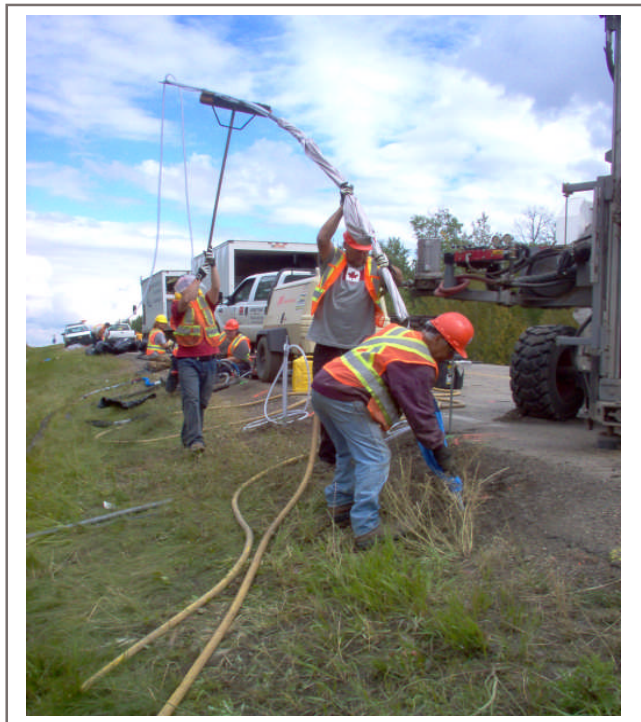
The containment units were constructed on site and adjusted based on the soil stratigraphy encountered as seen in Photo 3. The containment units were periodically measured by EBA and compared with design, and were constructed to lengths of 6.3 to 6.4 m, with bag lengths of 3.8 to 4.0 m. Once installed in the hole, an extension of varying lengths was attached to the unit to bring the containment bag to the required depth. Within the containment bags, two tremie hoses were fixed to the conduit at one-third and two-thirds of its length so that the entire bag was filled with foam as seen in Photos 4 to 5.

Photo 3. Containment unit assembly and installation

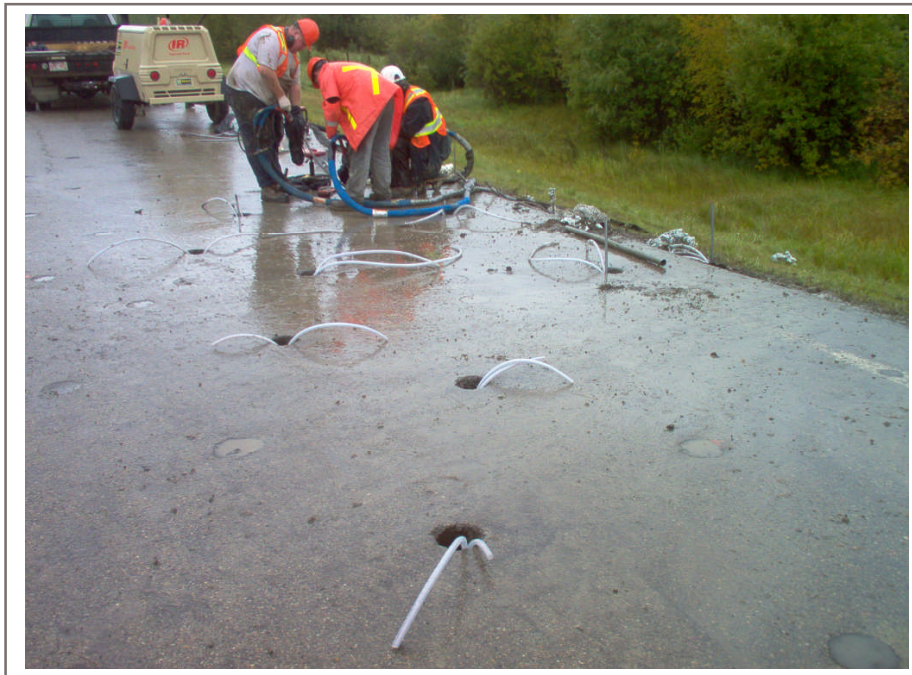
Photo 4. Finished installing confinement unit and hose into borehole. Workers attaching tremie hoses to foam guns.

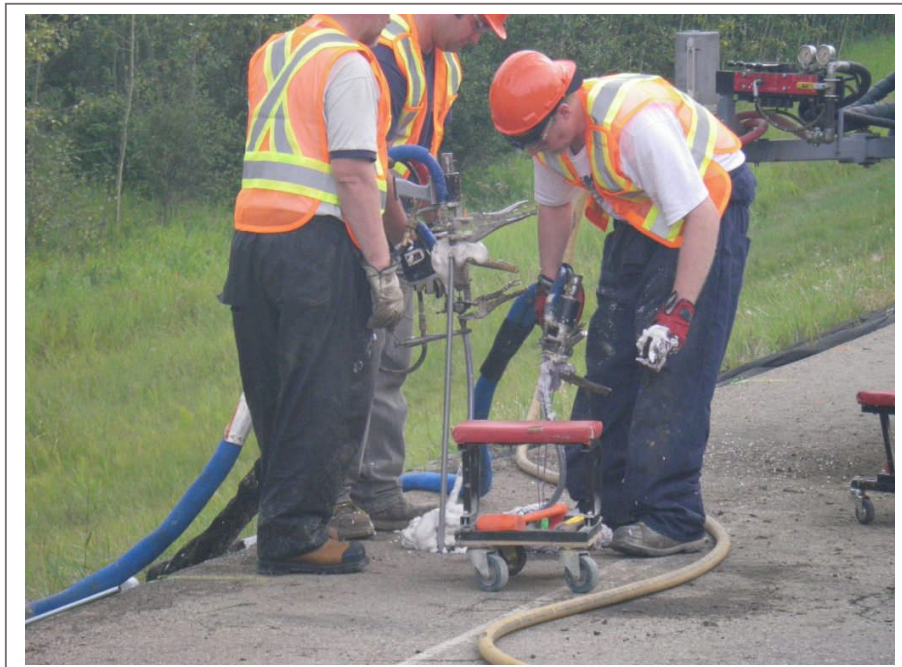
A total of 60 lbs. of polyurethane foam was injected into each hole. Following foam injection, the conduit and tubing remaining above ground was cut a couple inches below the road surface. If any foam spilled onto the road it was also removed to a couple inches below road surface. A ready-mix asphalt cold-mix was used to patch the hole and bring it to grade as seen in Photo 6. The site after paving can be seen in Photo 7.

Photo 5. Foam injection

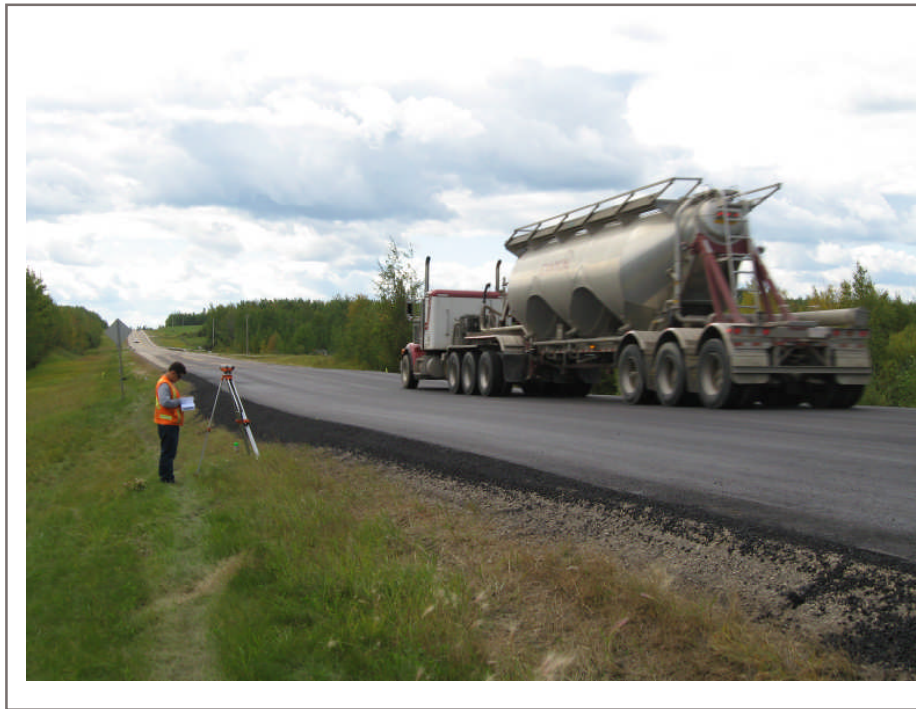
An initial survey was completed by EBA, on August 26, 2010 to establish relative road elevations before construction. Survey monitoring points were established on the roadway surface along the centerline, east edge of pavement (EOP) and west edge of pavement (EOP) to assess the relative elevation of the road profile prior to drilling and to assess if there was uplift of the asphalt surface during treatment. The survey pins were replaced and re-surveyed upon completion of asphalt overlay works conducted at the end of foam injection as seen in Photo 8. As part of this pilot study the site will be surveyed three times per year during the frost free months, over the next two years to monitor the results of the treatment.

Photo 8. Looking south. Re-establishing the survey points after the asphalt overlay was placed
