# UPDATE ON THE LITTLE SMOKY LANDSLIDE

Roger Skirrow, Alberta Infrastructure and Transportation, Edmonton, Alberta, Canada

Don Proudfoot, Thurber Engineering Ltd, Edmonton, Alberta, Canada

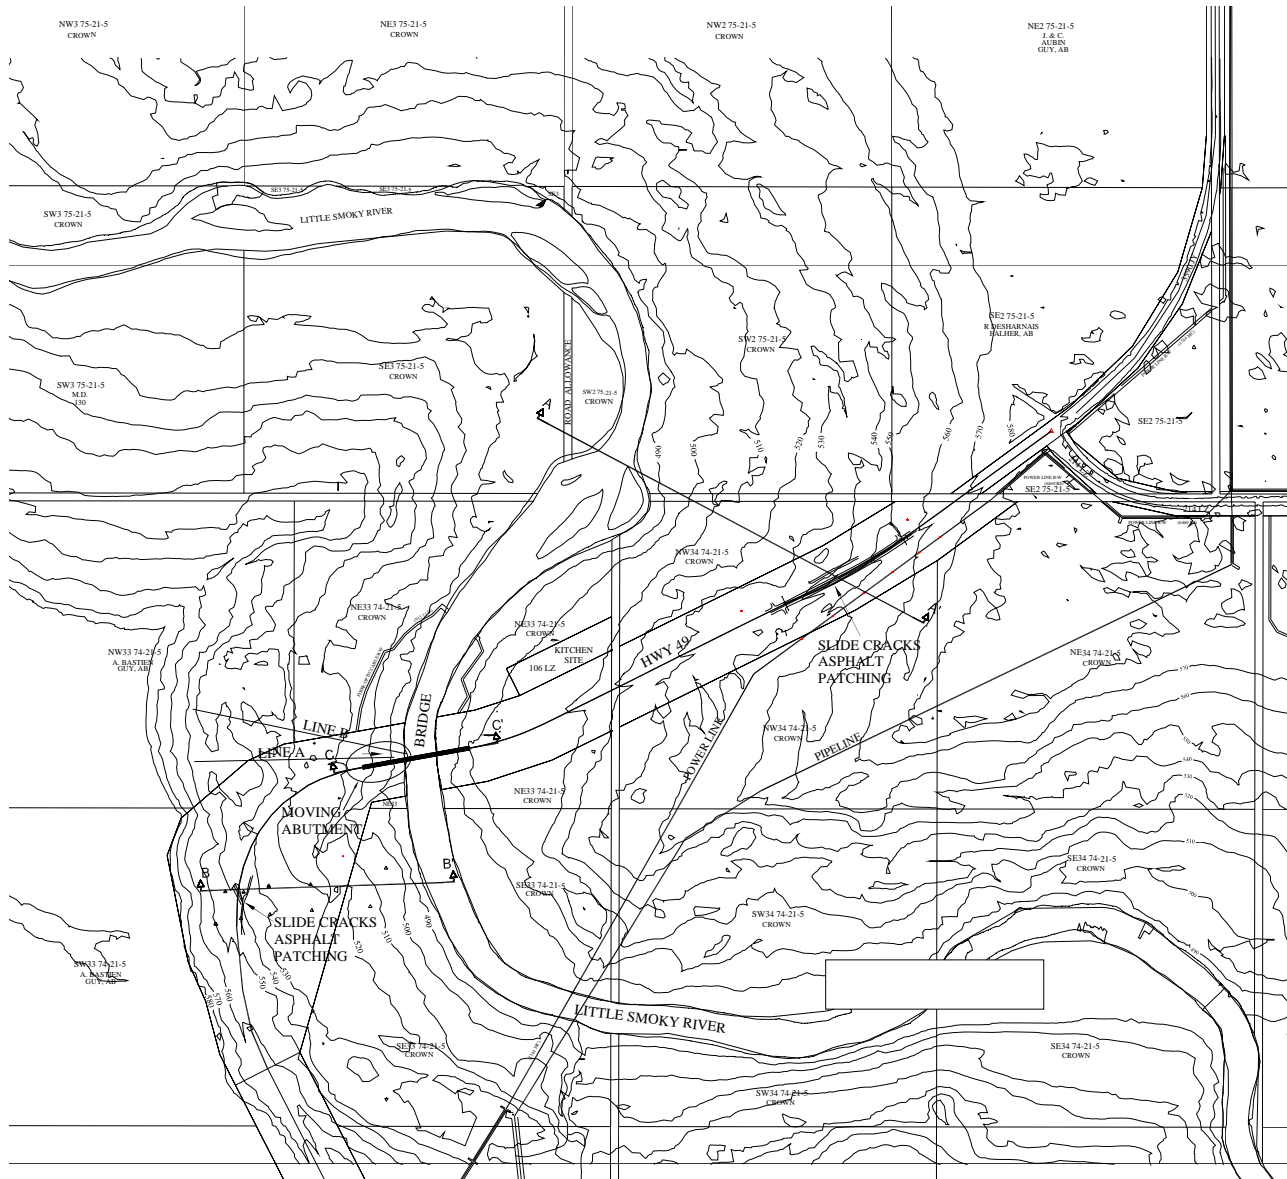
Fig. 2. Site Contour Plan

The most obvious and pervasive feature of the Little Smoky River valley is the presence of large-scale landslide features that extend from the river level up to the prairie upland. These landslides are present along the outside bend of the river, which presents toe erosion as the main trigger to the slope movements. Signs of slope movement are obvious on both sides of the valley.

Large blocks movement is evident, with major blocks in the order of 50 m wide. Major scarps are several metres in height, and are generally overgrown eroded and diffuse, which is a reflection of the relatively slow rate of slope movement. Numerous minor scarps can be traced. Sag ponds are present, common and well established. Pistol butt trees, drunken forests, upturned and bent trees are common in localized areas, representative of minor slides that are relatively shallow and discrete. At the subject site the average valley slope angle is about 7 degrees on the north side and about 9 degrees on the south side.
