Stabilization of Roadway Landslide Using Anchored Drilled Shaft Piles Performance Evaluation over the Last 15 years

Vishnu A. Diyaljee, F.ASCE, P.Eng

Managing Director, GAEA Engineering Ltd, 33 Ashby Field Road, Brampton,
Ontario, Canada; diy001@gaeaeng.com

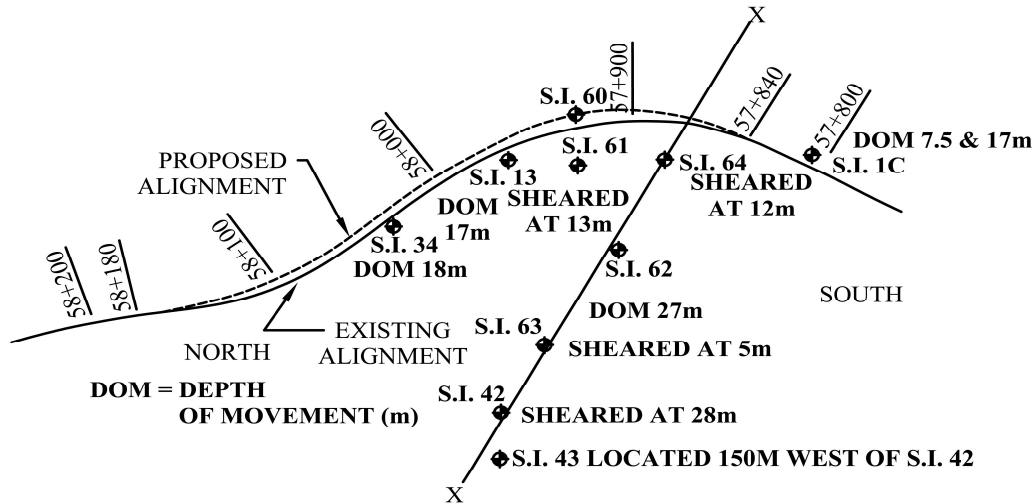
FIG. 3. Location of Slope Indicators and Depths of Movement

Five (5) slope indicators were installed within the Zone 1 slide during the period 1986 and 1994 in testholes that were drilled to depths varying from 20 to 36 m below the ground surface. Of these, one (SI 1C) was installed in 1986, SI 13, 34 and 43 in 1992, and SI 42 in 1994. These slope indicators were installed by the GSS of AT. SI 1C installed to a depth of 30 m north of the scarp of the slide showed between 1991 and 1996 movements of 60 mm in a distinct shear zone at a depth of 7.5 m and 7 mm in a shear zone at 17 m depth.

Slope Indicators (SI 42 and 43) were located downslope of the slide to the north to monitor potential movement on a larger scale. SI 42 indicated shear movement at a depth of 28 m. The locations of the slope indicators installed are shown on plan in Fig.3. Around March 1994, the District reported that there was significant progressive deterioration of Zone D1 slide. This report prompted an immediate overview of the concerns of the instabilities both with the slide in question as well as other areas along the Judah Hill Road that were undergoing deterioration.

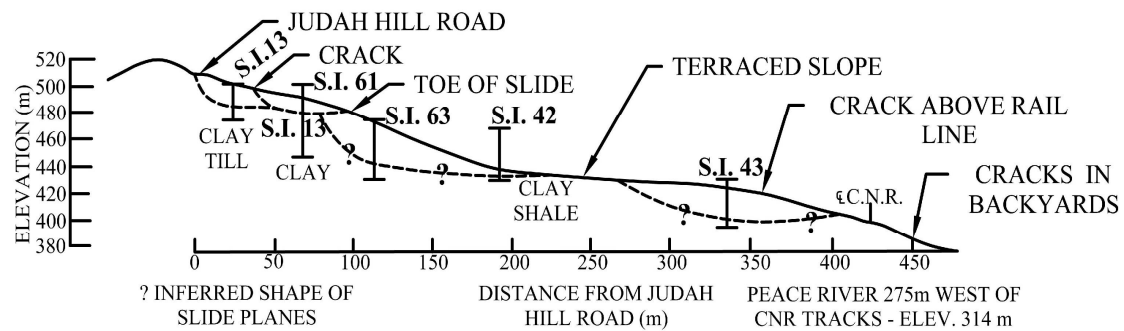
FIG.5. Cross-Section XX (Fig.3) through Slide Area

The slope indicators were read three times after their installation and confirmed the depths of movements and the active nature of the slide. SI 61 and 62 sheared within a few days of installation showing movements at 13 and 5 m depth respectively while SI 63 and 64 showed shear zones at 27 and 12 m respectively.

Fig.5 shows some of the soil stratigraphy at SI locations. The regional and site geology of the Judah Hill road have been reported previously (Diyaljee, 1992). Also shown in Fig.5 are the inferred planes of movement from the Judah Hill Road to the Peace River some 700 m to the west of the Judah Hill Road.
