Void backfill design for a steeply dipping coal-mine void below a highway in Canmore, Alberta,

Chris Grapel, P.Eng., Courtney Mulhall, EIT, & Hanh Hong, P.Eng.
Klohn Crippen Berger, Edmonton, Alberta, Canada
Brian Rogers, P.Eng.
Klohn Crippen Berger, Calgary, Alberta, Canada
Neil Parry, P.Geoph.
TetraTech Canada Inc., Edmonton, Alberta, Canada
Roger Skirrow, P.Eng.
Alberta Transportation, Edmonton, Alberta, Canada

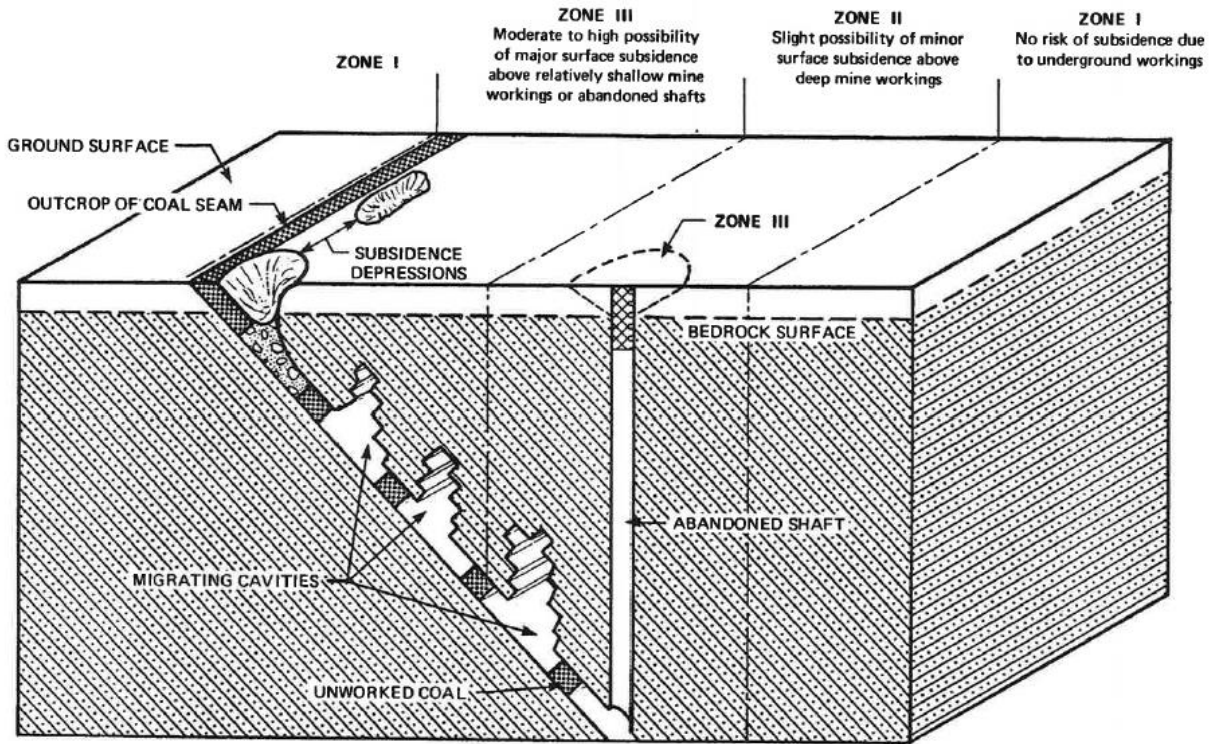
Figure 5. Schematic diagram showing collapse mechanisms for steeply dipping coal mine (after EBA 1982)

Coal-mine-roof collapse can involve either collapse of a roof between pillars or due to the failure of pillar(s) of coal. For horizontal or near-horizontal mines, bulking would tend to limit upward void migration if the bedrock above the coal mine was 8 to 12 times the seam thickness (Statham and Treharne 1991). For steeply dipping coal-mine voids like at the S012 site, roof or pillar collapse material could be

transported by gravity downslope towards the first level, with no bulking of collapsed material to stabilize the roof. A figure showing the collapse mechanisms for a steeply dipping coal mine property (EBA 1982) is included as Figure 5.

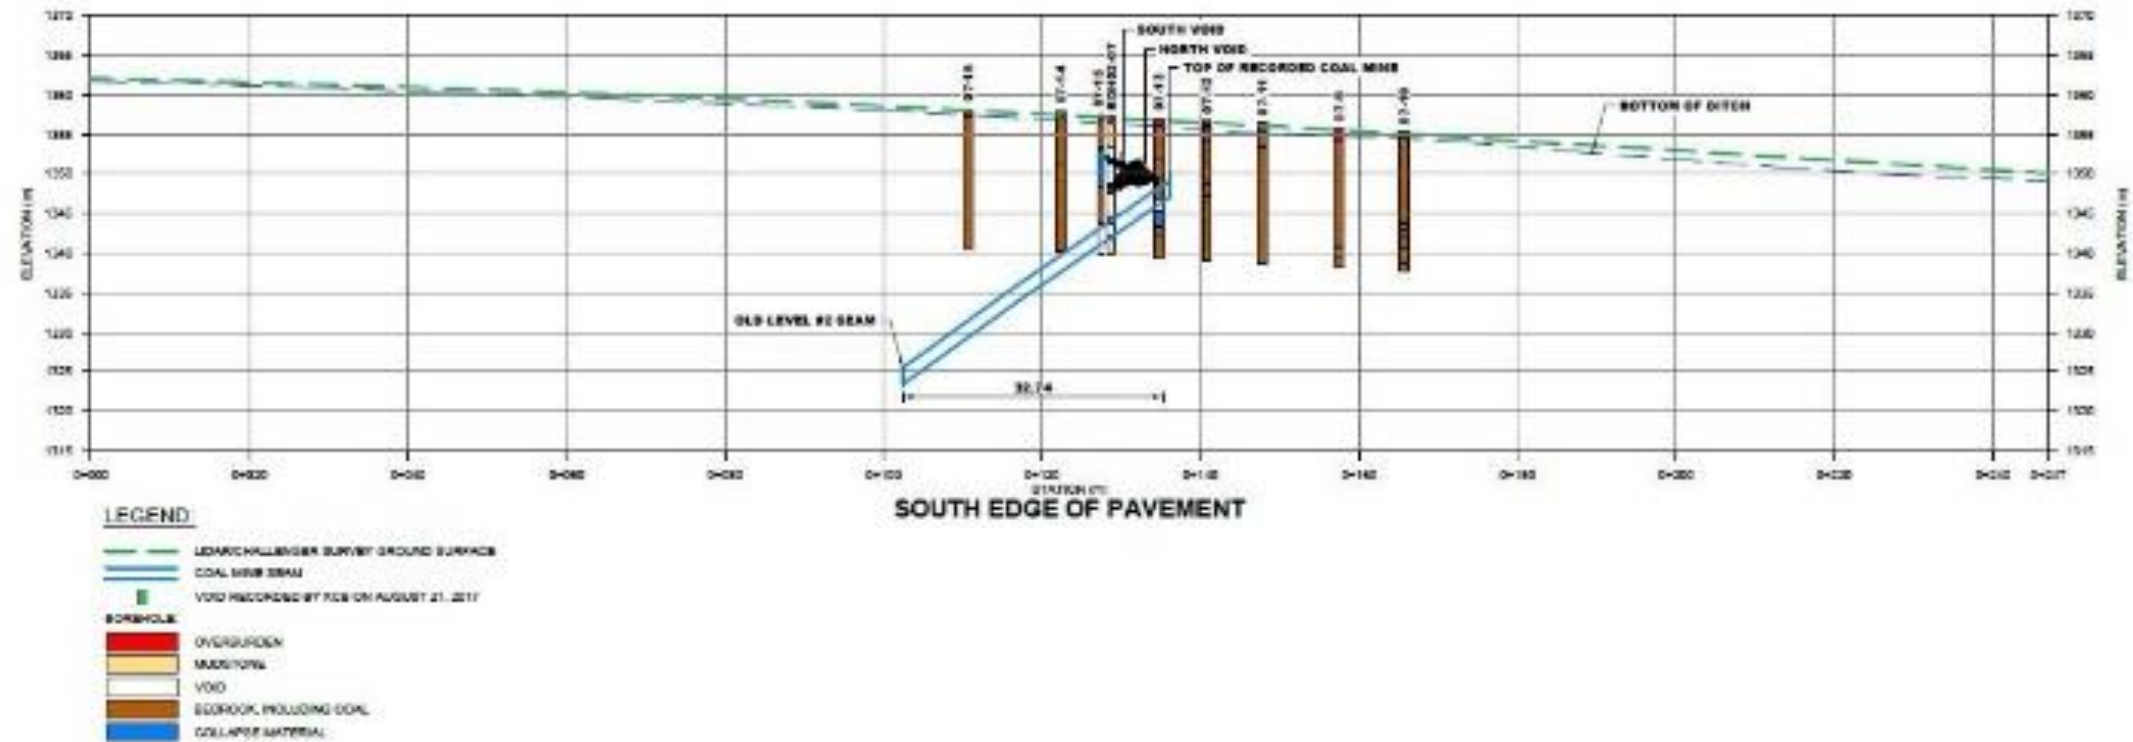
Figure 11. Cross section through Civil 3D model along Line 01 (south edge of pavement)

The historic coal-mine record drawings and the data collected from the 2003, 2007 and 2017 investigations were assembled in the Civil 3-D model. Sections through the Civil 3D model are shown in Figures 10 and 11. Figure 10 shows how the floor of the modelled coal-mine and the interpreted open voids and voids backfilled with collapse material generally matches the 2003 and 2007 borehole data. Some variations were noted between the borehole data and the modelled coal-mine void, and drilling is planned to investigate the location of the coal-mine workings at greater depths.
