Channel Stability Investigation Report

Red Deer River Hazard Study

1783039-070-R-Rev0

July 17, 2019

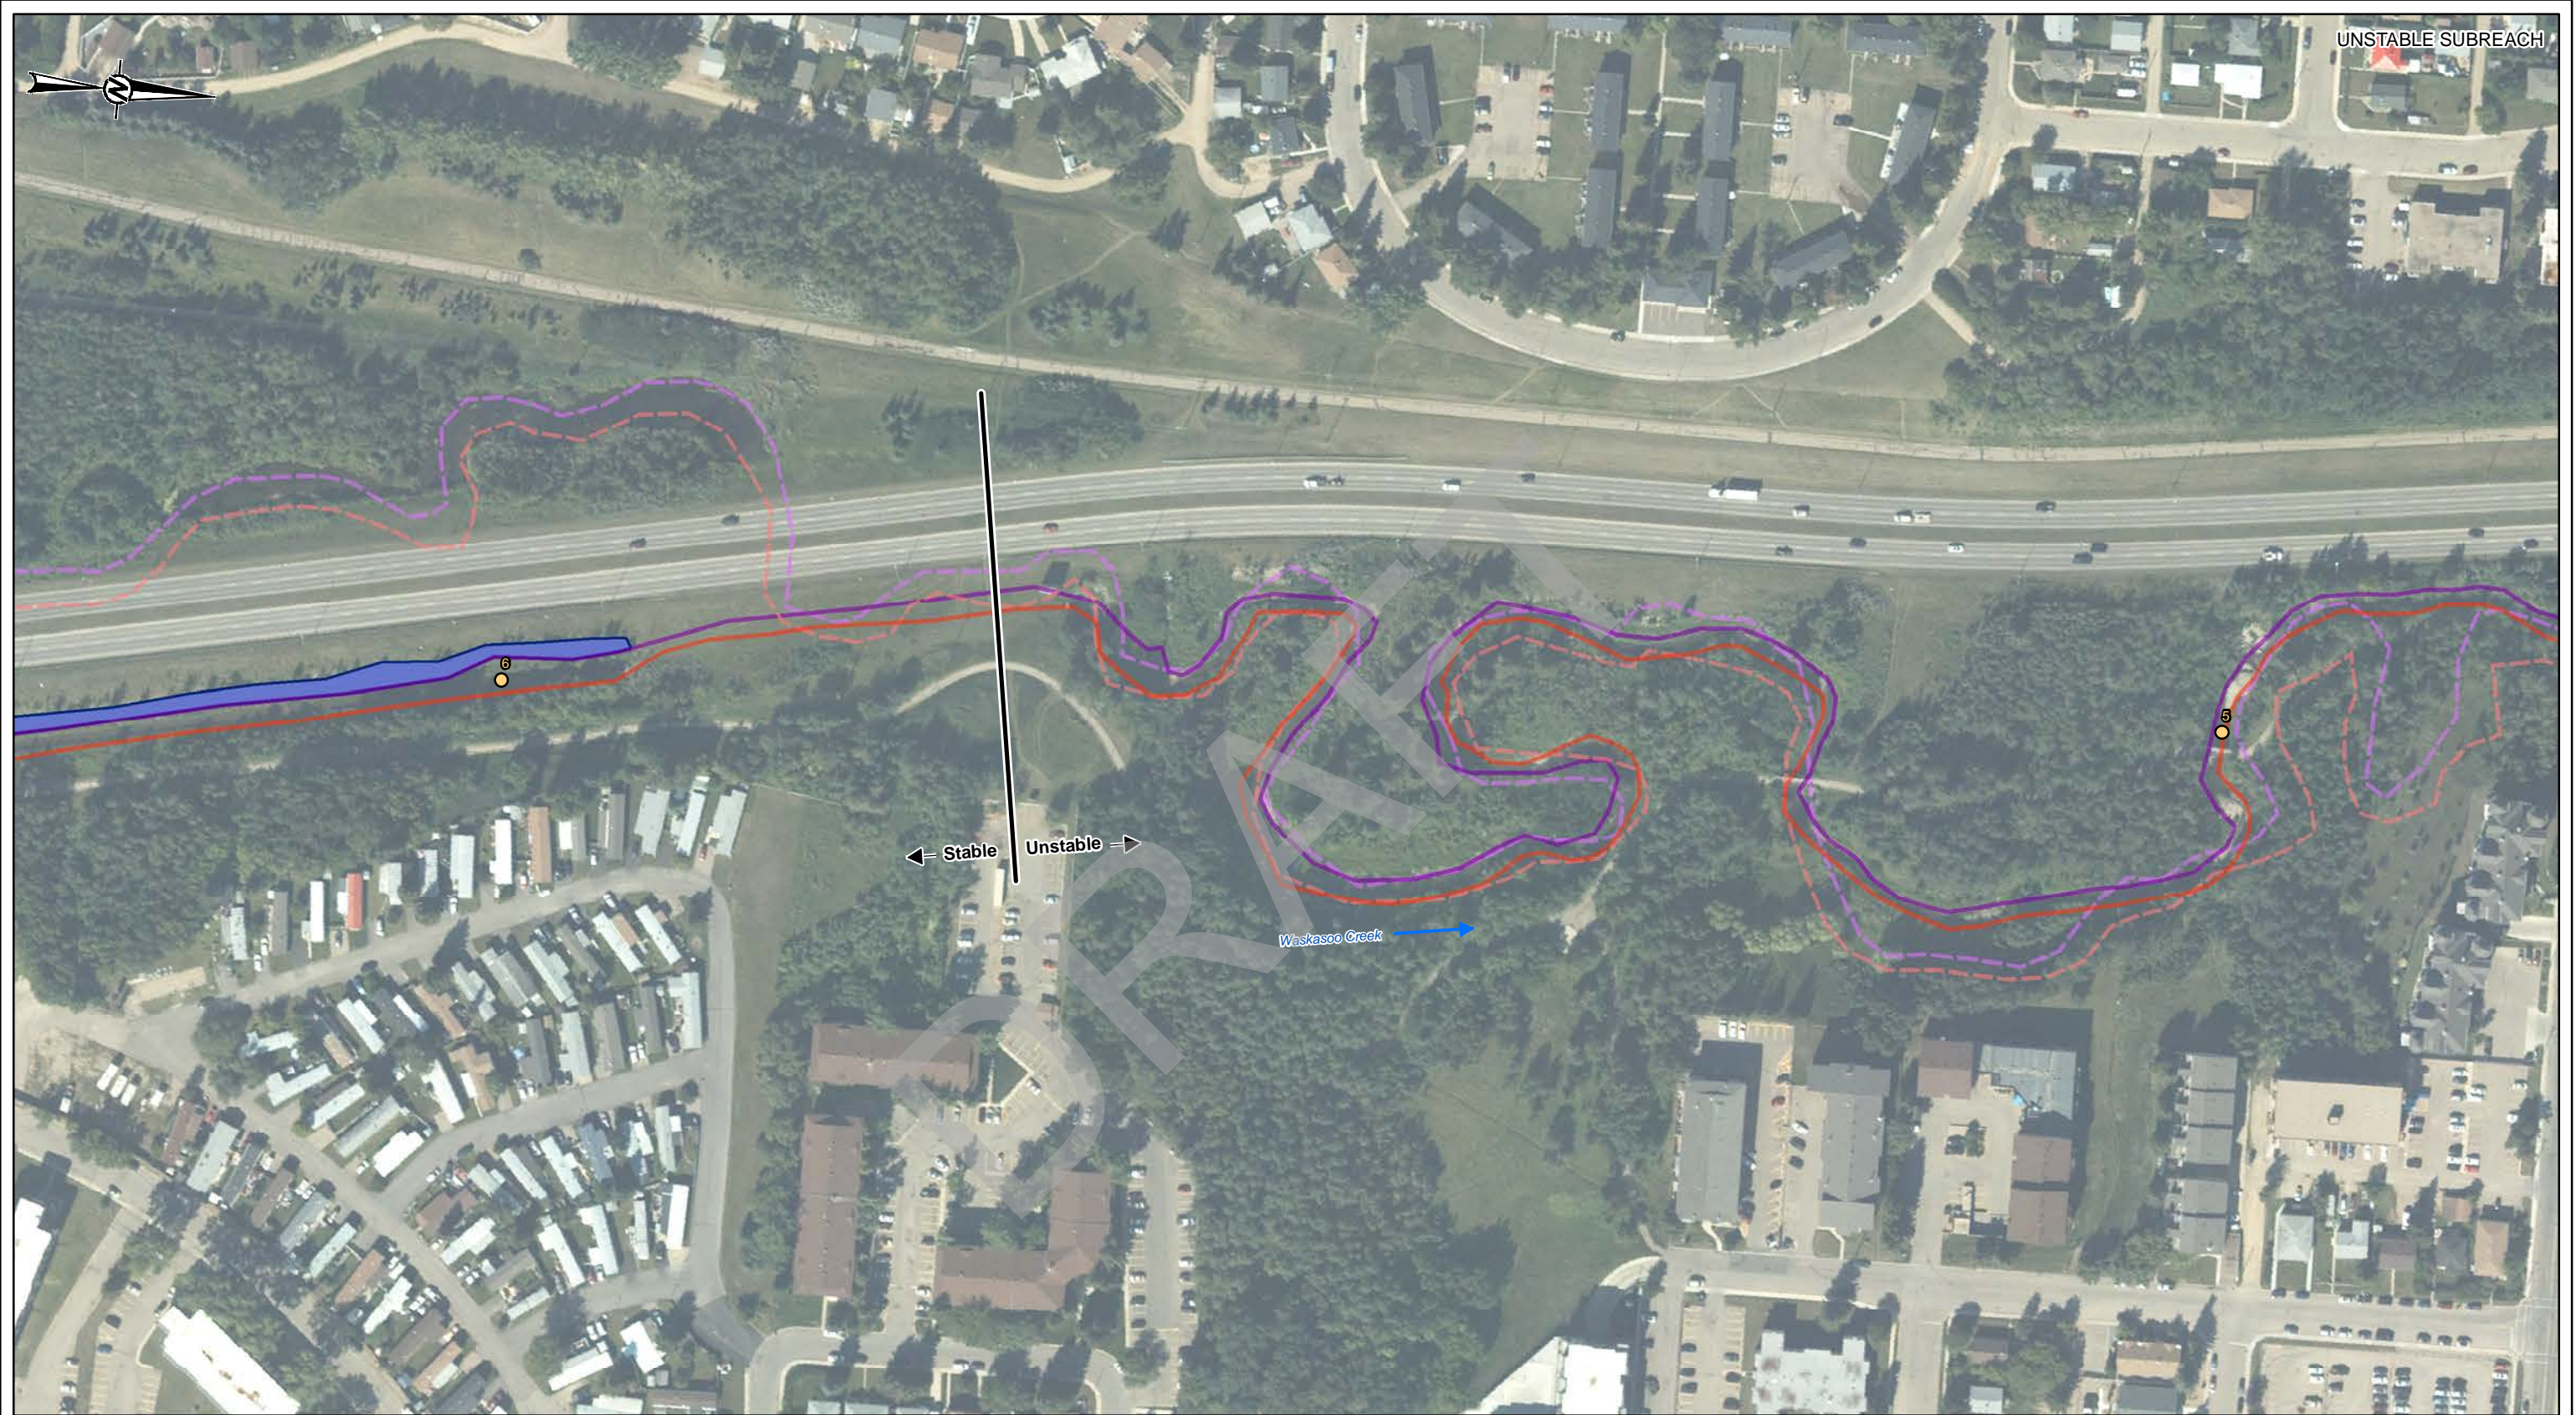
PROJECT NO. 1783039 CONTROL 8000 REV. 0 FIGURE 6

A second subset of Reach 4 showing stable conditions typical over the rest of the reach is presented in Figure 6. The channel corridor appears to have remained in approximately the same position, although visibility of the active channel was low due to tree cover. Limited bank erosion may have occurred at the apexes of the meander bends.

A subset of Reach 4 showing the typically unstable conditions near the stream mouth is also presented in Figure 6. The channel appears to have been artificially straightened prior to 1962. Over the observed period, the channel transitioned to a more meandering planform. Meander bend apexes migrated up to approximately 20 m, and the stream mouth migrated downstream approximately 30 m in response to a leftward shift of the right bank of Red Deer River.

The straight portions of Reach 5 are similar to those presented in the straight sub-reach of Reach 4 in Figure 6.

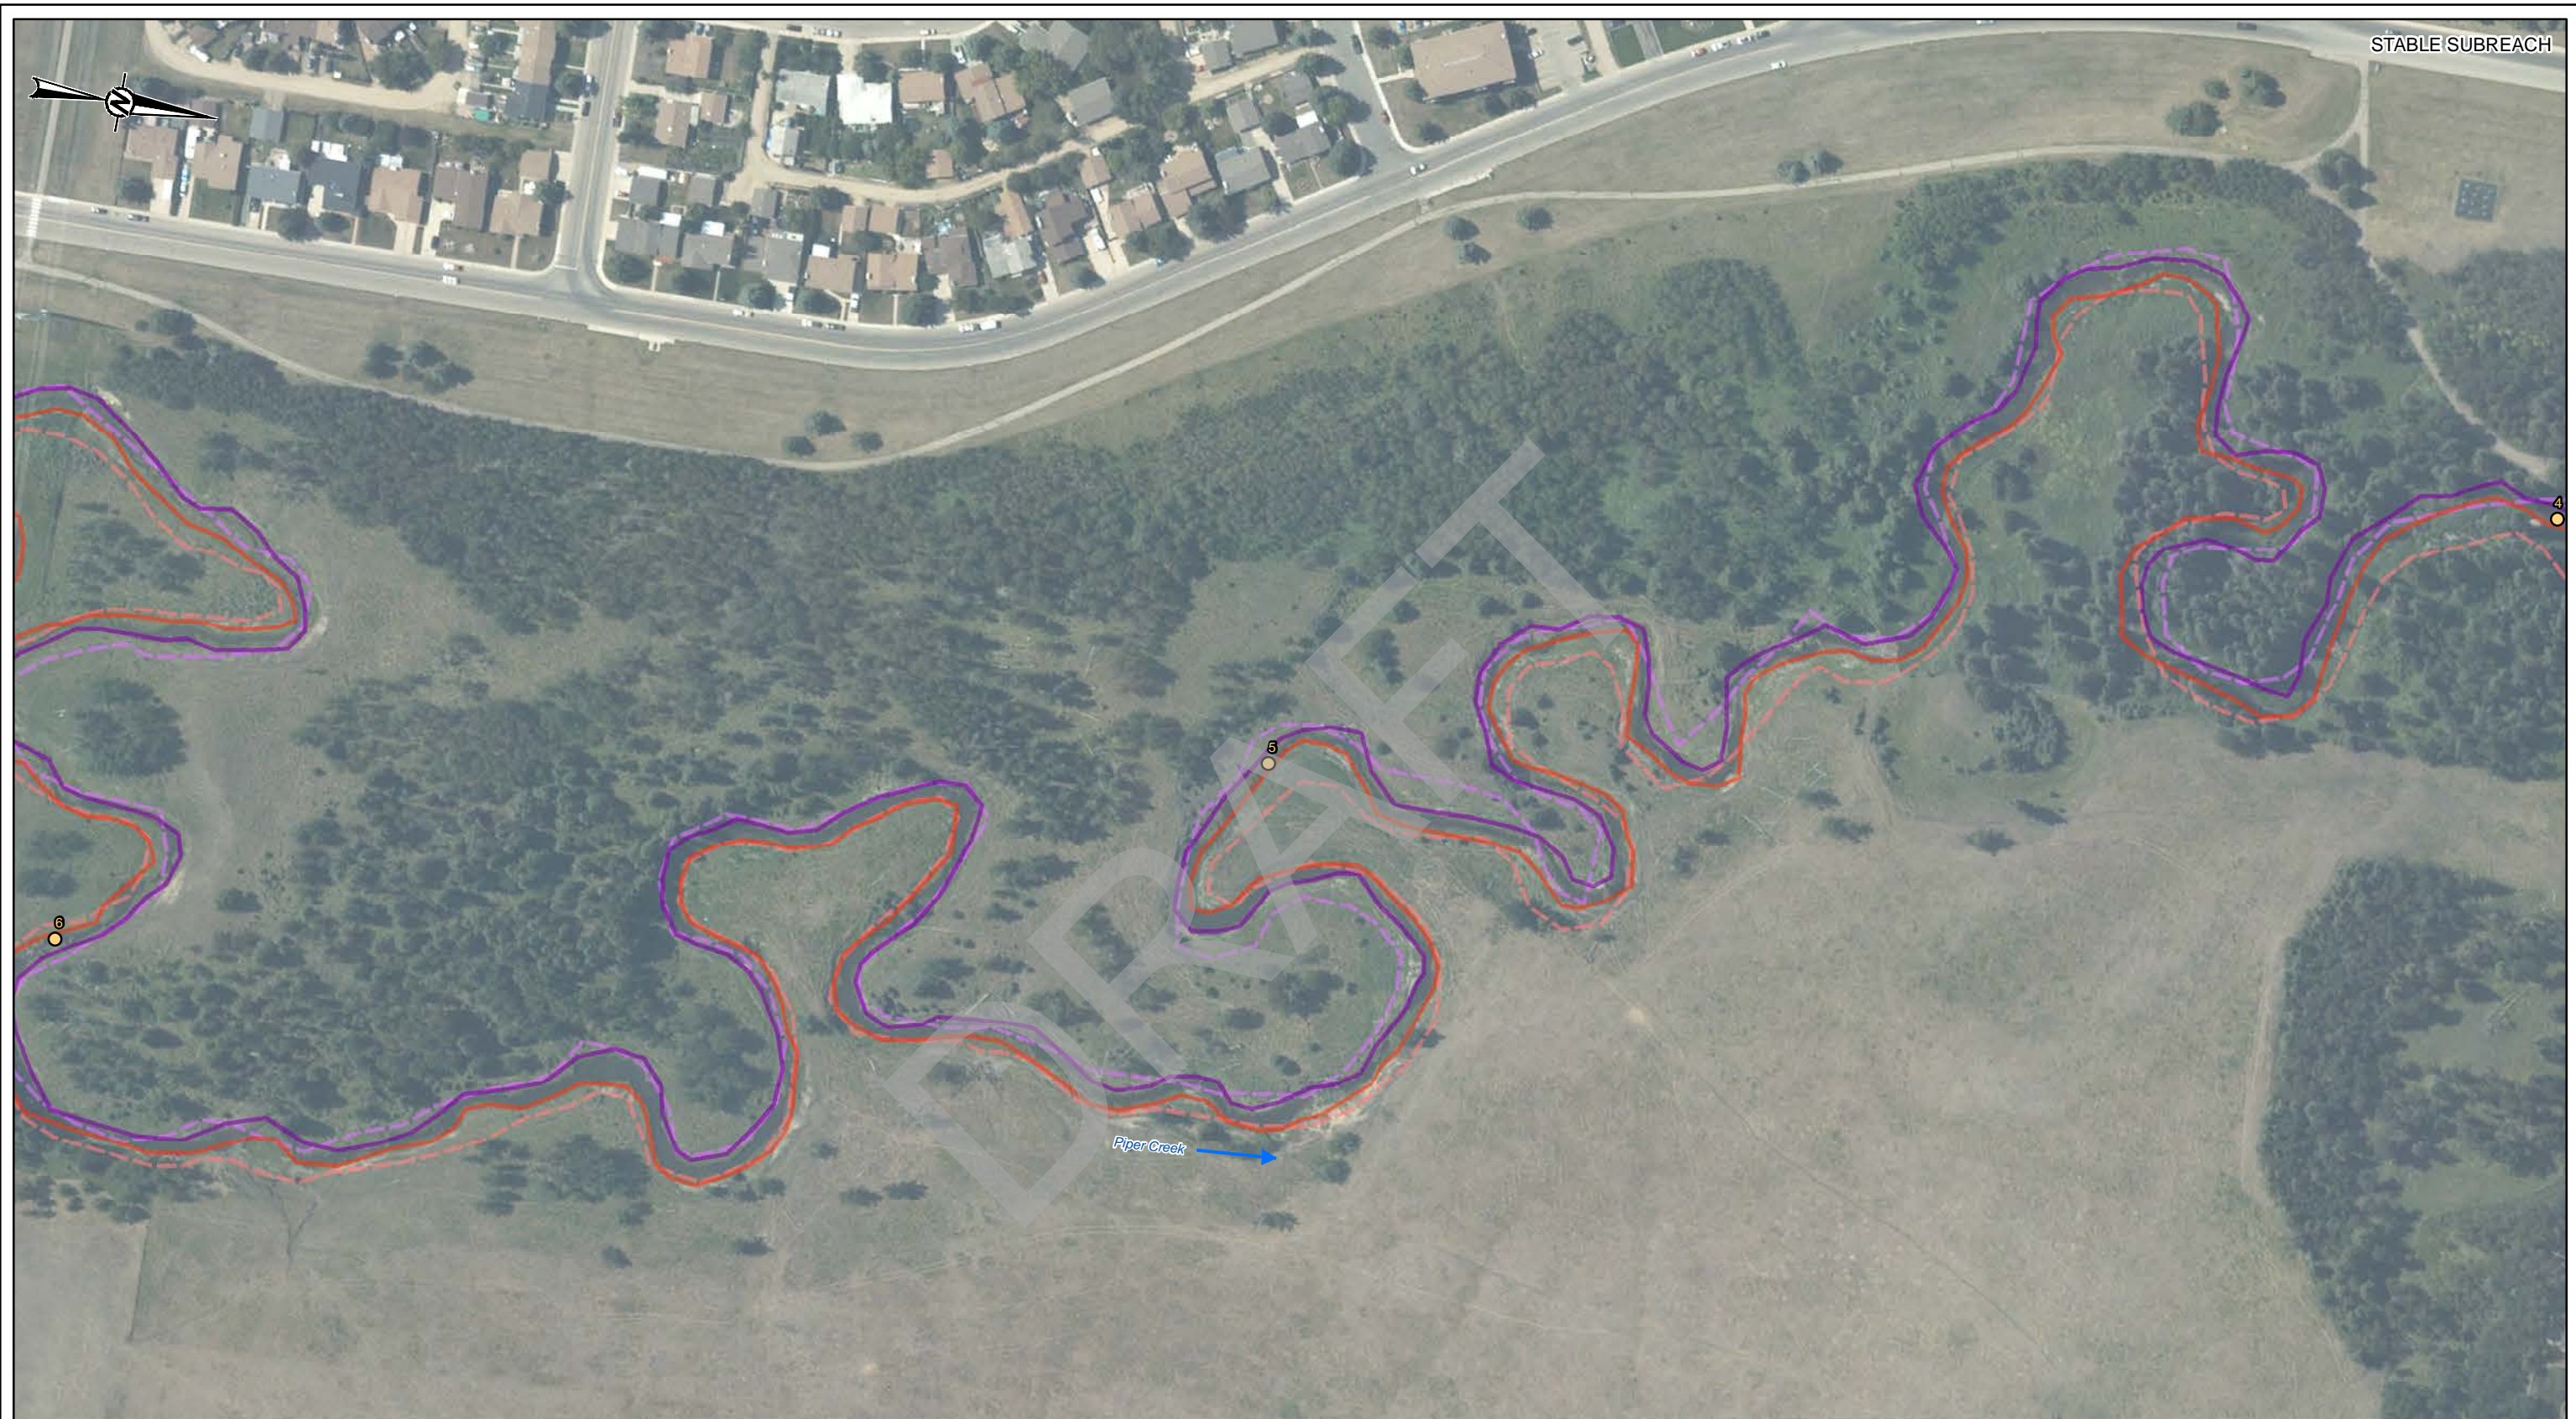
PROJECT NO. 1783039	CONTROL 8000	REV. 0	FIGURE 9
------------------------	-----------------	-----------	--------------------

A subset of Reach 7 showing typically straightened channel corridor conditions is presented in Figure 9. In this location, the historical channel was tortuously meandering, and two meander bend cutoffs appear to have been in progress, resulting in short multi-threaded channel sections containing vegetated islands. By the modern period, the channel had been apparently anthropogenically straightened.

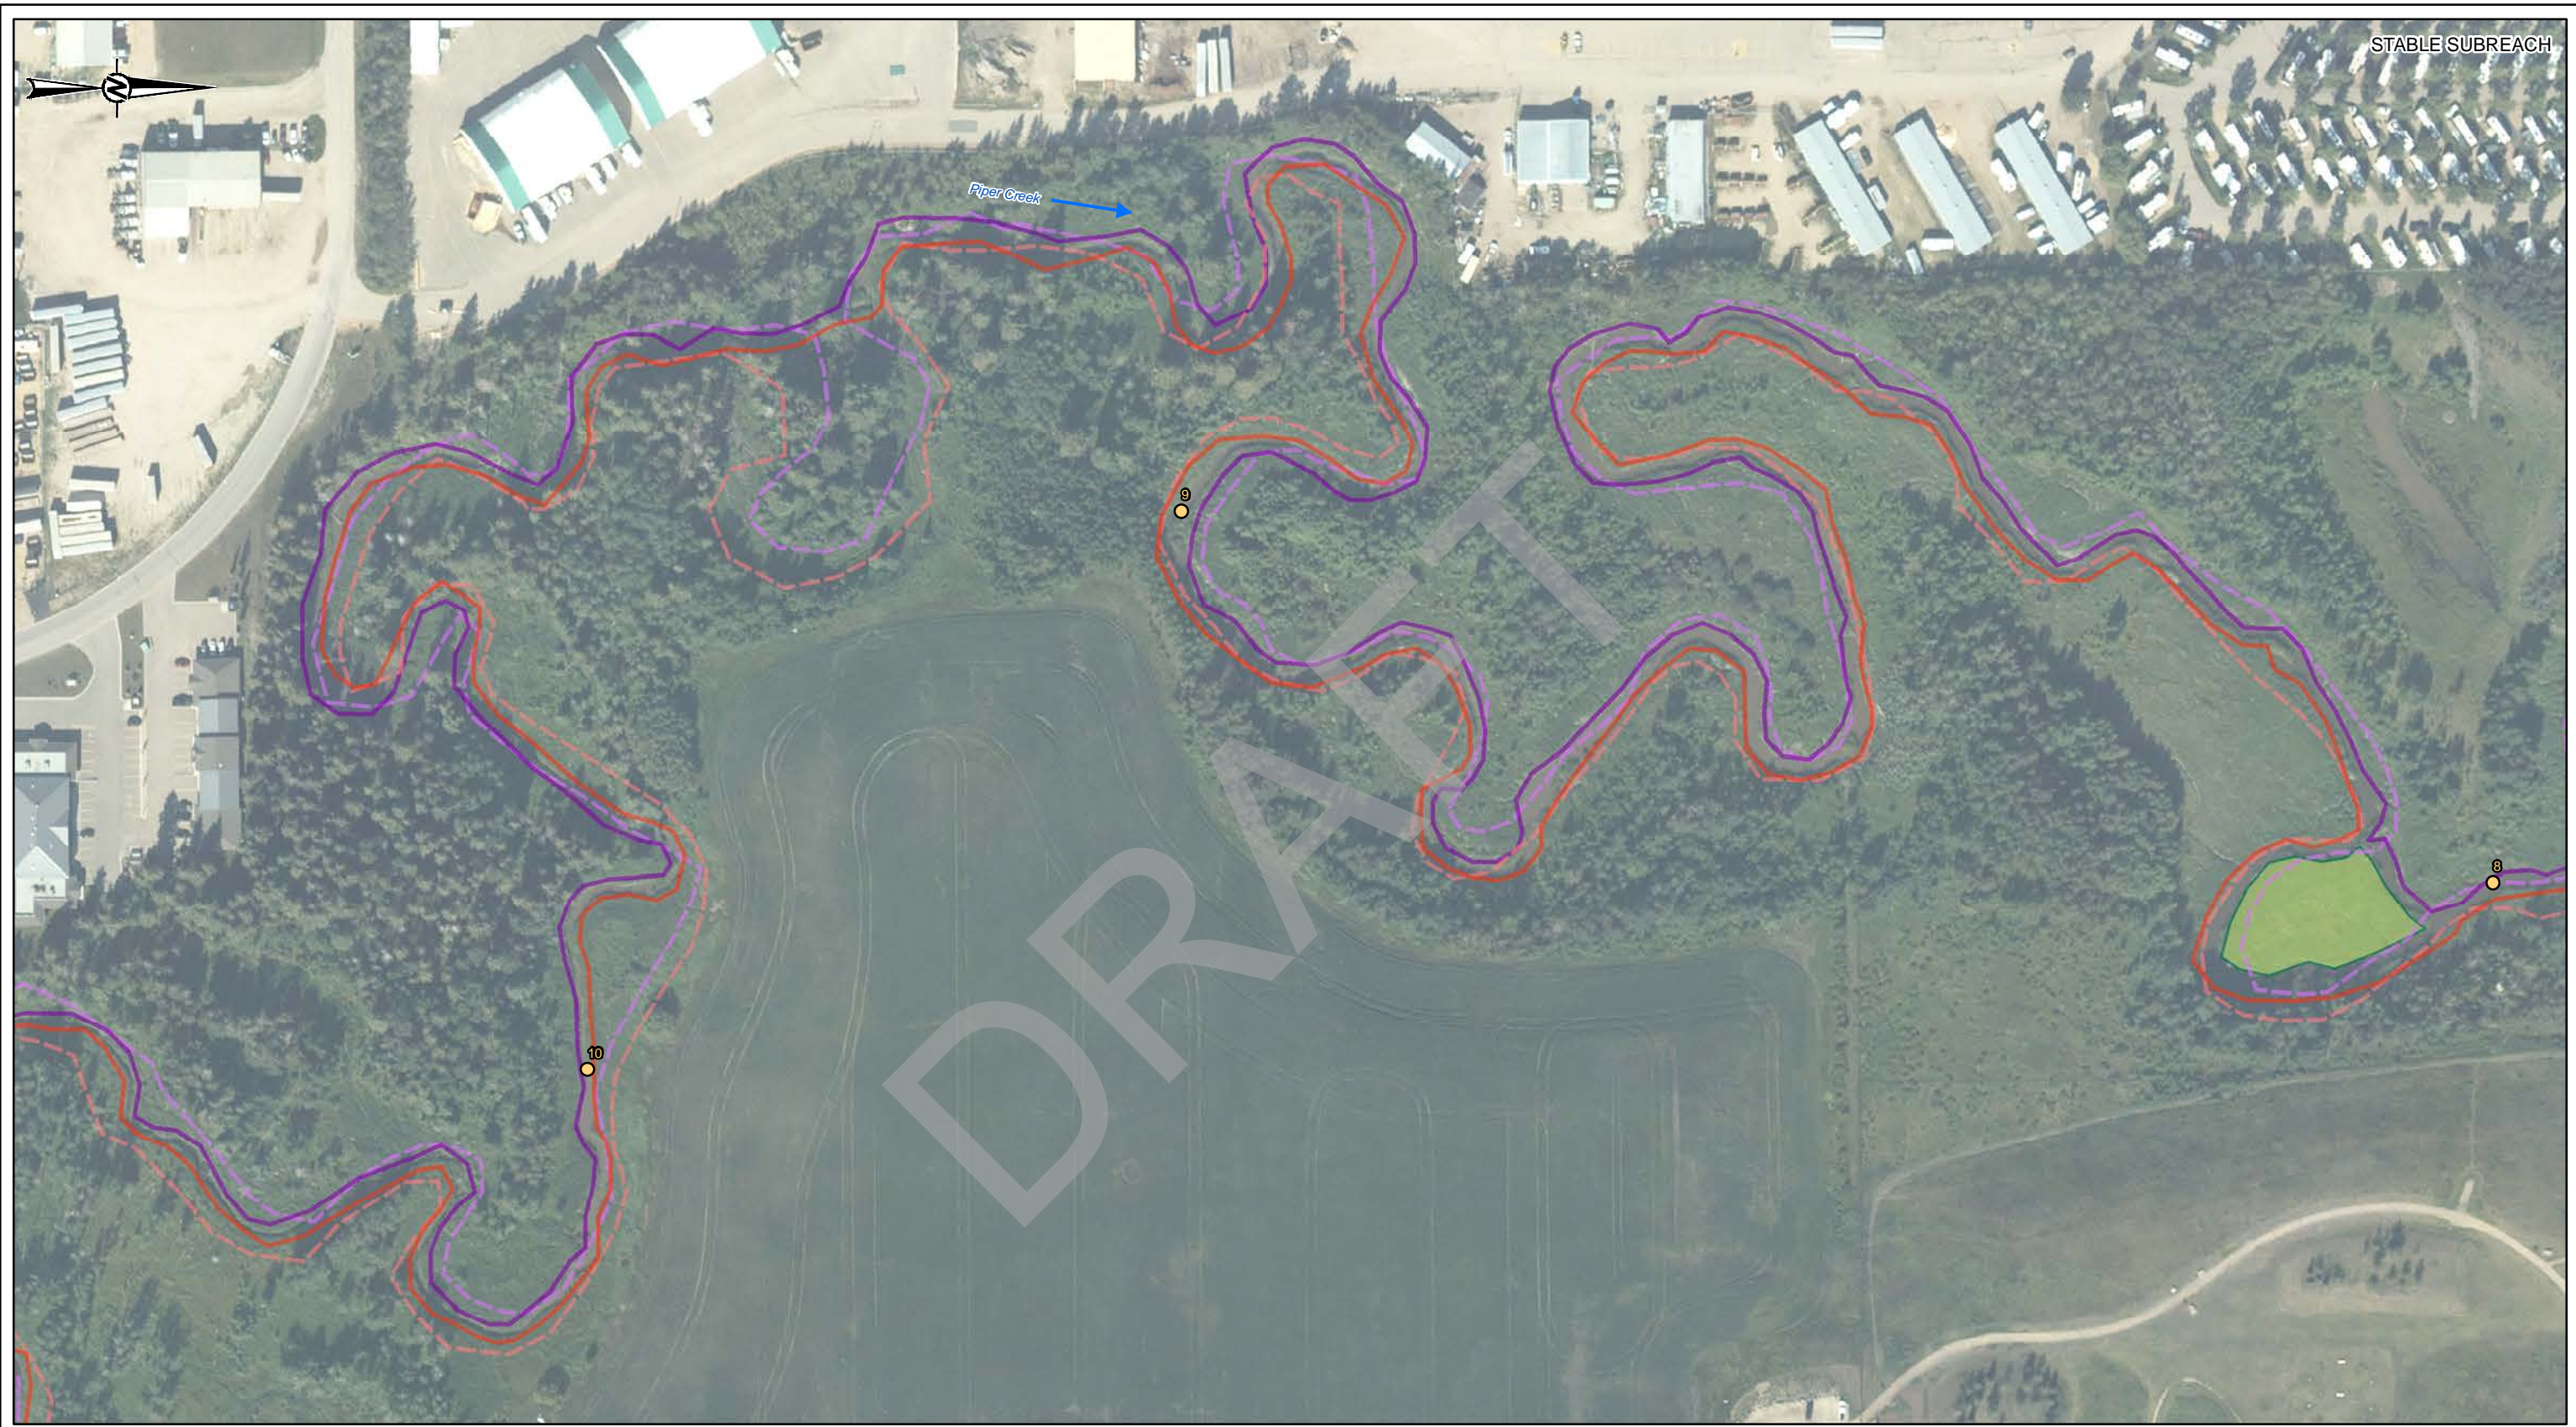
CLIENT ALBERTA ENVIRONMENT AND PARKS			
CONSULTANT			
YYYY-MM-DD	2019-07-17	DESIGNED	M.TIDD
PREPARED	S.KURASH	REVIEWED	R.ATKINS
APPROVED	D.LONG		
PROJECT NO. 1783039	CONTROL 8000	REV. 0	FIGURE 10

A subset of Reach 8 showing typically stable conditions is presented in Figure 10. The channel corridor is typically tortuously meandering, and potential meander bend cutoff locations are present in sections where bends are less than approximately 15 m apart. The channel corridor has remained in approximately the same position over the observed period, and no meander bend cutoffs occurred.

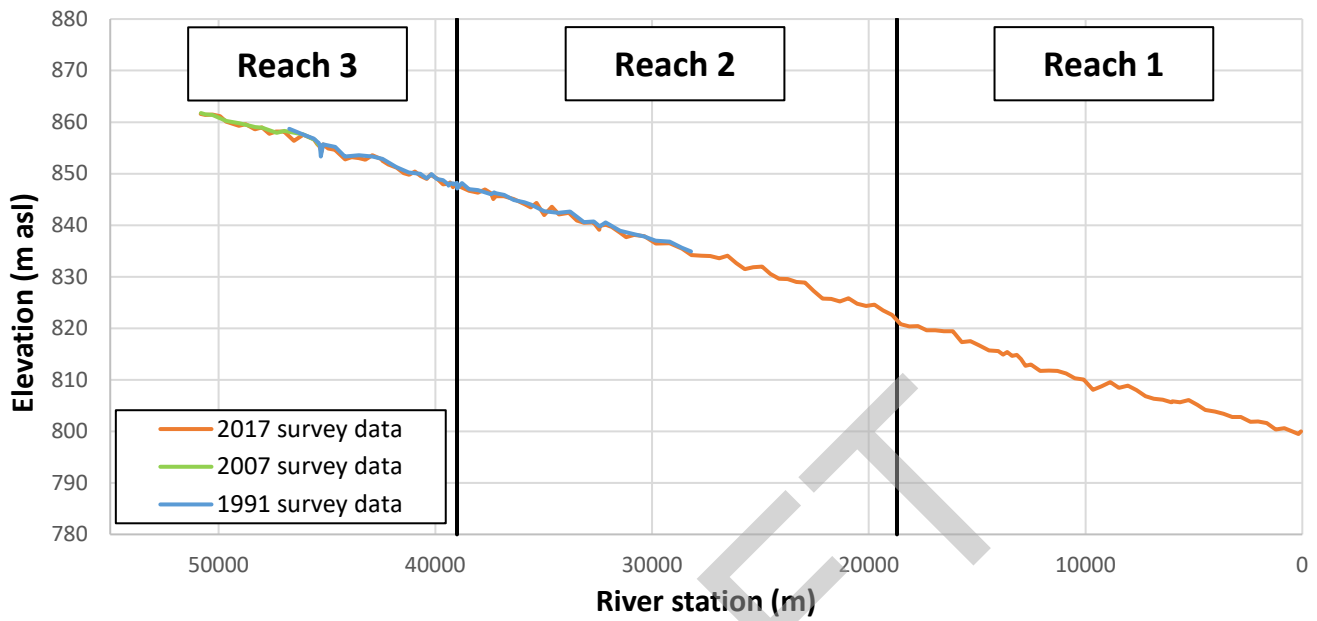
Figure 13: Longitudinal Profile for Red Deer River

The channel gradient of Red Deer River is approximately 0.1% throughout the study area (Figure 13). The study area comprises a relatively small portion of the river, so large-scale longitudinal patterns such as a concave profile may not be apparent in the thalweg data. It is also possible that the longitudinal profile is imposed by underlying bedrock or glacial sediments and is not a result of fluvial processes characteristic of the modern Red Deer River.

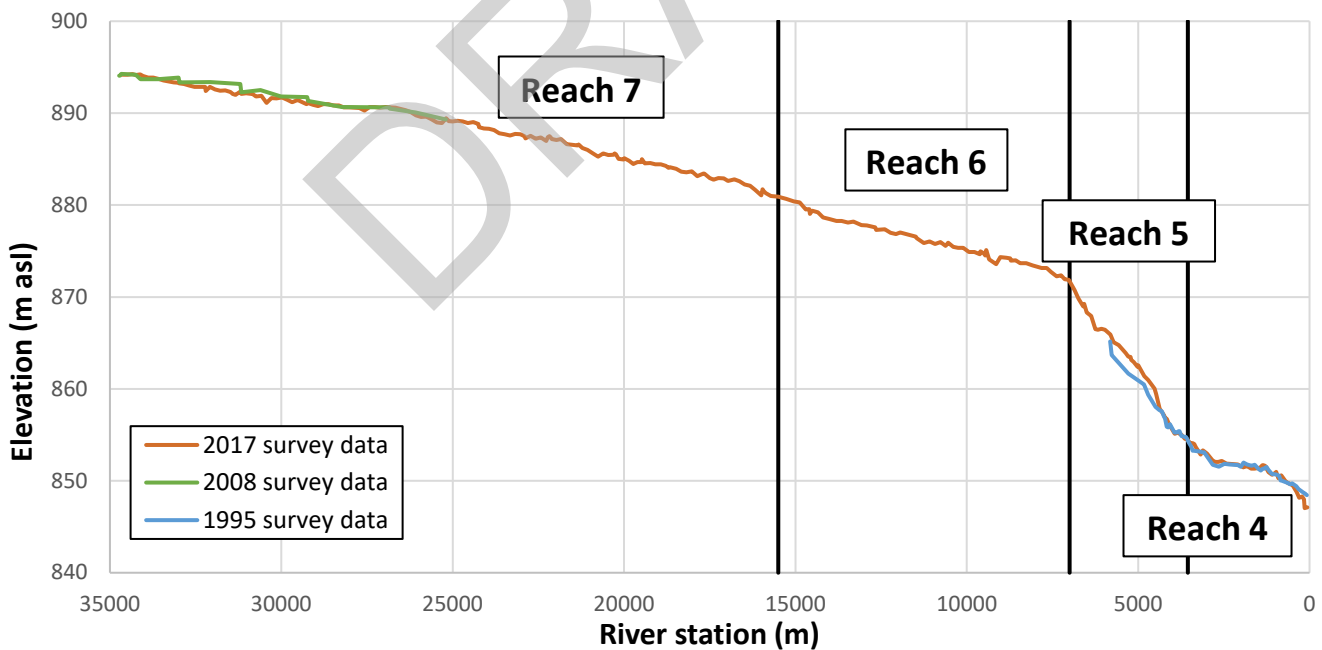
Figure 14: Longitudinal Profile for Waskasoo Creek

Waskasoo Creek flows through typically gentle terrain on the Prairies. Over the long term (thousands of years), the stream appears to be responding to base level lowering at its mouth caused by degradation on Red Deer River. Slope is gentle (approximately 0.07%) along Reach 7 (Figure 14). The channel begins to become incised within the general prairie surface along Reach 6, where the slope increases to approximately 0.1%. The slope increases abruptly to approximately 0.5% at a knickpoint located near the boundary between Reaches 5 and 6. It becomes gentler (approximately 0.2%) in Reach 4 where the stream flows across a terrace of Red Deer River, before steepening just upstream of the mouth.

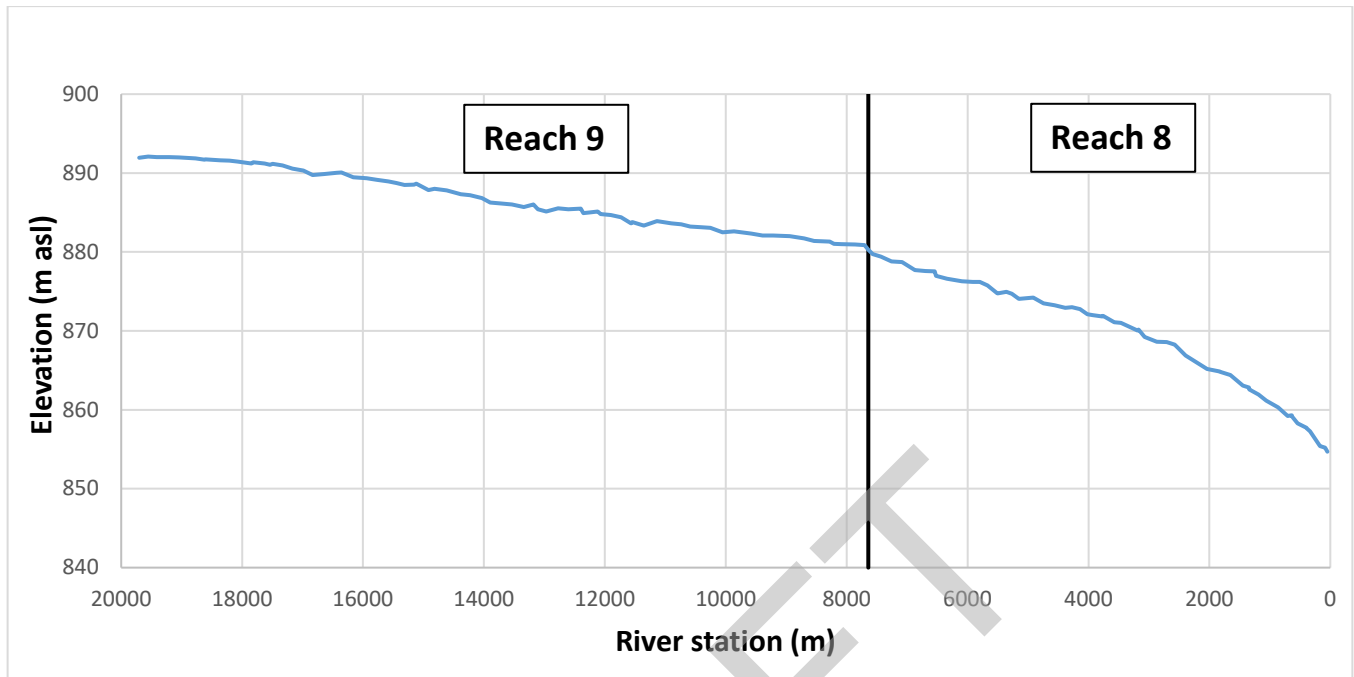
Figure 15: Longitudinal Profile for Piper Creek

Piper Creek flows through typically gentle terrain on the Prairies. Over the long term (thousands of years), the stream appears to be responding to base level lowering at its mouth caused by degradation on Waskasoo Creek. Slope is gentle (approximately 0.1%) along Reach 9 (Figure 15). It begins to increase gradually over Reach 8 (where the average slope is approximately 0.3%) until the stream mouth at Waskasoo Creek. The channel is typically incised within the general prairie surface except at the upstream end of Reach 9.
