Channel Stability Investigation Report

Upper Red Deer River Hazard Study

1783057-055-R-Rev0

July 2019

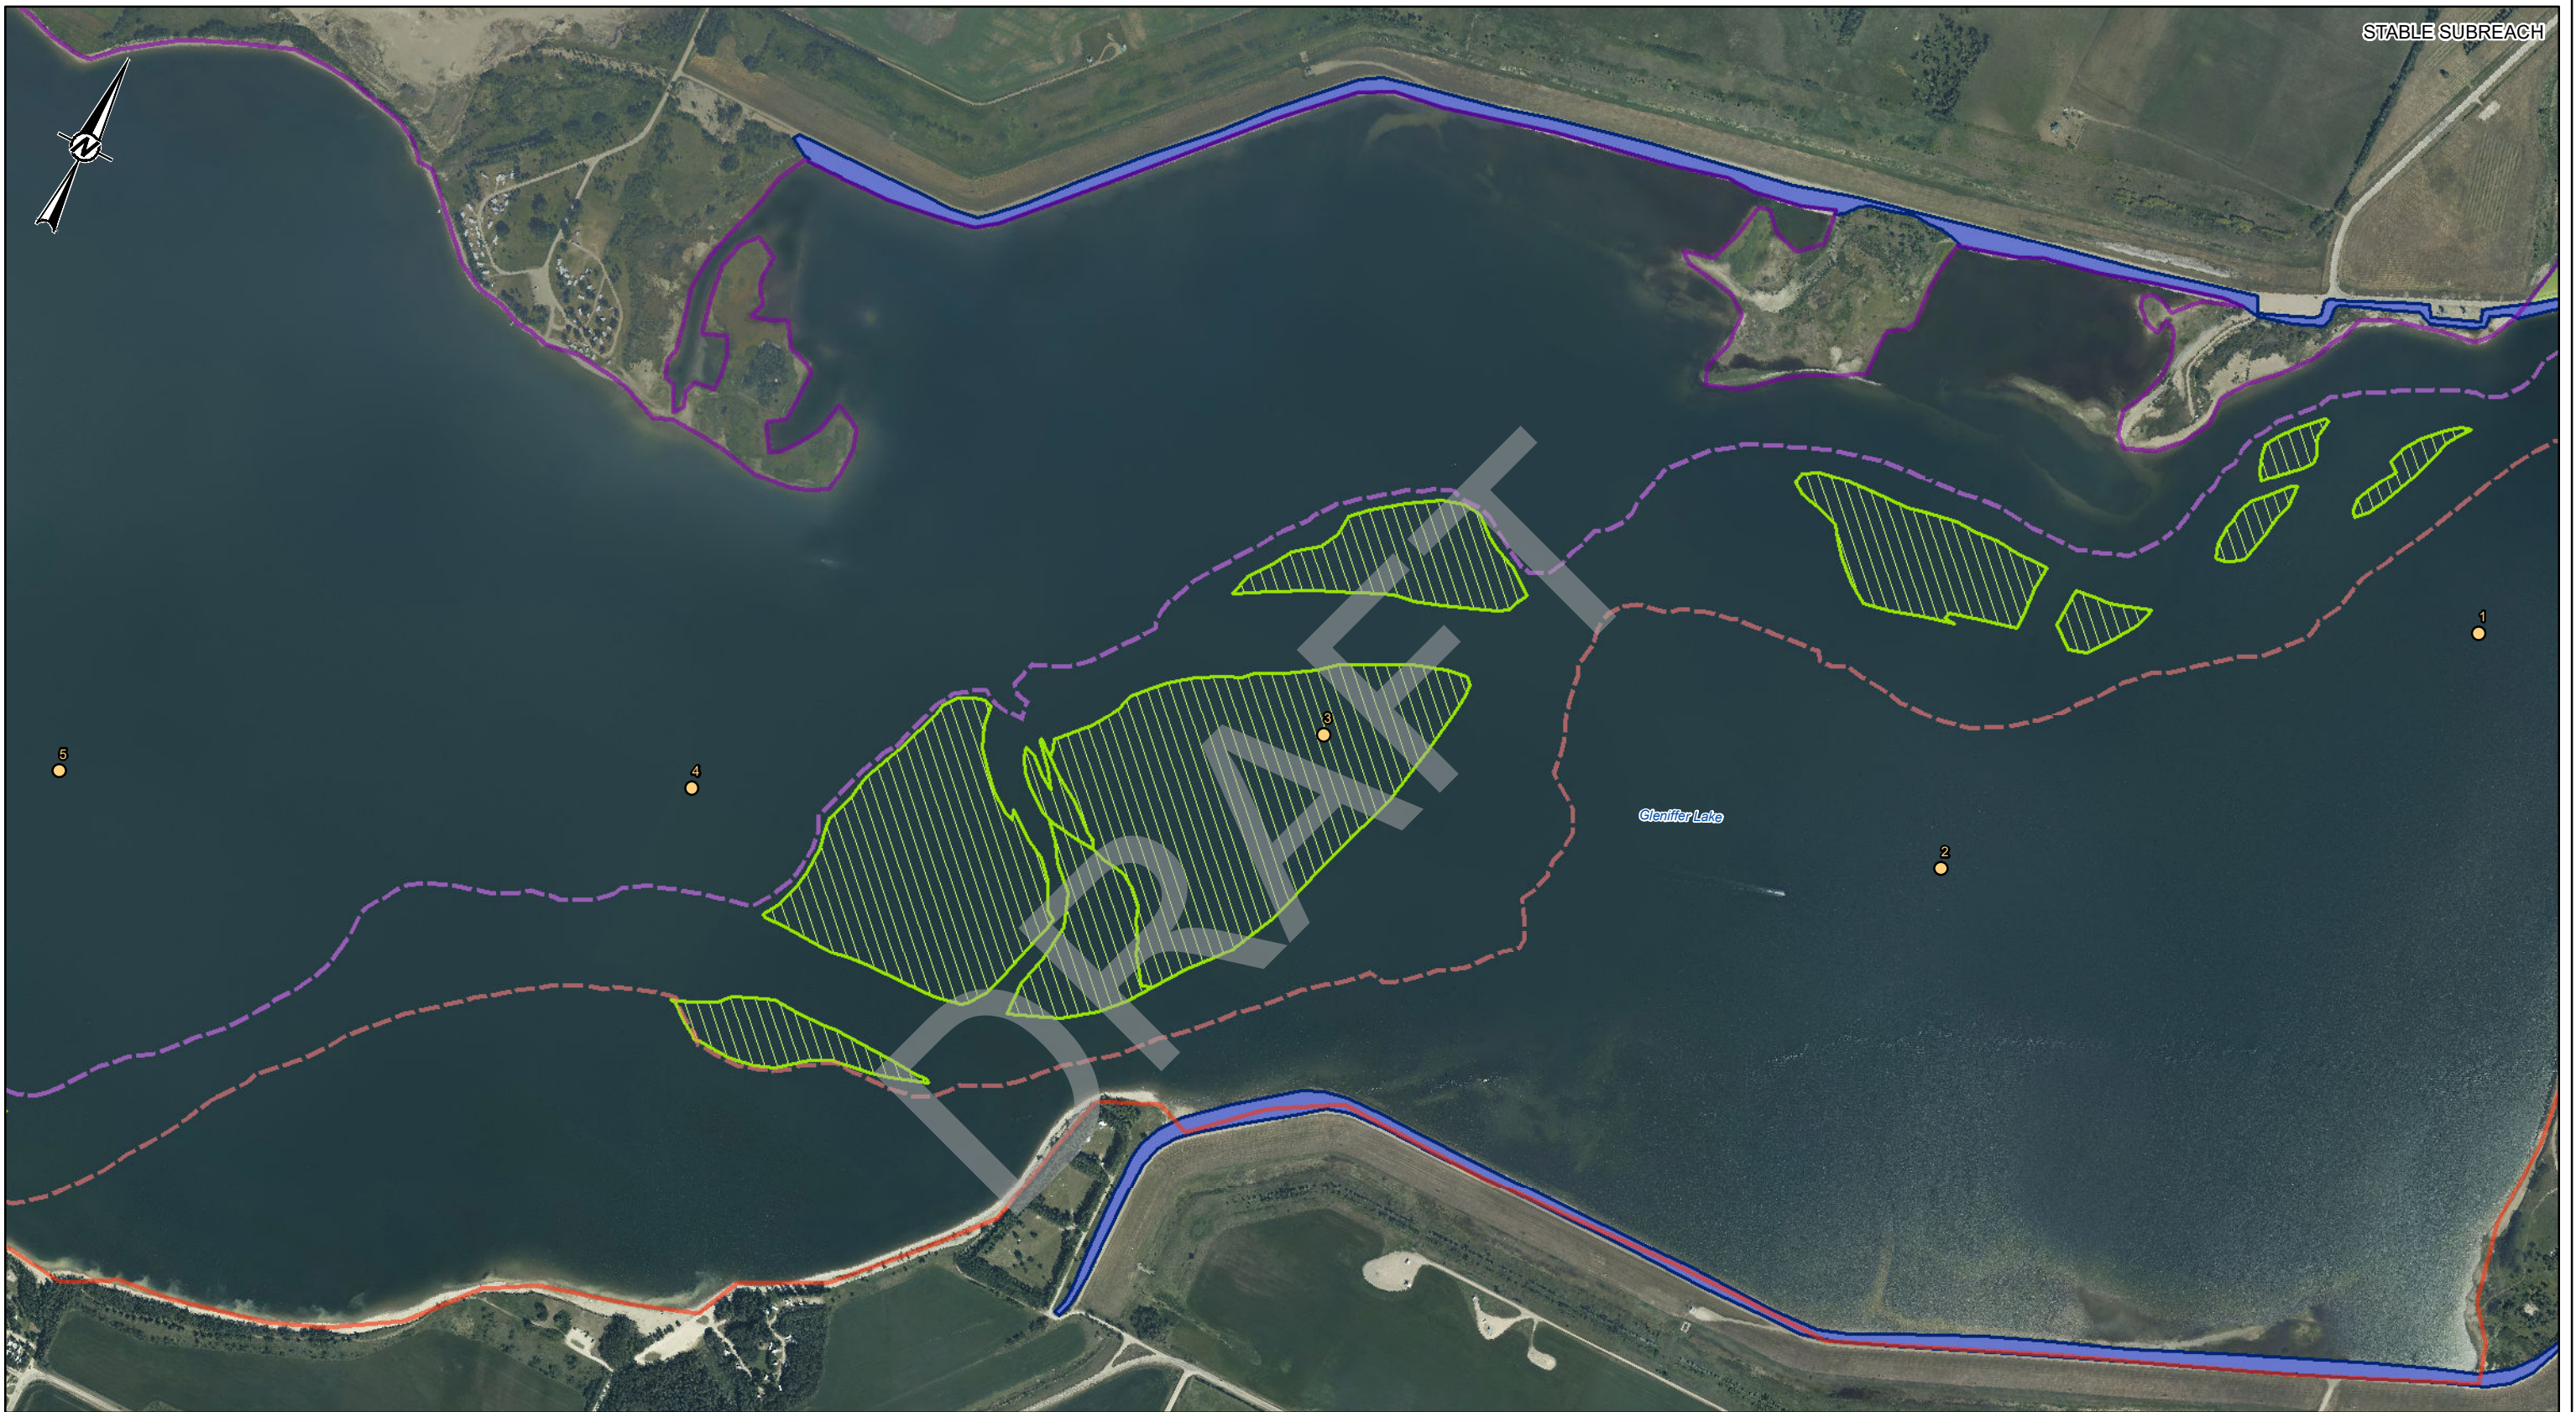
PROJECT NO. 1783057 CONTROL 8000 REV. 0 FIGURE 3

Reach 1 (Red Deer River), which extends from Dickson Dam to STN 13+000, is typically submerged by Gleniffer Lake. In the historical period, the channel exhibited a wandering (transitional between braided and single-threaded) planform. This wandering platform contained narrow, single-threaded sections separated by wider channel corridors. The wider channel corridor areas contained stable islands. A sub-section of Reach 1 is presented in Figure 3.

TITLE
 CHANNEL BANK COMPARISON OF REACH 1 - UPPER RED DEER RIVER FROM DICKSON DAM TO STN 13+000 - REPRESENTATIVE SUBREACH

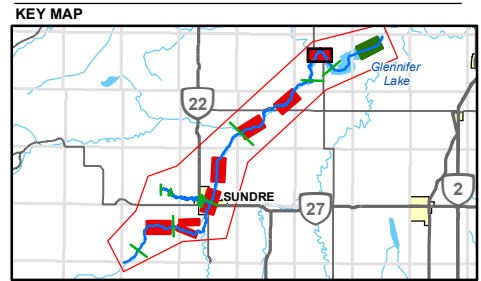
PROJECT NO. 1783057 CONTROL 8000 REV. 0 FIGURE 4

A subset of this reach is presented in Figure 4. The dominant channel has migrated up to 300 metres (m) over the observed period, and the channel corridor widened up to 300 m due to the emergence of a new sub-dominant channel.

TITLE
CHANNEL BANK COMPARISON OF REACH 2 - UPPER RED DEER RIVER FROM STN 13+000 TO STN 23+600 - REPRESENTATIVE SUBREACH

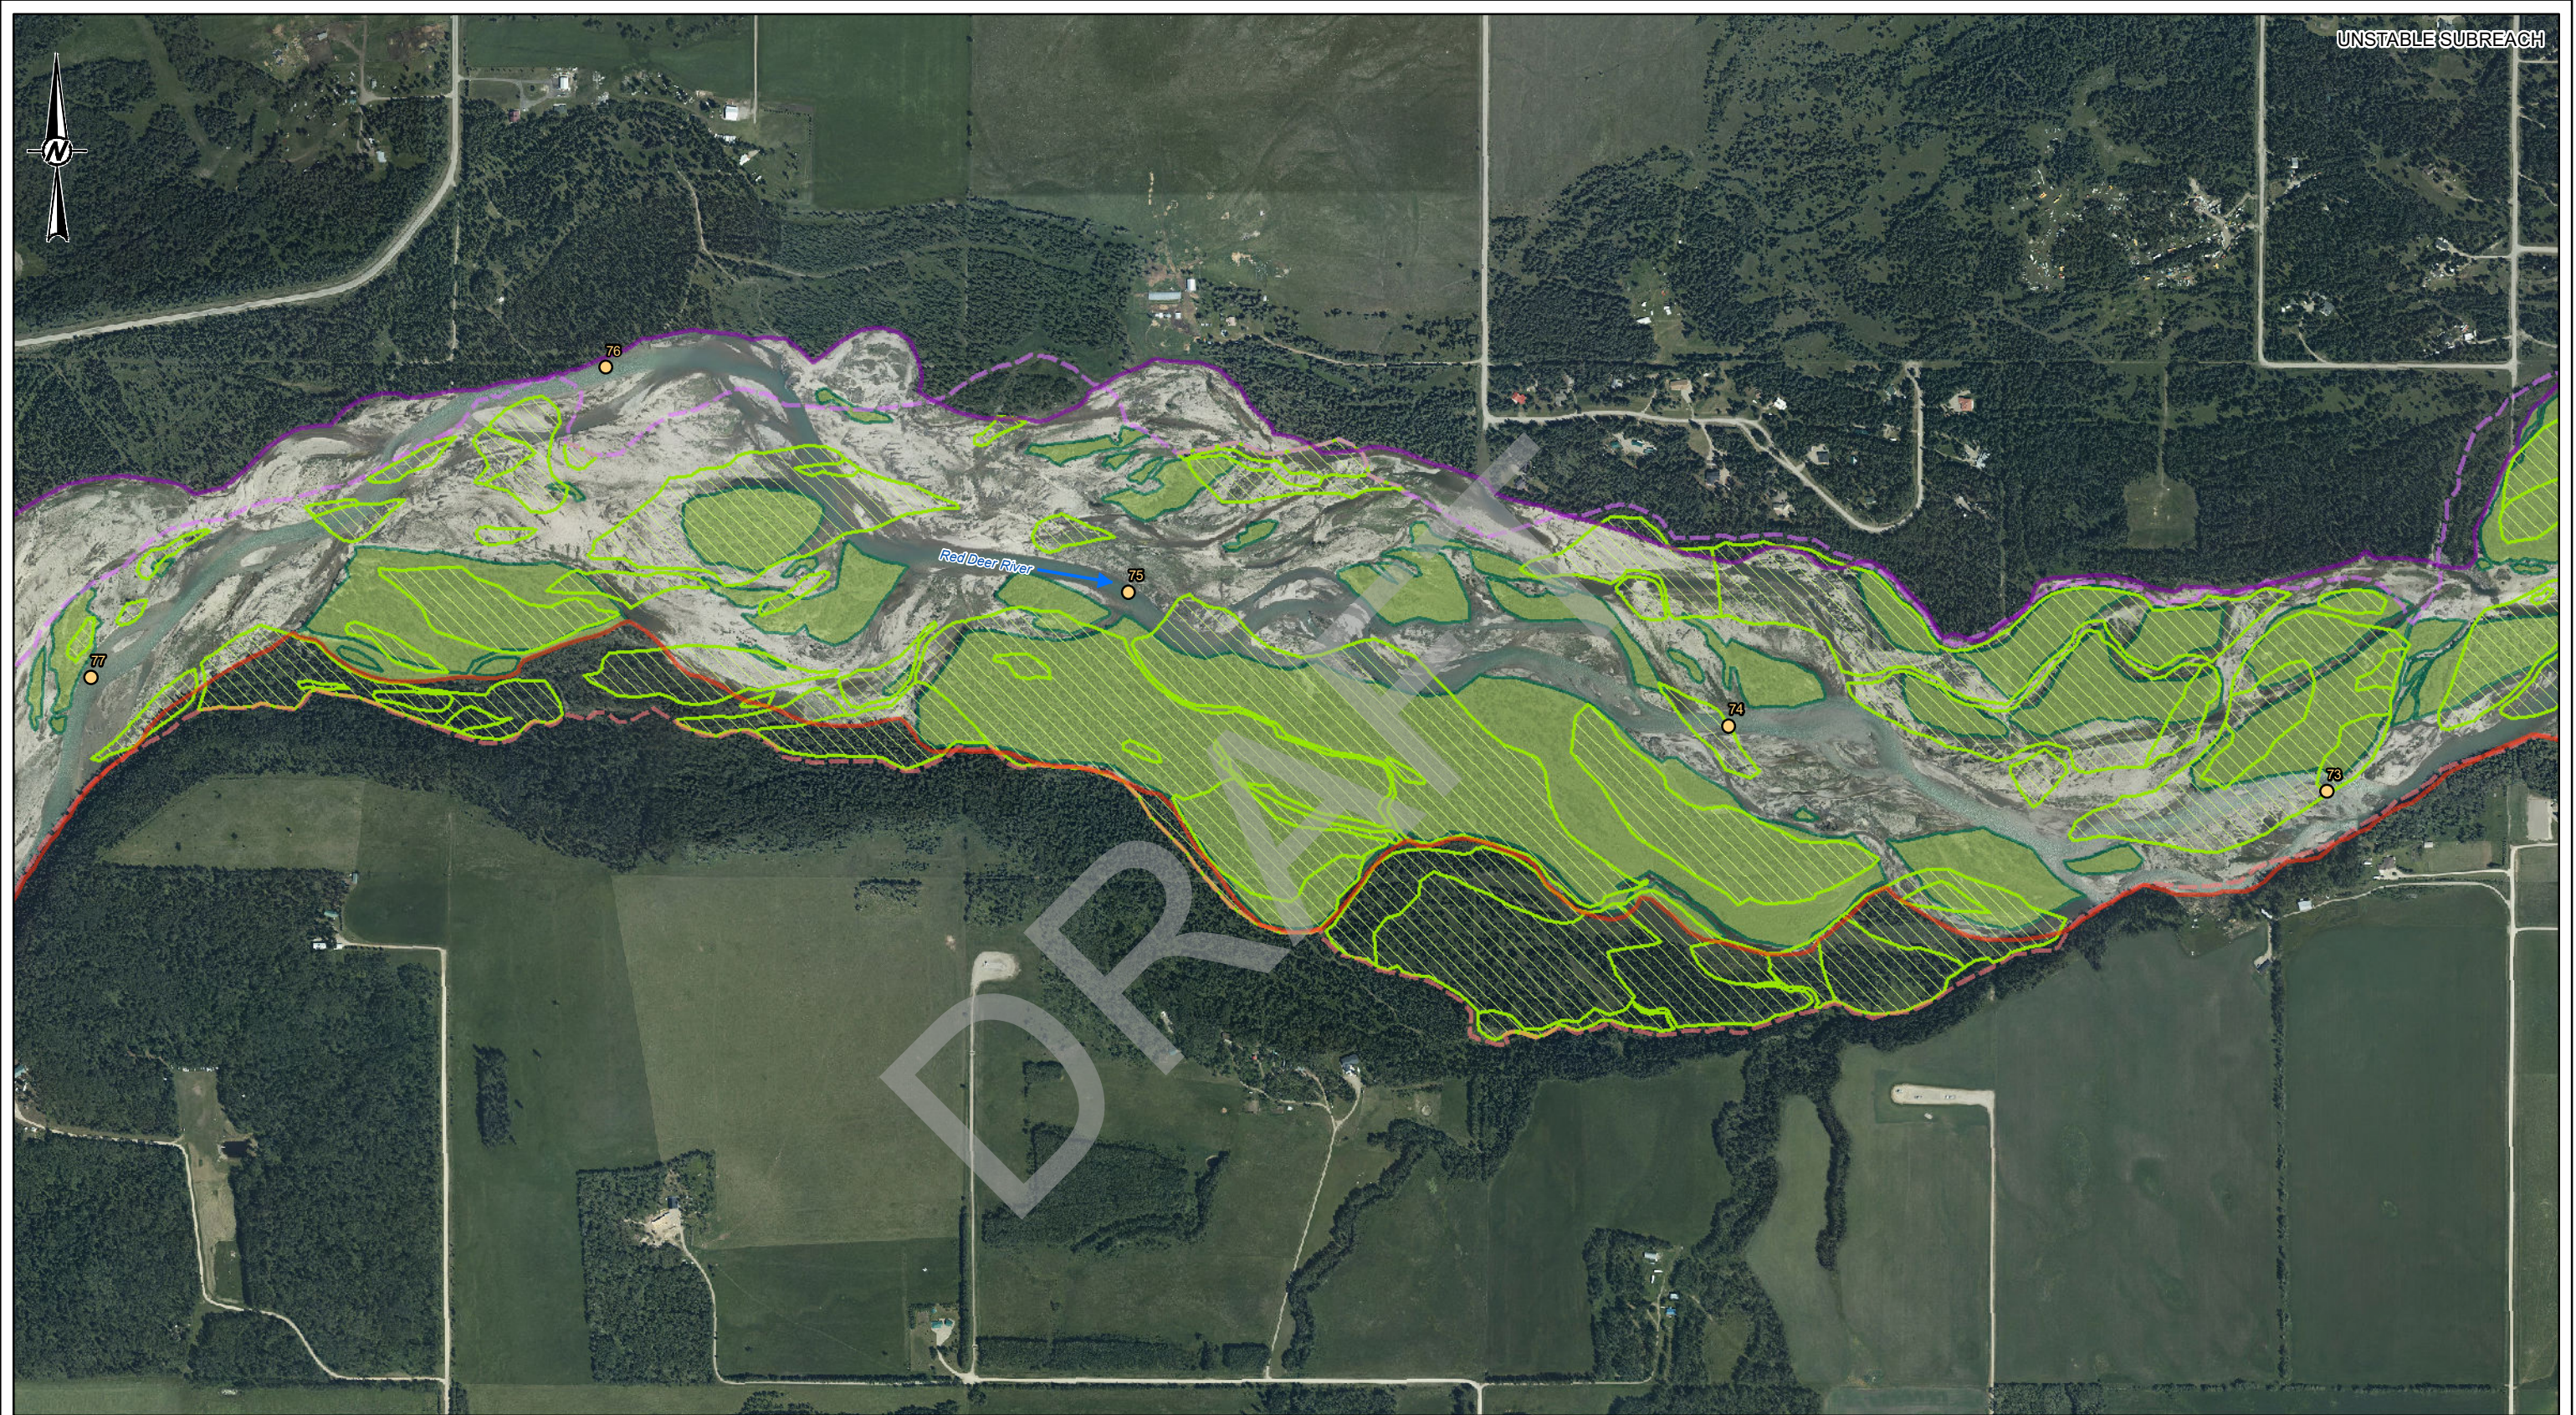
FIGURE 9

A representative sub-section of the southern fork is presented in Figure 9. The right margin of the channel corridor shifts to the south up to 200 m, and avulsion and channel migration of the dominant channel are prevalent.

An example of the northern fork (McDougal south) is also presented in Figure 9. In the historical period, it was typically wandering. The active channel was dissected by large vegetated islands. By the modern period, most of the flow has been diverted to the southern fork, and most channel sections have begun to stabilize. However, a defined segment of active channel emerges at the downstream end of the northern fork, so the fork is still considered active.

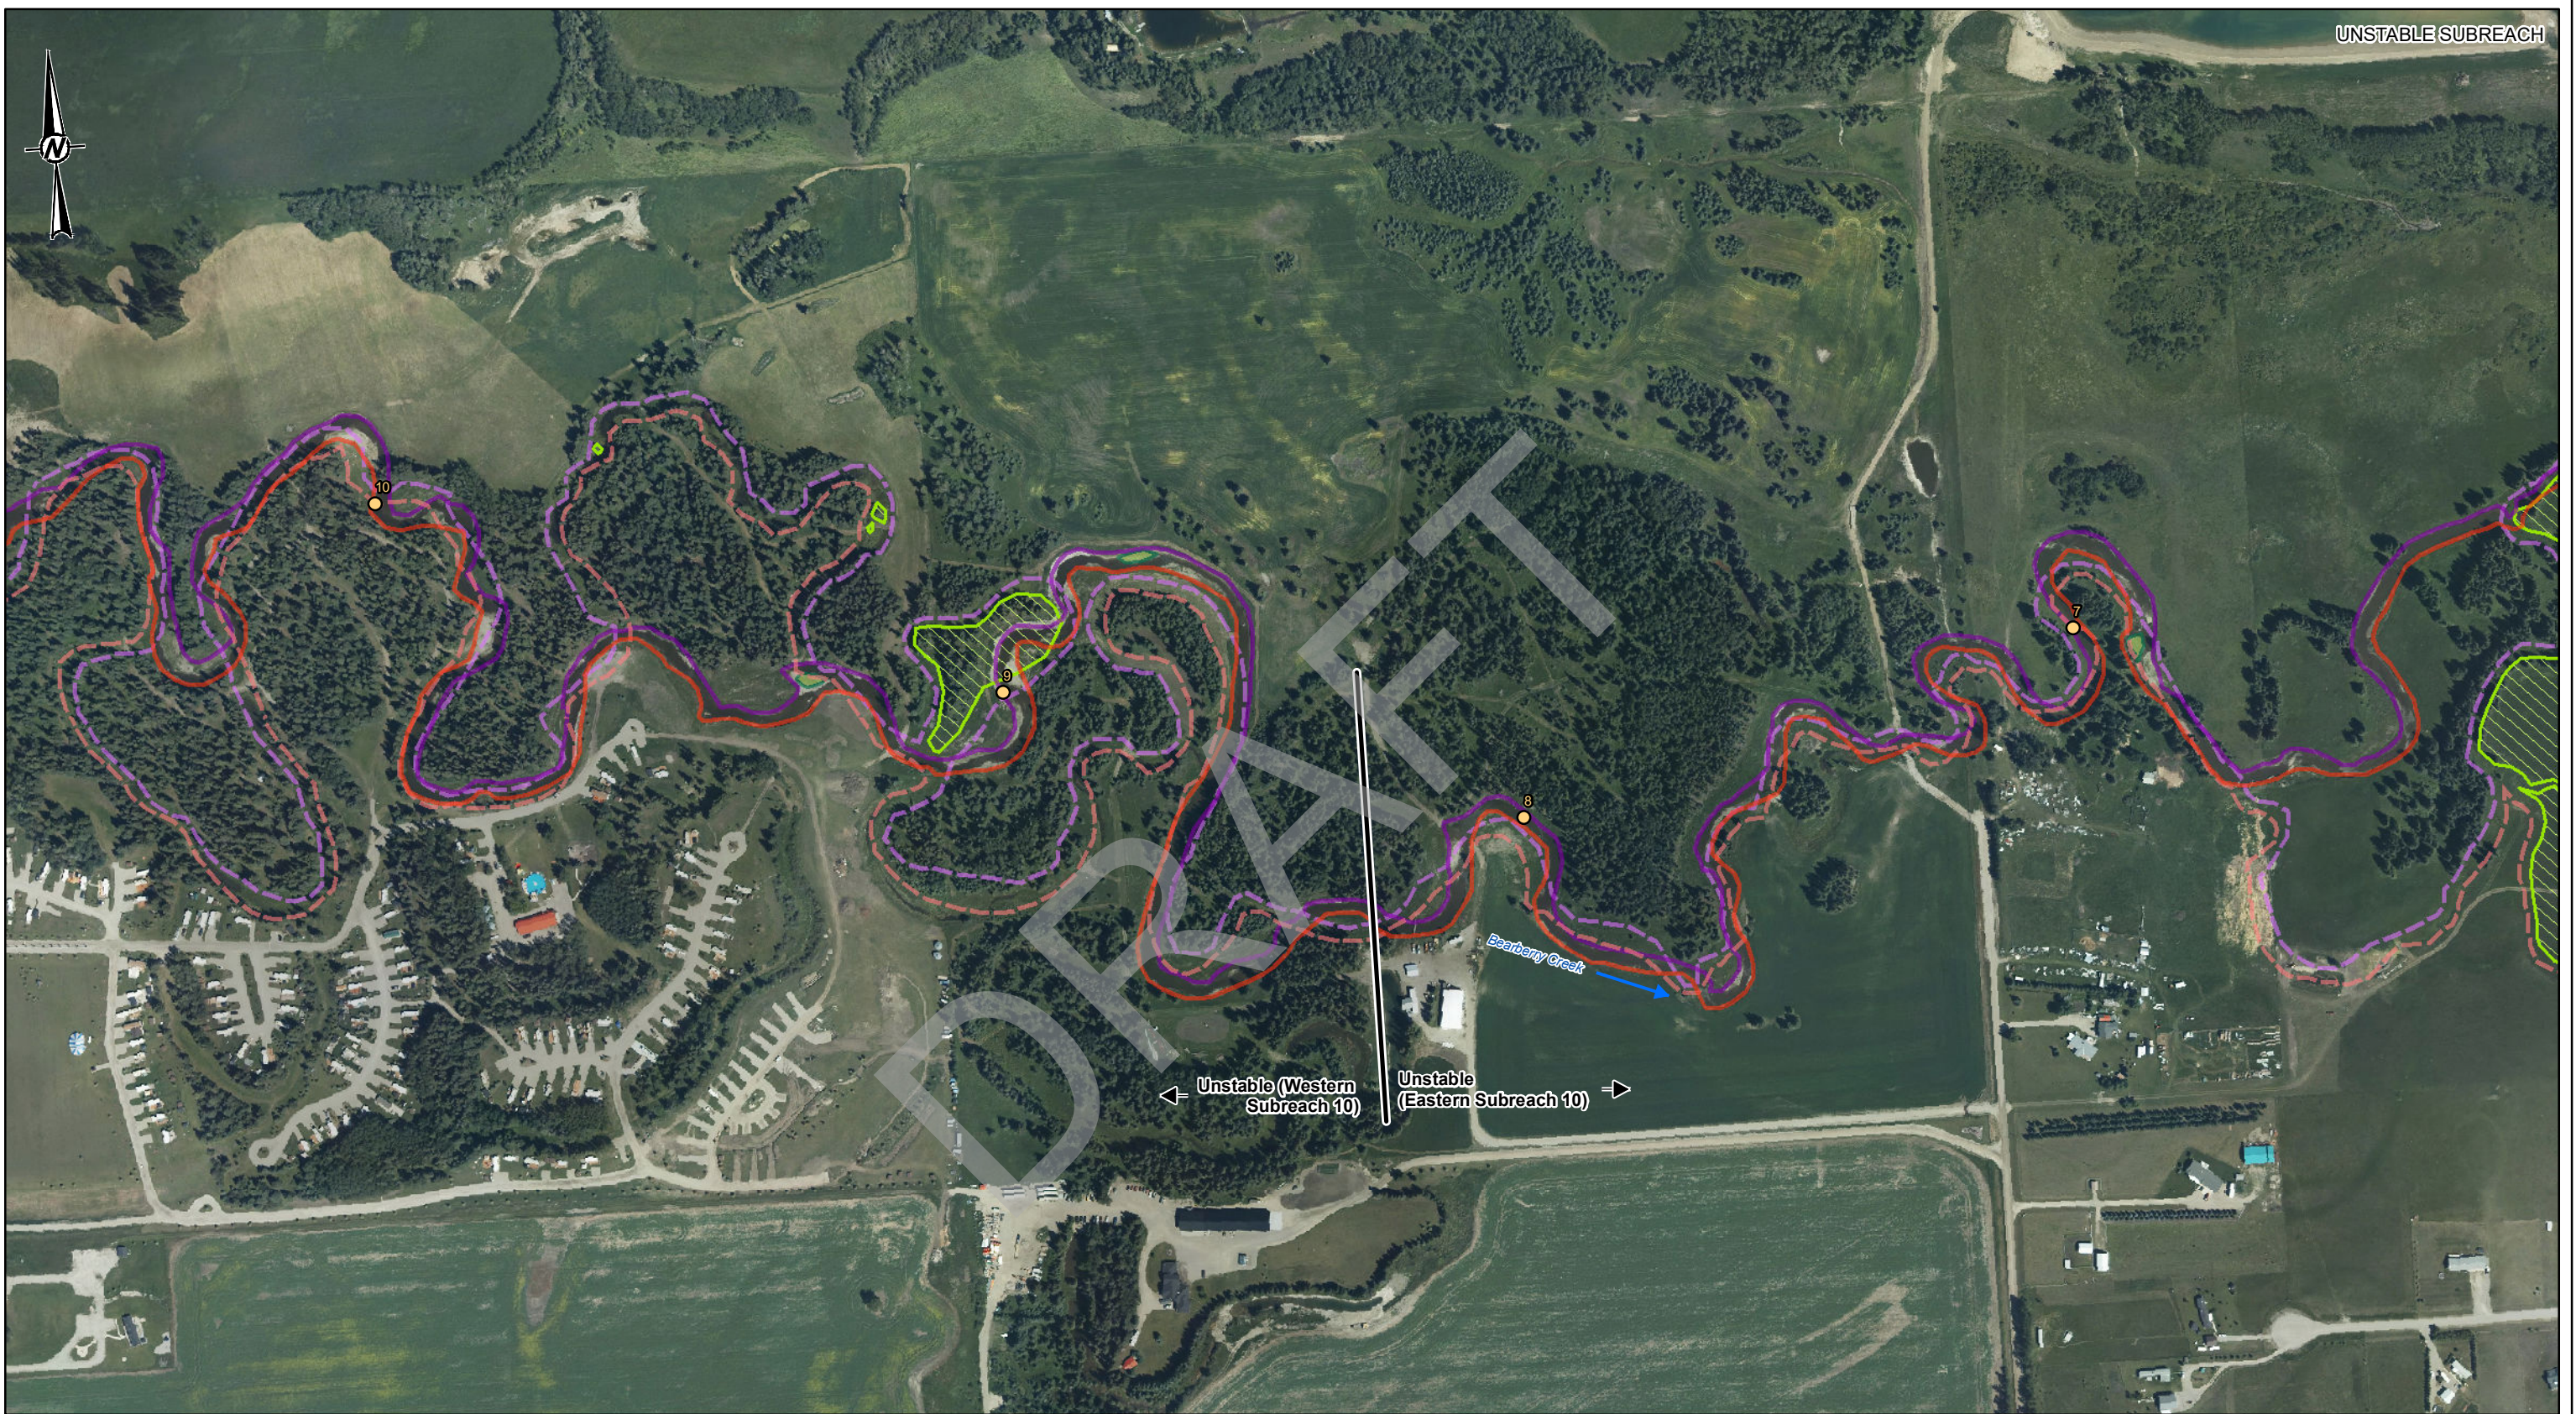
Reach 10 of Bearberry Creek is single-threaded with a torturous meandering planform. Occasional islands and side bars are present in this reach. Extensive migration at meander bends as well as avulsion due to meander bend cut-off were frequently observed, and the channel degraded locally. This reach is considered unstable.

TITLE
CHANNEL BANK COMPARISON OF REACH 10 - BEARBERRY CREEK FROM COWBOY TRAIL TO STN 13+300 - REPRESENTATIVE SUBREACHES

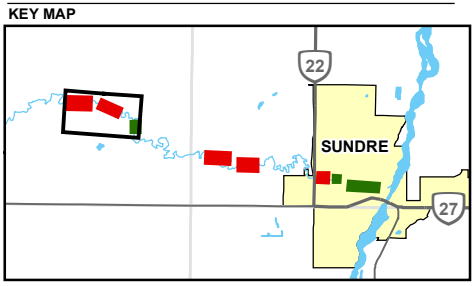
PROJECT NO. 1783057 CONTROL 8000 REV. 0 FIGURE 13

Reach 11 of Bearberry Creek is characterized by a single-threaded, meandering channel with a low sinuosity, and the channel alignment has remained approximately stable over the observed period. There are no apparent bars or islands present. This reach is considered stable.

Reach 12 of Bearberry Creek is single-threaded with a torturous meandering planform. Extensive migration at meander bends as well as avulsion due to meander bend cut-off were frequently observed. Islands and side bars are rare. This reach is considered unstable.

Reach	Representative Subreach (km)	Description
Reach 12 (Bearberry Creek)—STN 14+200 to STN 17+100	15-16	<ul style="list-style-type: none"> ■ Single-threaded, torturous meandering planform ■ Rare small side bars present ■ Channel corridor is unconfined ■ Channel corridor bend has been cut off, abandoning approximately 100 m of channel ■ Channel corridor has migrated approximately 10 m on outer bend ■ Subreach is considered laterally unstable
	16-17	<ul style="list-style-type: none"> ■ Single-threaded, torturous meandering planform ■ Rare small mid-channel and side bars ■ Channel corridor is unconfined ■ Channel corridor bends have been cut off in two locations abandoning approximately 300 m and 770 m of channel, respectively ■ Channel corridor migration on outer bends of typically ~20-40 m ■ Subreach is considered laterally unstable

TITLE
CHANNEL BANK COMPARISON OF REACHES 11 AND 12 - BEARBERRY CREEK UPSTREAM OF STN 14+200

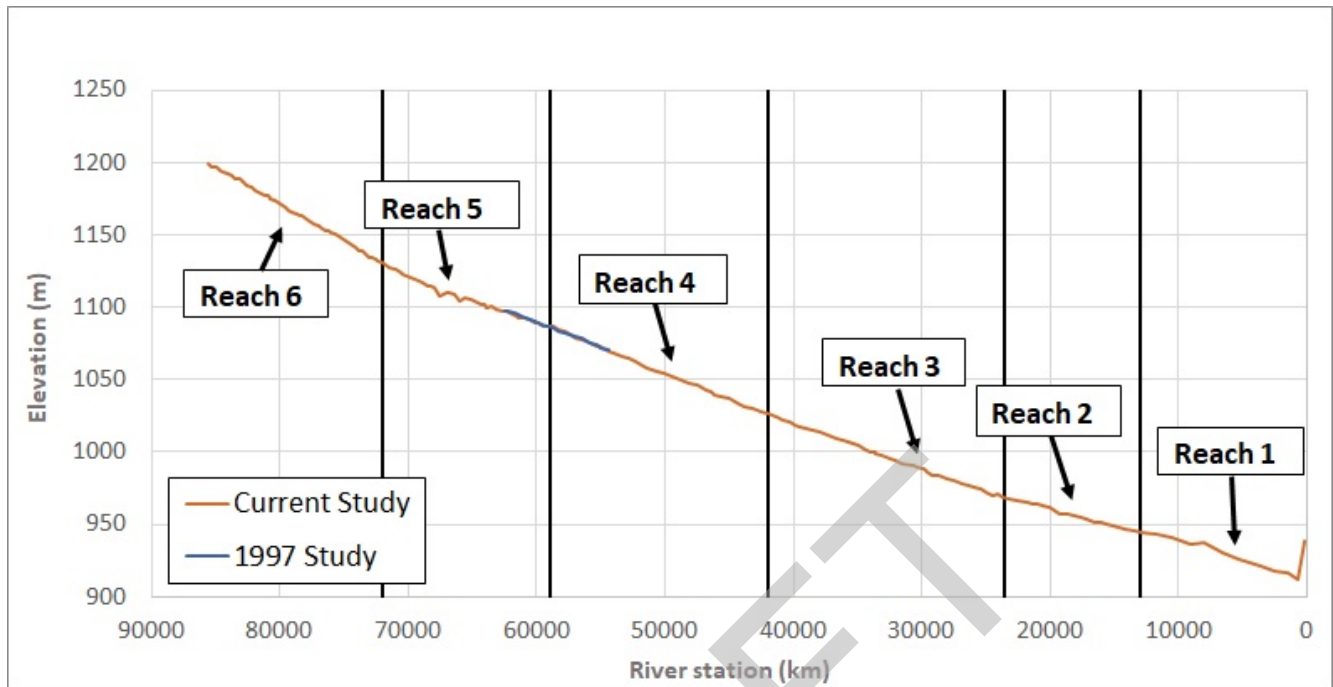
Figure 16: Longitudinal profile for Upper Red Deer River

Longitudinal profiles exhibiting a concave shape are typical of a stream reach in equilibrium (Ritter et al., 1995). The longitudinal profile for the Upper Red Deer River (Figure 16) exhibits an approximately concave profile with the exception of Reaches 4 and 5, where the profile is slightly convex. The Bearberry Creek longitudinal profile (Figure 17) is convex, which suggests that the river is generally out of equilibrium. More details on each river are provided below.

There is a discontinuity in the longitudinal profile in Reaches 4 and 5. The gradient in Reach 4 (approximately 0.0036) is slightly greater than the gradient in Reach 5 (approximately 0.0034), and the bed elevation is not stable over the observed period. Reach 5 is characterized by degradation; over the downstream ~4 km of the reach, the thalweg has lowered up to 2 metres (Figure 18) and the reach has experienced a net loss of over 2,000 m³ of sediment per unit channel width (Table 7). The cause of the degradation is not apparent; however, one possibility is that the ability of the river to transport sediment has increased. Since the partial abandonment of the northern fork of the Red Deer in Reach 5 over the observed period (see Section 4.2.5), the southern fork will have received a greater proportion of flow, which may have increased the overall stream power in the reach. The rate of sediment transport is typically proportional to stream power.

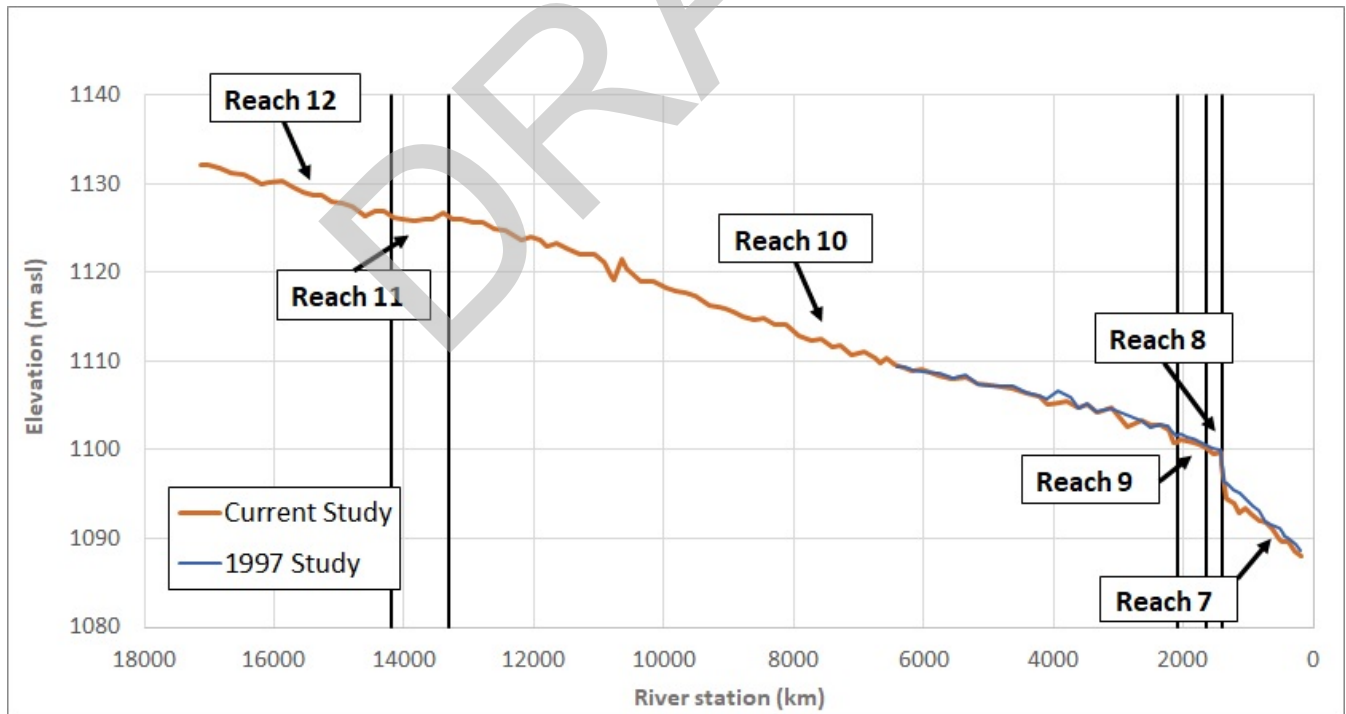
Figure 17: Longitudinal profile for Bearberry Creek

Bearberry Creek flows through typically gentle terrain on the Prairies. In general, the gradient of Bearberry Creek increases in the downstream direction; it is approximately 0.0020 in Reach 12 and 0.0057 at the stream mouth. The exception is Reach 11, where the gradient locally flattens to approximately 0.00010 (Figure 17). Historical thalweg data is not available for this reach, so it is unclear whether the bed elevation is stable. The channel has not apparently migrated or experienced width change like surrounding Bearberry Creek reaches (see Section 4.2.11), so it is possible that there is a geologic control that defines the gradient and channel position.

Reaches 7, 8, and 9 are steeper than the upstream reaches. They have all been artificially straightened, and this typically results in gradient increases because the length of stream decreases while the total elevation change remains approximately the same. Net degradation has occurred in all three reaches over the observed period (Table 7, Figure 19) and has generally resulted in an overall lowering of the bed as well as the creation or deepening of pools (Figure 17). Reach 10 has experienced net degradation as well, possibly as a response to a lowering base level downstream. However, degradation appears to have been primarily limited to two locations: a pool was scoured at approximately river station 2+800, and a wedge of sediment roughly one kilometre upstream of the pool was evacuated.

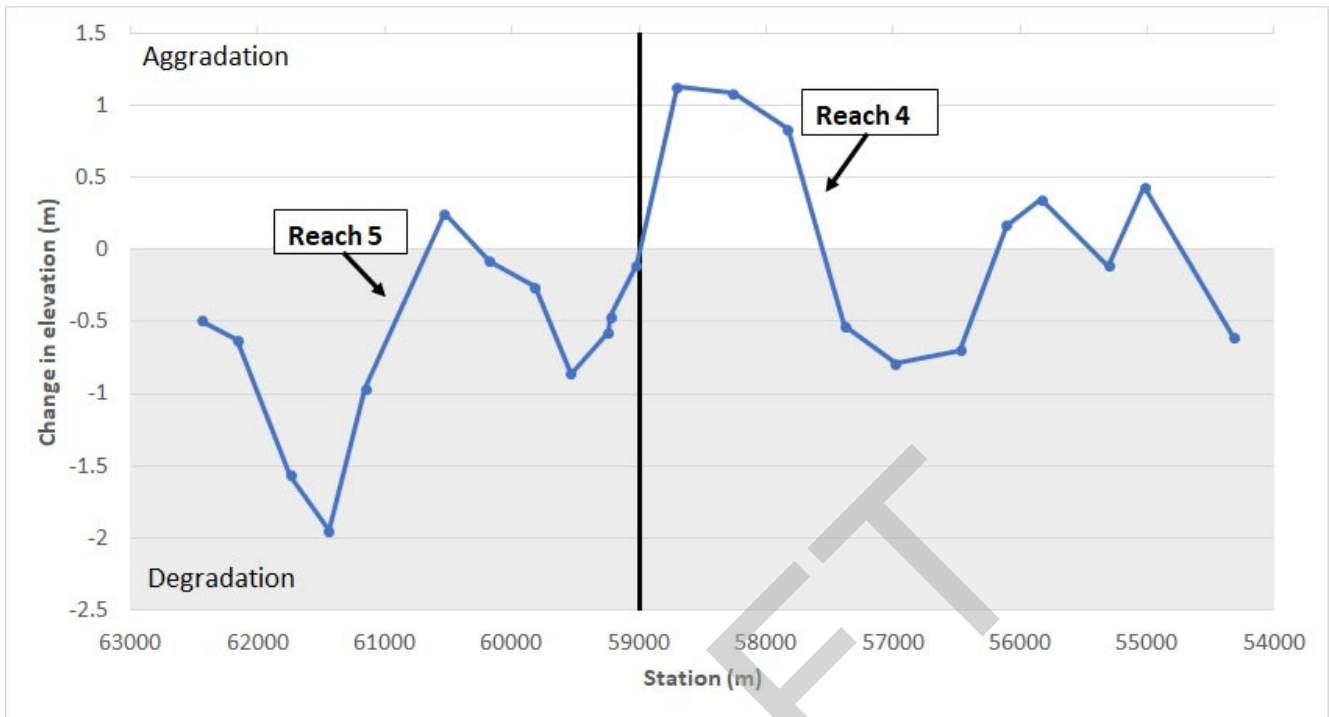
Figure 18: Upper Red Deer River thalweg elevation difference

Reach 4 has accumulated just under 1,000 m³ of sediment per unit channel width in river kilometres 54 to 59 over the observed period. Most sediment deposition has occurred in the first kilometre downstream of Bearberry Creek (Figure 18), where the thalweg elevation has risen approximately 1 metre over the observed period. Much of this sediment is likely sourced from Reach 5 as well as Bearberry Creek, which has also experienced a net loss of sediment over the observed period (see below). Degradation has occurred over river kilometres 56 to 58, likely because of the local increase in slope due to deposition upstream. The thalweg elevation has remained more stable over river kilometres 54 to 56.
