HIGHWAY 63:11 PINCH POINT EAST WALL NORTH OF ATHABASCA RIVER BRIDGE IN FORT MCMURRAY, ALBERTA

GEOVANCOVER
2016

Tarek Abdelaziz, Donald Proudfoot
Thurber Engineering Ltd., Edmonton, Alberta, Canada

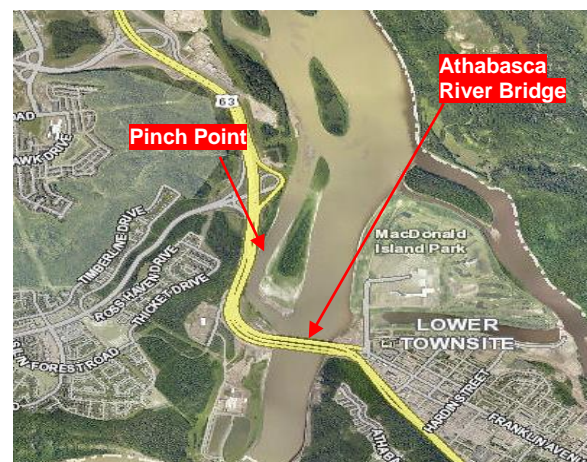
Figure 1. Satellite image showing site location

Point” that governed the highway upgrading design. Figure 1 presents a satellite image of the project site.

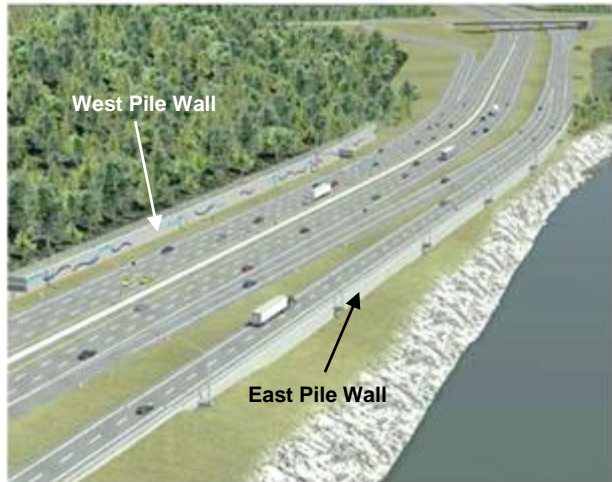
Figure 2. Artistic depiction of upgraded Hwy 63 and East and West Retaining Walls, looking north

In order to accommodate the substantial increase in the out-to-out width of the roadway corridor from 33 m to 68 m a 420 m long secant pile wall, known as the West or Hillside Pile Wall (WPW), was constructed on the west side of the highway, and a 320 m wall, known as the Riverside or East Pile Wall (EPW) was constructed on the east side of the highway. An artistic depiction of the east and west walls is shown on Figure 2. The construction of both walls was completed between June 2010 and July 2012 and the construction cost was in the range of 21 Million Dollars. Although both walls are equally important to the success of the overall widening scheme, the EPW is the focus of this paper. Provided herein is a summary of the design and construction aspects of the wall, including a brief discussion of the instrumentation monitoring results.

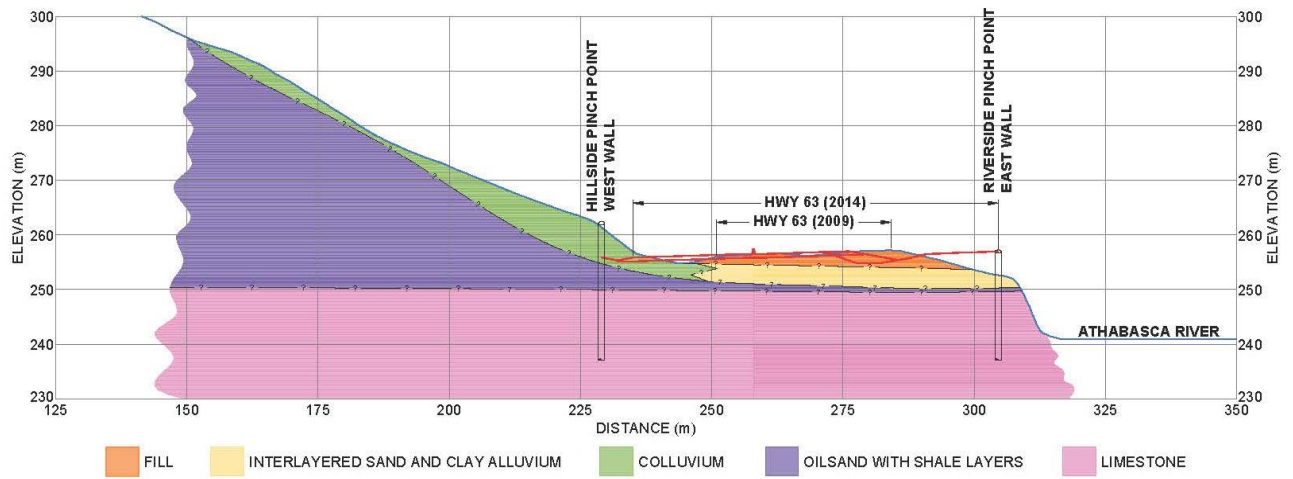
Figure 4. Simplified stratigraphic cross section at the Pinch Point location

A geotechnical investigation, consisting of auger and core holes and installation of slope inclinometers and piezometers, was carried out by Thurber Engineering Ltd. between 2006 and 2008. The study characterized the sub-surface conditions and provided design recommendations for the walls. A shaded relief plan showing the old and upgraded highway alignments, and the wall locations is presented in Figure 3. A simplified stratigraphic cross section of the highway at the pinch point location is also presented in Figure 4.

The subsurface conditions at the highway generally consist of clay fill underlain by about 2 to 10 m of interbedded loose sand and firm clay (alluvial deposits) over 1 to 2 m of dense to very dense oil sand with clay shale interbeds overlying interbedded weak to extremely argillaceous limestone and strong to medium strong nodular and biomicritic limestone bedrock. The oil sand thickness appears to thin out near the banks of the river and the limestone surface elevation varies by about 3 to 4 m along the highway alignment. The upper 1 m of the limestone bedrock is closely jointed and weathered. The uniaxial compression strength of the McMurray formation typically ranges from less than 1 to 3 MPa (i.e. weak to extremely weak bedrock). For the Devonian Formation, the uniaxial compression strength typically ranges from less than 1 MPa (i.e. extremely weak argillaceous limestone bedrock) to more than 50 MPa (i.e. strong nodular and biomicritic limestone). Groundwater table is about 5 to 13 m below ground surface.

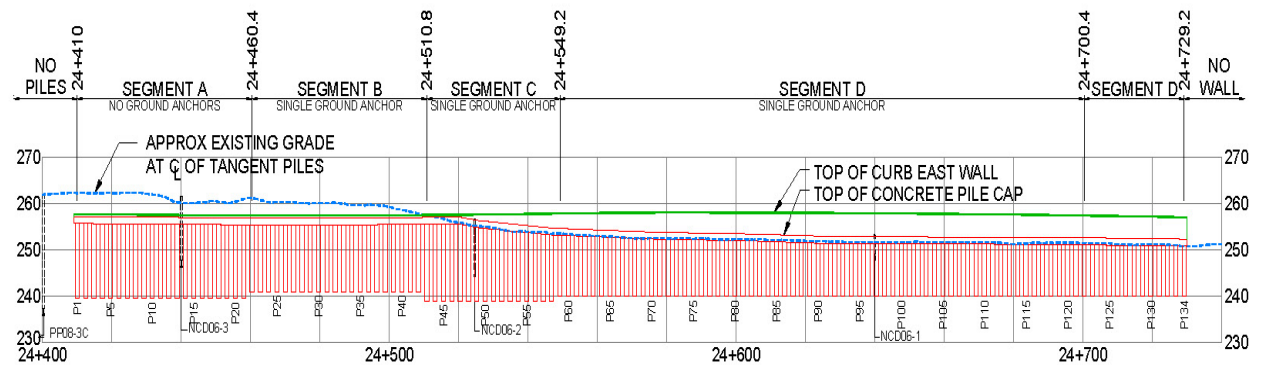
Figure 5. Design profile along the EPW alignment

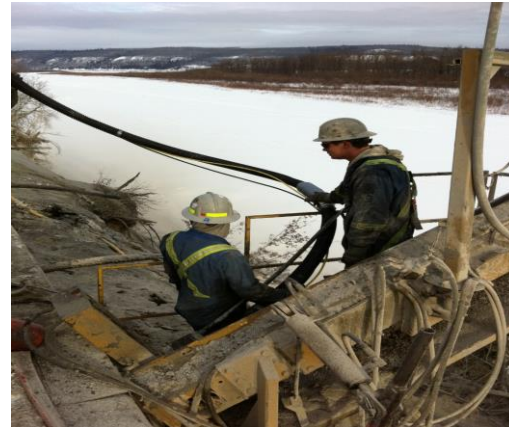
Figure 9. Feeding strands into anchor holes

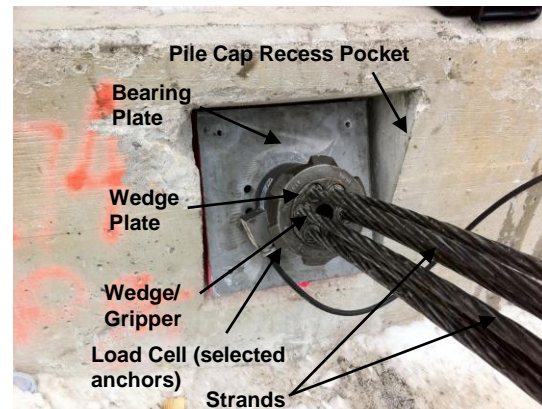
Figure 10. Strand anchor anchorage system

The production anchors were grouted in two stages. The first stage included grouting the anchor corrugated sheathing in the free zone to about 2 m below the recess pocket, followed by cutting the individual Polyethylene smooth sheathing for each of the strands to 25 mm below the recess pocket. A temporary bearing plate was used to complete the proof and performance load tests of the anchors. Each of the production anchors was proof loaded to 1.33 times the design load using a C1437 hydraulic jack. Creep testing was undertaken on all production anchors for 10 min, and all anchors passed the creep acceptance criterion. After passing the proof load test, a permanent bearing plate, complete with a 2 m long trumpet and a grouting hole, was affixed to the recess pocket. The strands were fed into a re-stressable wedge plate placed on the bearing plate followed by placing the gripper/wedge on each of the strands. The DSI HOZ Tensa 1700 multi-strand hydraulic jack was used to lock off the anchors. For each of the design segments, the anchor free length elastic elongation was estimated and the jack load was increased to account for 6.5 mm of wedge seating losses. The automatic seater was activated to seat the wedges simultaneously into the wedge plate. Once the wedges were set in place, the jack pressure was relieved to transfer the load into the anchor head. A lift off test was achieved through applying tension from the jack nose to confirm the transferred load was in the range of 5 percent of the lock off load. All anchors were locked off at 50 percent of the ultimate strength of the strands to eliminate the need of using shims. After completing the lock off, the jack was removed and the second stage of grouting was completed through the grout hole in the bearing plate to fill the annulus between the trumpet and the anchor hole. followed by injecting grease into the trumpet and the installation of a plastic protective cap. The anchor anchorage system is shown in Figure 10.

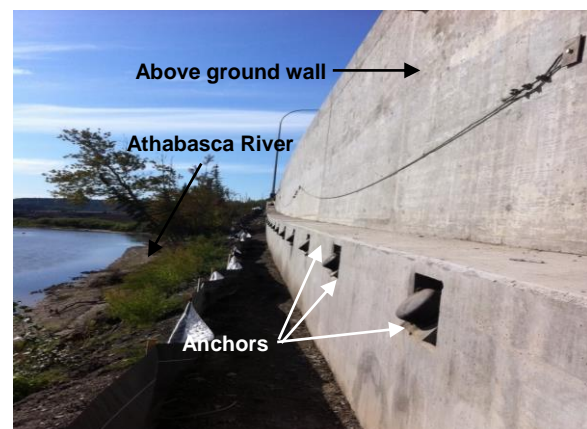
Figure 11. Looking south at the wall from the riverside

After completion of the underground pile wall, the above ground wall was constructed followed by backfilling against the wall and paving of the new highway surface. Figure 11 presents a view of the wall from the river side after construction completion.

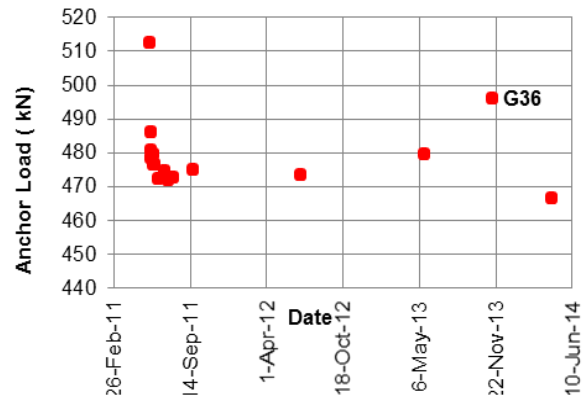
Figure13. Variation in G36 load versus time

The load cells exhibited different patterns of anchor load variation with time. At locations where the above-ground wall was not required, the anchors exhibited a behaviour similar to the pattern shown in Figure 13 for G36. Figure

13 shows an instantaneous loss of a portion of the anchor load, followed by a slower gradual loss until the load exhibited minor fluctuation with time. A similar behaviour of load loss in anchors has been reported by Benmokrane et al. (1991).

In general, the load loss in the anchors occurred within 60 days (Segment B) to 120 days (Segments C and D) after the installation date. The transition between the instantaneous and gradual drop of the load occurred within 45 days of locking off the anchors. The loss of anchor loads generally ranged from less than 10 percent (Segment B) to up to 15 percent (Segments C and D). Since the anchors were locked off at 50 percent of the elastic yield stress of the steel, it was not possible to attribute the load reduction to stress relaxation. For the monitored anchors, it appears that the load loss tends to increase as the free length increases and the number of strands increases. It is speculated that the initial sharp reduction in anchor loads may have occurred due to seating losses and friction losses in response to the “wobble” effect. The gradual loss may be attributed to the non-simultaneous locking of anchors and re-distribution of loads along the wall with time. Relatively similar reductions in anchor loads have been observed in other pile wall projects and this phenomenon is not deemed a concern as long as it is not accompanied by unacceptable wall deflection and was serviceability issues.

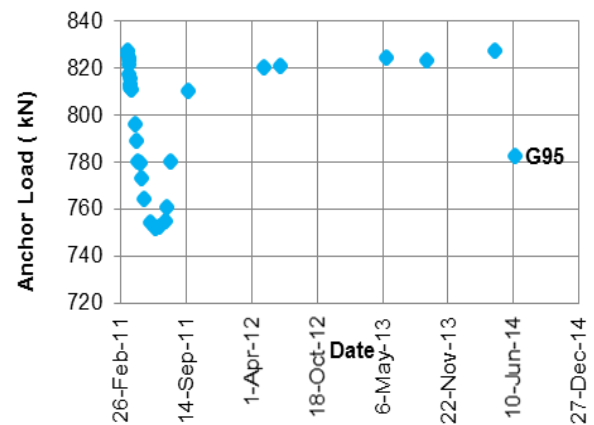
Figure14. Variation in G95 load versus time

Figure 14 illustrates a different pattern of behavior for anchors installed within the above-ground wall sections. Initially, the anchor showed a reduction in the load (similar to the pattern presented in Figure 13) followed by a gradual increase in the load before stabilizing with time. The increase in the anchor load corresponded to the placement and compaction of gravel backfill behind the wall. The increase in anchor loads ranged from 20 kPa

for 2 m high wall sections to up to 68 kPa for 6 m high wall sections.

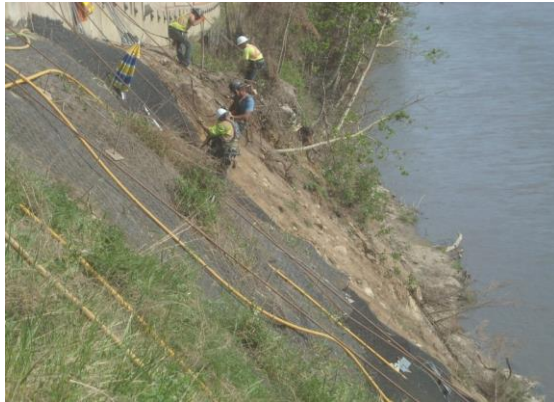
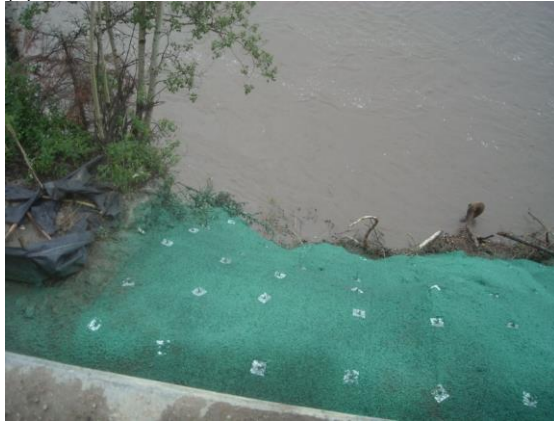
(a)

(b)

Figure 15. River bank erosion protection; (a) Mountain climbers installing MacMat R and (b) Hydro-seeded mat and final product

The slope protection included hydro-seeding and placement of a High Performance Turf Reinforcement Mat, MacMat R, installed along the eroded face of the alluvial deposit. This product is a three dimensional geocomposite consisting of a twisted steel wire mesh filled with a spun finer mesh of polypropylene yarn. The mat was anchored to the prepared slope surface using U shaped pins, and 1x1 m² grid of 1.5 m deep Manta Ray anchors and galvanized steel plates. The mat was also anchored to the limestone below the eroded surface and to the sides of the pile cap at the top of the slope. Due to the steepness of the slope, mountain climbers with safety

harness and cables anchored to the top of the wall were retained by the contractor to complete the installation (refer to Figures 15 a through b).
