Geohazard Reviews of Highway Corridors Through Mountainous and Foothills Terrain, Southwestern Alberta

Andrew Bidwell, M. Eng., P. Eng.
AMEC Earth & Environmental, Calgary, Alberta
Dave Cruden, Ph.D., P.Geol.
Department of Civil & Environmental Engineering, University of Alberta, Edmonton, Alberta
Roger Skirrow, M.Sc., P.Eng.
Alberta Transportation, Edmonton, Alberta

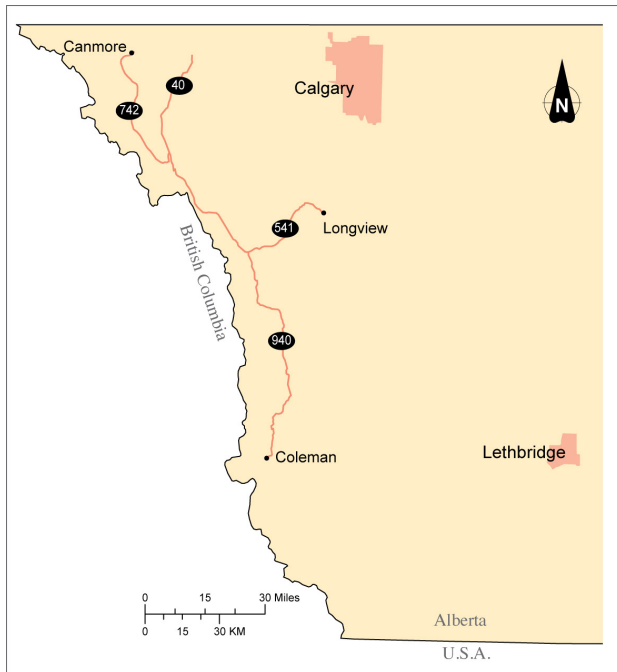
Figure 1. Locations of the Highway 40/541, 742 and 940 corridors, Southwestern Alberta.

The locations of the highway corridors that were reviewed are shown on Figure 1

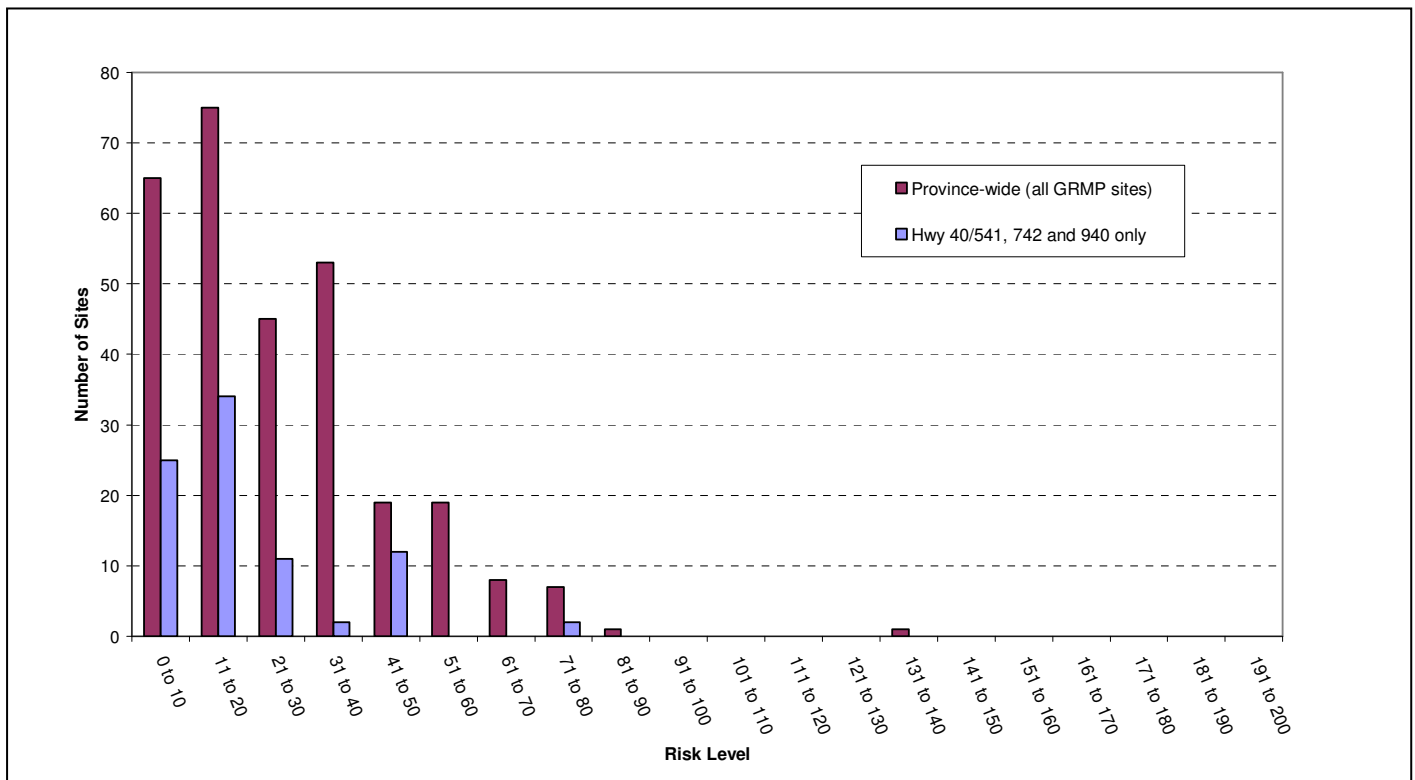
Figure 6. Histograms of Risk Levels for identified geohazard sites.

A histogram of the Risk Levels for the identified sites along Highways 40/541, 742 and 940 is provided in Figure 6, along with a histogram for AT's entire GRMP site inventory for comparison. Of note, no sites with multiple hazard types were found during the Highway 40/541, 742 and 940 corridor reviews and it was not necessary to cumulate the Risk Levels from individual hazards at any site.
