DESIGN STANDARDS/PRACTICE EXCEPTION REQUEST SUMMARY

Title: Highway 56:14 Improvement

Memorandum (or Approval) Date: May 7th, 2014 Design Exception Request Date: April 15th, 2014

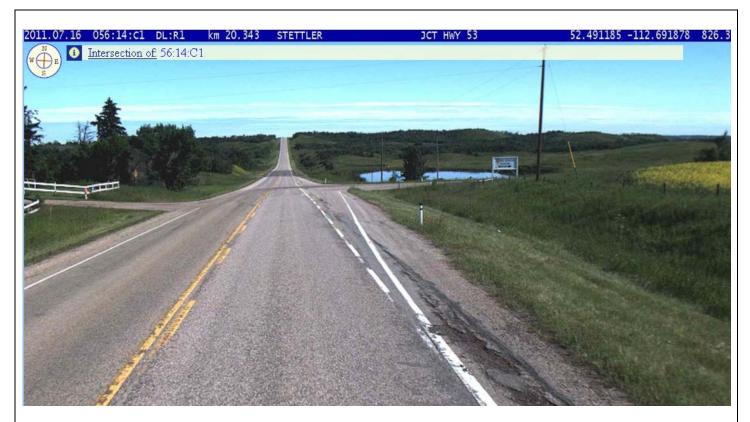
Hwy 56:14 Typical Road Cross-Section and Pavement Markings (Source: WebMap; km 20.343 looking North)

AT Design Bulletin #18/2013 for two-lane undivided highways require rumble strips to be installed on a minimum shoulder width of 1.4m. The design exception request is for rumble strips to be installed on a 1.1 m wide shoulder.
